Corrosion of Silver-Plated Copper Conductors

The purpose of this paper is to detail the findings of the metallurgical examinations performed by ESA on cables discovered to have degraded by red plague corrosion. In addition, an extensive laboratory test programme was undertaken in an attempt to gain a more comprehensive understanding of the red plague phenomenon. The aims of this programme will be discussed, as will the results achieved to date. A test method based on the laboratory procedures of Anthony & Brown¹ has been developed into a draft ESA specification, which is thought suitable for the acceptance-testing of fabricated wires and cables.

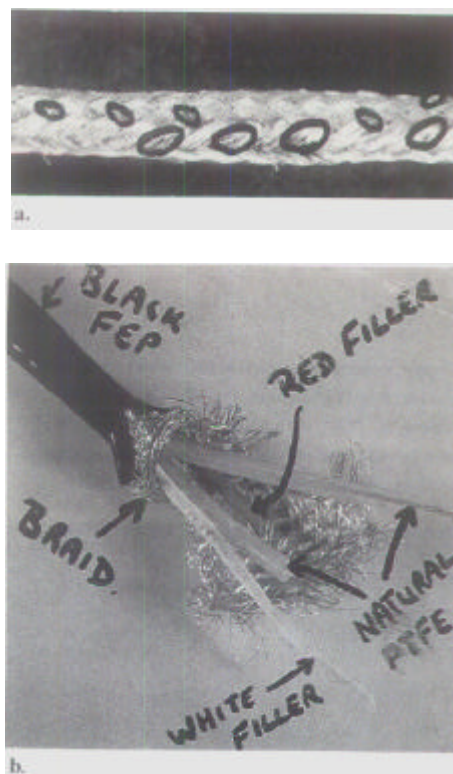
After removal of the outer jackets, many local areas of discolouration could be seen on the silver strands; they had a red, black and green-blue appearance. Several individual strands were noted to have shattered in a brittle manner (Figs. 1 & 2).

Figure 1. Appearance of the most severely corroded braid after approximately 5 years of storage. Despite the presence of many corrosion sites (circled in a), the braid is still mechanically intact and can be spread out (as in b)

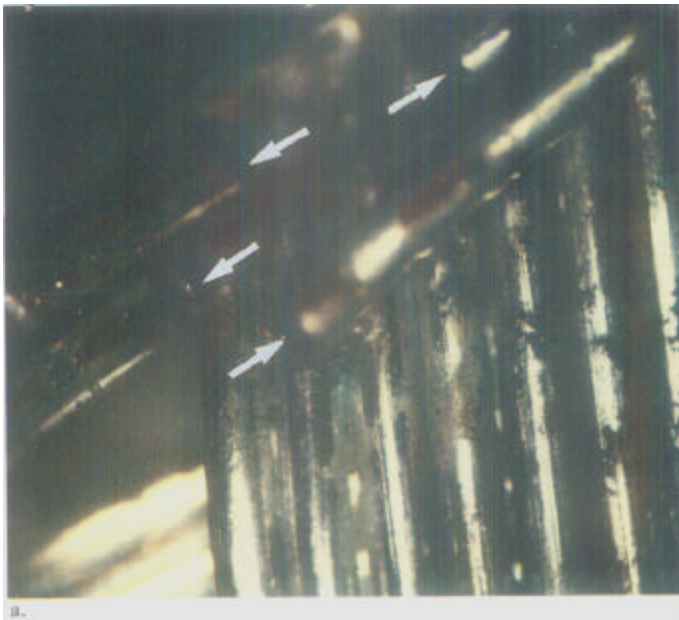
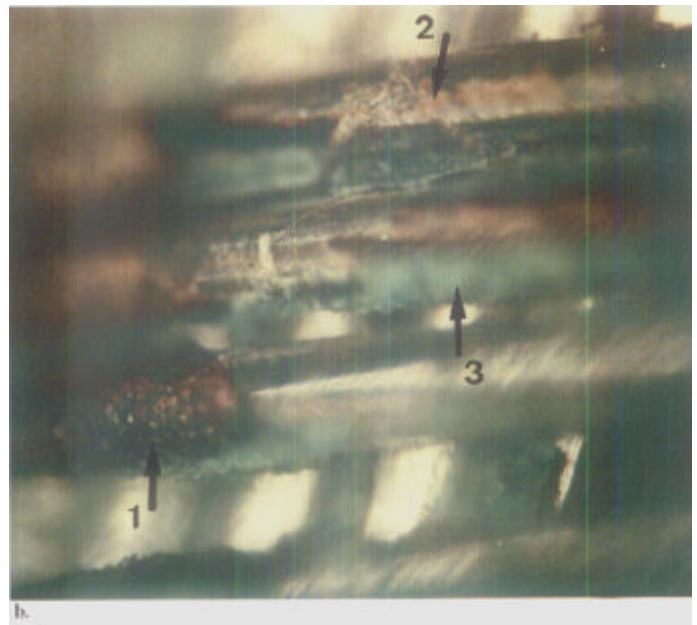
Figure 2. Colour photomicrographs of typical 'red-plague' corrosion areas on braiding, as circled in Figure 1.

- a. Red and green corrosion products associated with two strands that have completely broken; the brittle fracture surfaces are arrowed (x 100);
- b. Corrosion products are black (1), red (2) and green-blue (3)

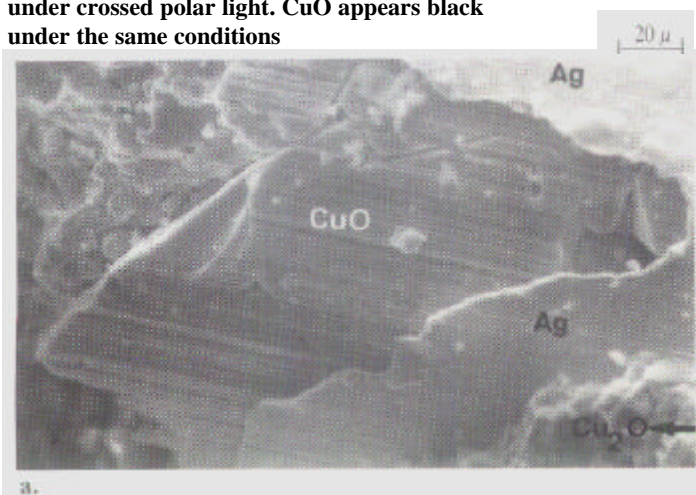
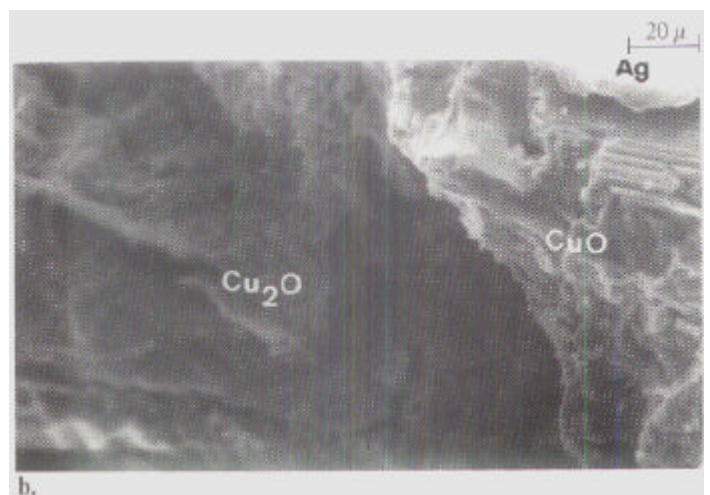
Examination of the corroded strands in the SEM showed them to consist entirely of brittle oxidised copper crystals. Adjacent strands supported crystals of cuprous oxide which were adherent to the silver platings (Fig. 3). Only the presence of copper, silver and a trace of chlorine were detected by EDAX analysis of the strand surfaces.

Figure 3. Scanning electron photomicrographs of fractured ends of strands from braid shown in Figure 2a. The Cu₂O phases are characteristically seen as ruby-red crystals under crossed polar light. CuO appears black under the same conditions

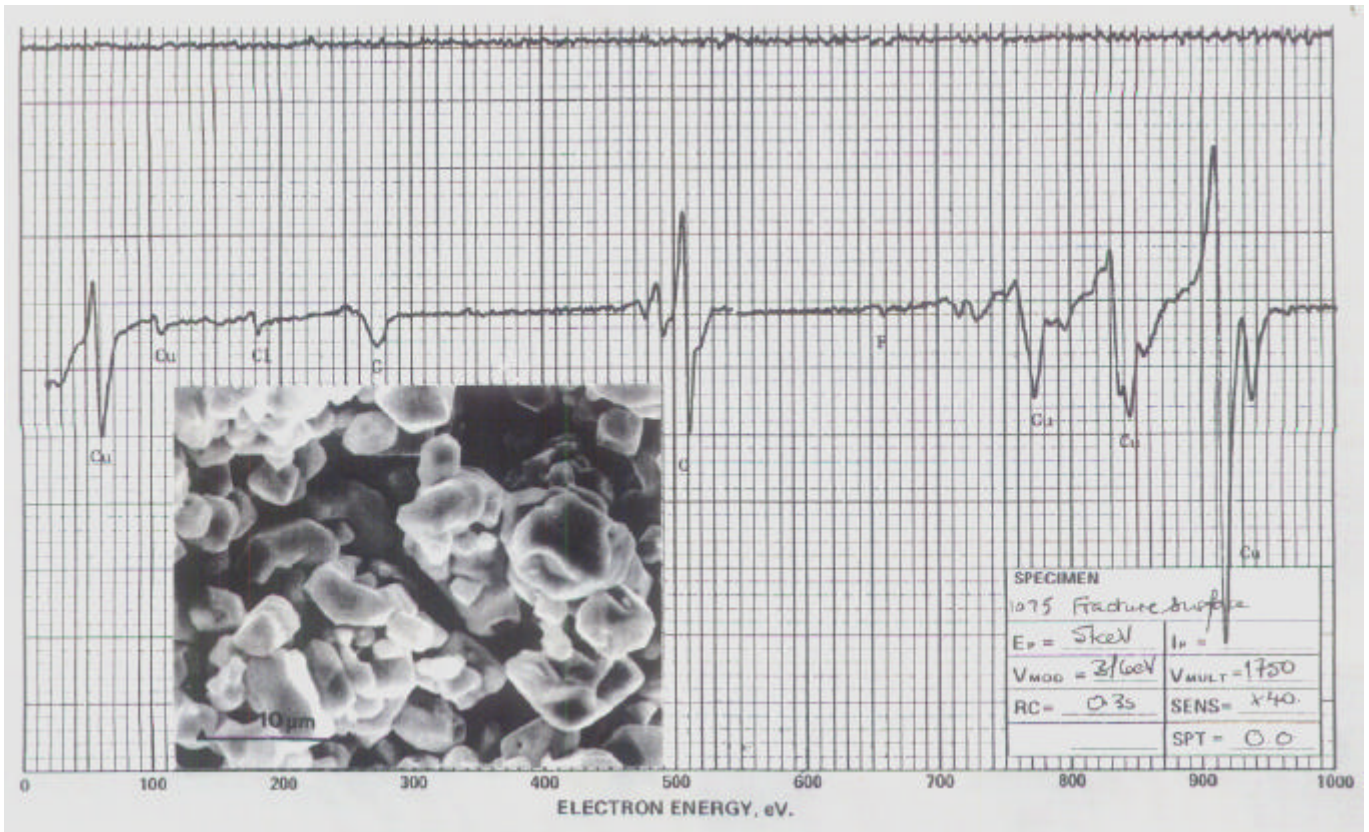
Auger examination revealed that both the silver surfaces, and the copper-oxide films were contaminated by chlorine and fluorine to a maximum of 5 at%. Depth profiles revealed fluorine in the silver plating to a depth of 40 Å. Further Auger analyses also detected the presence of chlorine and fluorine at the central area of the strand fracture surface. This area was composed entirely of copper-oxide crystals (Fig.4). Both chlorine and fluorine, when present as free ions, would tend to be an accelerating factor in any galvanic corrosion mechanism.

Figure 4. Secondary electron image of the copper-oxide crystals seen at the centre of a corroded and fractured strand. The SEM image is superimposed on the Auger analysis of this area (showing traces of chlorine and fluorine associated with copper oxides)

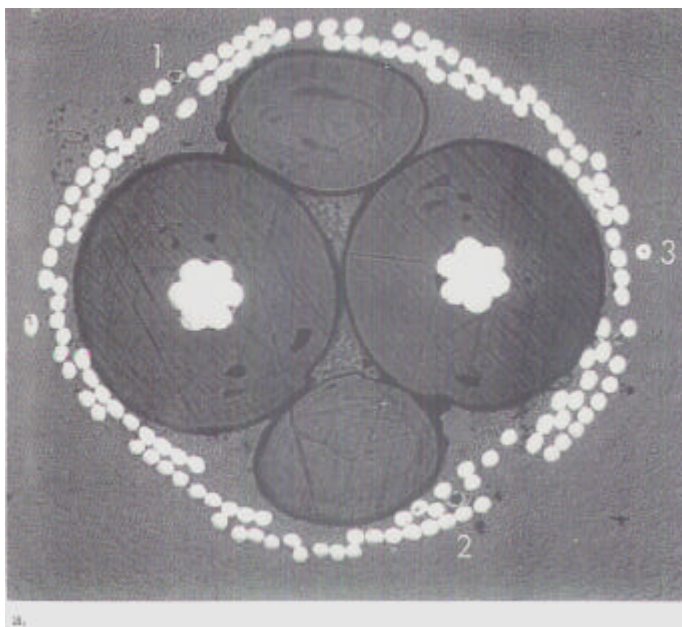
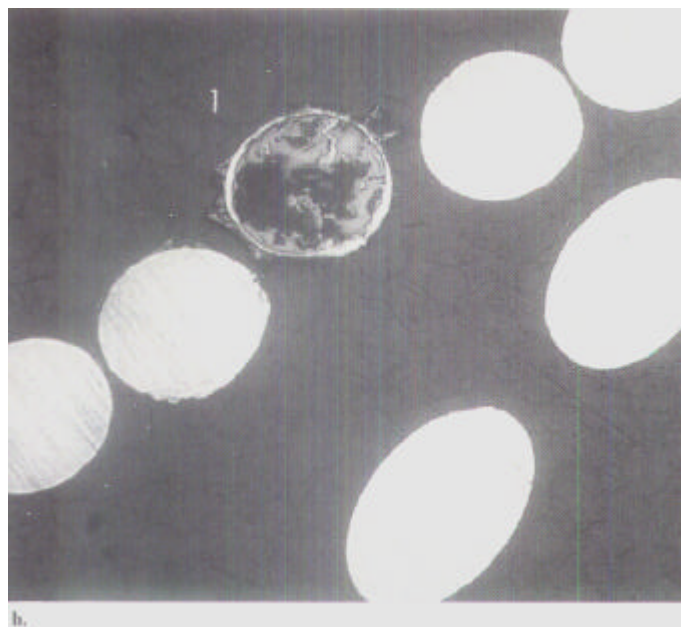
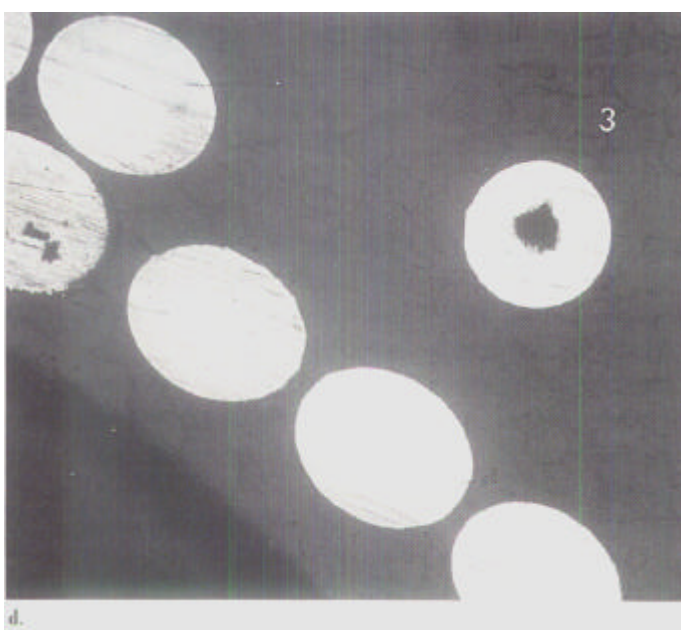
Figure 6a. Section through X -X (see Fig. 5), the superimposed numbers referring to corroded strands. Three of the 143 strands are corroded to some extent (2.1%)

Figure 6b. Detail of strand no. 1 from Figure 6a. Adjacent strands are uncorroded, but support crystals of cuprous oxide (x150)

Figure 6d. Tunnelling corrosion along strand no. 3 (x 150)

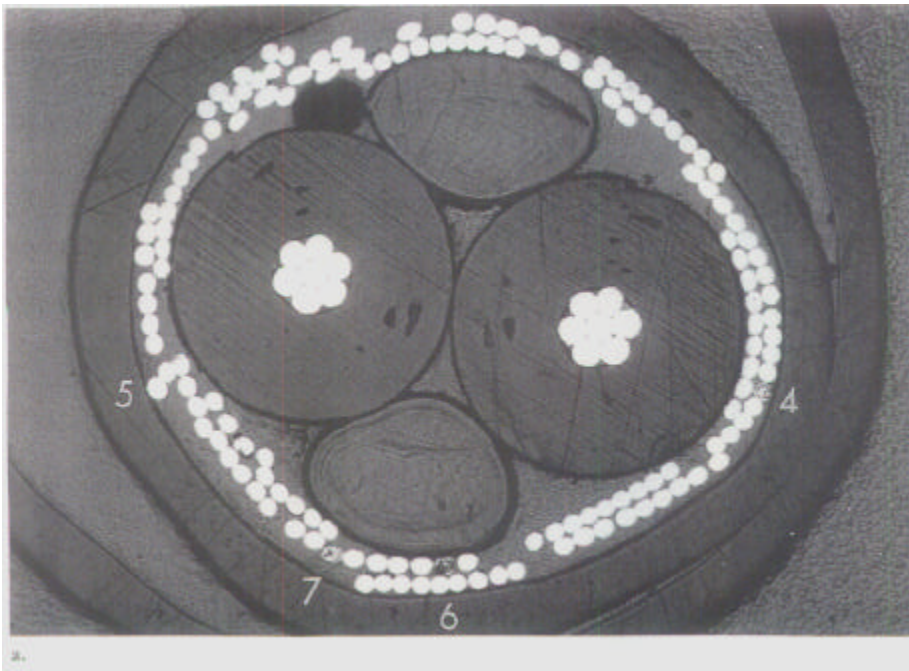
It is noticeable that the outer jackets are loose-fitting and particularly suitable for the ingress of moisture from unsealed cable ends. The volume of air that is contained within the 125 Ω cable has been derived from the transverse cross-section shown in Figure 7a.

Figure 7a. Section made through Y-Y (see Fig. 5). Superimposed are numbers referring to corroded strands. Four of the 143 strands are to some extent corroded (2.8%) (outer FEP jacket has been peeled back and appears as two rings)

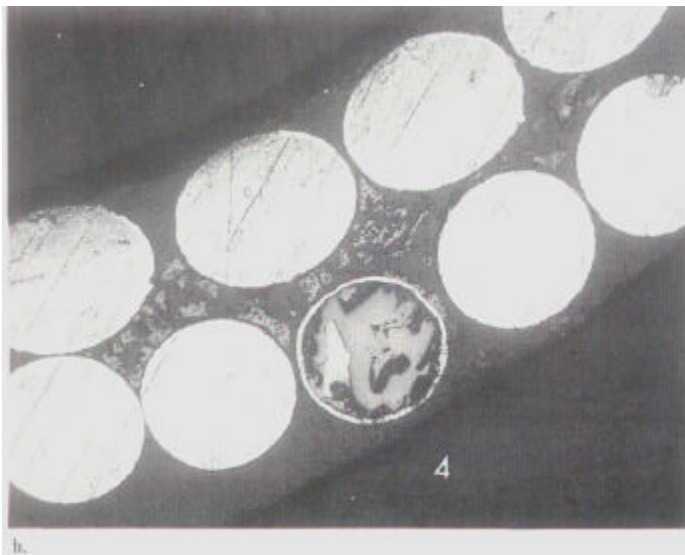
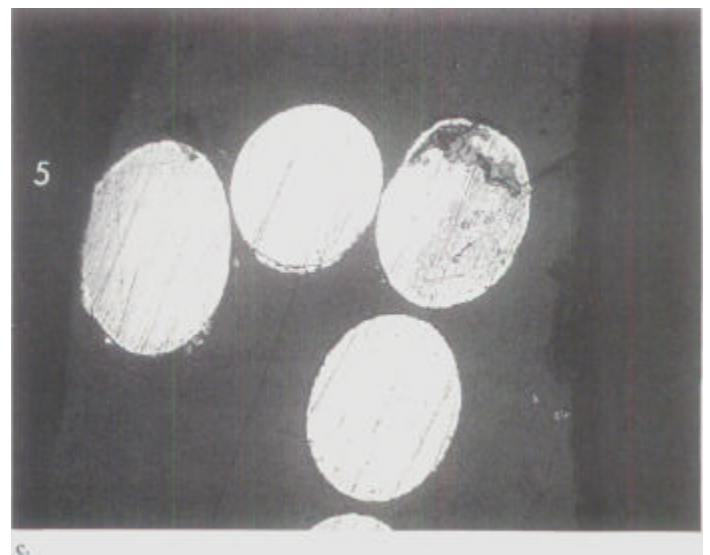
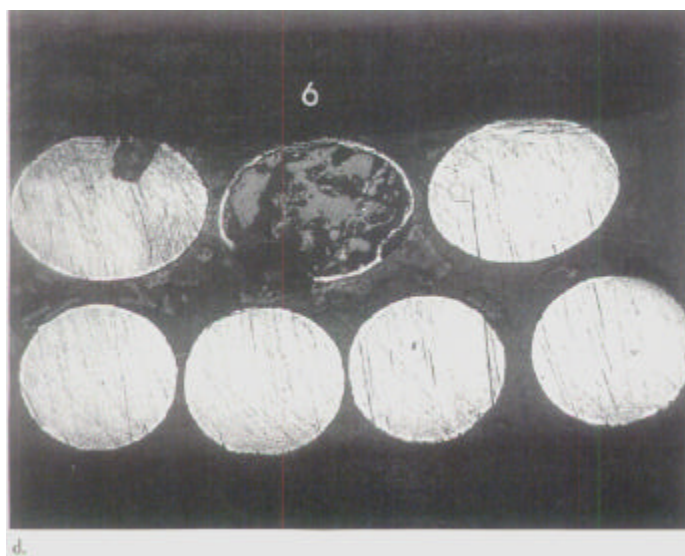
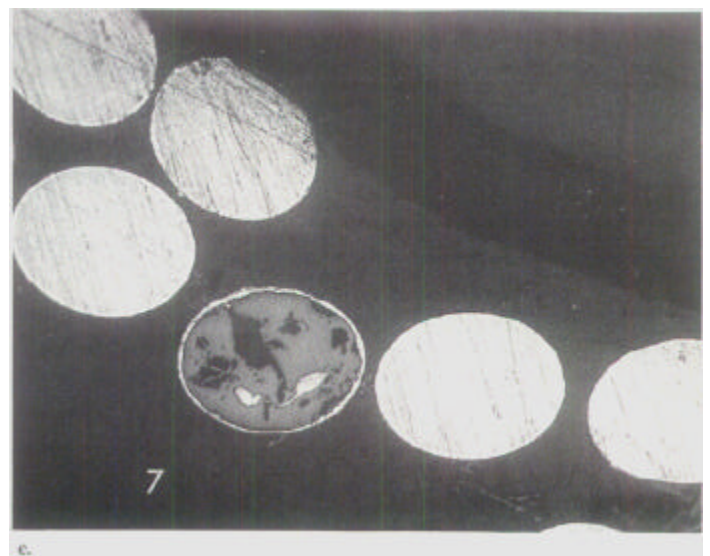
Figure 7b. One corroded strand is surrounded by non-corroded adjacent strands covered by cuprous-oxide crystals. Note large air gaps between outer FEP jacket and inner wire insulants (x 150)

Figures 7c-e. Remaining corroded strands in section Y-Y (x 150)

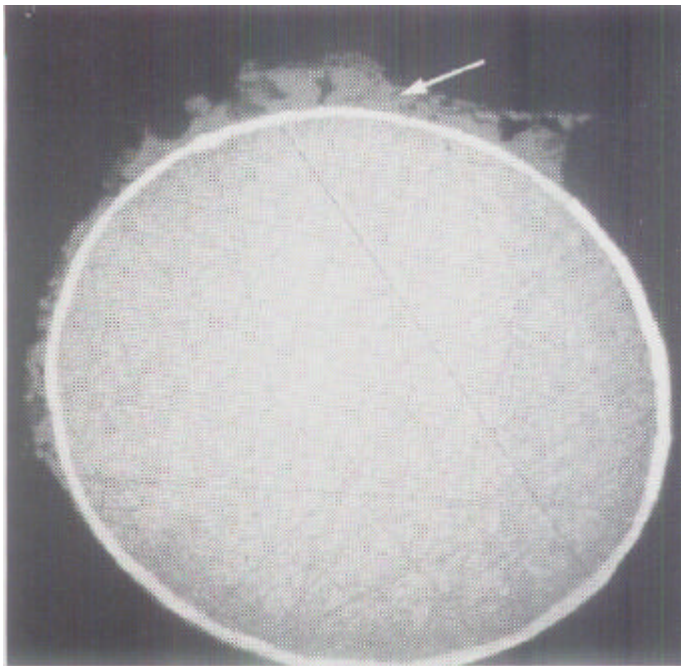
Figure 8. Section through red crystals on the intact 2 - 3 μm thick silver coating on strand from corroded braid (x 600)

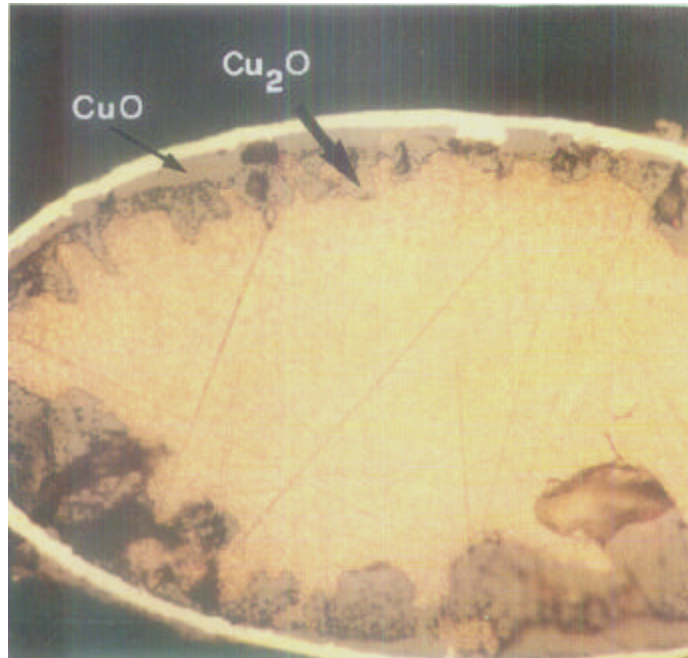
Figure 9. Colour micrograph clearly showing the various copper oxides to have 'tunnelled' beneath the silver coating. They are also present on the outer surface (x 600)

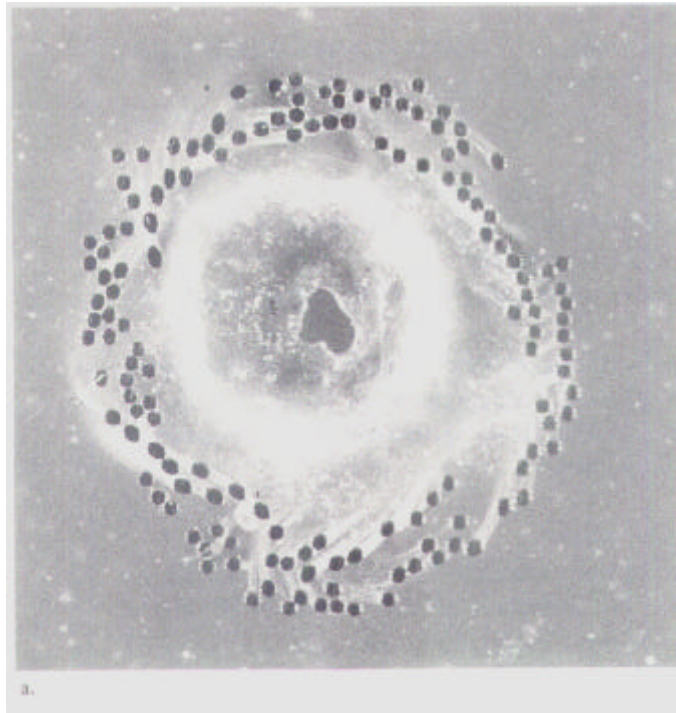
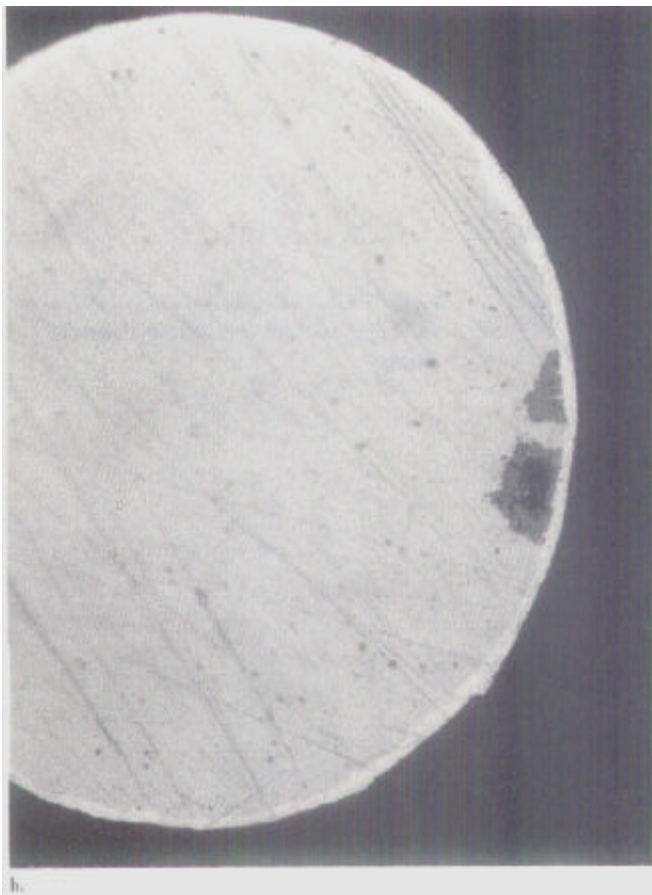
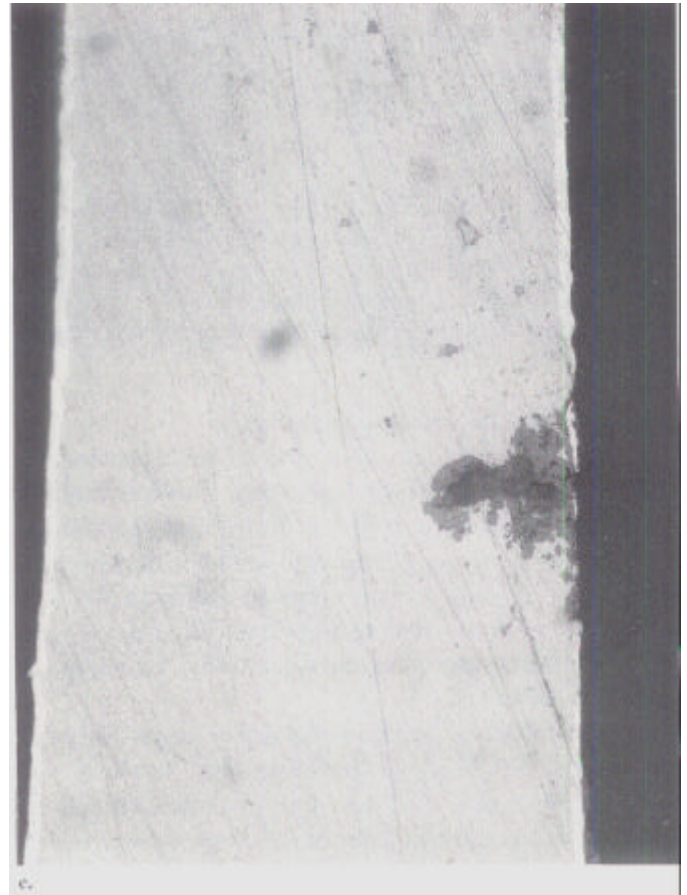
Figure 18. Transverse and longitudinal sections through red-plague corrosion site on sample no. 16. The braid consists of 144 strands, of which only two-support copper corrosion. All strands are of 2 mm silver-plated copper. The insulation materials are black FEP for the outer jacket and natural PTFE on the inner conductors. The longitudinal sections show that galvanic corrosion has initiated at local breaks in the silver plate (after 10d of accelerated corrosion testing).

- a. Outer braid sectioned across site of worst corrosion. Note braid has 144 strands, two of which show signs of internal corrosion
- b. Transverse section through worst corrosion site (x 800)
- c. Longitudinal section through worst corrosion site (x 600)

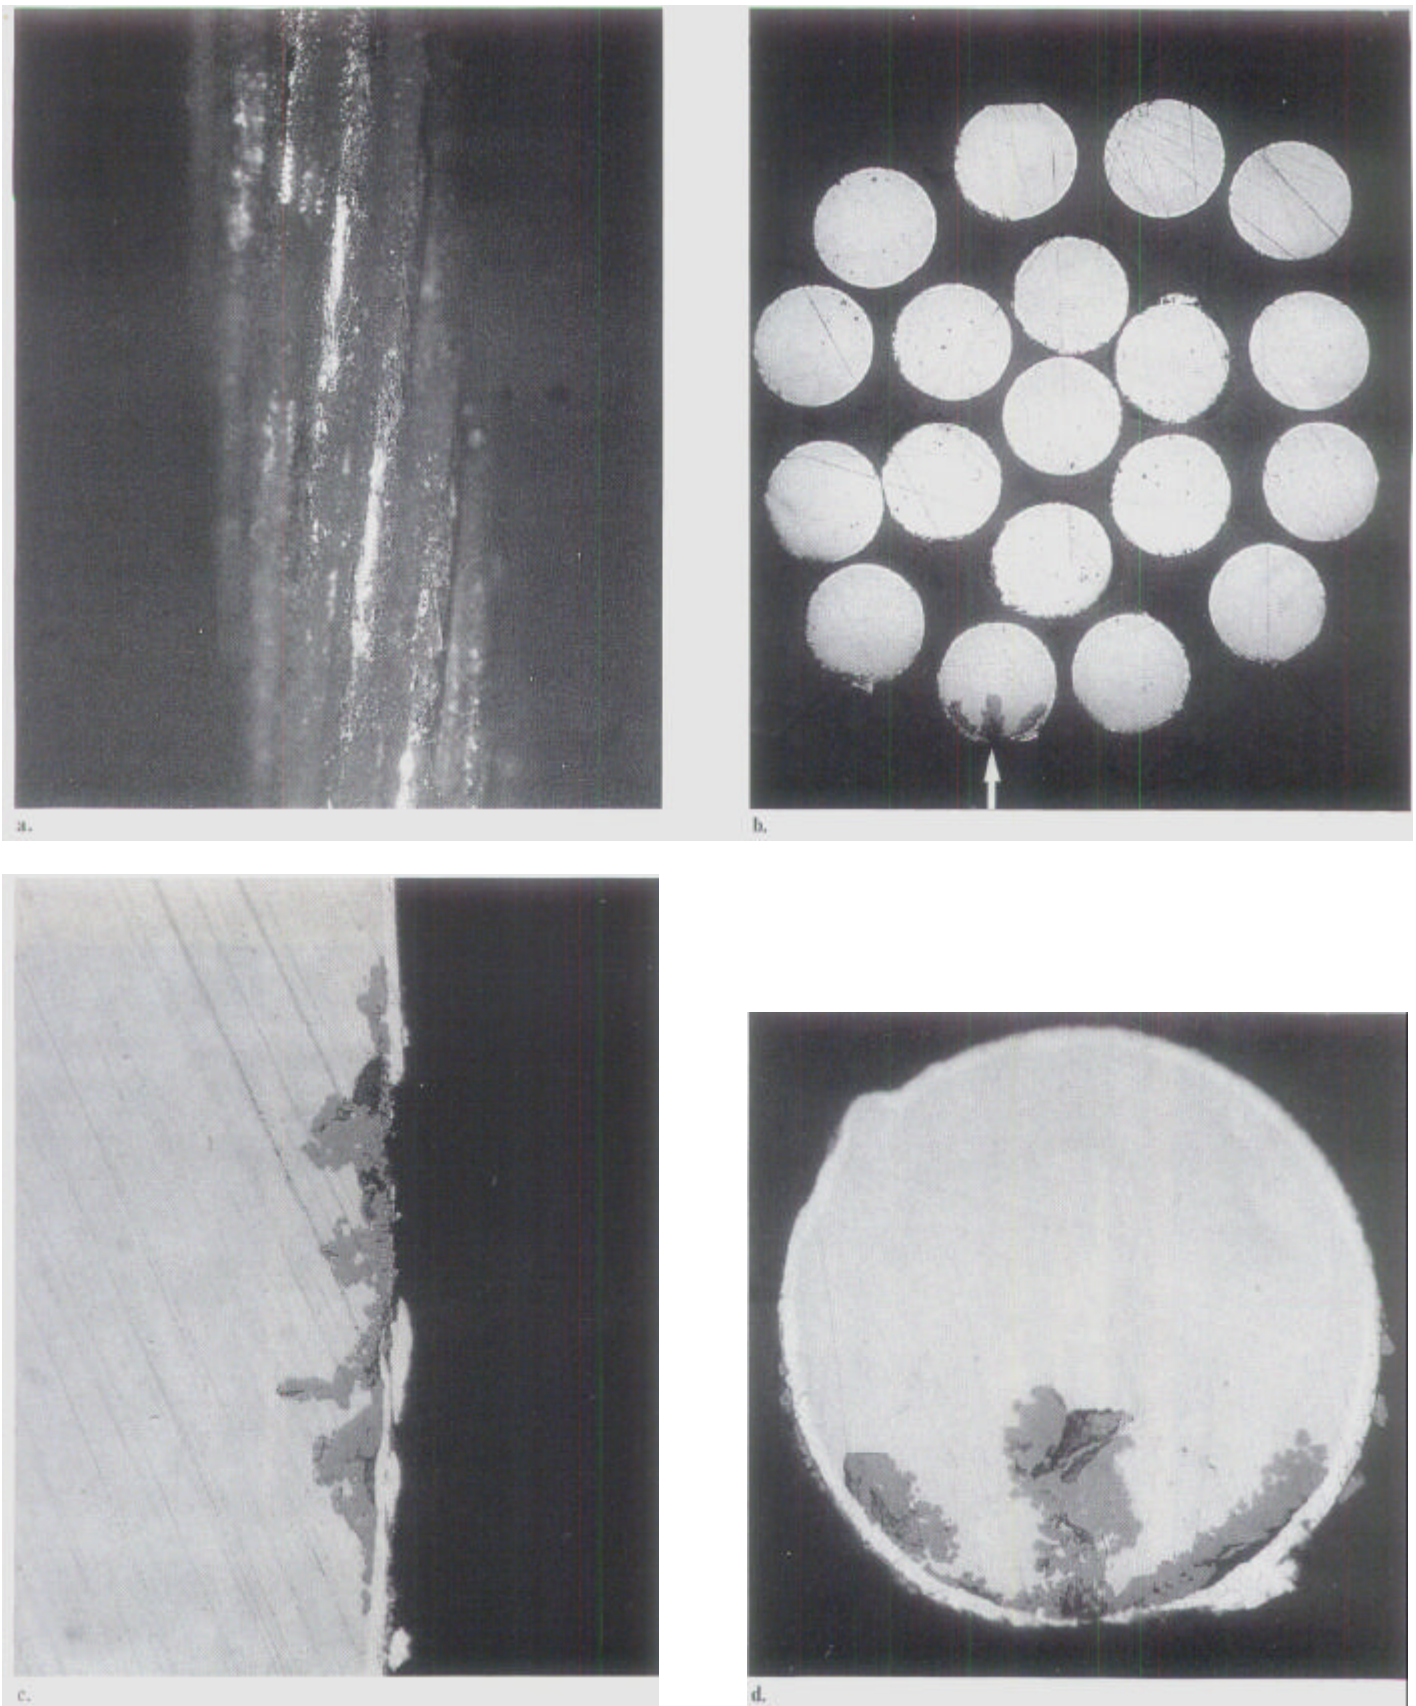
Figure 19. Transverse and longitudinal sections through red-plague corrosion site on sample no. 34. All strands are of $2\ \mu\text{m}$ silver-plated copper. The insulation material is Tefzel-ETFE. In any transverse plane only one strand is noted to be corroded, initiation progressing from local defects in the Avez plating (after 10 d of accelerated corrosion testing).

- a. Extensive red corrosion on adjacent strands (x 60);
- b. Transverse section in most corroded area (x120);
- c. Longitudinal section through severely corroded area (x 600);
- d. Transverse section in most corroded area (x 600)

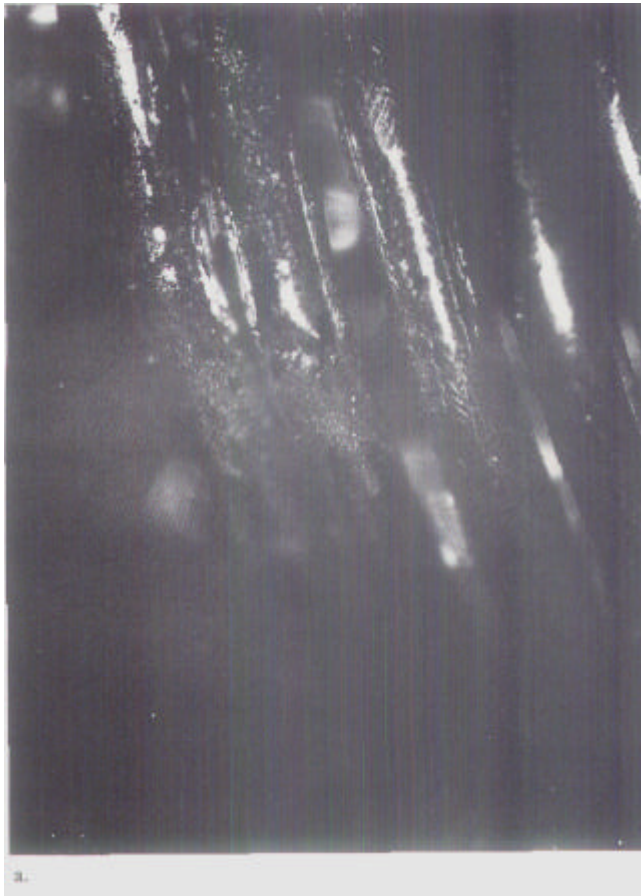
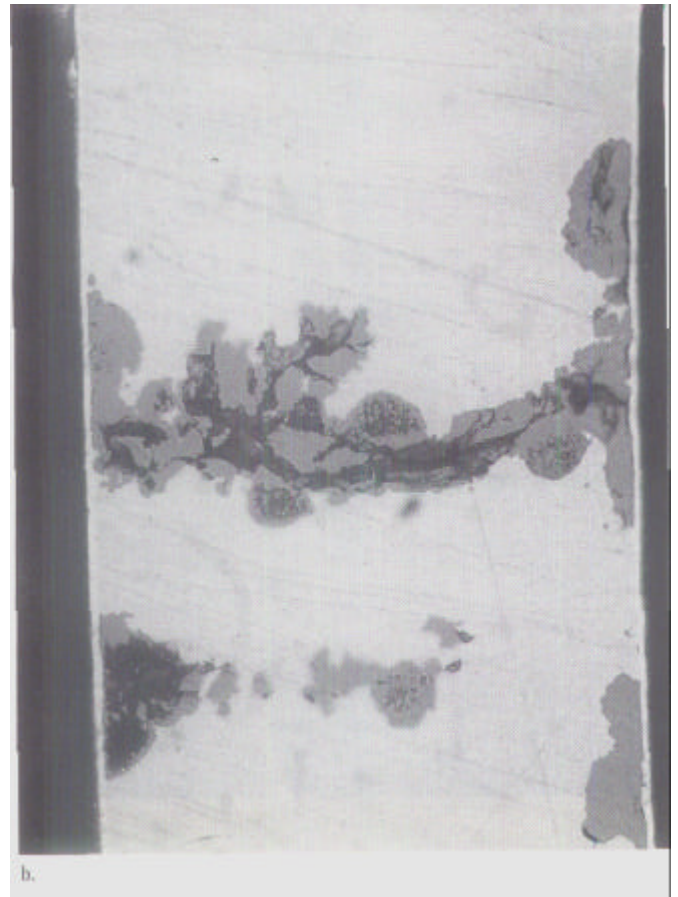
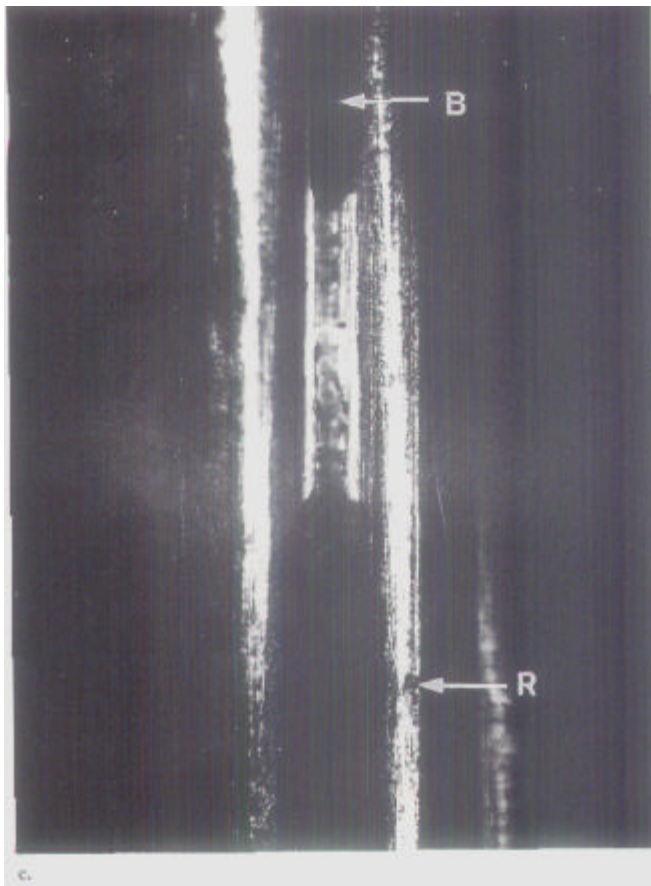
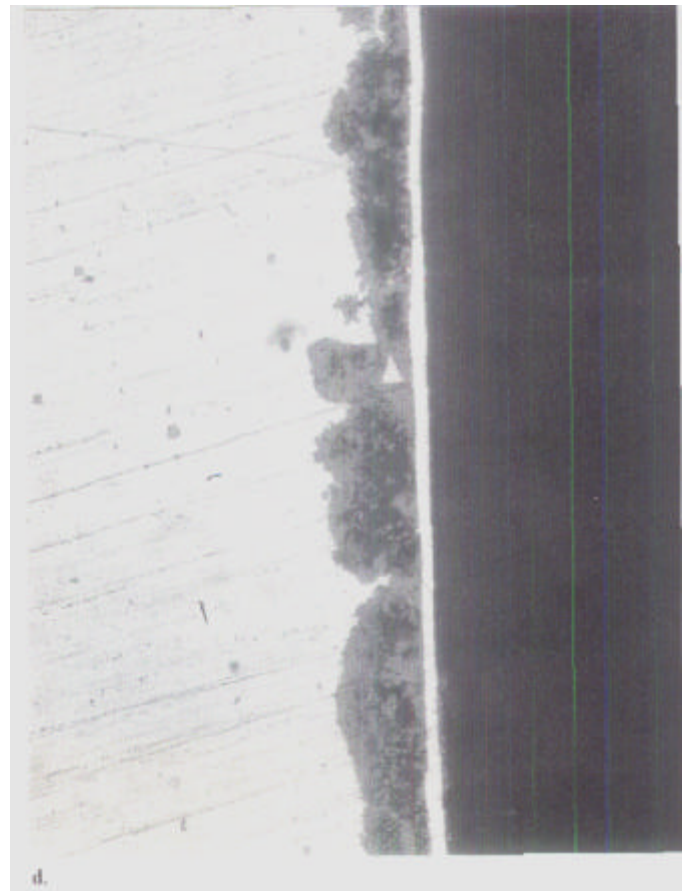
Figure 20. Longitudinal sections showing the most severely corroded strands (some oxidised throughout their section) from sample no. 9. Slight subsurface exists oil on one strand of the inner conductor, after 10d of accelerated corrosion testing. All strands are of 1 mm silver-plated

copper. The insulation materials are natural FEP for the outer jacket and natural PTFE on the inner conductors.

- a. Extensive red corrosion on adjacent strands (x 100);
- b. Corrosion and fracturing occurred through many strands (x 600);
- c. Inner conductor shows some red (R) and black (B) spots (x 100);
- d. internal corrosion (x 600)

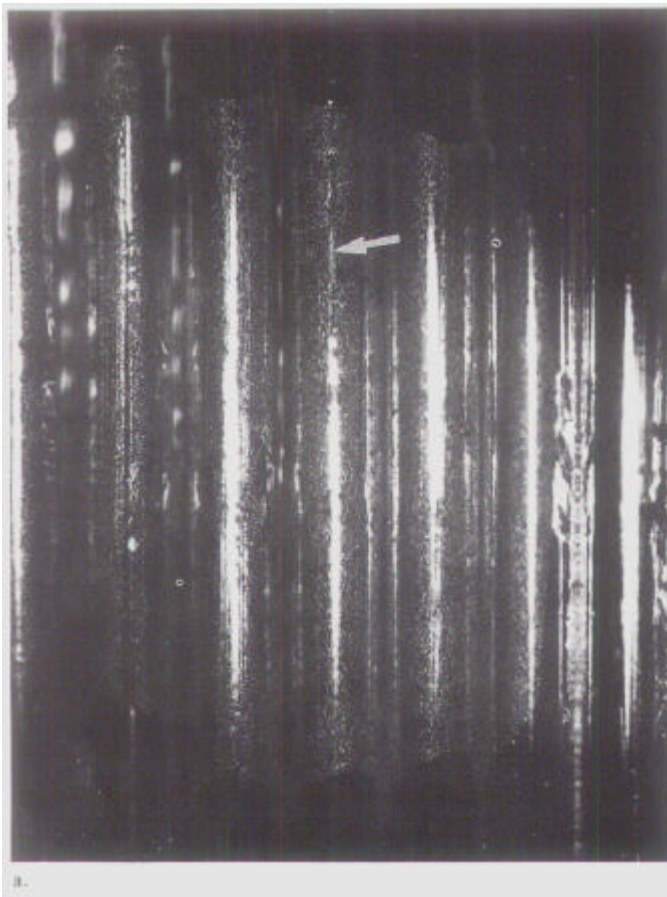
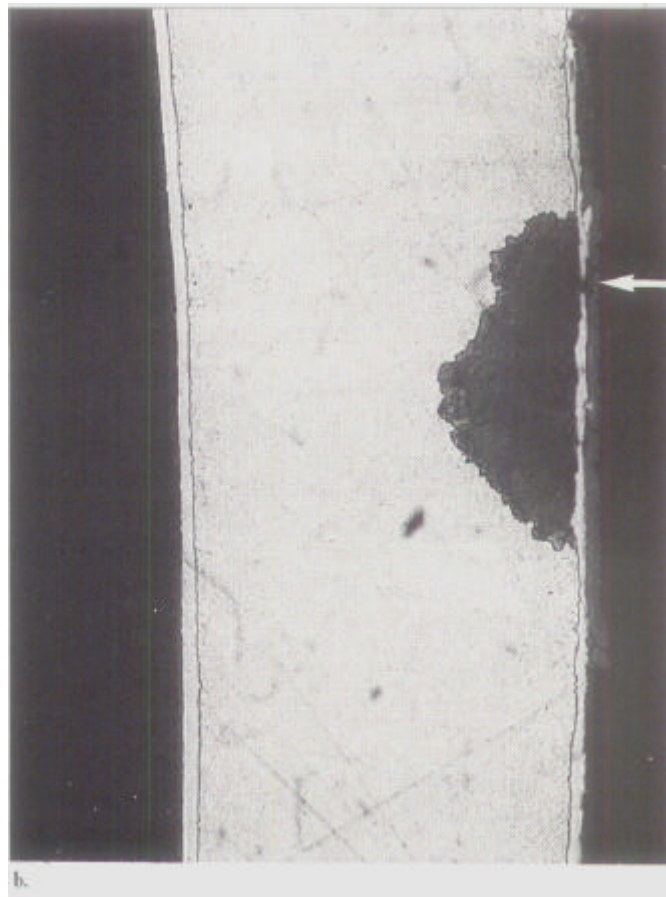
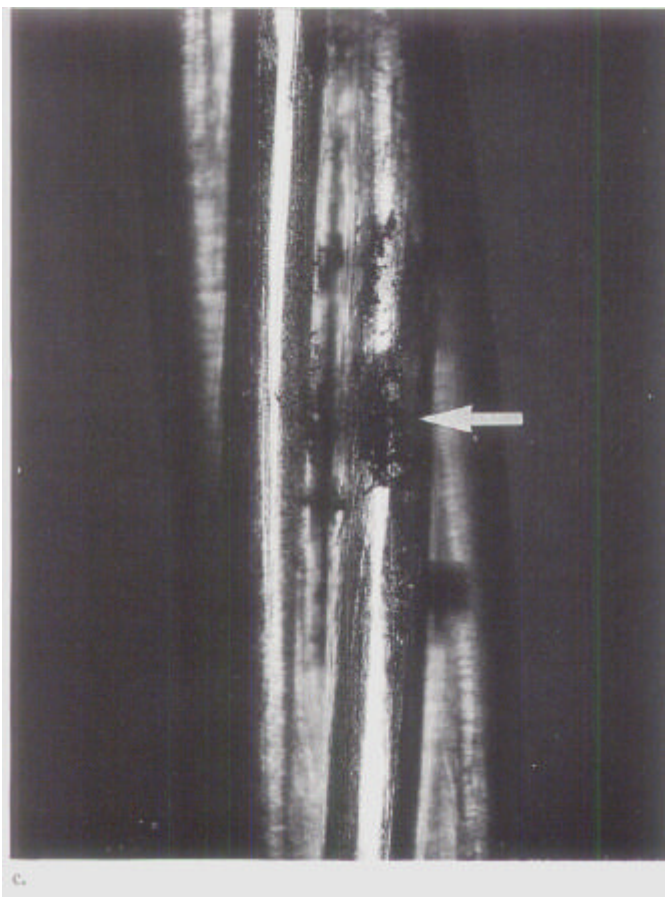
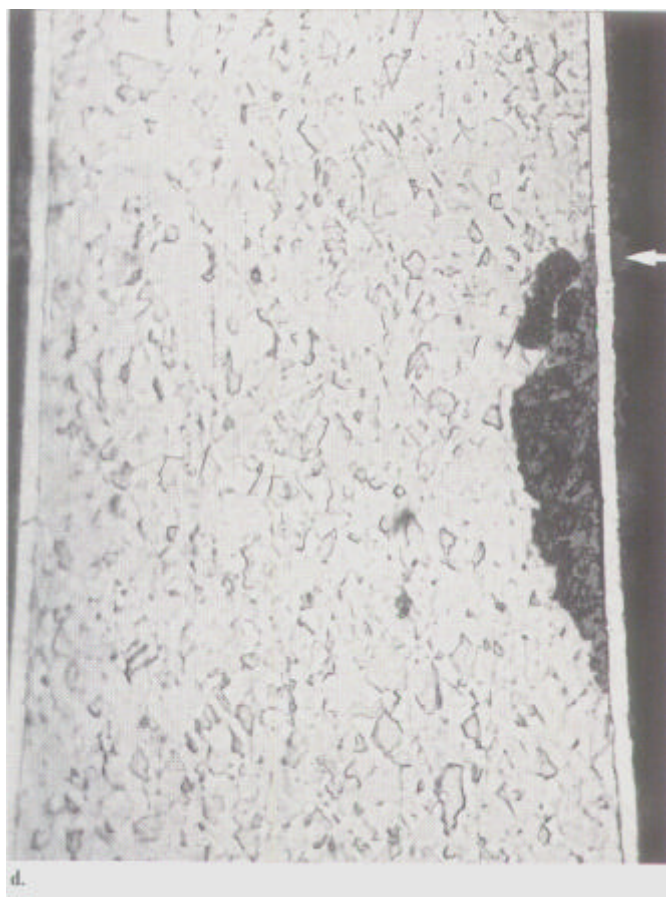
Figure 21. Longitudinal sections through the most severely corroded strand selected from sample no. 8, with Nickel-Plus braiding and 2 μm silver-plated stranded inner conductors after 10 d of accelerated corrosion testing. The insulation materials are natural FFP with kapton hinder for

the outer jacket and natural PTFE on the inner conductors. Subsurface cavities are formed at occasional breaks in the nickel plating, enabling localised corrosion couples to be set up. Corrosion of the inner conductor is extremely limited.
