## Corrosion of Silver-Plated Copper Conductors

**Abstract** Silver-plated conductors, insulated, with fluorocarbon plastics or aromatic polyimide resin and used in aerospace applications, in both Europe and the United States, have been examined for evidence of red-plague corrosion. Extensive metallurgical investigations have shown that, in the worst cases, 3% of the strands making up the braid cross-section can have some degree of corrosion. Metallography revealed that it had initiated at isolated defects in the silver-plating.

In the latter half of 1983, ESA experienced the first case of red plague identified on a short length of  $125\Omega$  RF cable withdrawn from a contractor's store. On stripping the outer insulation, severe corrosion was noted to be present in small irregular patches along the newly exposed braid. To assess the origin and extent of this problem, and to define remedial actions, extensive efforts were made to locate and inspect all silver-plated copper wires and cables purchased and stored by ESA contractors from the same cable manufacturer. Finally, new wires and the remainders of wires and cables on reels from various silver-plated wire/cable suppliers we

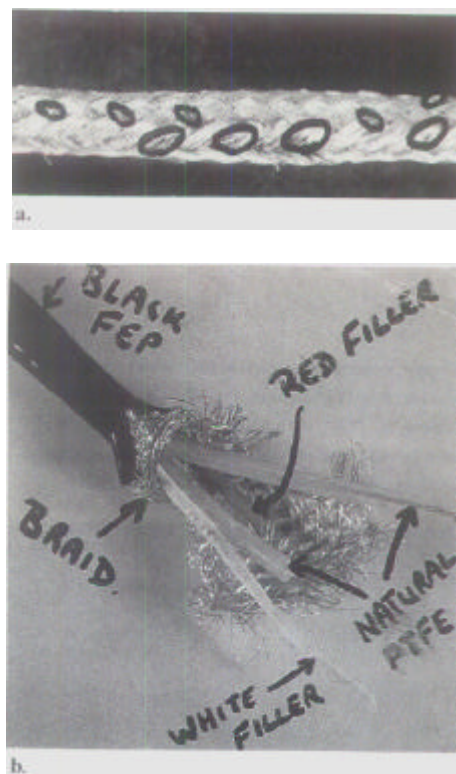
After removal of the outer jackets, many local areas of discolouration could be seen on the silver strands; they had a red, black and green-blue appearance. Several individual strands were noted to have shattered in a brittle manner (Figs. 1 & 2).

**Figure 1.** Appearance of the most severely corroded braid after approximately 5 years of storage. Despite the presence of many corrosion sites (circled in a), the braid is still mechanically intact and can be spread out (as in b)

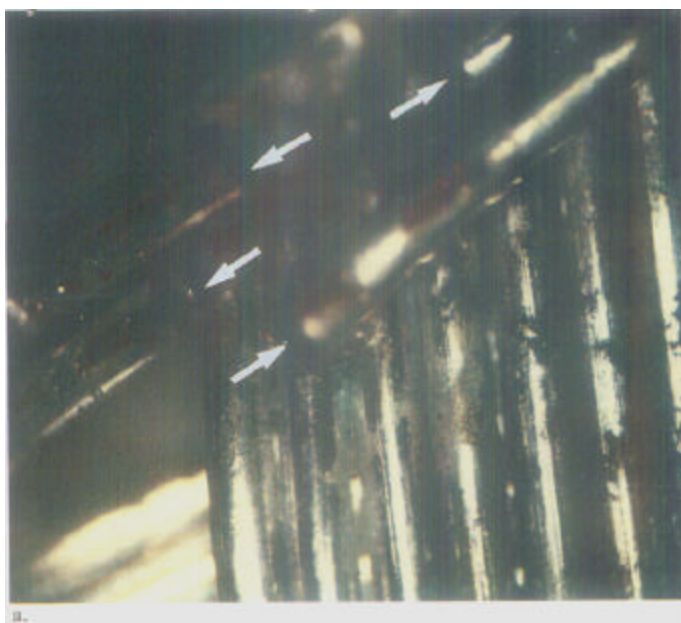
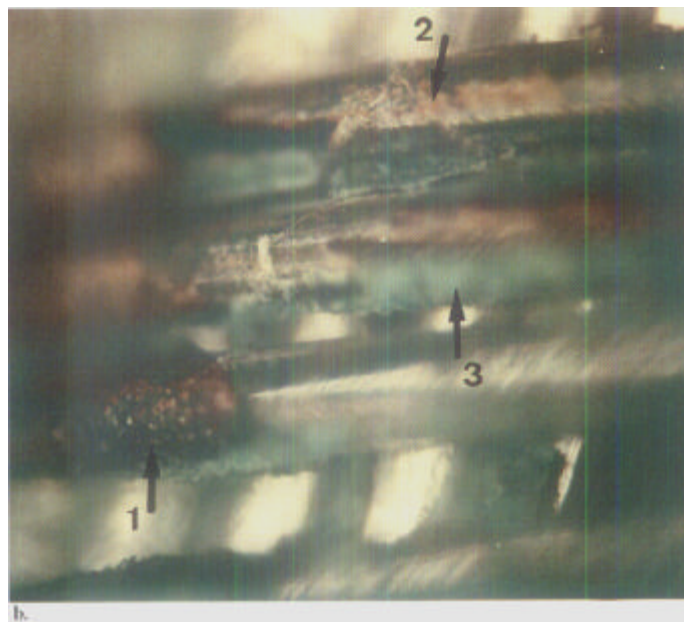
**Figure 2. Colour photomicrographs of typical 'red-plague' corrosion areas on braiding, as circled in Figure 1.**

- a. Red and green corrosion products associated with two strands that have completely broken; the brittle fracture surfaces are arrowed (x 100);
- b. Corrosion products are black (1), red (2) and green-blue (3)

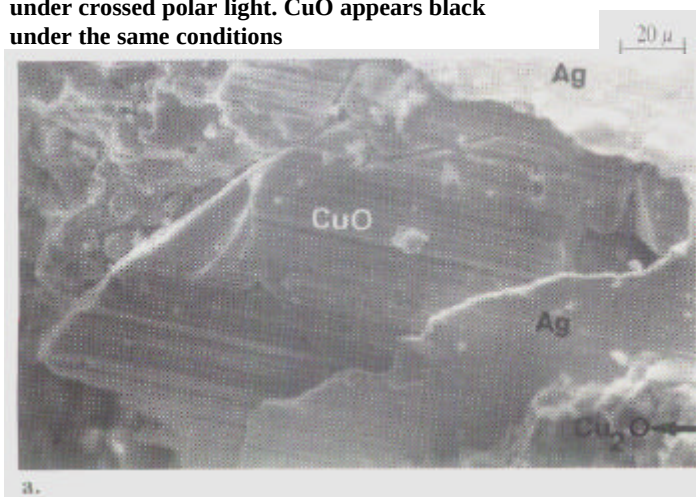
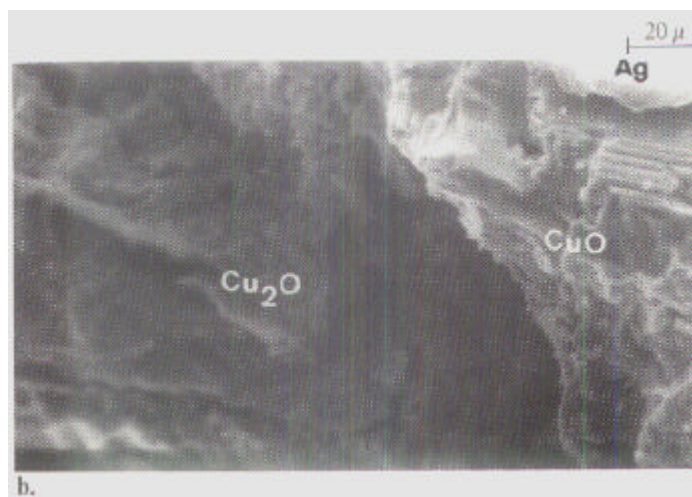
Examination of the corroded strands in the SEM showed them to consist entirely of brittle oxidised copper crystals. Adjacent strands supported crystals of cuprous oxide which were adherent to the silver platings (Fig. 3). Only the presence of copper, silver and a trace of chlorine were detected by EDAX analysis of the strand surfaces.

**Figure 3. Scanning electron photomicrographs of fractured ends of strands from braid shown in Figure 2a. The  $\text{Cu}_2\text{O}$  phases are characteristically seen as ruby-red crystals under crossed polar light.  $\text{CuO}$  appears black under the same conditions**

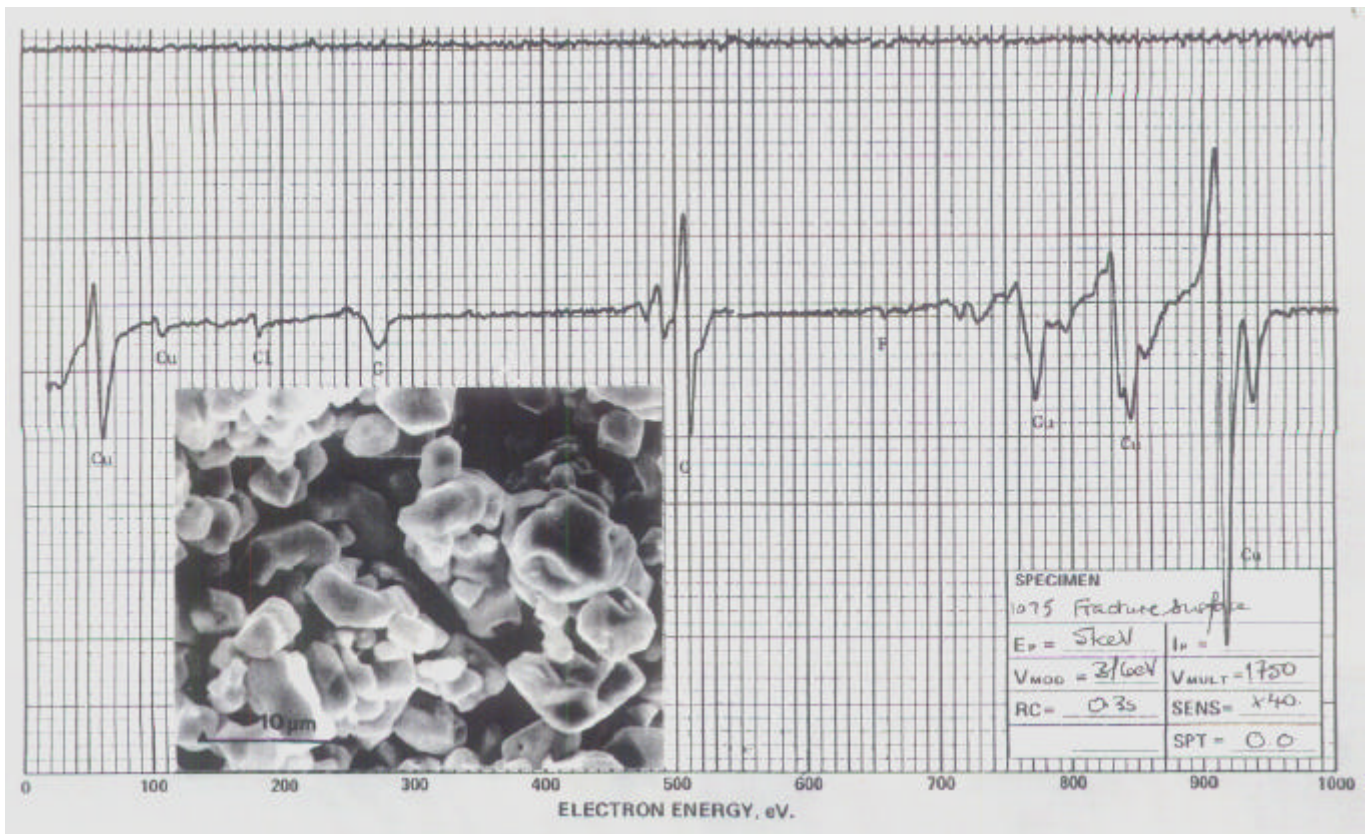
Auger examination revealed that both the silver surfaces, and the copper-oxide films were contaminated by chlorine and fluorine to a maximum of 5 at%. Depth profiles revealed fluorine in the silver plating to a depth of 40 Å. Further Auger analyses also detected the presence of chlorine and fluorine at the central area of the strand fracture surface. This area was composed entirely of copper-oxide crystals (Fig.4). Both chlorine and fluorine, when present as free ions, would tend to be an accelerating factor in any galvanic corrosion mechanism.

**Figure 4. Secondary electron image of the copper-oxide crystals seen at the centre of a corroded and fractured strand. The SEM image is superimposed on the Auger analysis of this area (showing traces of chlorine and fluorine associated with copper oxides)**

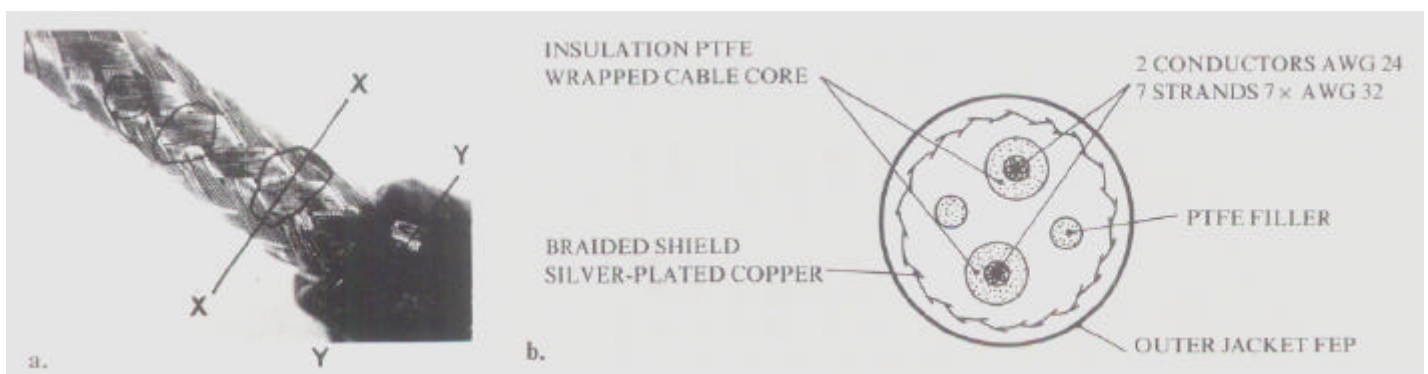
**Figure 5. Detailed metallographic examination of the red-plagued cables. The most severely corroded cable (shown in a) was potted and micro-sections made through the severely corroded braid in the X-X plane. A second section was made in the Y-Y plane which is still covered in black FEP**  
**a. Extensive red plague on braid;**  
**b. General construction of cable examined**

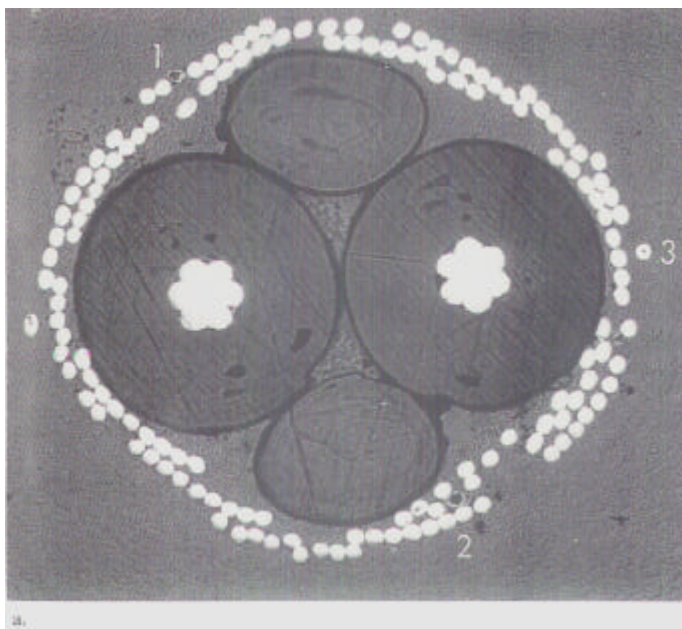
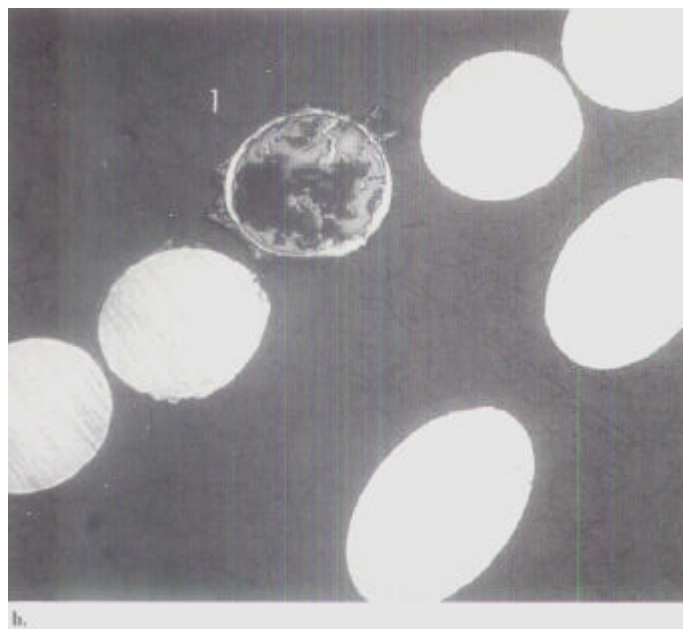
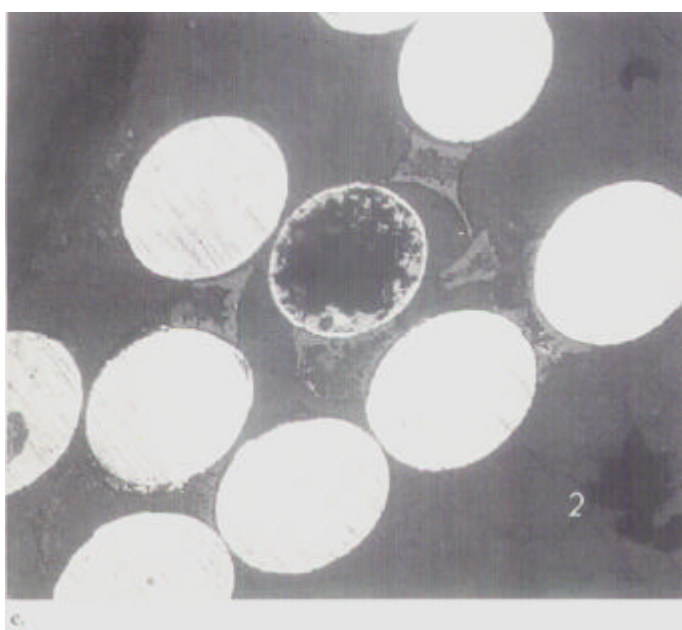
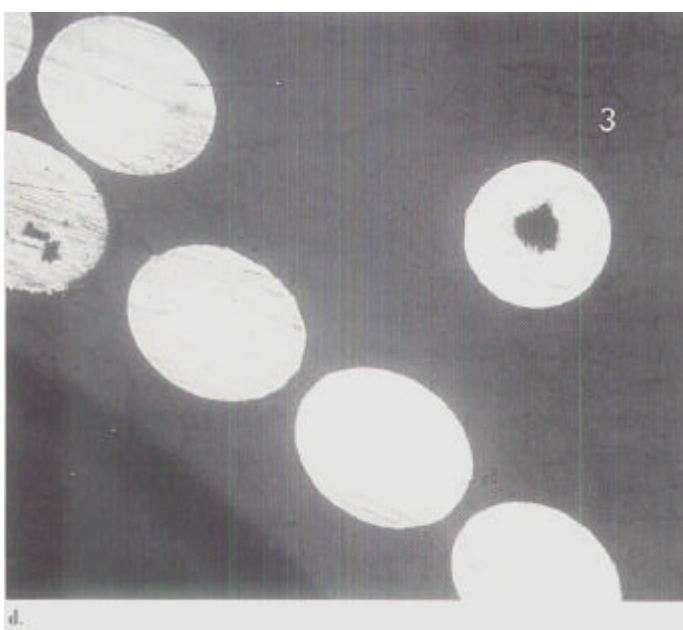
**Figure 6a.** Section through X -X (see Fig. 5), the superimposed numbers referring to corroded strands. Three of the 143 strands are corroded to some extent (2.1%)

**Figure 6b.** Detail of strand no. 1 from Figure 6a. Adjacent strands are uncorroded, but support crystals of cuprous oxide (x150)

**Figure 6d.** Tunnelling corrosion along strand no. 3 (x 150)

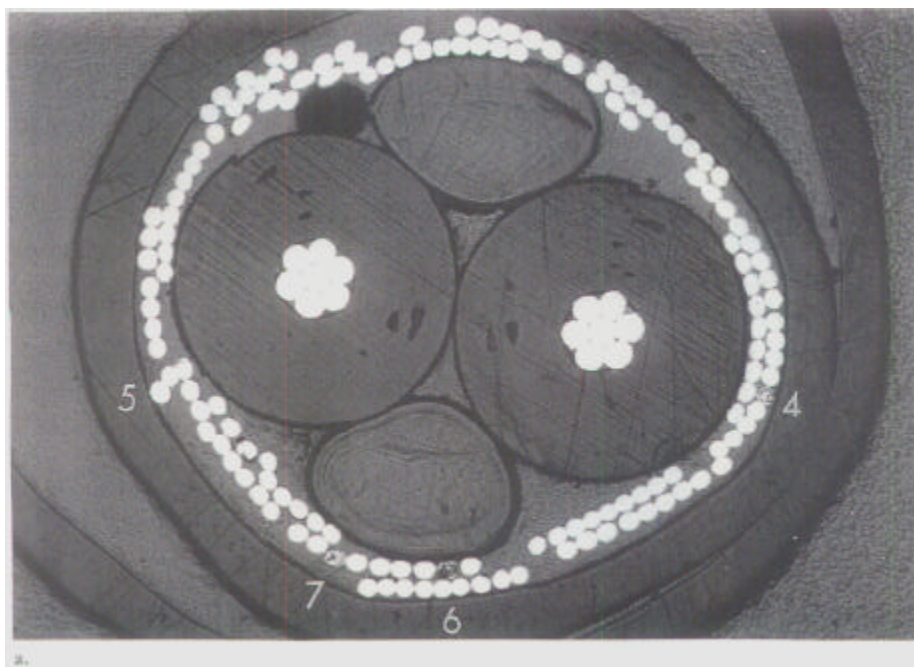
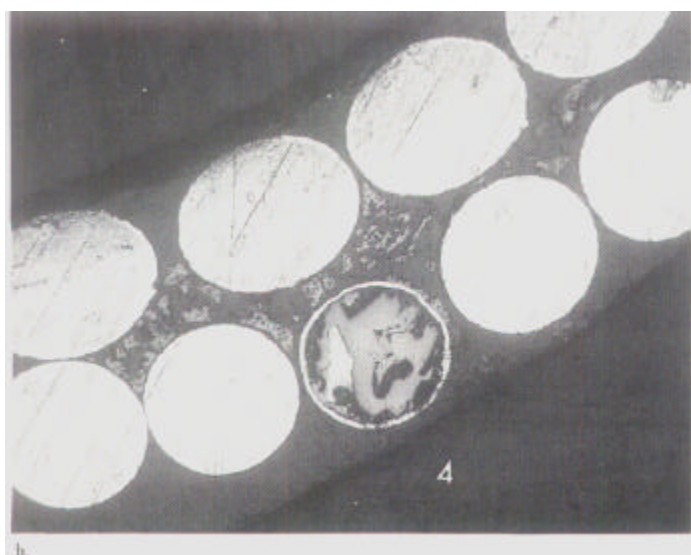
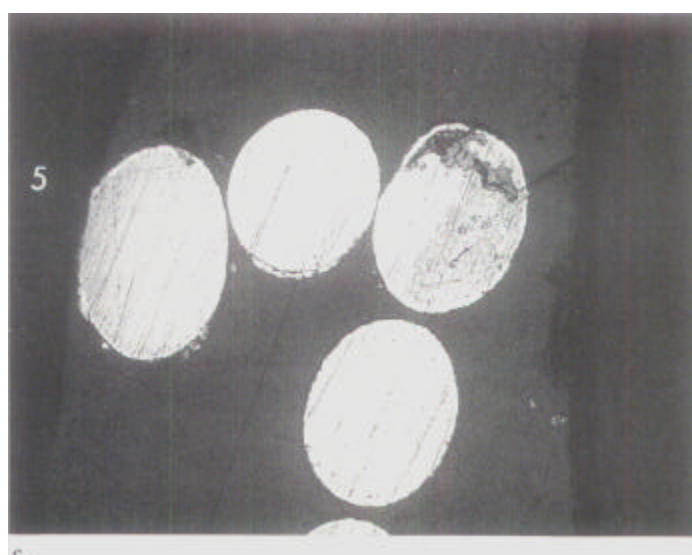
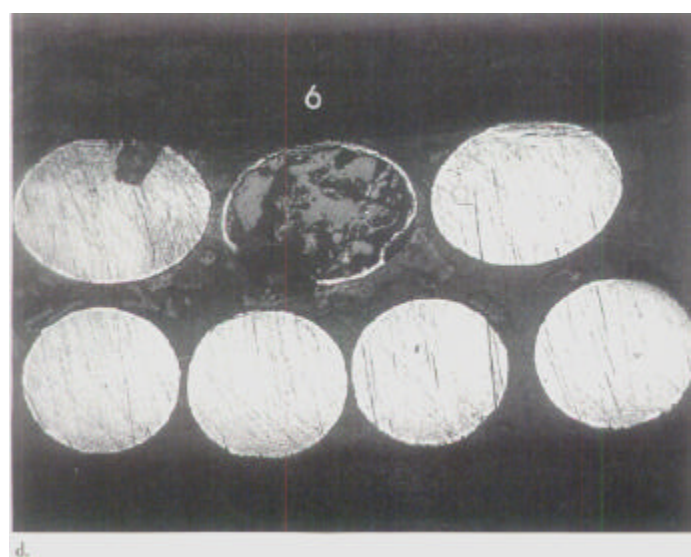
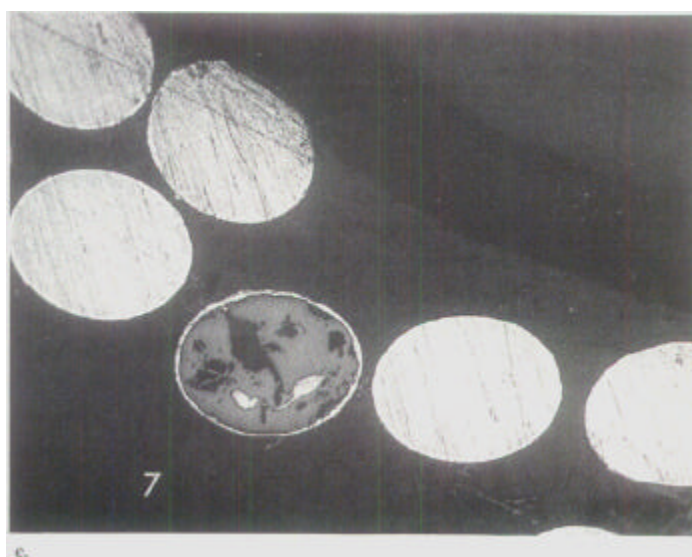
It is noticeable that the outer jackets are loose-fitting and particularly suitable for the ingress of moisture from unsealed cable ends. The volume of air that is contained within the 125 Ω cable has been derived from the transverse cross-section shown in Figure 7a.

Figure 7a. Section made through Y-Y (see Fig. 5). Superimposed are numbers referring to corroded strands. Four of the 143 strands are to some extent corroded (2.8%) (outer FEP jacket has been peeled back and appears as two rings)

Figure 7b. One corroded strand is surrounded by non-corroded adjacent strands covered by cuprous-oxide crystals. Note large air gaps between outer FEP jacket and inner wire insulants (x 150)

Figures 7c-e. Remaining corroded strands in section Y-Y (x 150)

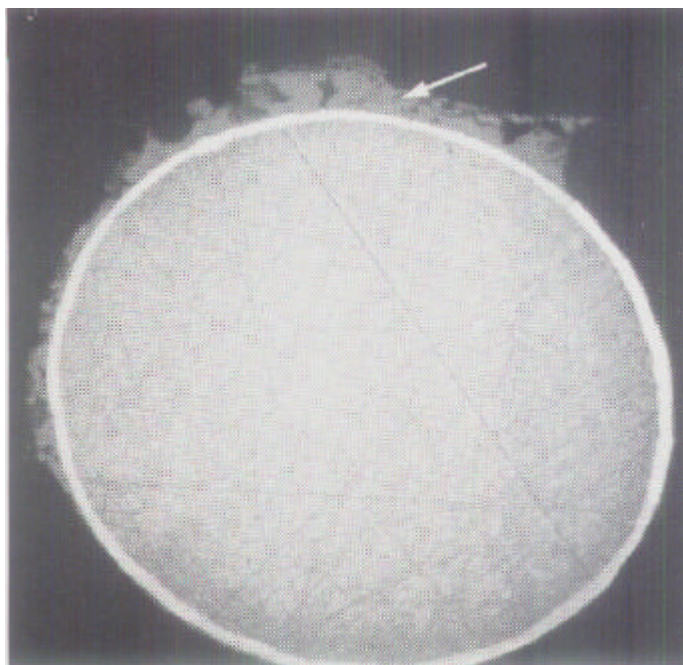
Figure 8. Section through red crystals on the intact 2 - 3  $\mu\text{m}$  thick silver coating on strand from corroded braid (x 600)

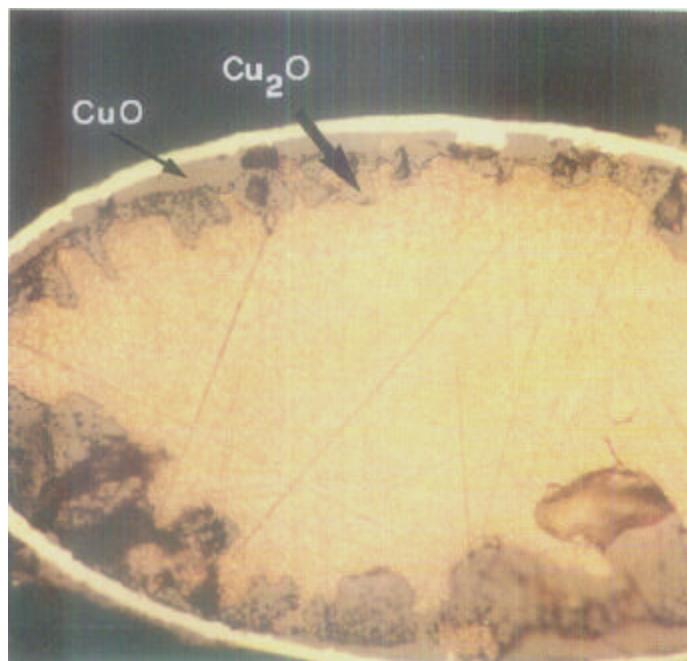
Figure 9. Colour micrograph clearly showing the various copper oxides to have 'tunnelled' beneath the silver coating. They are also present on the outer surface (x 600)

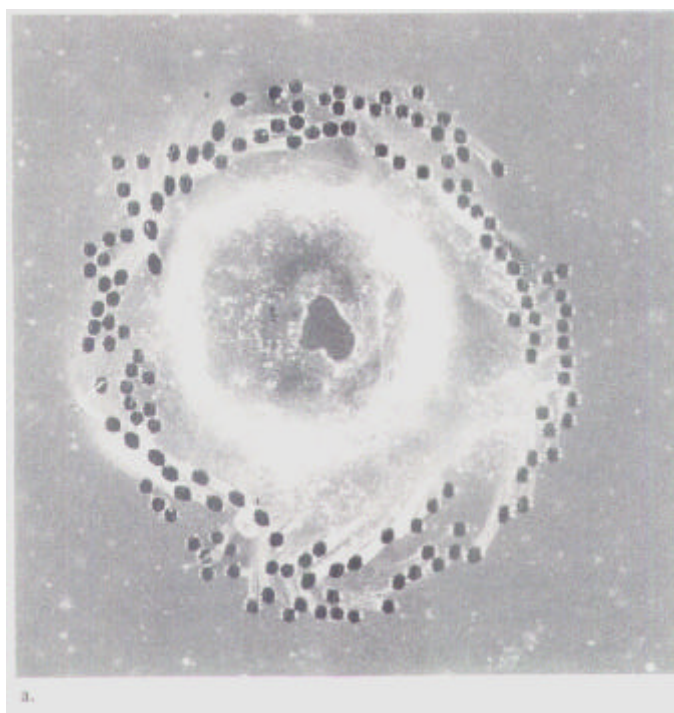
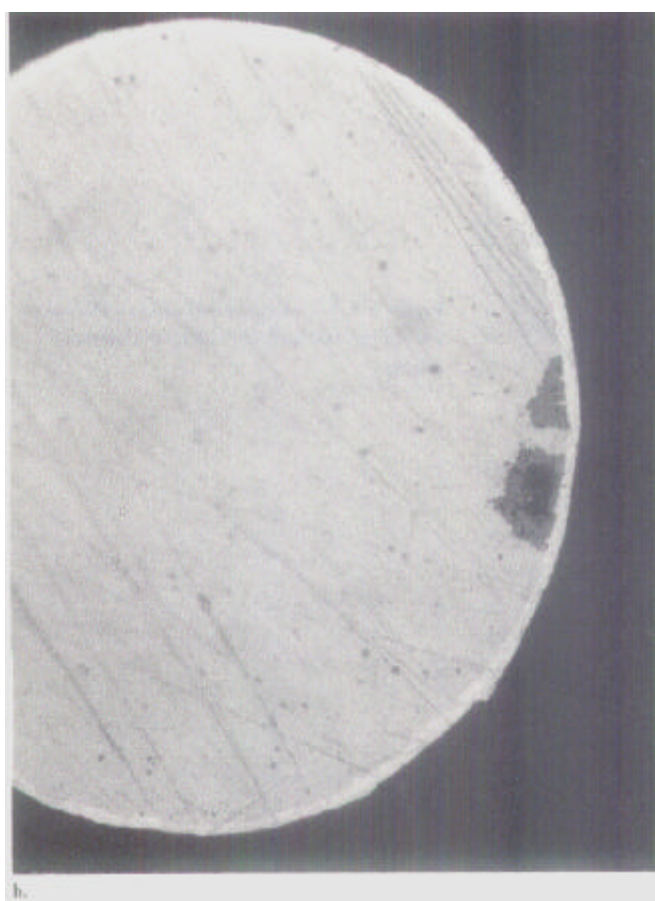
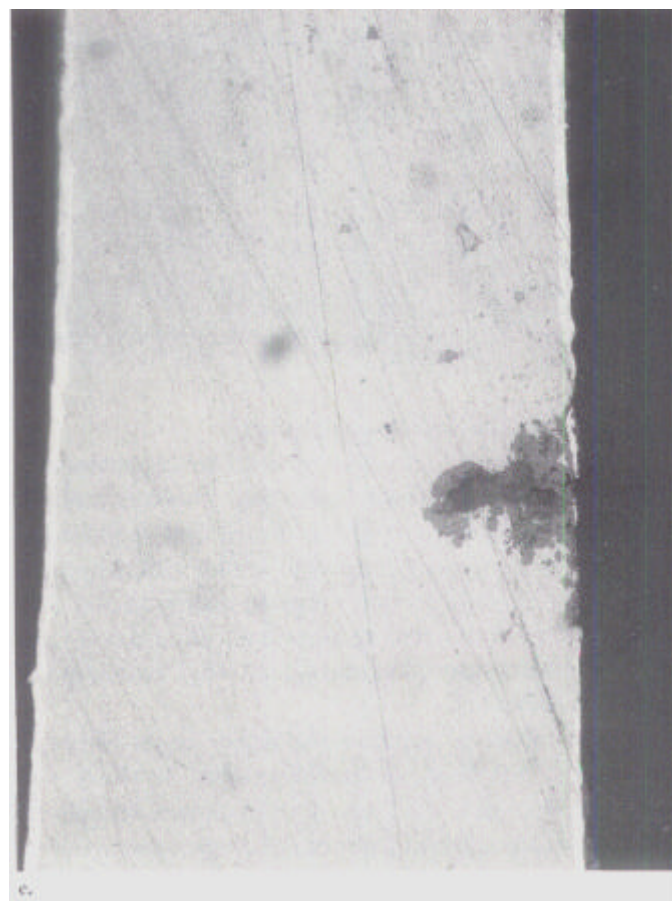
Figure 18. Transverse and longitudinal sections through red-plague corrosion site on sample no. 16. The braid consists of 144 strands, of which only two-support copper corrosion. All strands are of 2 mm silver-plated copper. The insulation materials are black FEP for the outer jacket and natural PTFE on the inner conductors. The longitudinal sections show that galvanic corrosion has initiated at local breaks in the silver plate (after 10d of accelerated corrosion testing).

- a. Outer braid sectioned across site of worst corrosion. Note braid has 144 strands, two of which show signs of internal corrosion
- b. Transverse section through worst corrosion site (x 800)
- c. Longitudinal section through worst corrosion site (x 600)

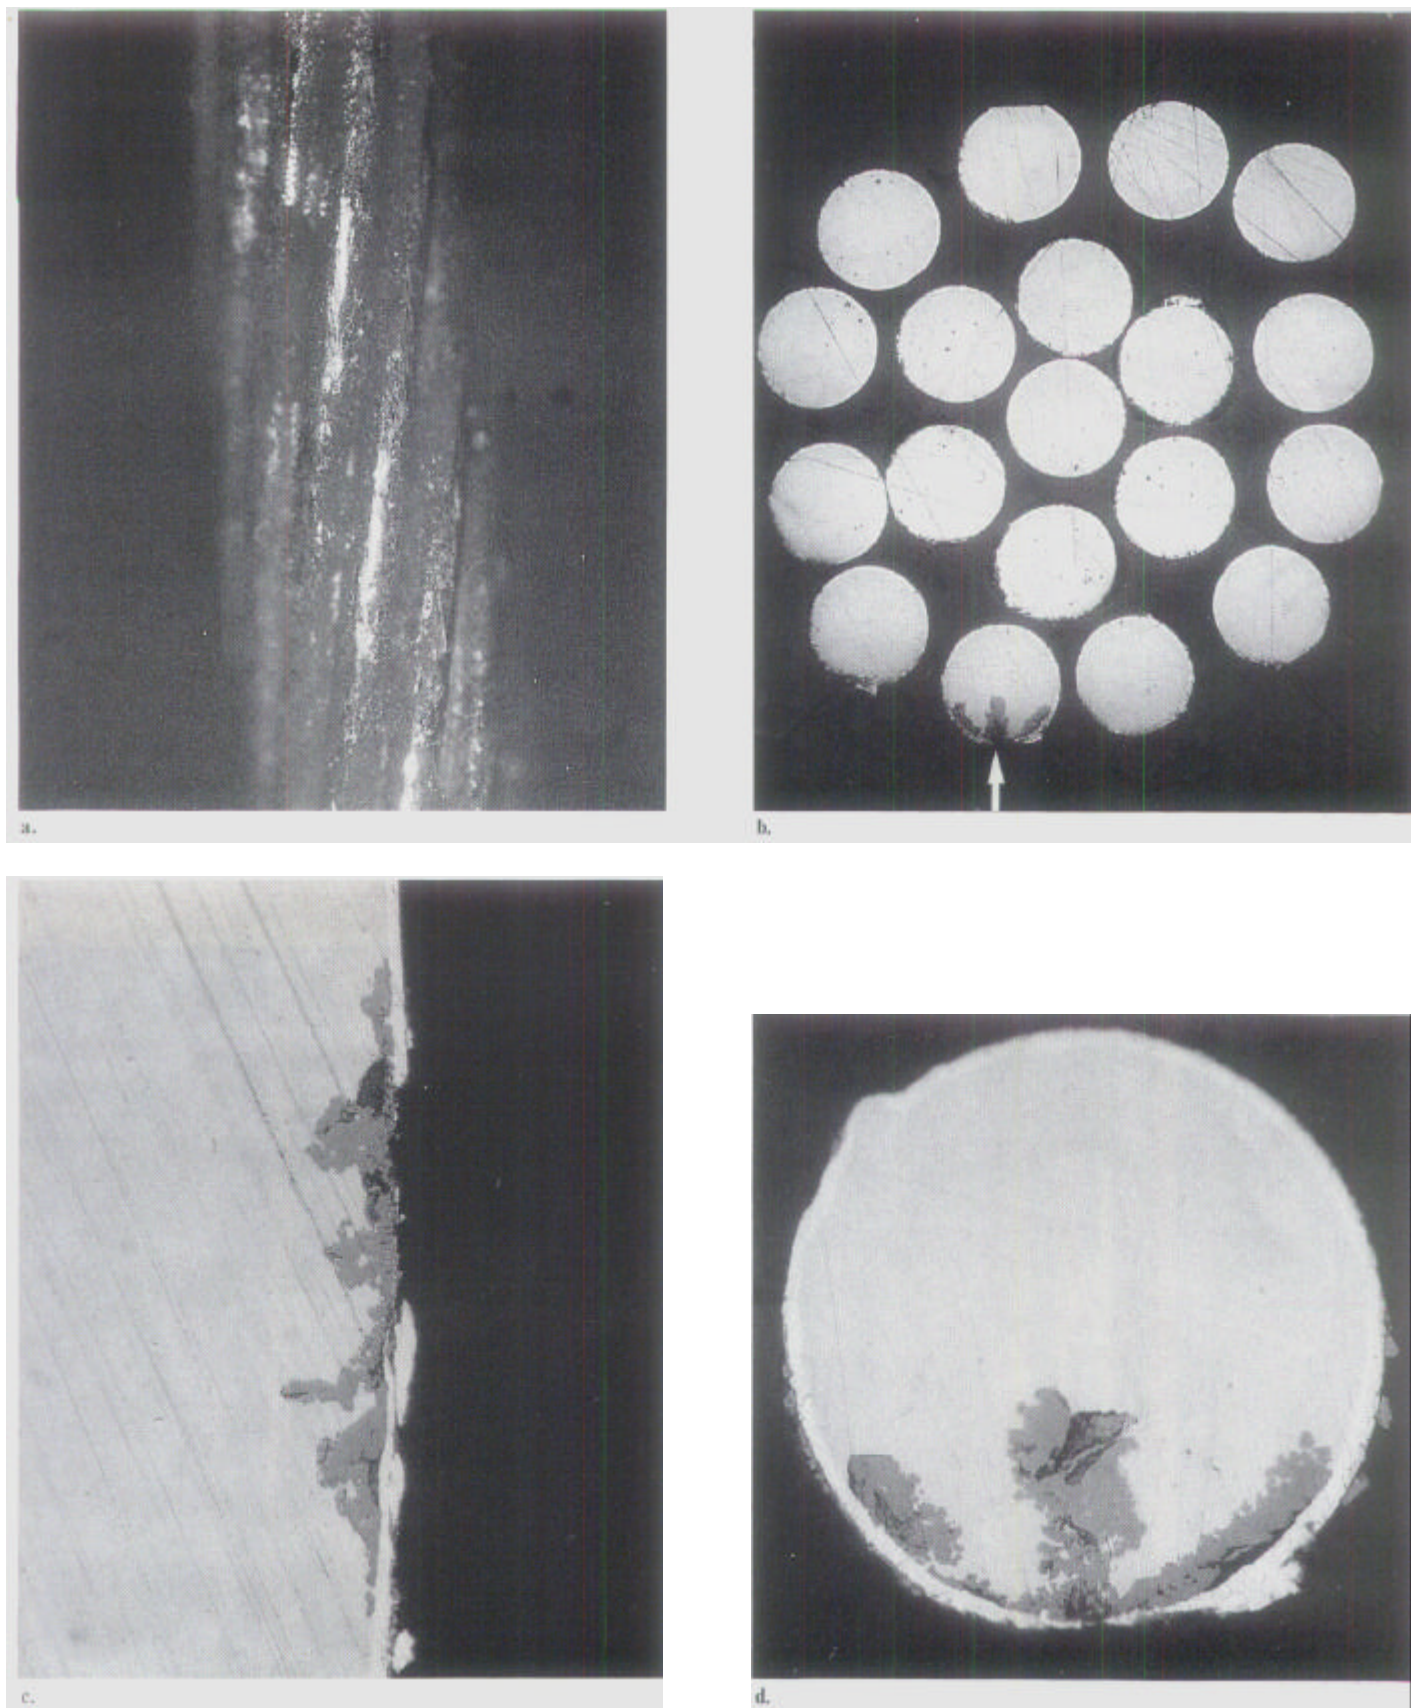
**Figure 19. Transverse and longitudinal sections through red-plague corrosion site on sample no. 34. All strands are of 2  $\mu$ m silver-plated copper. The insulation material is Tefzel-ETFE. In any transverse plane only one strand is noted to be corroded, initiation progressing from local defects in the Auer plating (after 10 d of accelerated corrosion testing).**

- a. Extensive red corrosion on adjacent strands (x 60);**
- b. Transverse section in most corroded area (x120);**
- c. Longitudinal section through severely corroded area (x 600);**
- d. Transverse section in most corroded area (x 600)**

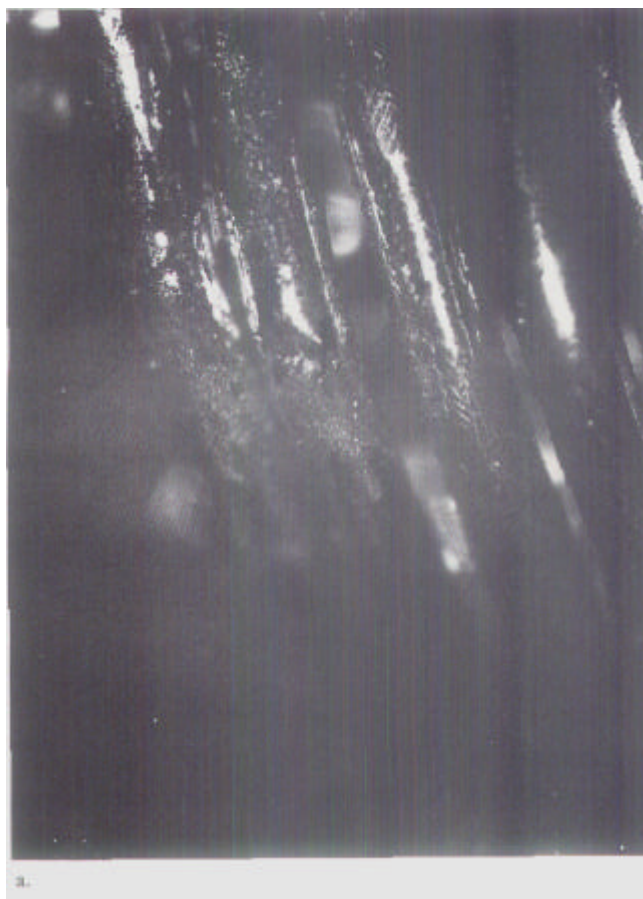
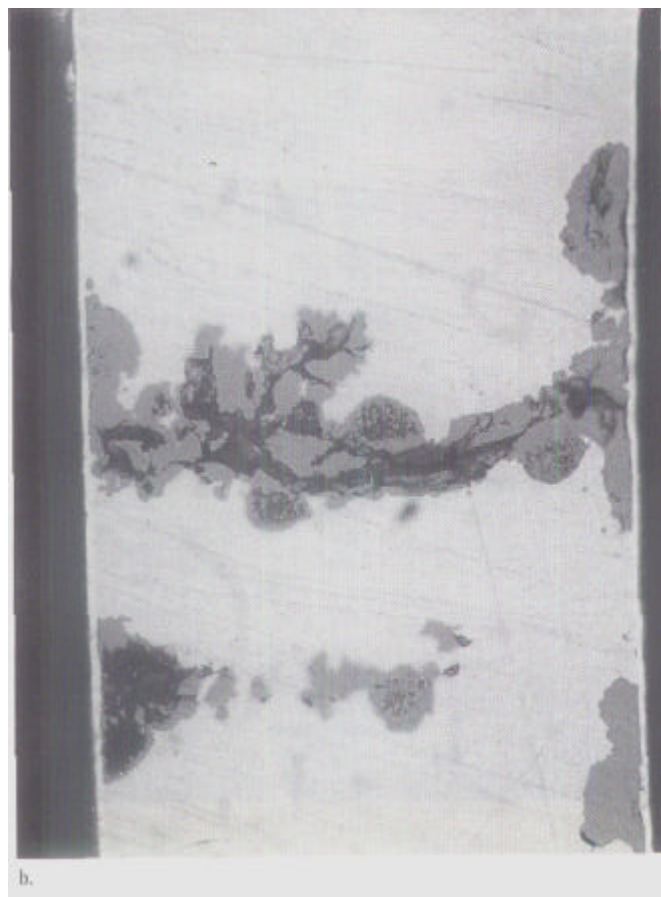
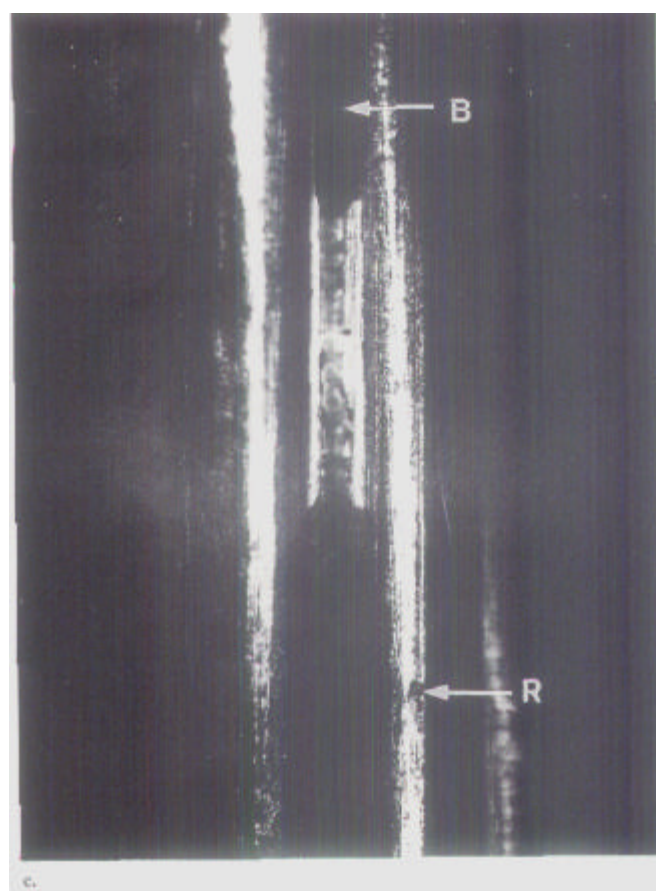
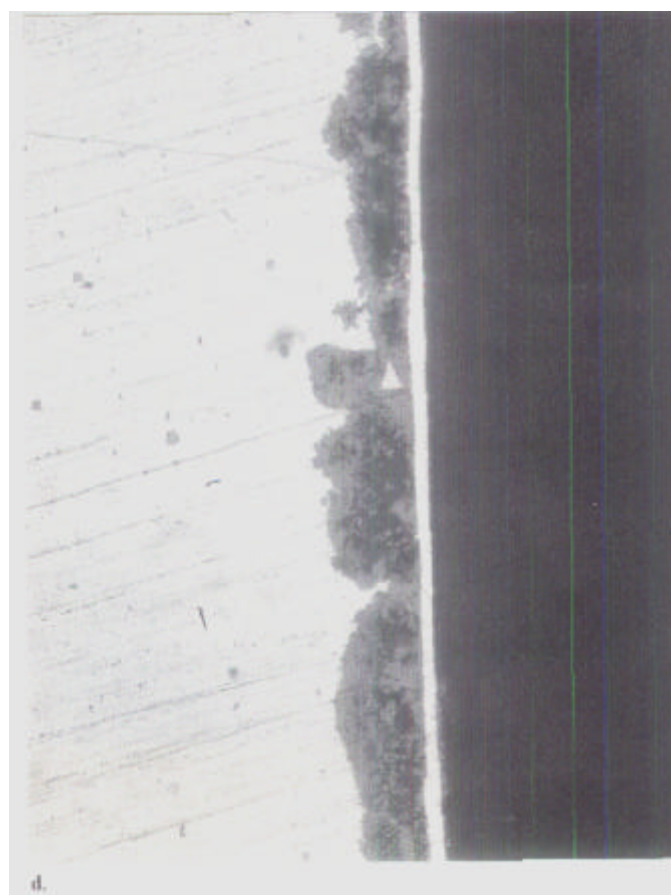
Figure 20. Longitudinal sections showing the most severely corroded strands (some oxidised throughout their section) from sample no. 9. Slight subsurface exists oil on one strand of the inner conductor, after 10d of accelerated corrosion testing. All strands are of 1 mm silver-plated

copper. The insulation materials are natural FEP for the outer jacket and natural PTFE on the inner conductors.

- a. Extensive red corrosion on adjacent strands (x 100);
- b. Corrosion and fracturing occurred through many strands (x 600);
- c. Inner conductor shows some red (R) and black (B) spots (x 100);
- d. internal corrosion (x 600)

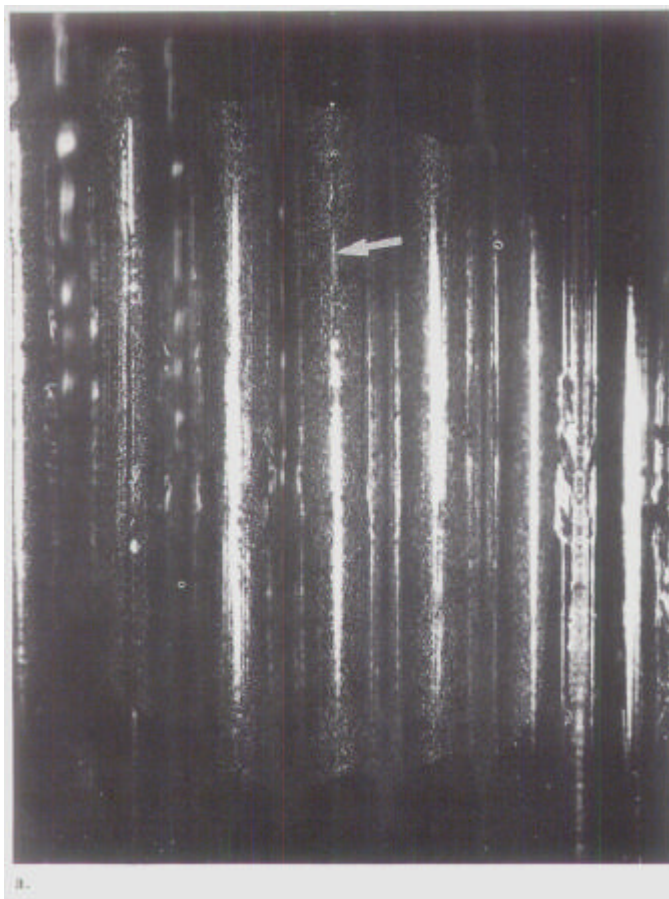
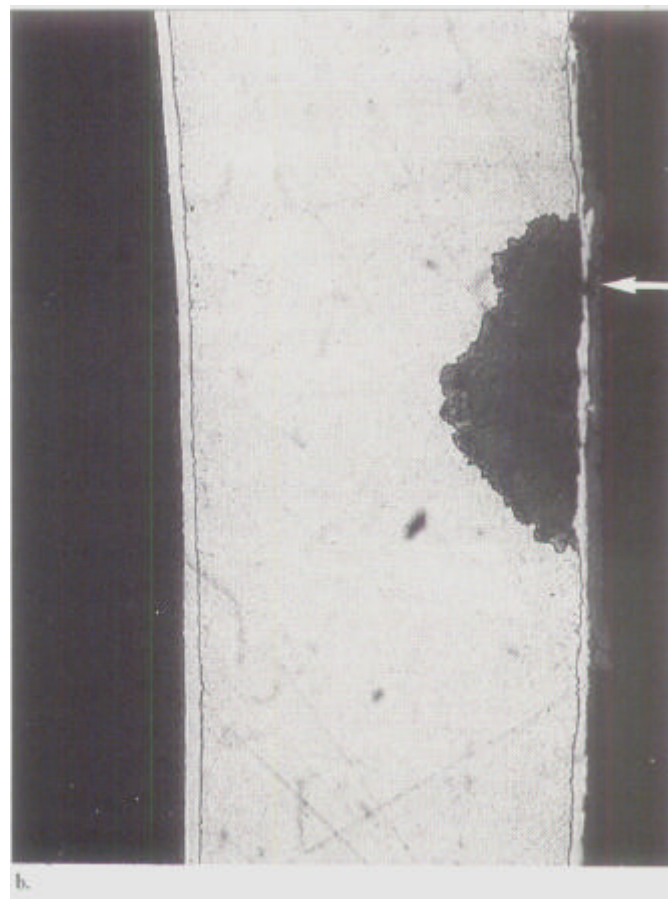
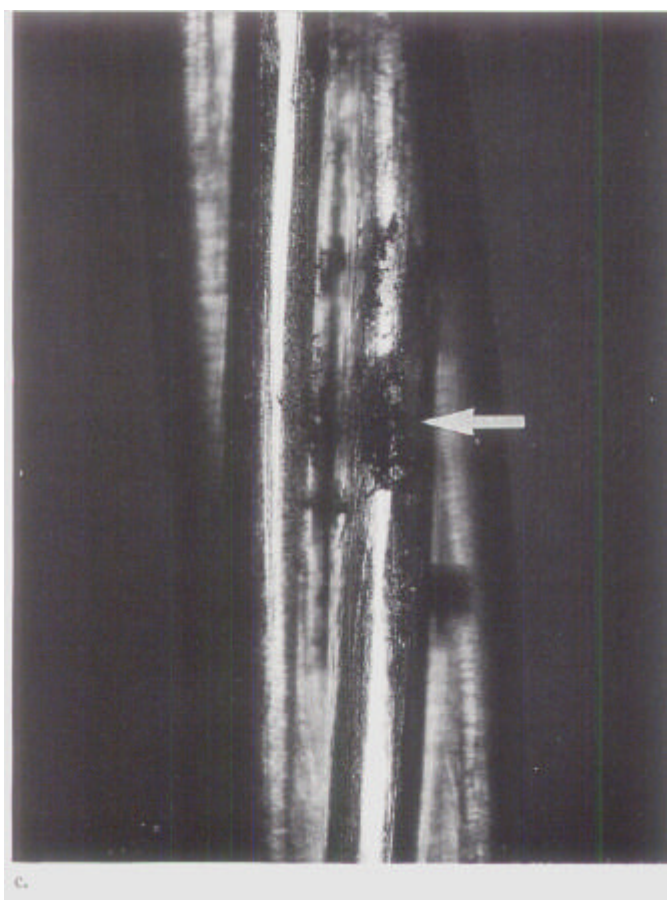
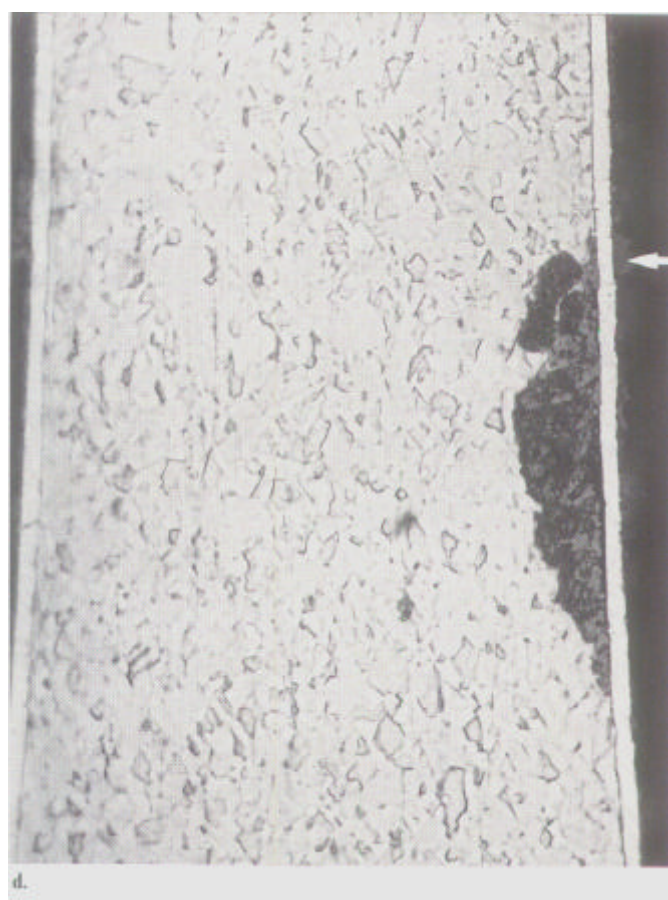
**Figure 21.** Longitudinal sections through the most severely corroded strand selected from sample no. 8, with Nickel-Plus braiding and 2  $\mu\text{m}$  silver-plated stranded inner conductors after 10 d of accelerated corrosion testing. The insulation materials are natural FFP with kapton hinder for

the outer jacket and natural PTFE on the inner conductors. Subsurface cavities are formed at occasional breaks in the nickel plating, enabling localised corrosion couples to be set up. Corrosion of the inner conductor is extremely limited.
