Heavy Ion Effects of low voltage LVDS line driver/receiver from National Instruments

Saab Ericsson Space AB, Göteborg, Sweden

**Final Presentation of ESTEC Contract 11407/95/NL/CCN-5, COO-8/III.
Report Reference: ESA_QCA0418S_C**

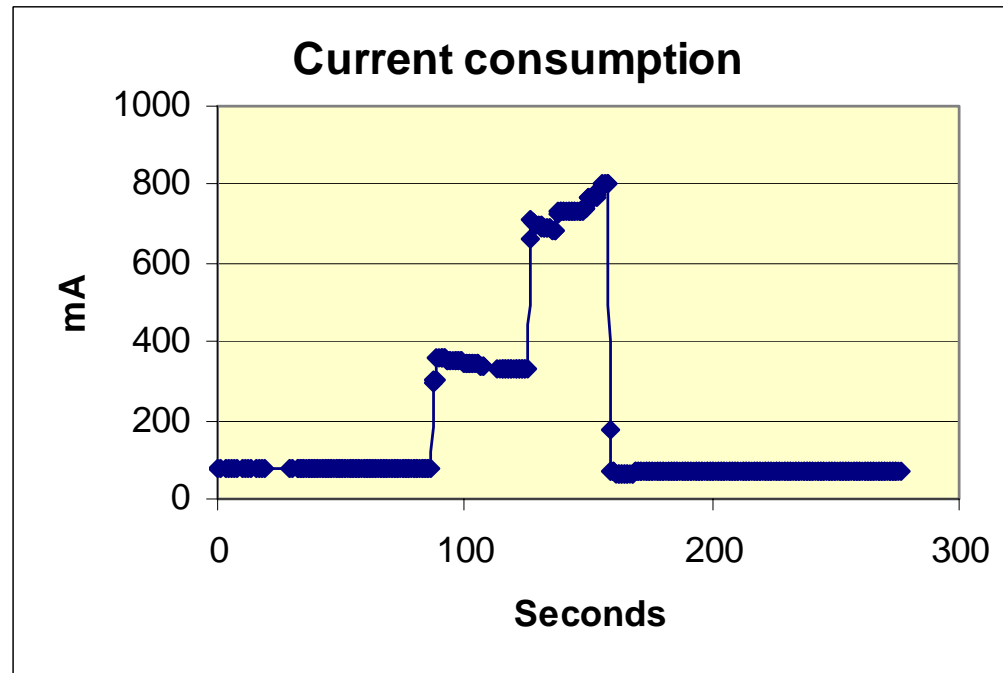
Partial SEL

Current as a function of test time.

First LU leave the device at about 350 mA, second LU initially at 700 mA.

The LU-protection unit was set to shut down the DUT at 800mA.

For each SEL, the current increase was about 350mA

After the current was shut down by LU-protection unit, the component operated as normal

Both the Driver and the Receiver showed the same behavior and sensitivity for SEL

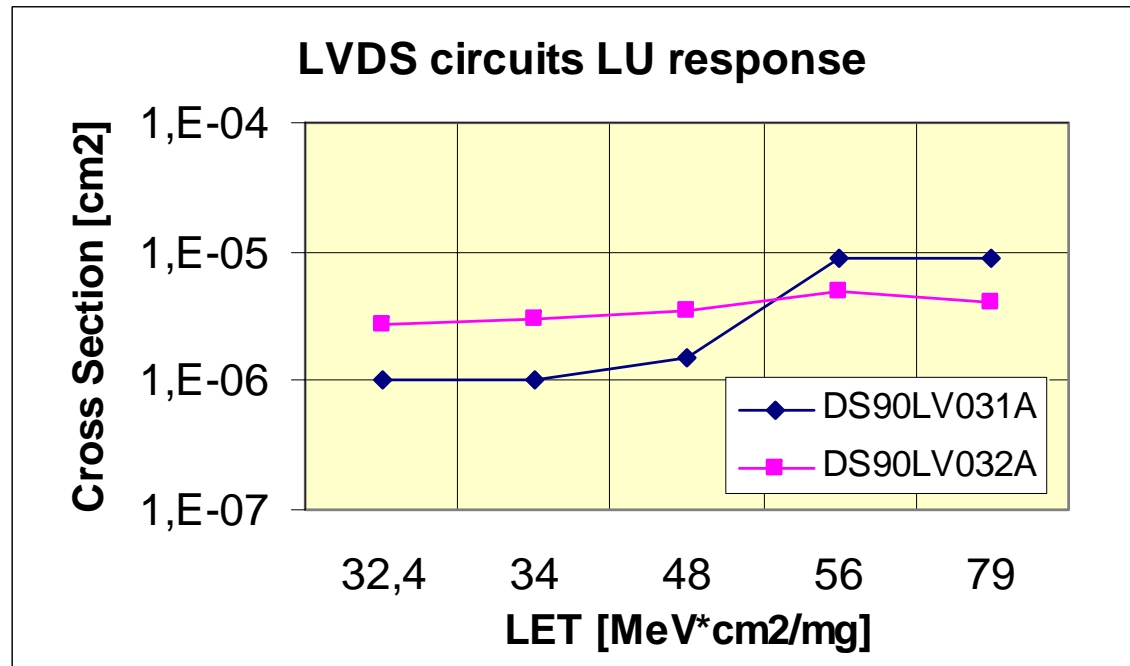
SEL Cross Section vs LET

No clear threshold value was recorded

Fluence of 1E6 → Few SEL's
