# Rendezvous Sensor on ATV:

## Fiber Optic Link of Optical Head and E-Box

## Investigations after Fiber Rupture on ATV Cone

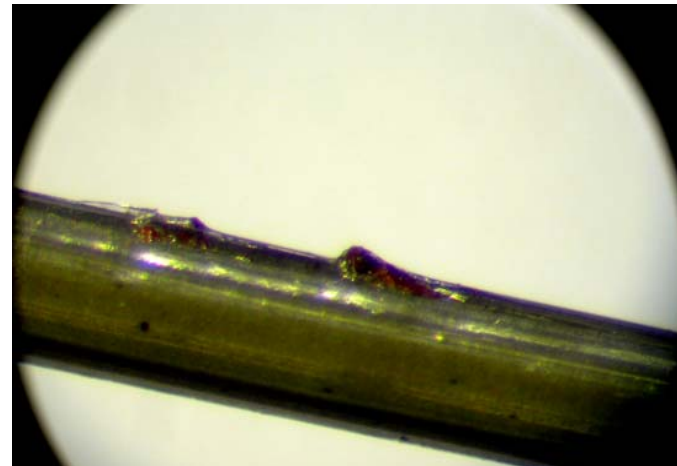
- F) Some irregularities were visible on the coating surface, not leading to increased risk of break

*Surface irregularity on a cut of the Step Index fiber*

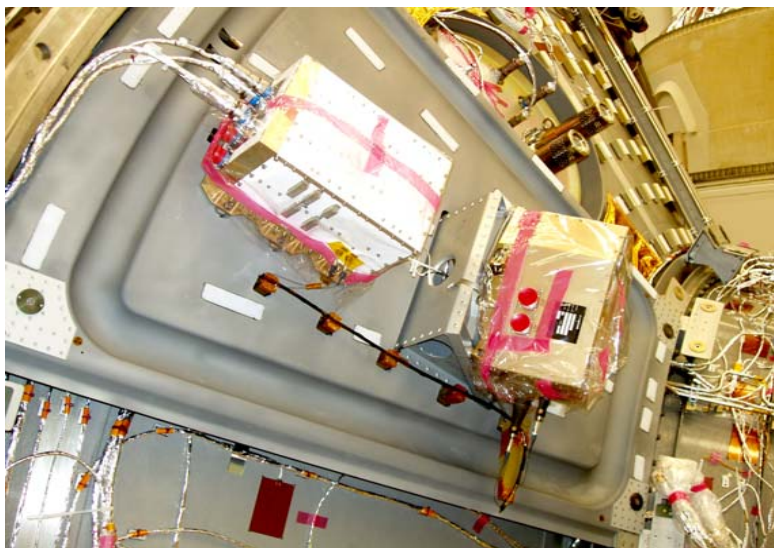
*RVS on the ATV cone*

Appropriate fiber handling is an important prevention of fiber break. The broken fiber (as well as the 3 other fibers on ATV cone) were already fixed - removed - fixed resulting from incomplete integration of components around RVS. Pre-damage of the fiber coating by the applied tools (knife to remove tape) cannot be excluded.

- **Simplified mounting procedure for fibers on further ATV**
- **Careful fiber cable handling, avoidance of “over-handling”**
- **Check of the already mounted cables by a magnifying lens**
- **Introduction of a mechanical protection on ATV to avoid fiber damage**
- **Dynamic bend test for cable assembly, and instead of Proof-test**
- **Optimization of fiber design and procedures in case of further fiber manufacturing (e.g. coating material, test methods)**

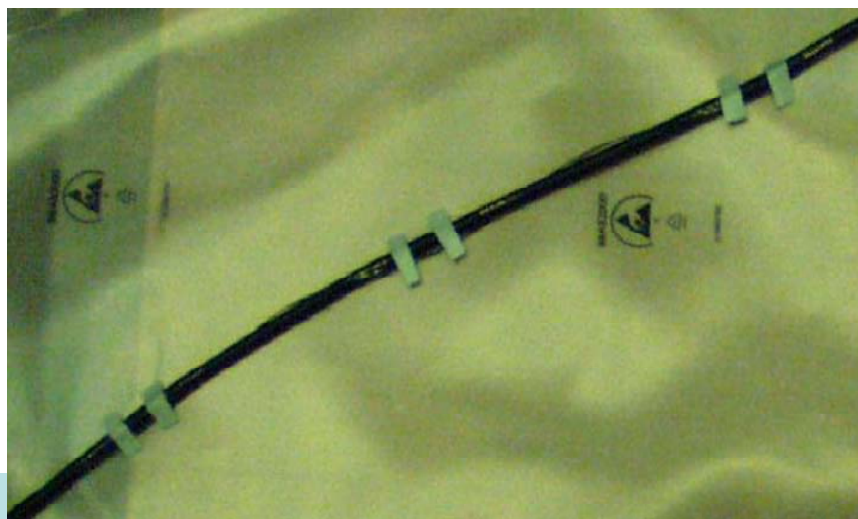
- H) Care must be taken on the bending radius of the fiber. The applied fixation by winding the fiber around a cable seams to be not optimum. An under-run of the allowable short term bending radius just before break seams probable.

*Fiber winding around the Triax cable*

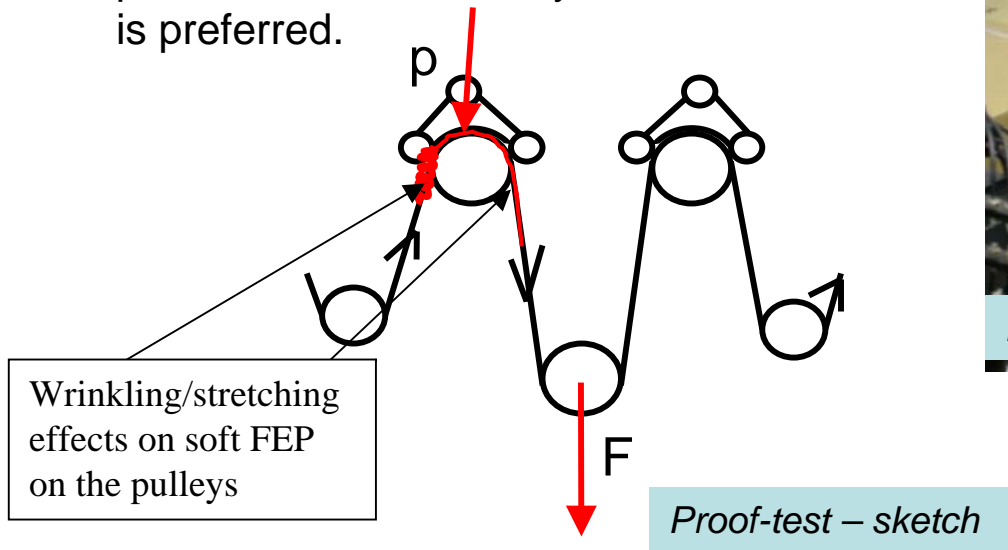
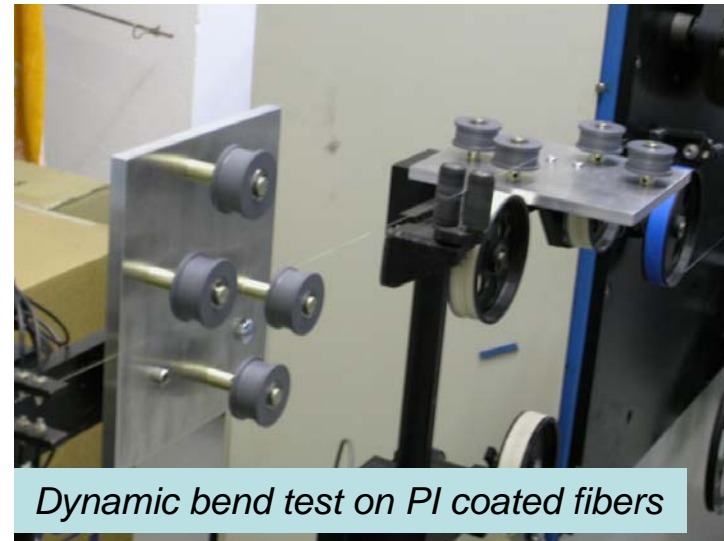
- 1) On a fiber with soft outer FEP coating and rather stiff inner PI coating, an execution of a conventional Proof-test turned out to be inadequate. The additional Proof-test (refer to p.7) damaged a part of the remaining fiber in a way that it could no more used.

Reason: In case of pressure application during Proof-test, stretching of the FEP on one side of the “take-on/off”-roll leads to a wrinkling on the opposite side and to micro bending stress on the fiber core. Thus, a Proof-test, if any, on FEP coated fibers must be performed under very low pressure. A so-called dynamic bend test is preferred.
