High Power Laser Diode Array Reliability Analyses

**2nd ESA-NASA Working Meeting on
Optoelectronics**

21-23 June 2006

Duane Smith, Andrew Schober, John Hobbs, Dale Bruns, Bruce Tiemann,
Nathan Woody, Orion Esch, Mike McFarland, Wayne Garrett, Brian Corcoran,
John Wenzel, Glenn Bennett

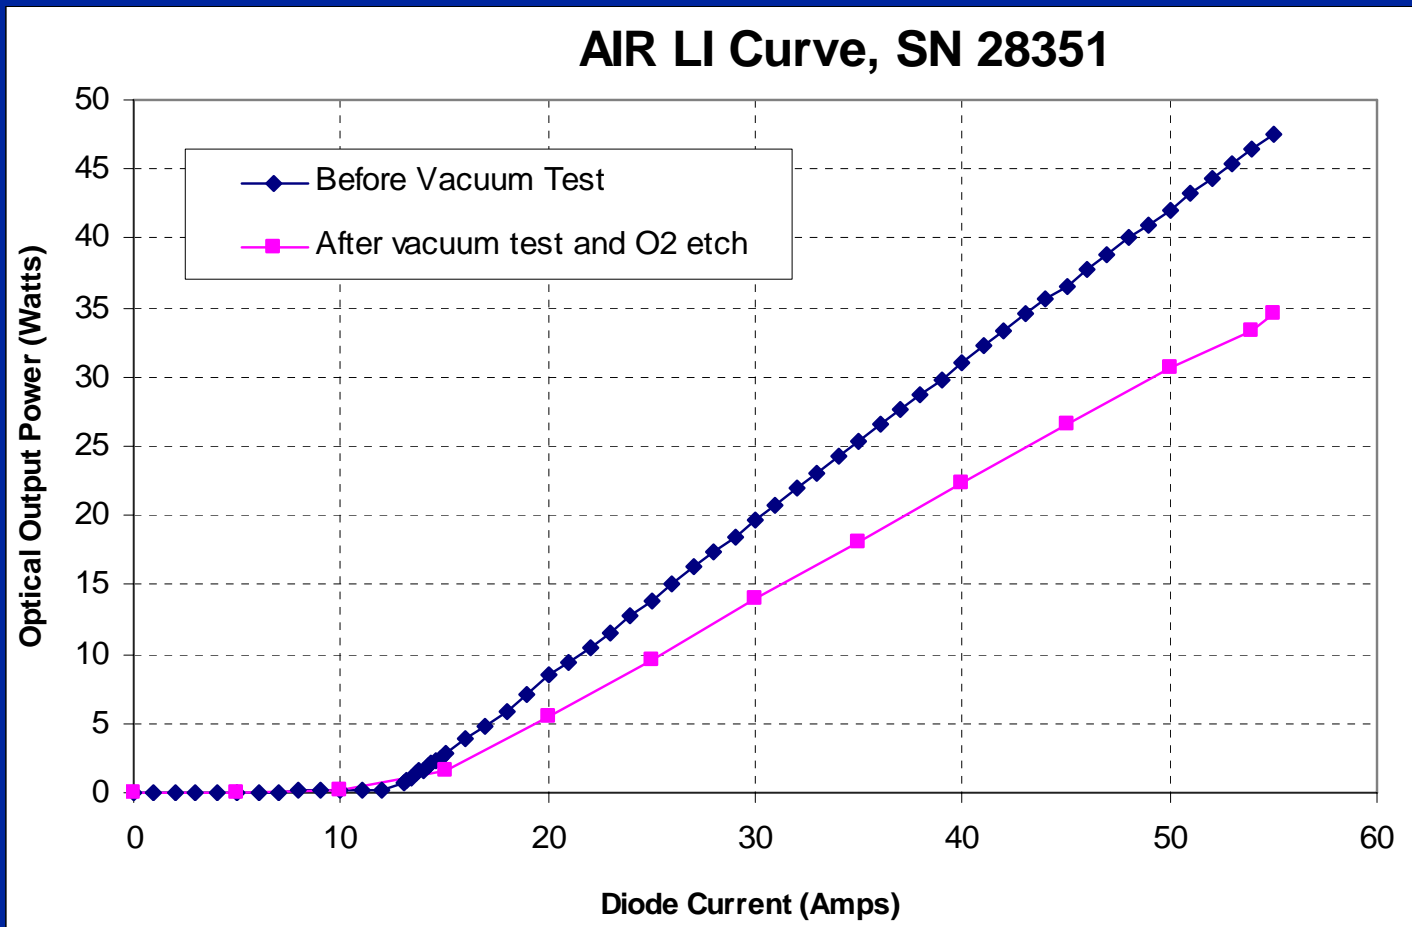
Five one-minute etches O_2 reactive ion plasma 50W drive power had no apparent effect to restore output power lost during vacuum testing

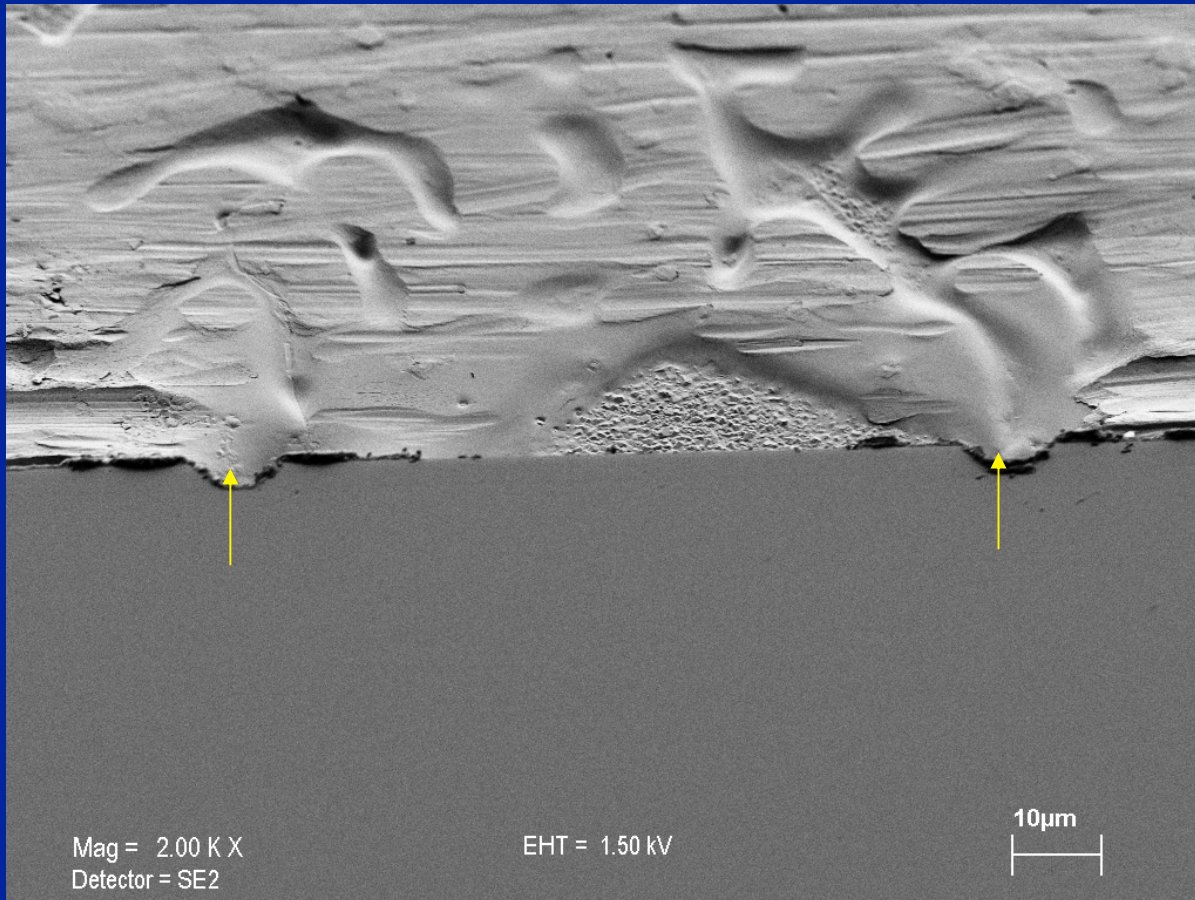
Test Article #28351, junction image 7, “clean facet area” after 100 hour test

Current and optical isolation trenches are periodically etched into the diode surface (here, the facet view).

360µm wide at emitters and 90µm spacers between emitters.

1cm long array & 450µm per emitter -> 22 emitters

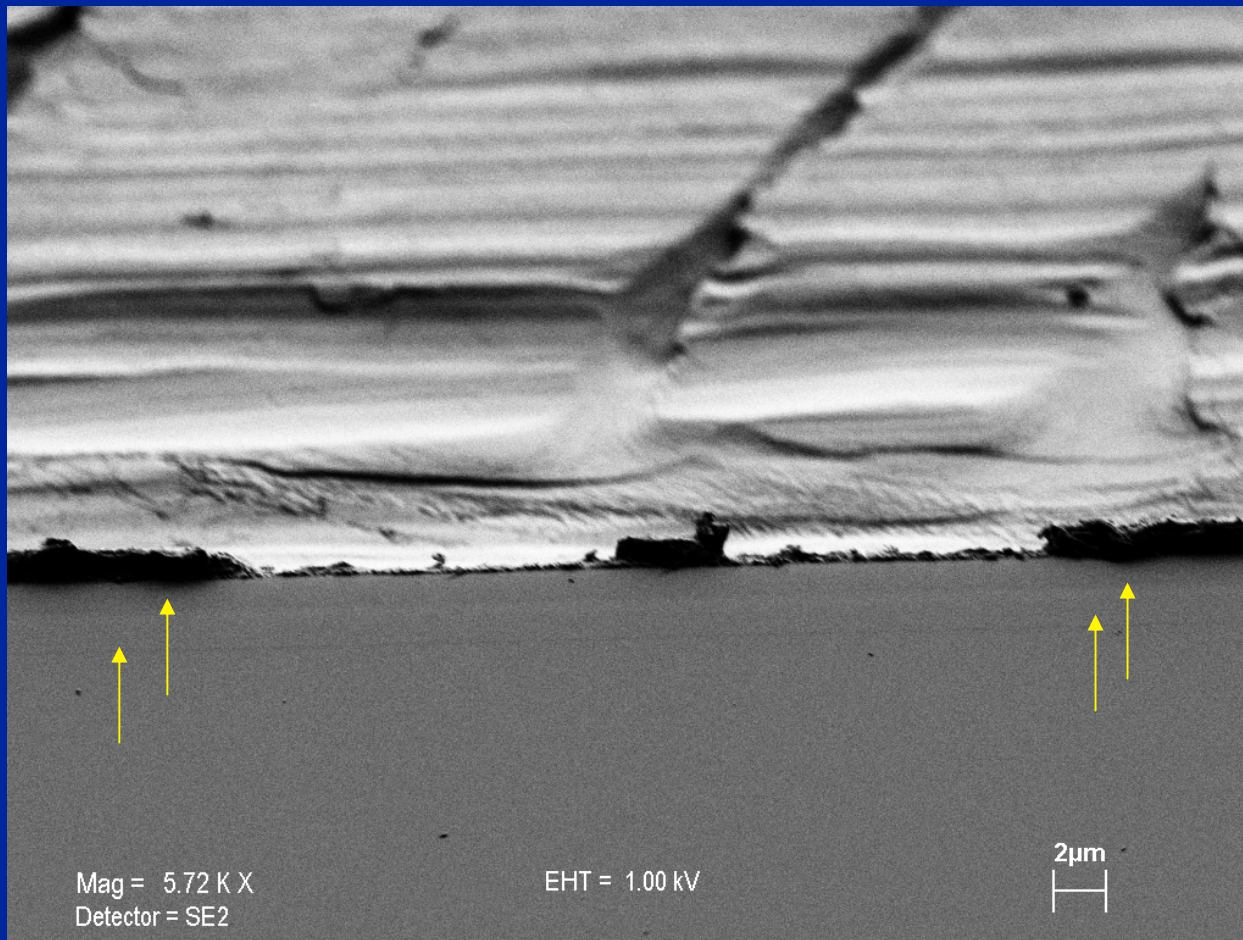
Test Article #28351, junction image 8, “clean area” after

Locating the junction/emitters is as shown. In a clean area of the diode facet, the thin bar, with edges marked by the arrows, represents the laser diode waveguide.

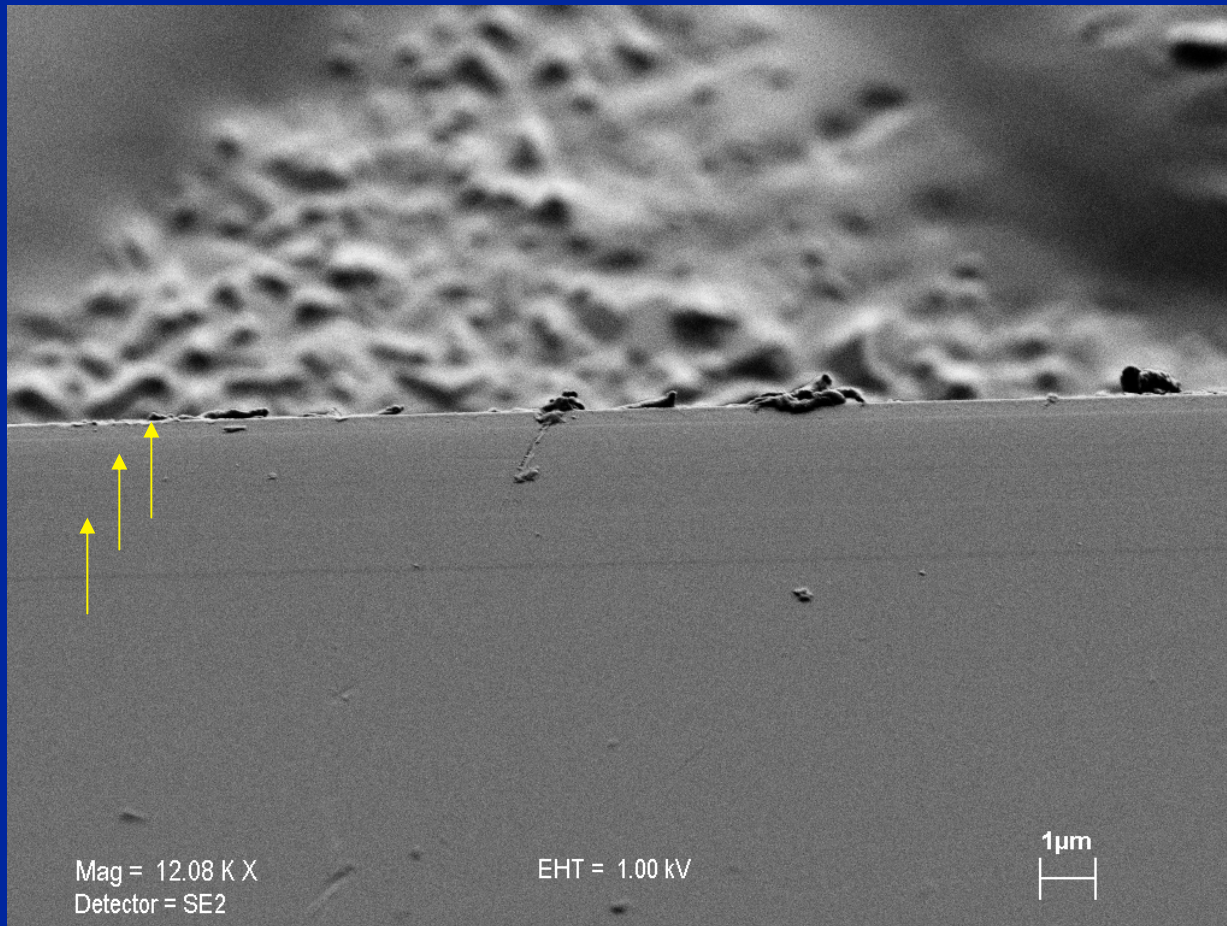
Test Article #28351, junction image 9, “clean area” after

Another view, showing a few of the epitaxial layers

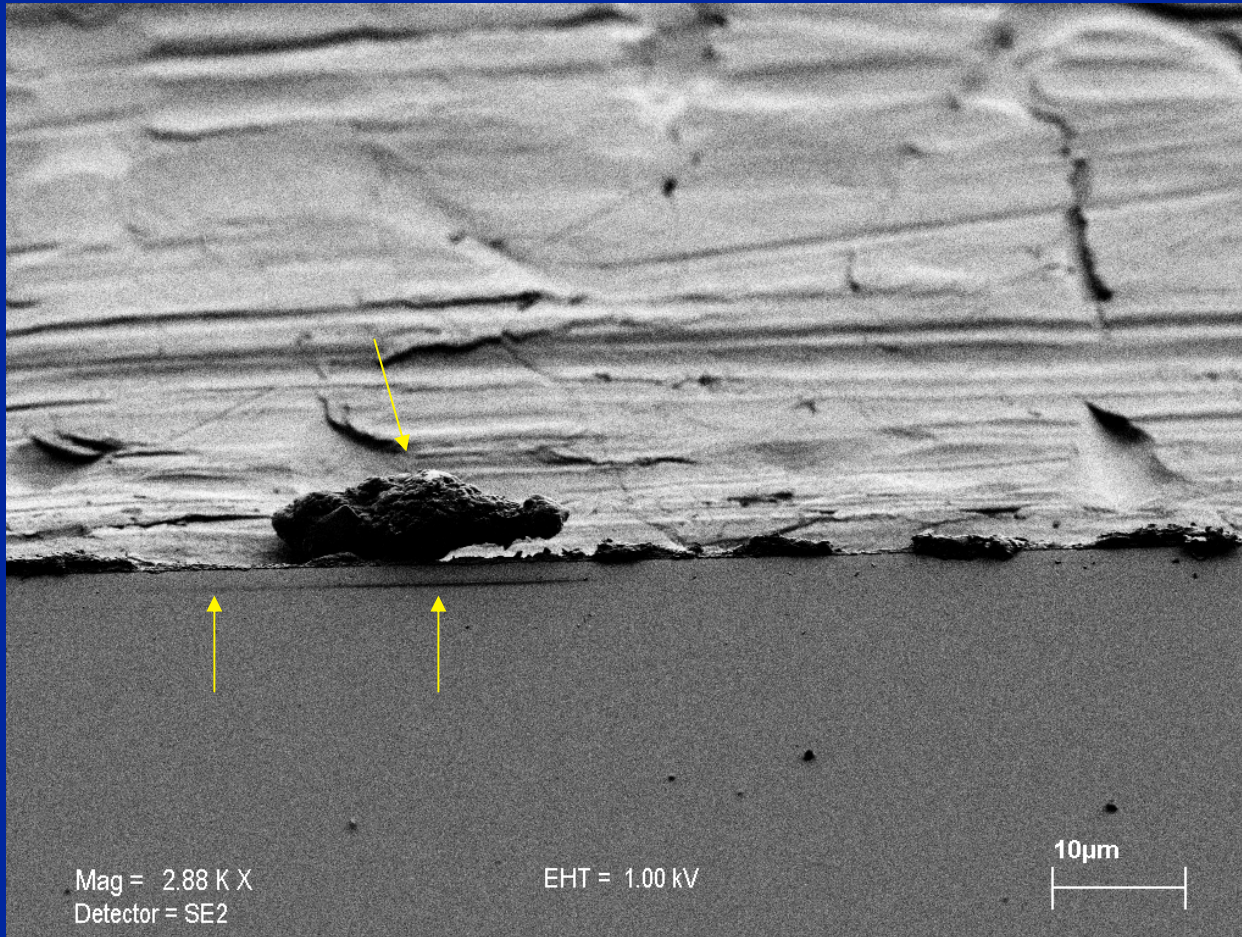
Test Article #28351, junction image 10, “clean area” after

Distinct “Alligator” – shaped landmark.

Note the thin dark line on the facet near this feature – origin is uncertain, possible delamination of epitaxial layers

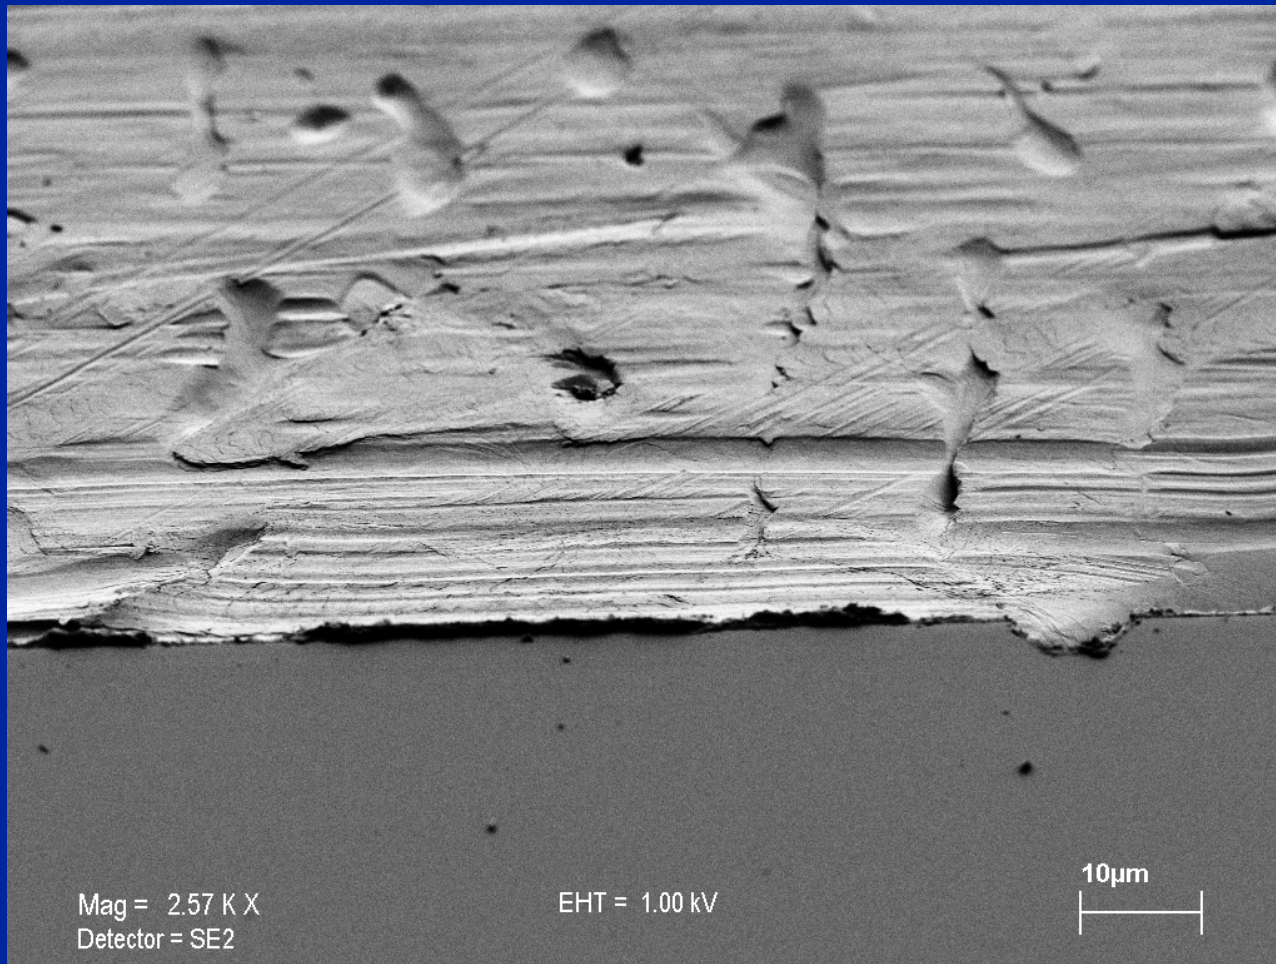
Test Article #28351, junction image 11, “clean area” after

Note pits in the surface of the solder – potentially bubbles of gas/flux that had burst.

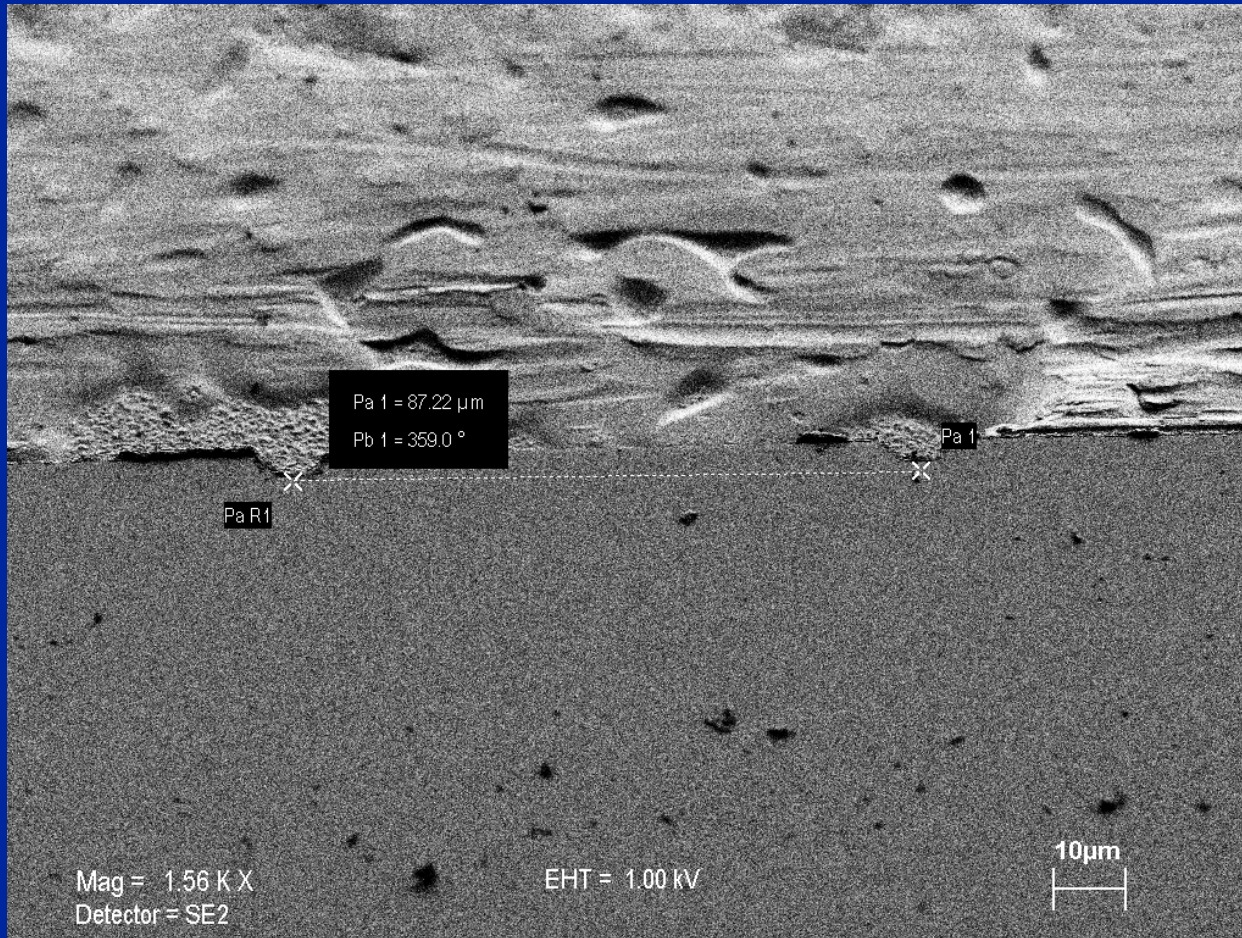
Test Article #28351, junction image 12, “clean area” after

Cursor measurement between markers reveals the narrow spacing is 87 microns.

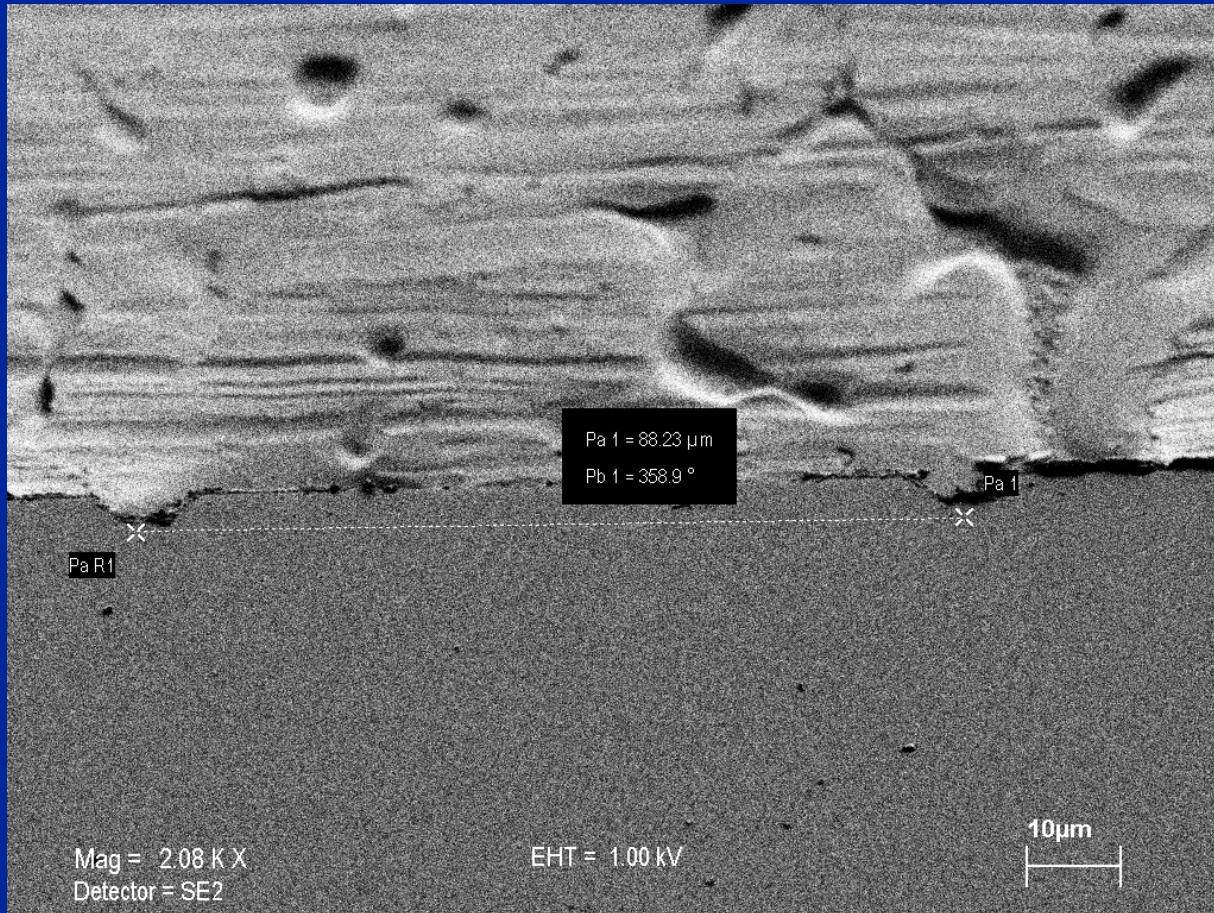
Test Article #28351, junction image 13, “clean area” after

Cursor measurement between markers shows the wide spacing (between which lies the emitters) of 88micron.

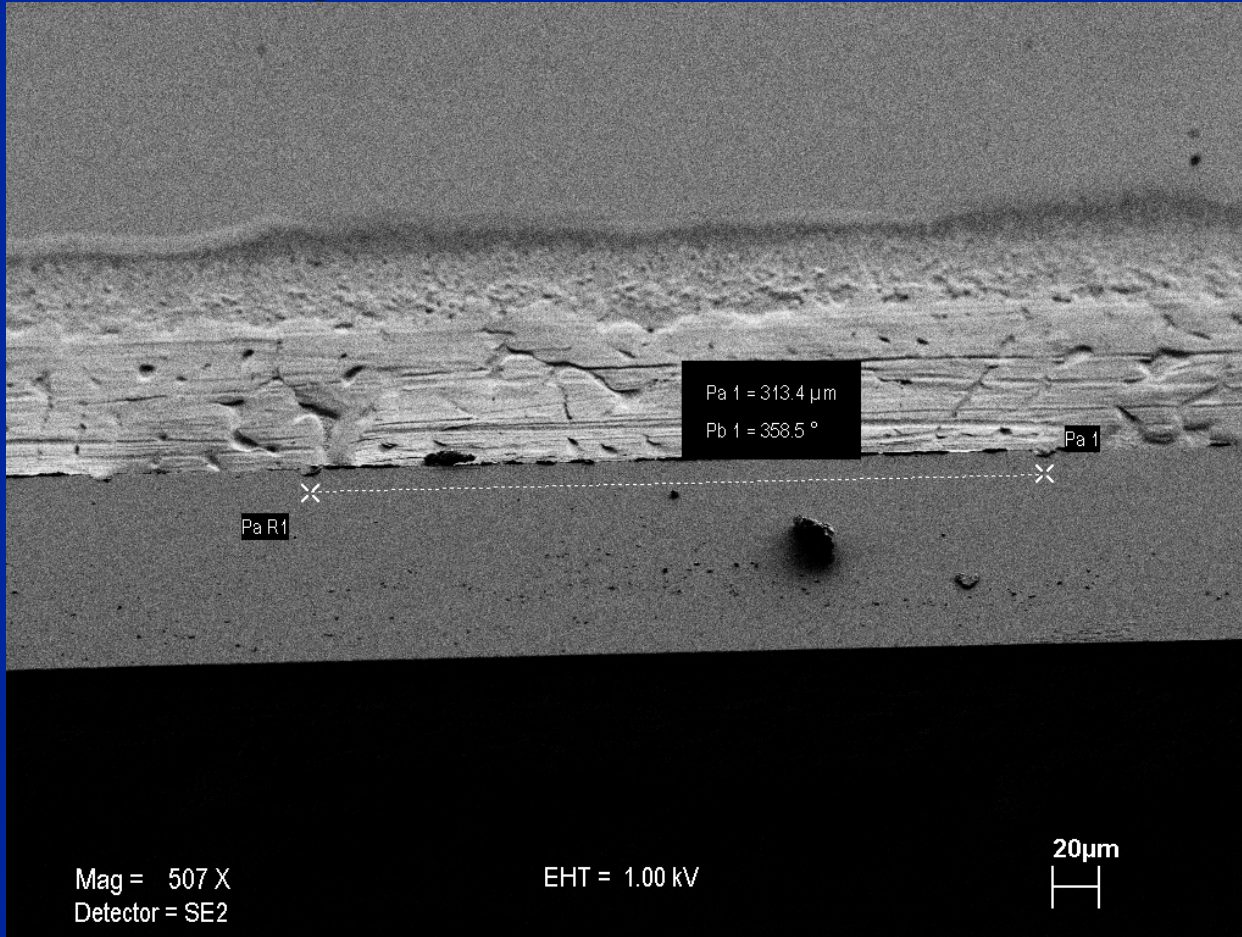
Test Article #28351, junction image 15, “clean area” after

Another lower magnification view of the emitters, spacers and isolation trenches

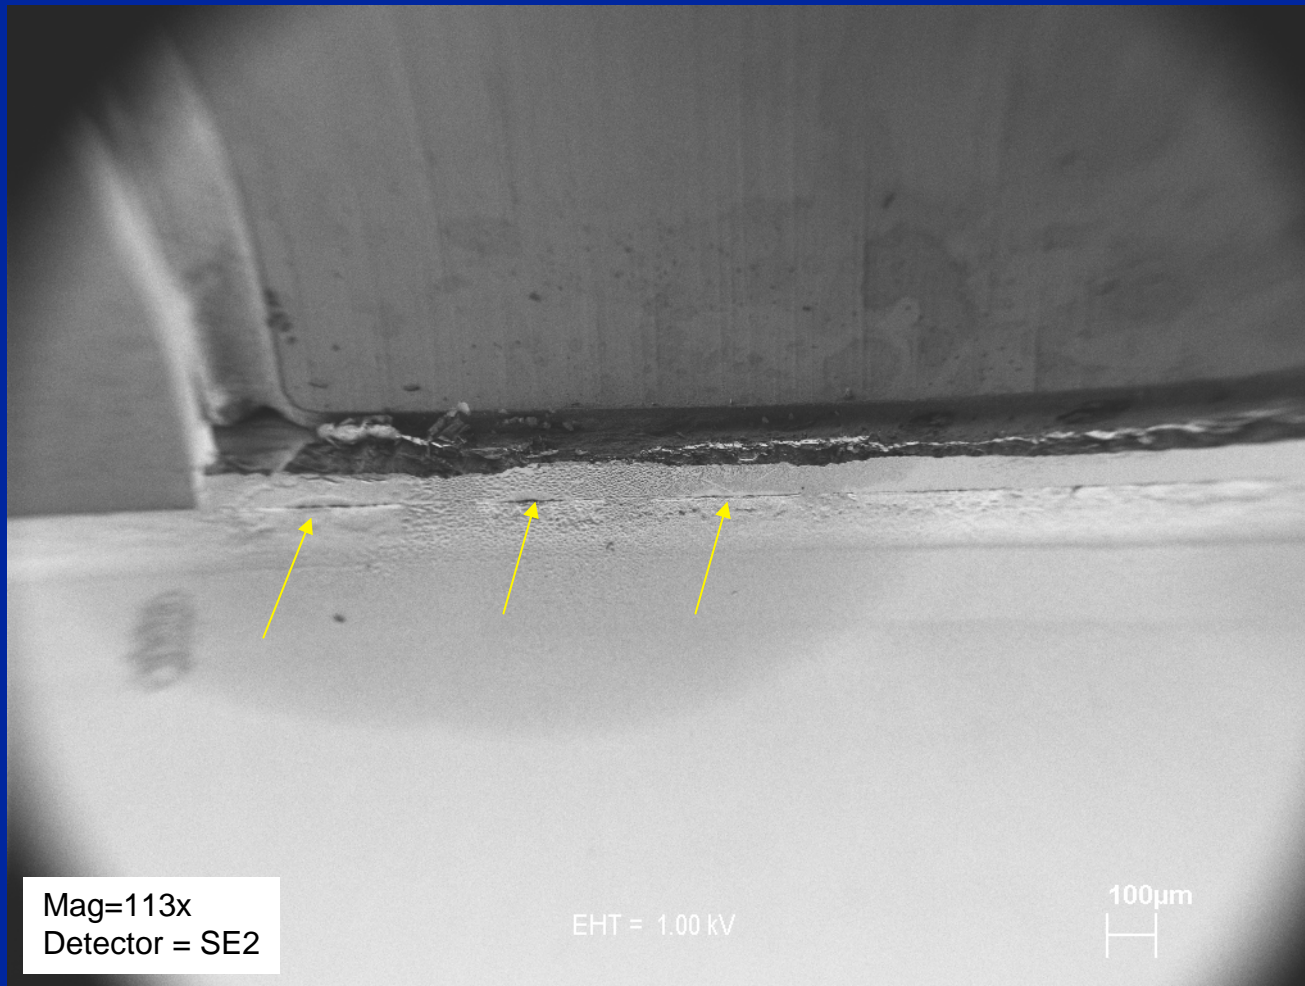
Test Article #28351, junction image 18, “eruption area” after

Low magnification view of the left edge of diode bar (looking head-on) where “debris” was ejected and deposited.

Can see where the diode light “blasted” its way through deposits.

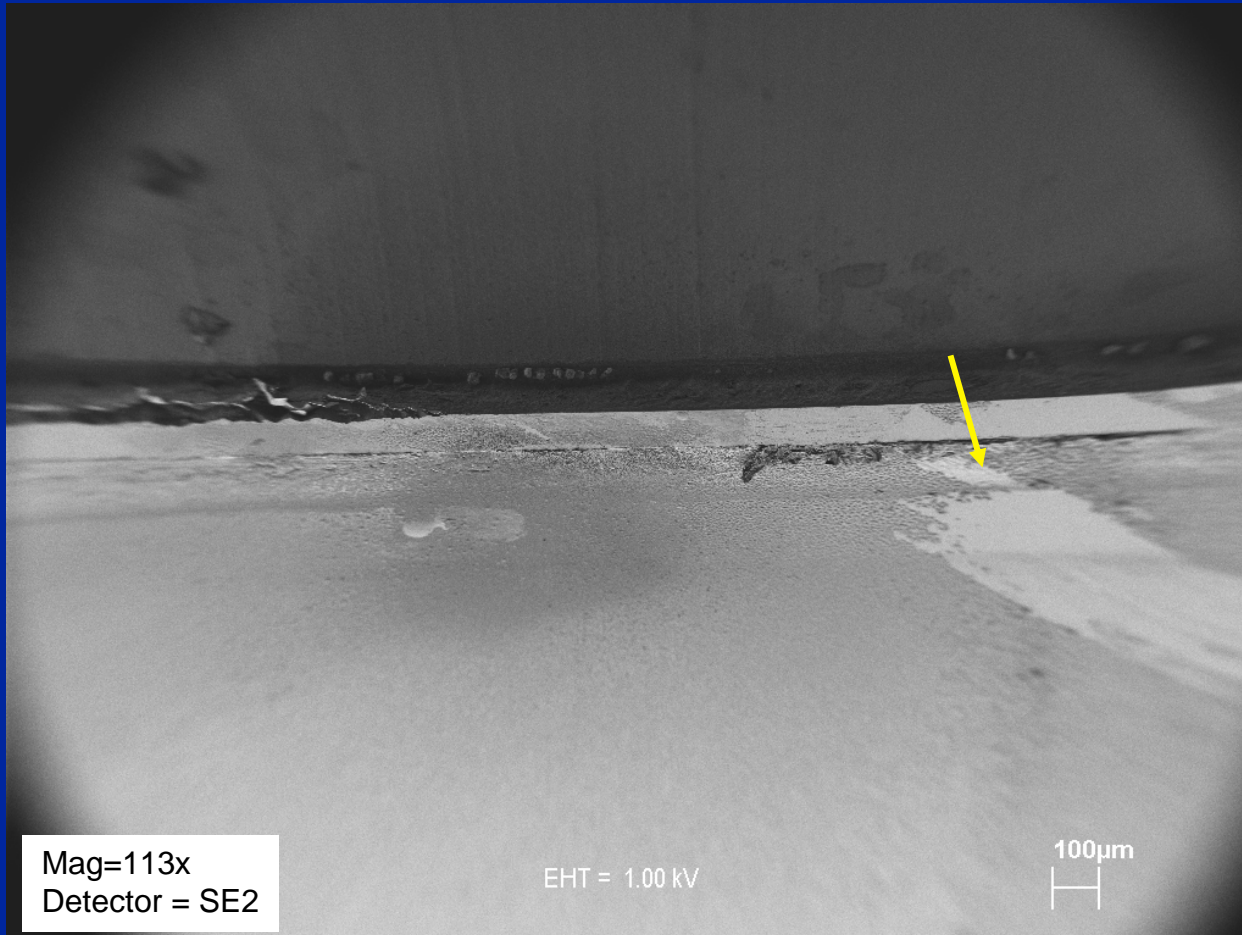
Test Article #28351, junction image 19, “eruption area” after

Low-magnification
view of central portion
of diode facet

Similar to optical
photos, patchy facet
coating near the
swipe on the right.

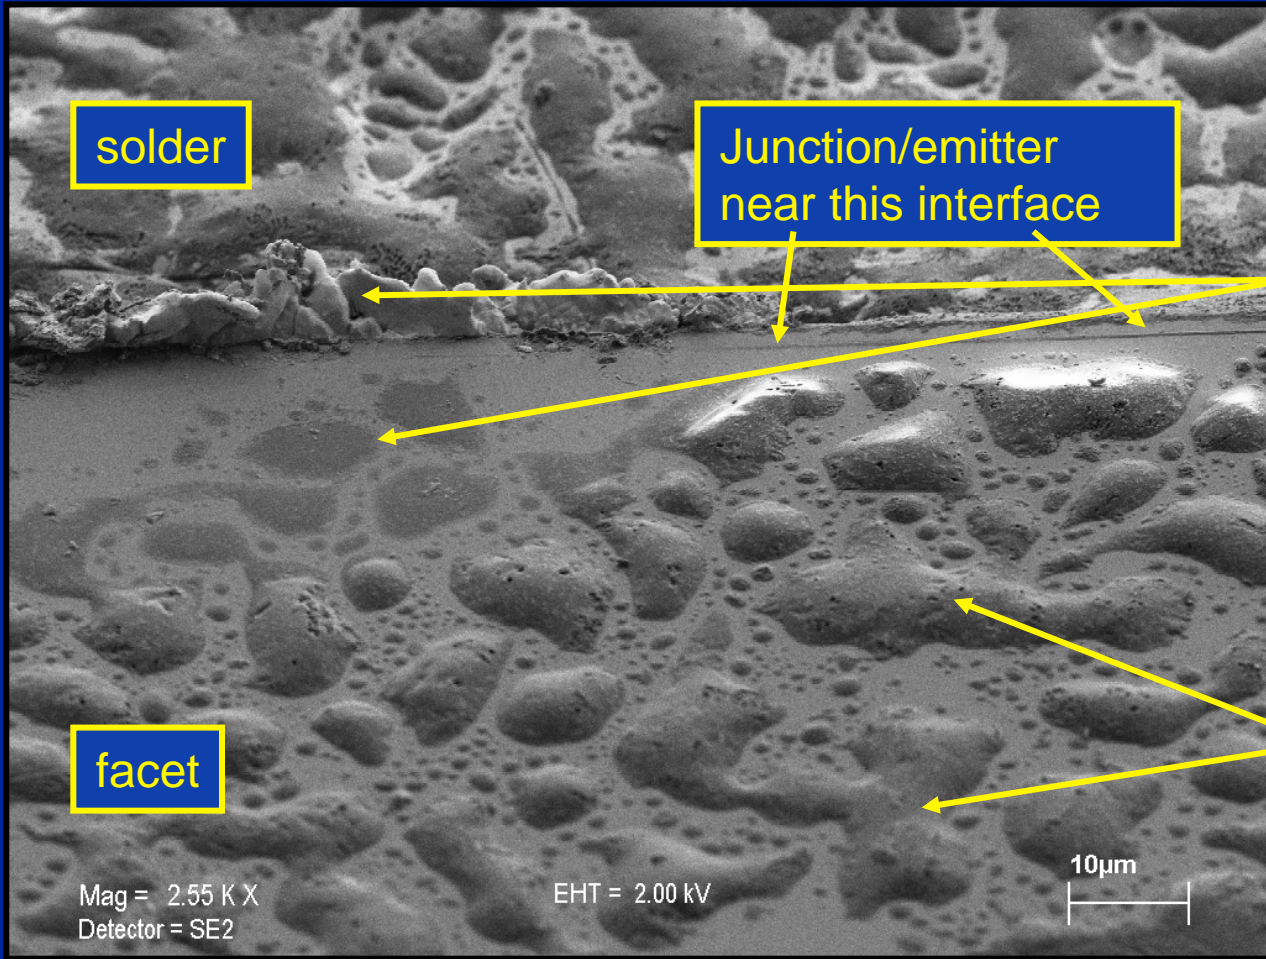
Test Article #28351, junction image 1, eruption area after

Note residue of melted (or partially melted) material near emitter, and associated “pile” that accumulates near the solder interface

Material deposited from “event” resulting from heating and/or vacuum operation
Not expected

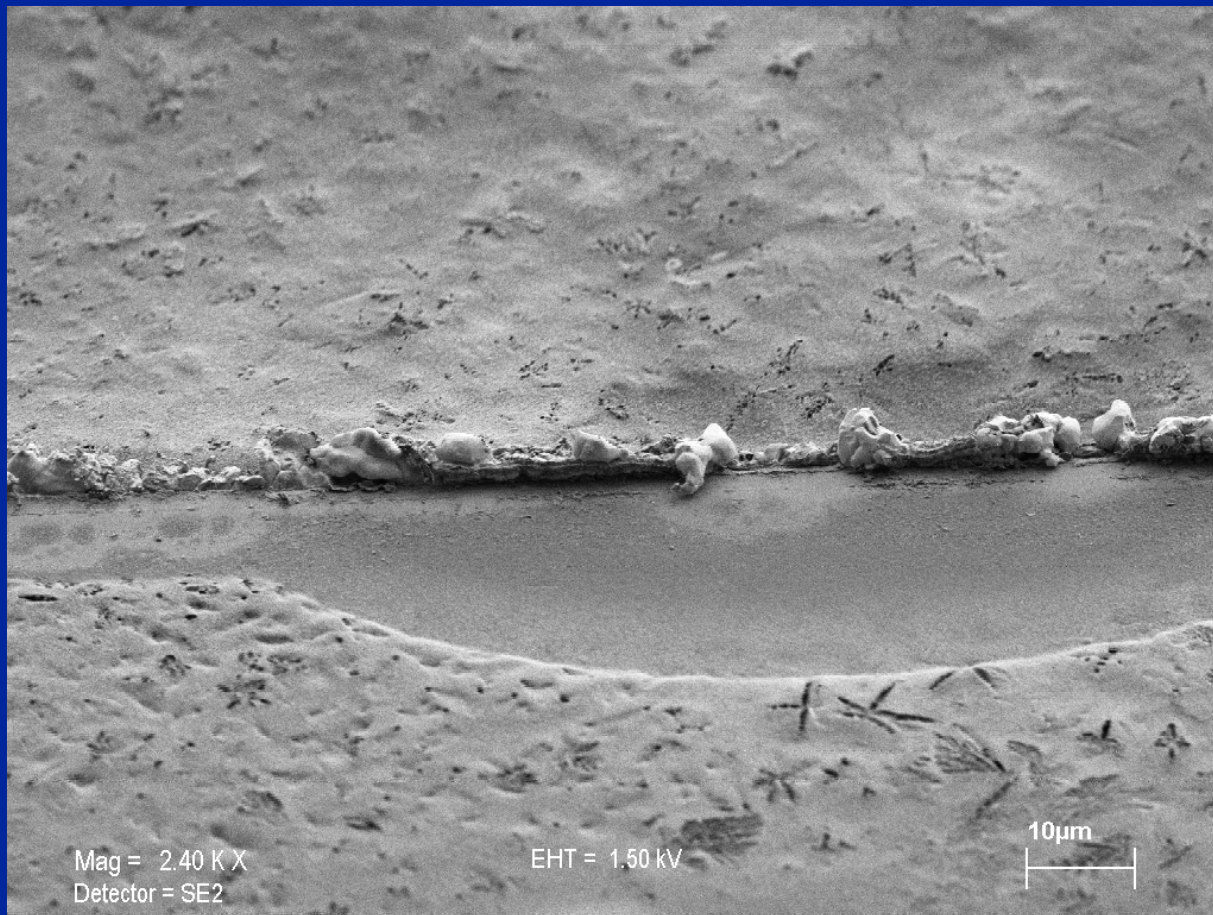
Test Article #28351, junction image 2, eruption area after

This area is heavily coated with “debris” – “debris” appears to be dominated by Carbon in the first 25 Angstroms. (see Auger results for detailed composition).

Note laser light (or local heating) appears to have burned out a half-moon shape in the deposited layer on the facet surface. Power was not affected by this facet contamination.

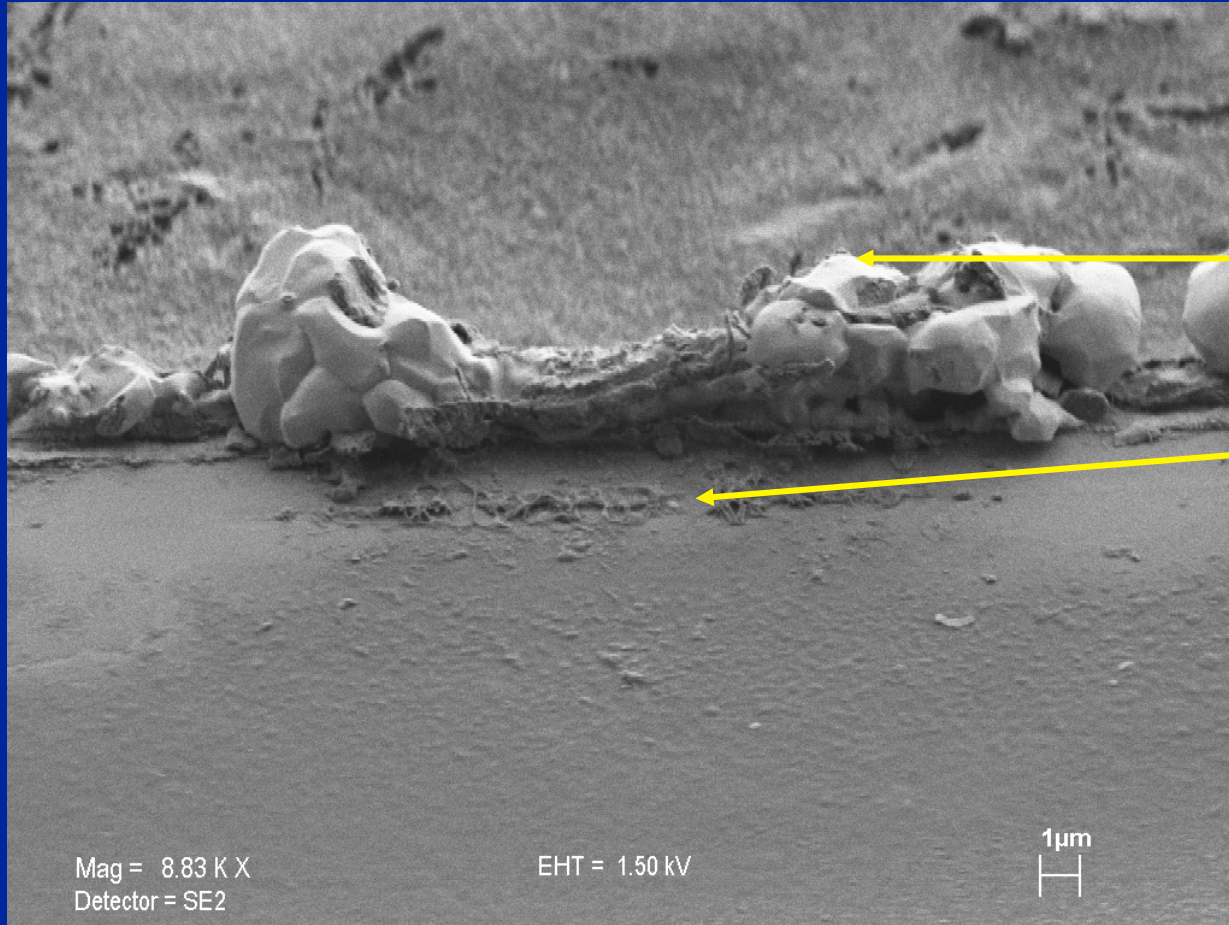
Test Article #28351, junction image 3, eruption area after

In some places, build-up appears near the facet-solder interface.

Sometimes, a thin line (possibly along the emitter) appears as well. Chemical composition of this line is being investigated.

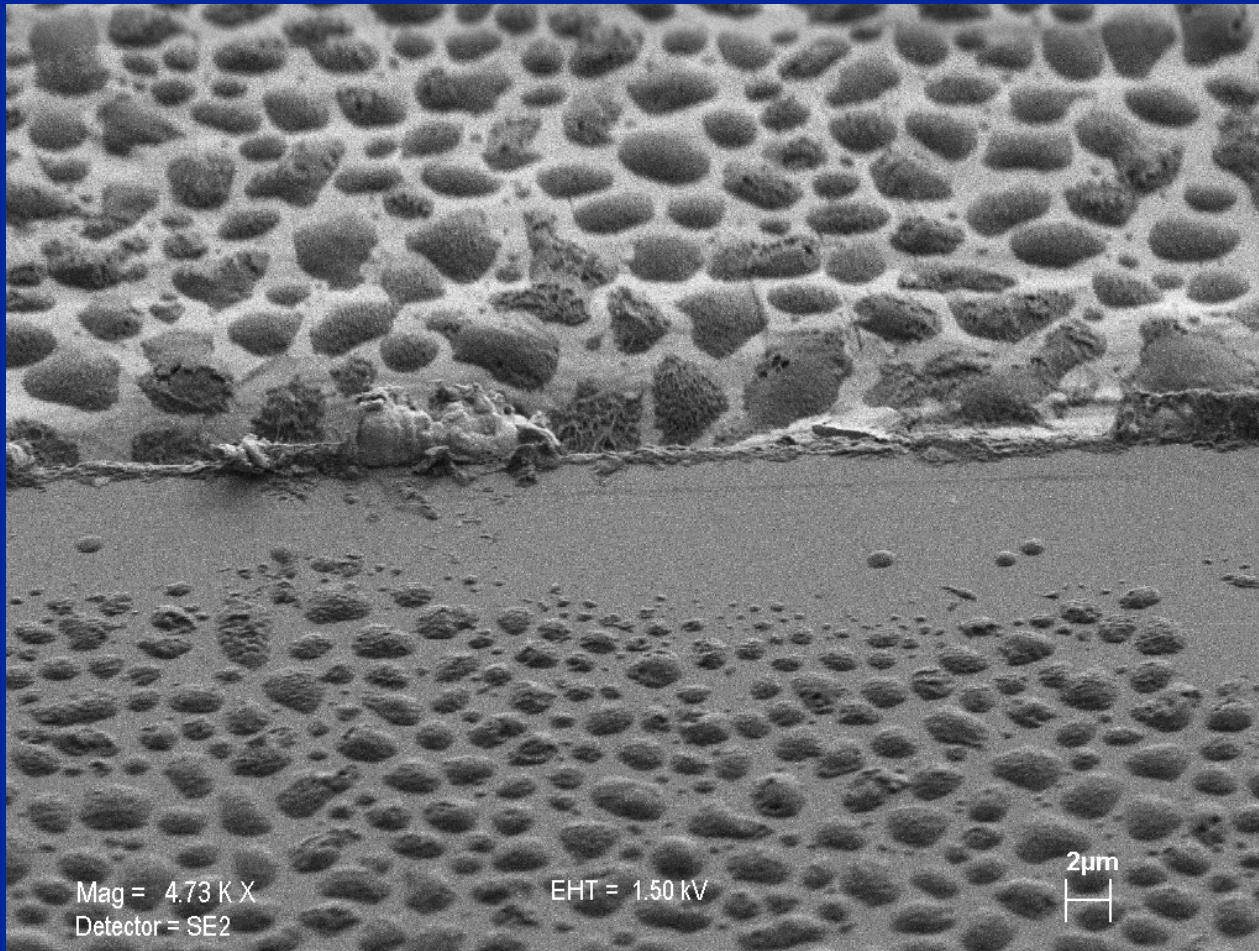
Test Article #28351, junction image 4, eruption area after

In many places, the deposits are beaded. Again, a thin dark line near the interface appears – possibly indicating a residue at the junction/emitter.

Auger analysis reveals that the beaded deposits are largely carbon, at least on the top 25 angstroms.

Source of carbon is unclear, despite bake-out and cleaning prior to test

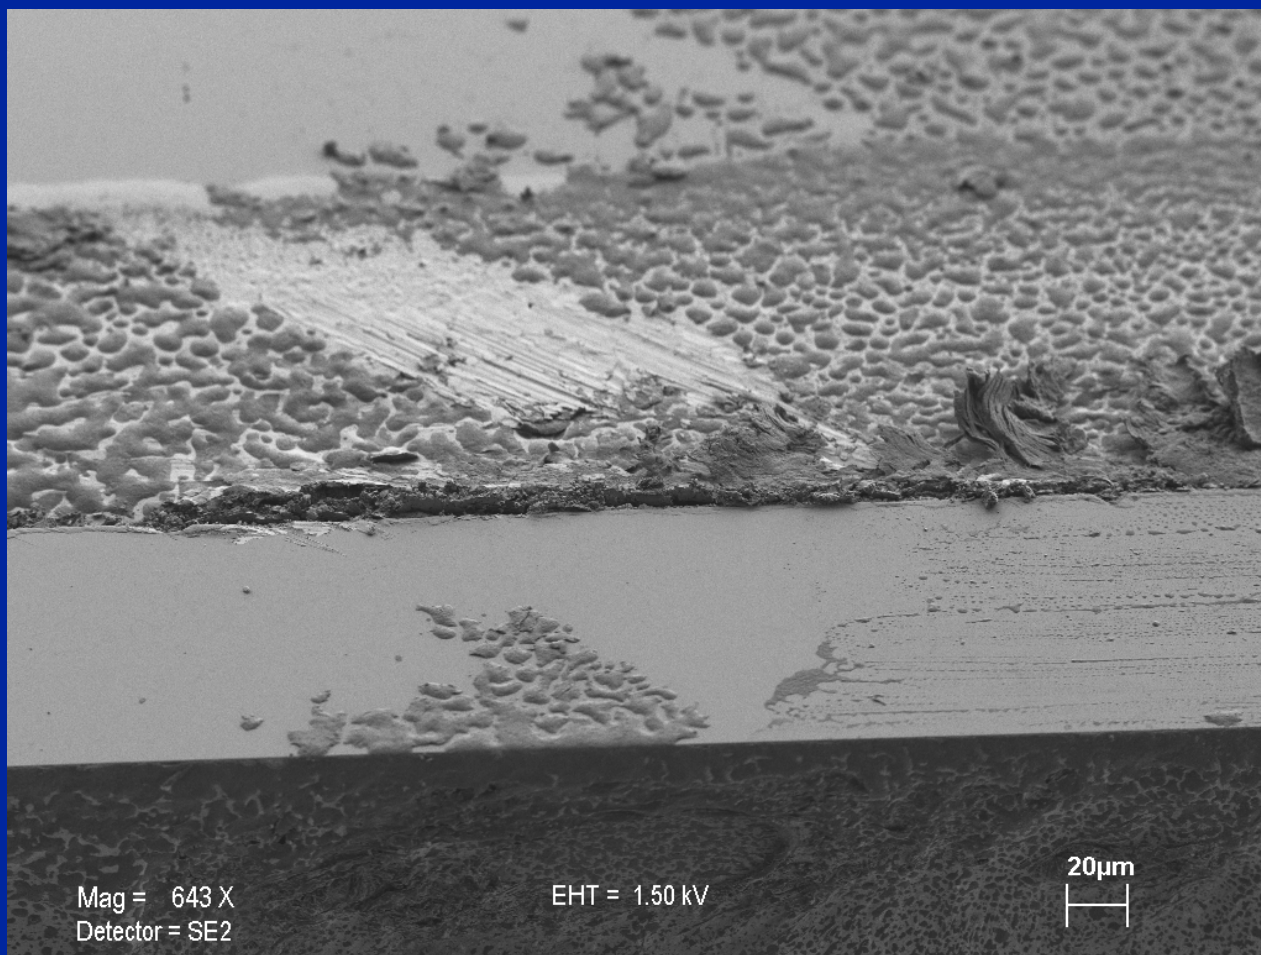
Test Article #28351, junction image 5, eruption area after

Near the center of the facet, a large swirle that is coincident with the ejection of “debris” on the die block – is visible to the unaided eye.

Note the facet, appears wet and mopped – origin uncertain.

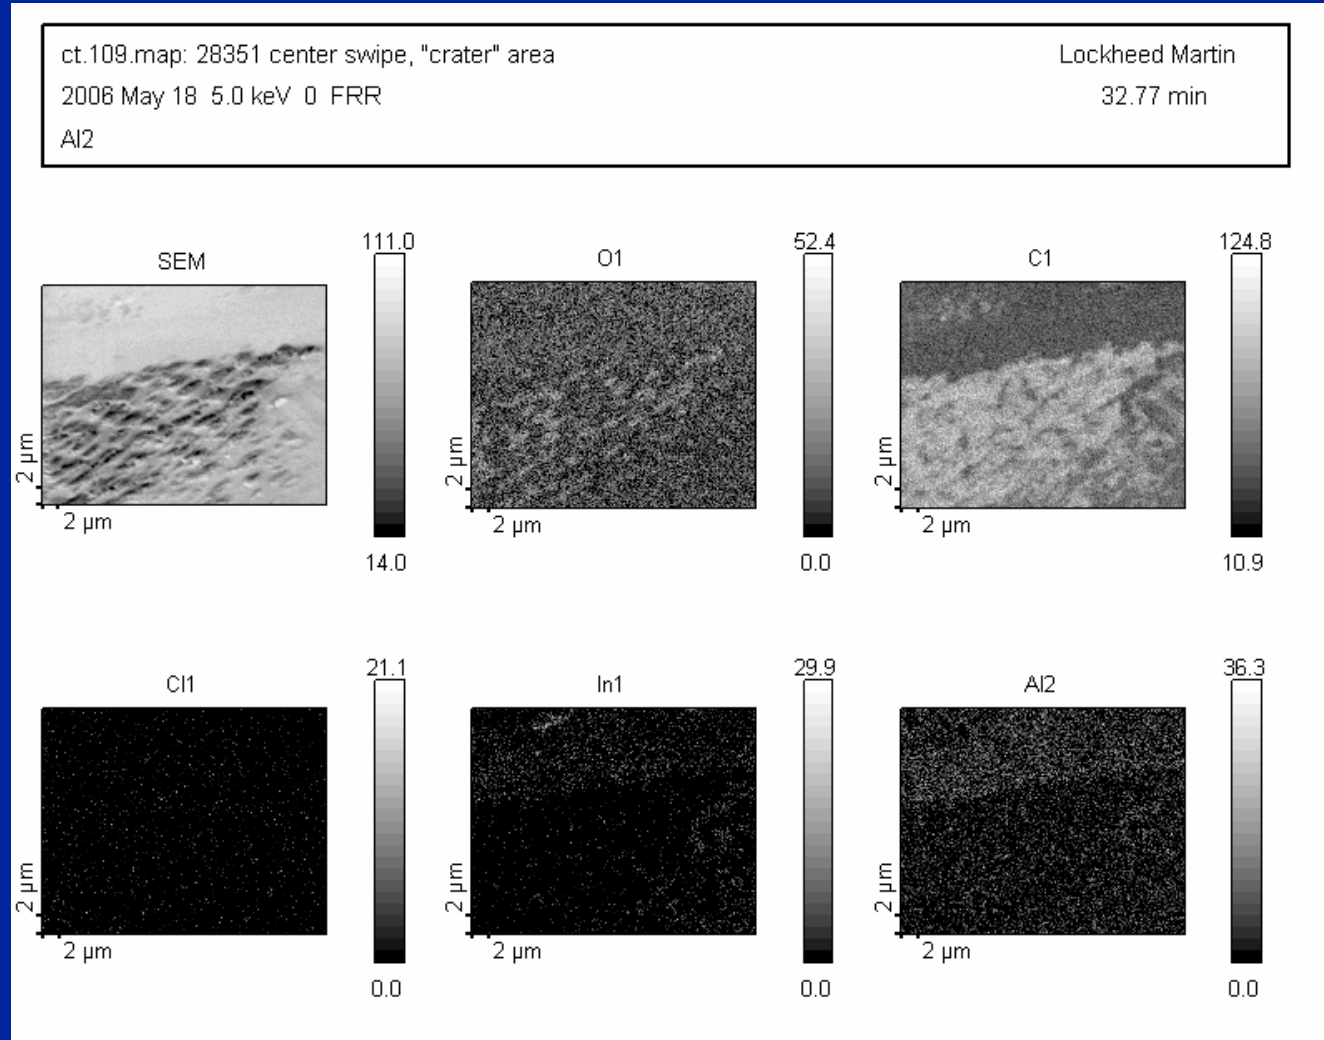
Test Article #28351, Auger analysis

Map of surface spanning “clean” and “dirty” sections of the sample indicate “dirt” contains increased amounts of carbon and oxygen, and decreased amounts of indium and aluminum (as compared to “clean” area).

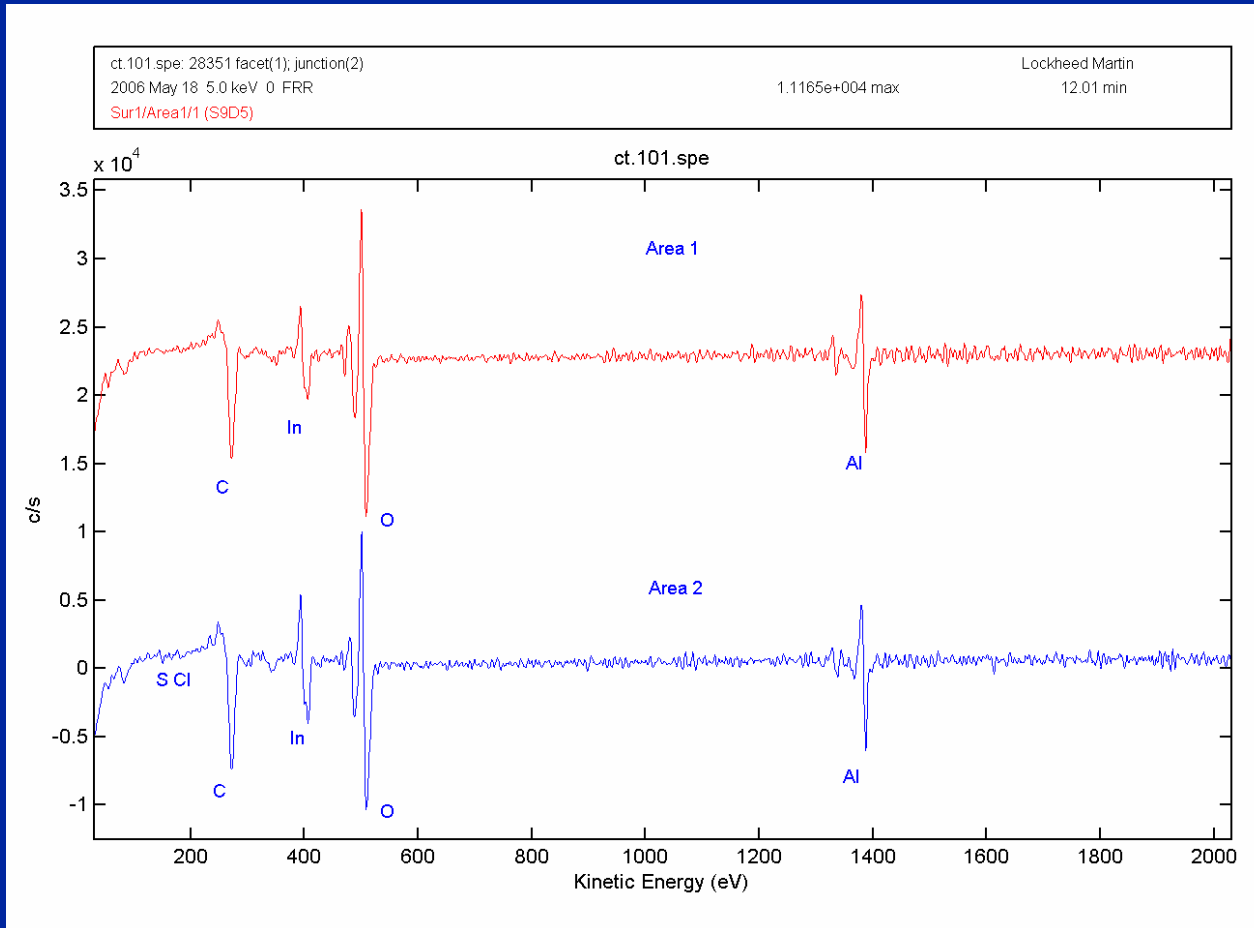
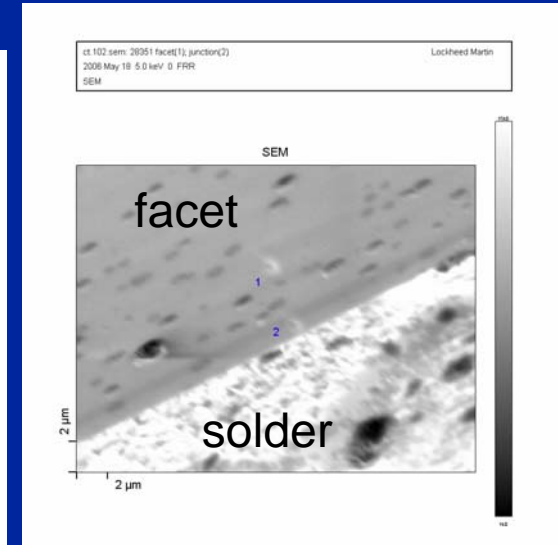
Test Article #28351, Auger analysis

Analysis of two areas (area 2: near junction and area 1: away from junction) indicate similar chemical signatures.

Area 2 has notably larger peaks for S, Cl, and In.
