High Power Laser Diode Array Reliability Analyses

**2nd ESA-NASA Working Meeting on
Optoelectronics**

21-23 June 2006

Duane Smith, Andrew Schober, John Hobbs, Dale Bruns, Bruce Tiemann,
Nathan Woody, Orion Esch, Mike McFarland, Wayne Garrett, Brian Corcoran,
John Wenzel, Glenn Bennett

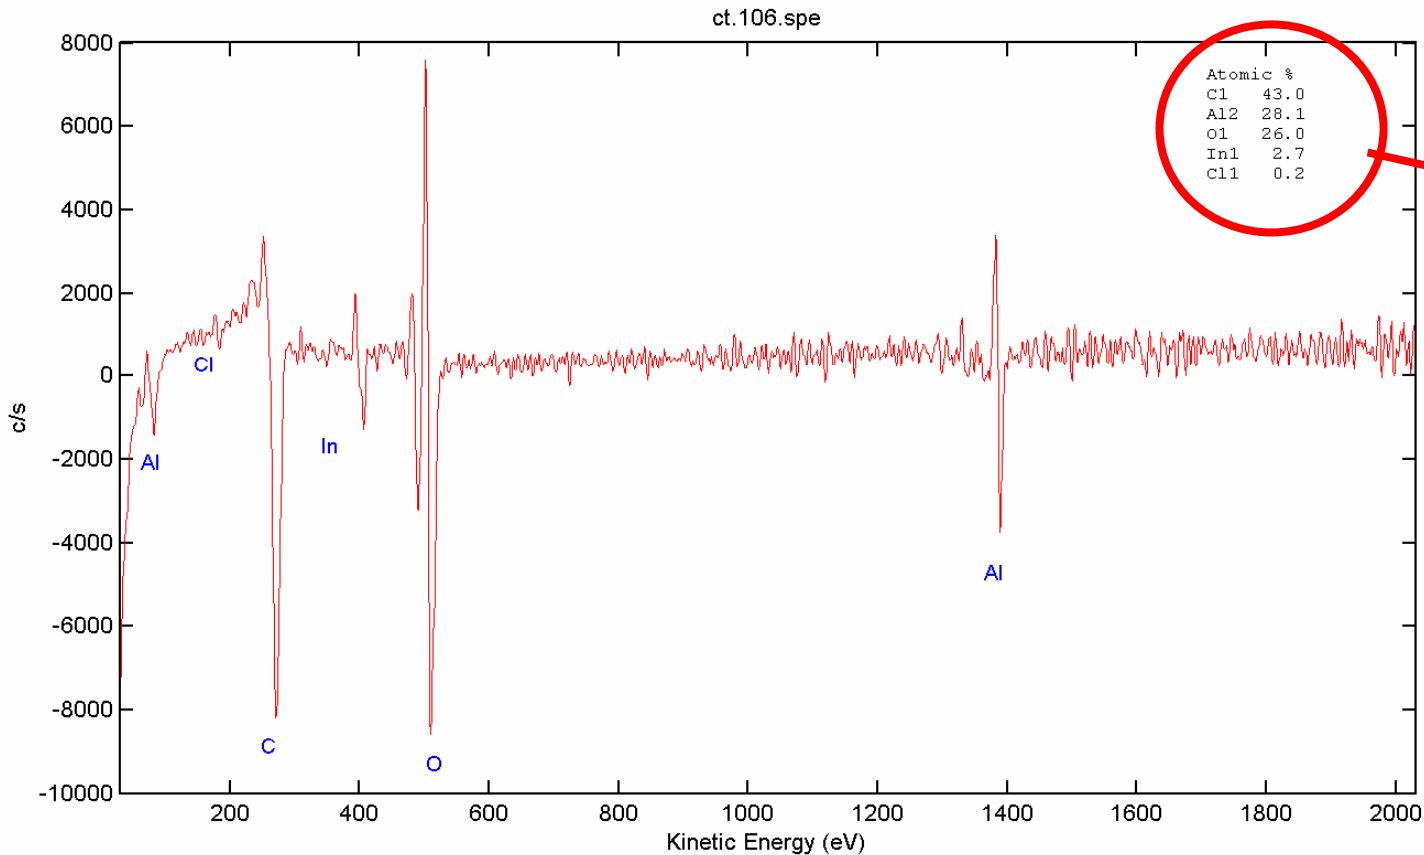
Test Article #28351, Auger analysis

Analysis of “clean” area:

Carbon: 43%
Aluminum: 28.1%
Oxygen: 26%
Indium: 2.7%
Chlorine: 0.2%

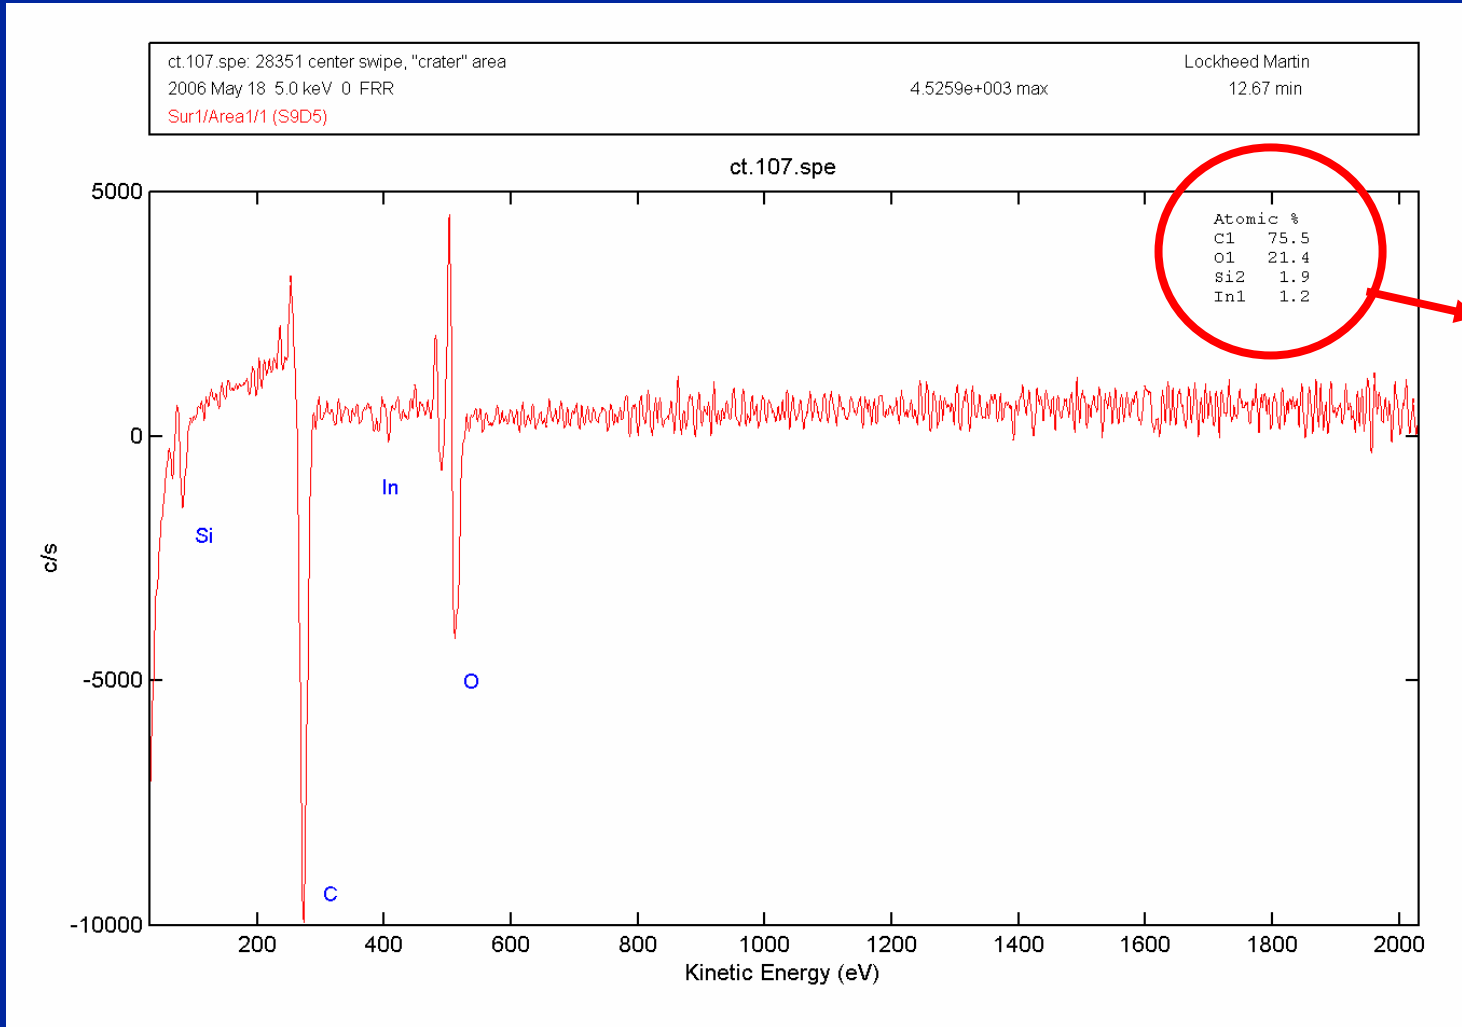
Test Article #28351, Auger analysis

Analysis of
"dirty" area:

Carbon: 75.5%
Oxygen: 21.4%
Silicon: 1.9%
Indium: 1.2%

Note absence of
Al compared to
"clean area"

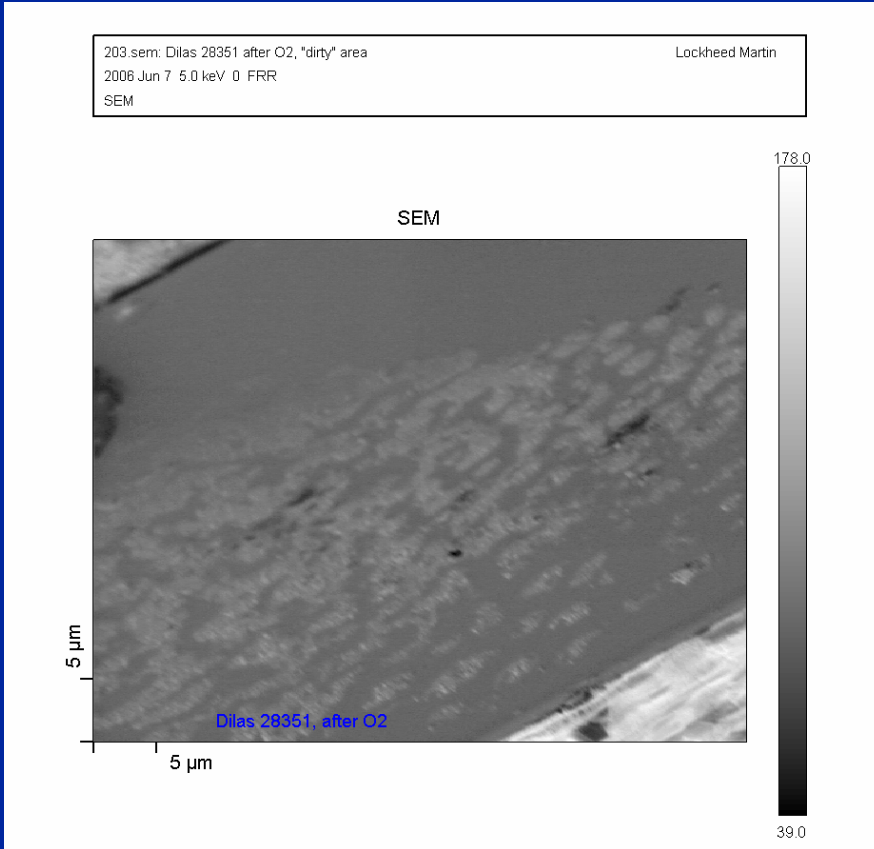
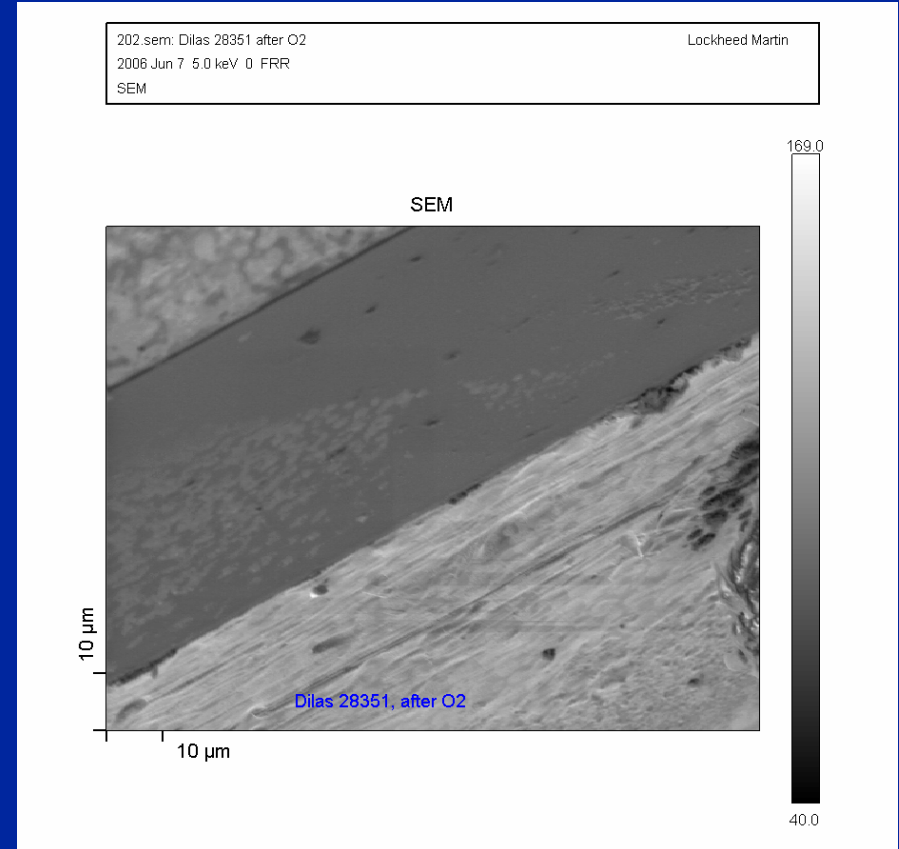
Test Article #28351, SEM

residue is not gone after 50W RF/5 minute O₂ etch that nominally removes 1 µm of non-refractory deposits, but appearance has changed and is cleaner

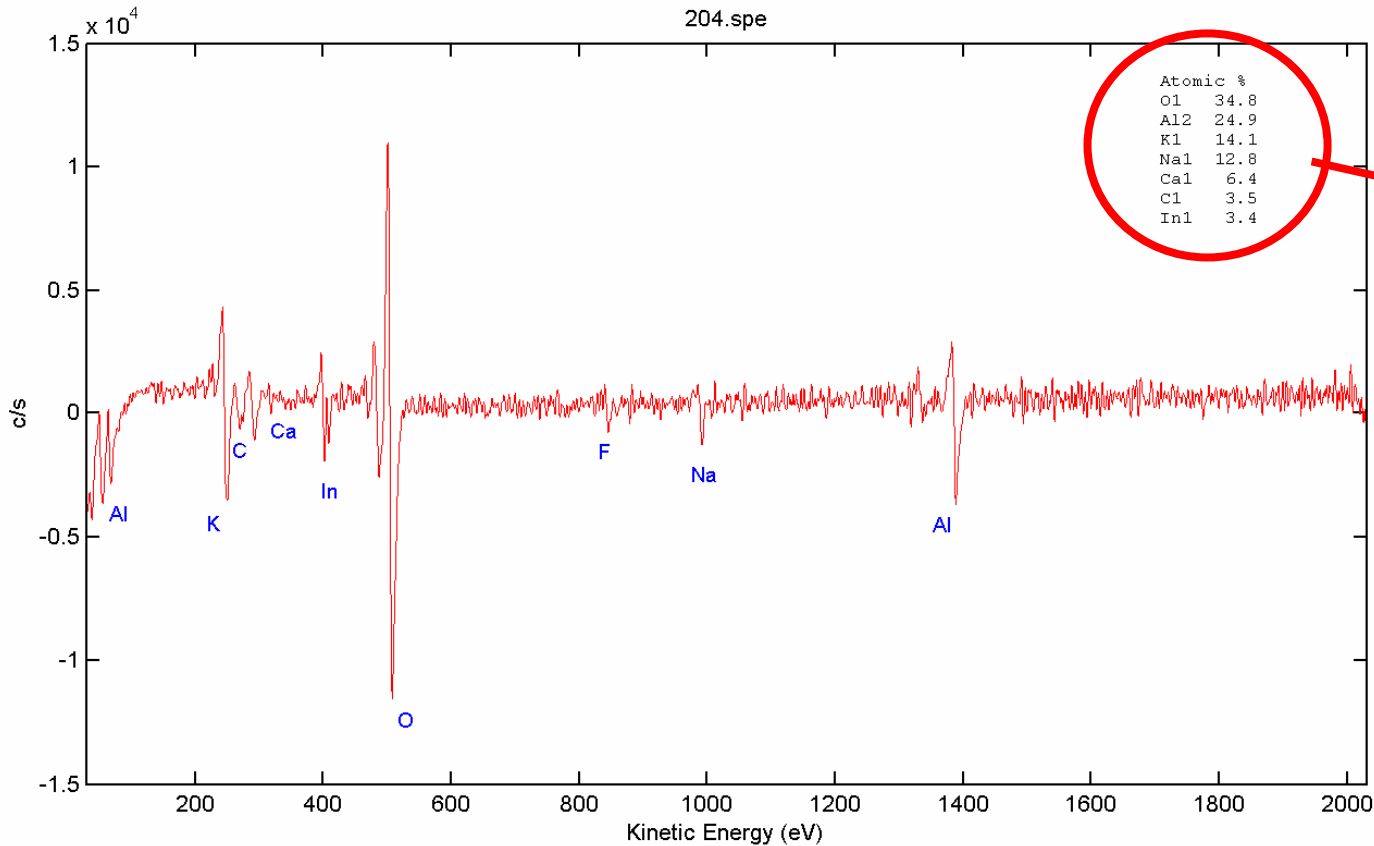
Test Article #28351, Auger analysis

Analysis of "dirty" area:

Oxygen: 34.8%
Aluminum: 24.9%
Potassium: 14.1%
Sodium: 12.8%
Calcium: 6.4%
Carbon: 3.5%
Indium: 3.4%

Carbon content went from 75% to 3.5% after O₂ plasma etch

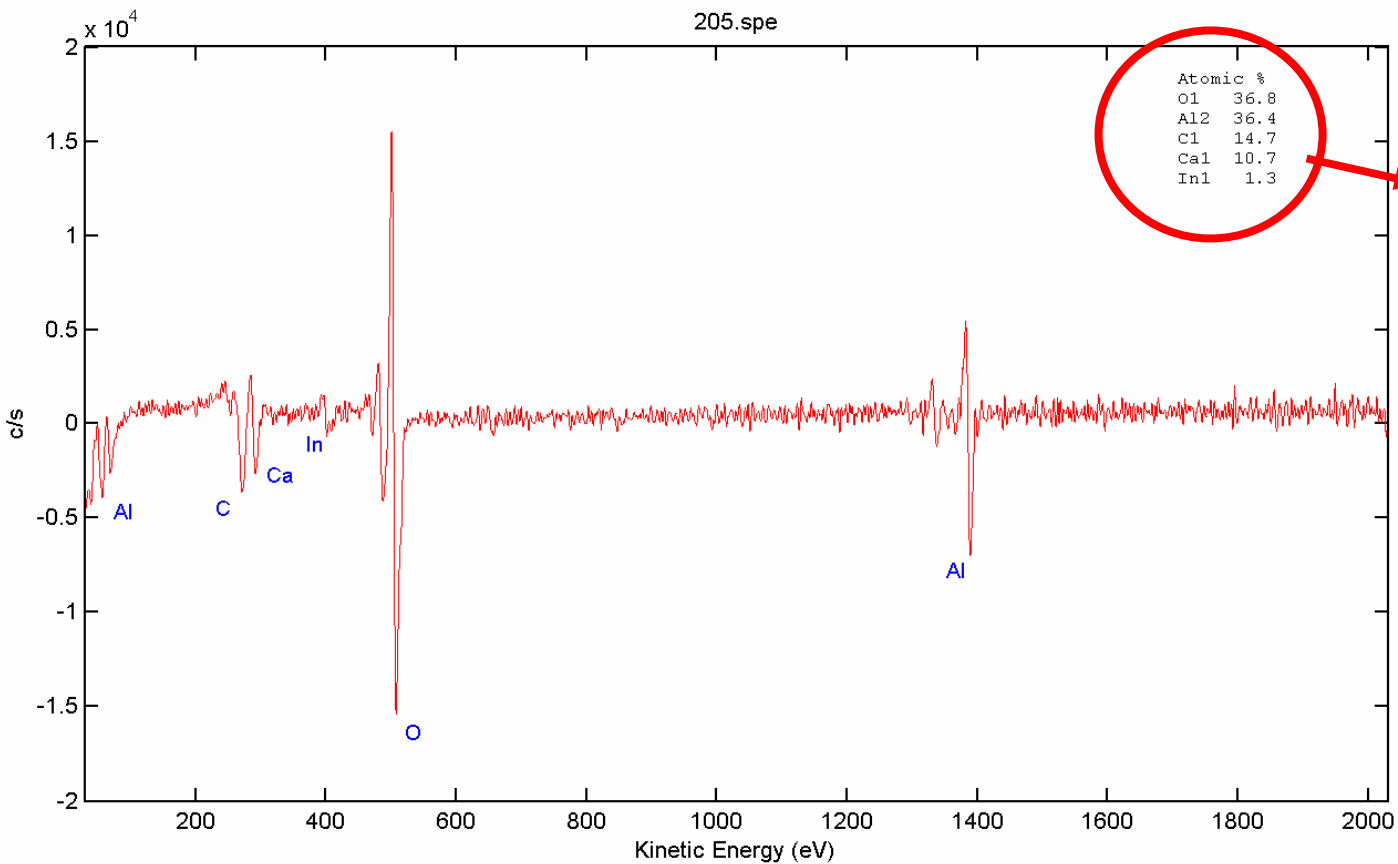
Test Article #28351, Auger analysis

Analysis of "clean" area:

Oxygen: 36.8%
Aluminum: 36.4%
Carbon: 14.7%
Calcium: 10.7%
Indium: 1.3%

Carbon content went from 45% to 14.7% after O₂ plasma etch
