# Atmel CGA 625 Mounting Evaluation

Saab Space

Estec, May 22nd, 2007

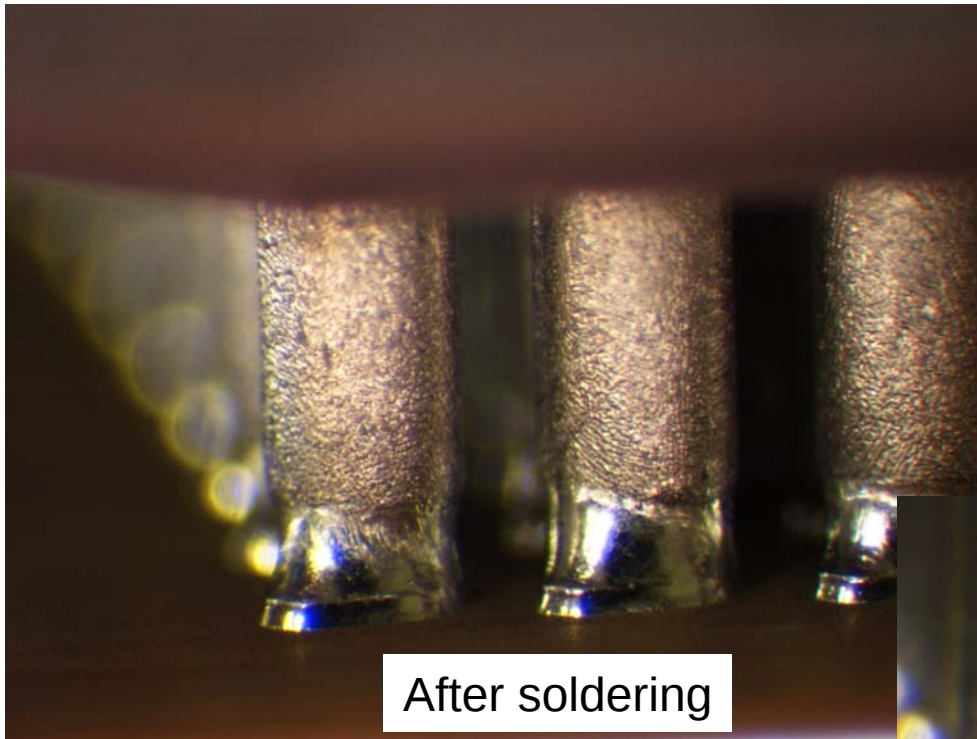
## Visual Inspection - teardrop (1356)

After soldering

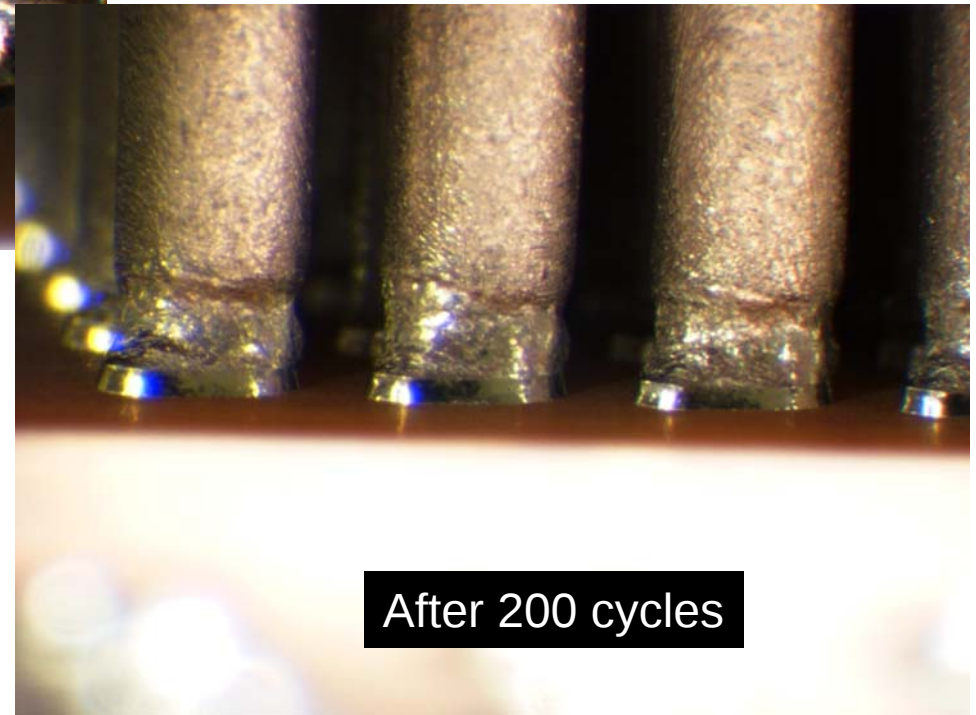
After 200 cycles

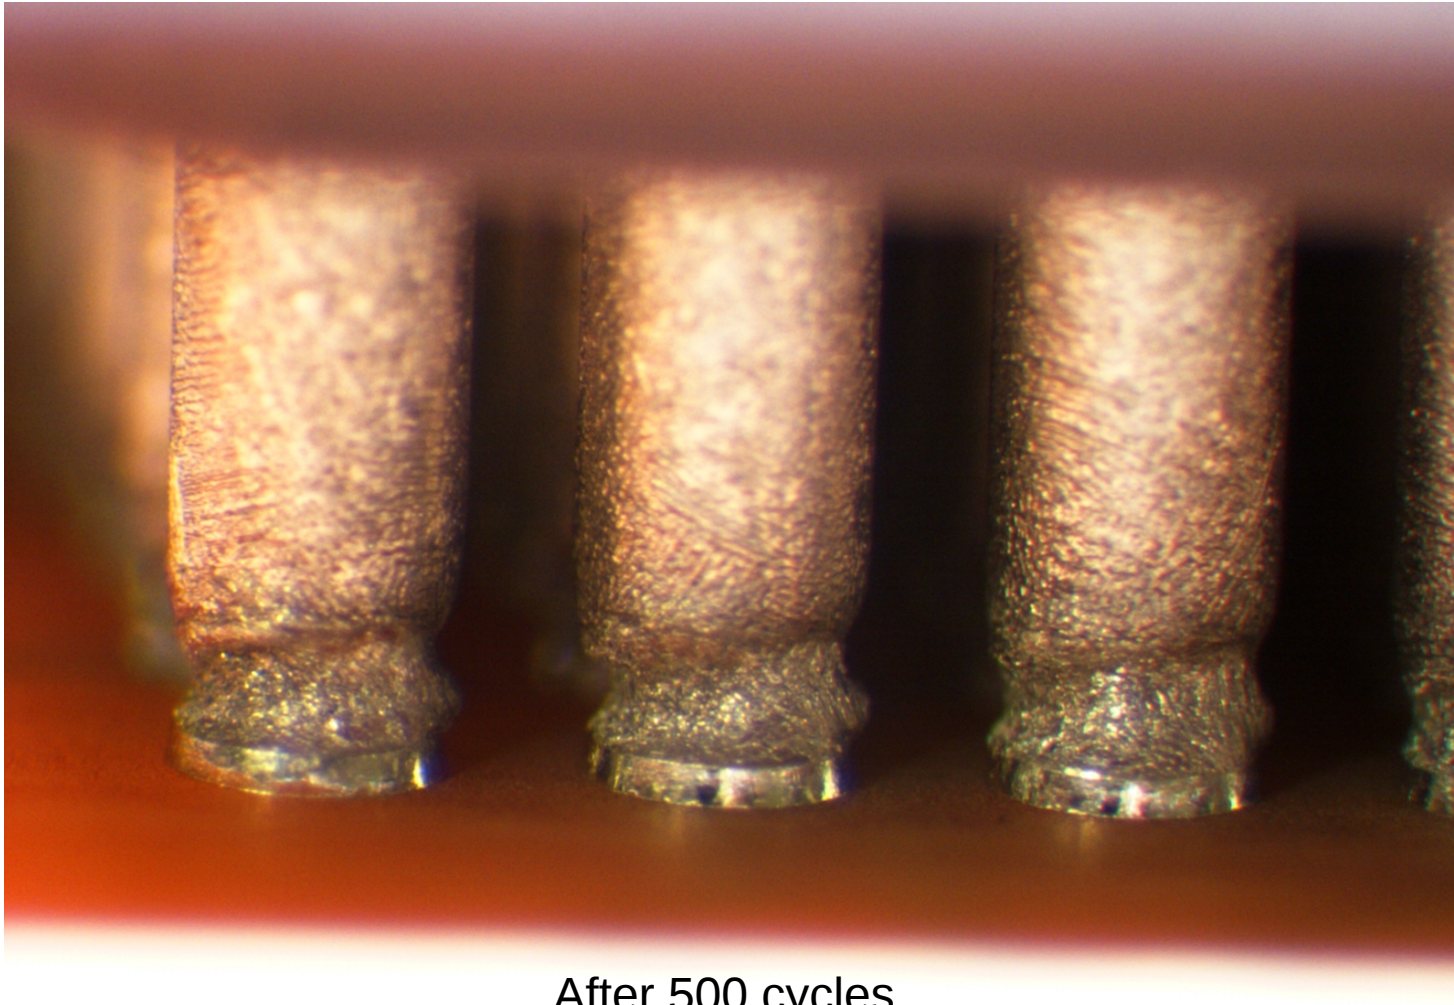
## Visual Inspection – circular pad (1353)

After 500 cycles

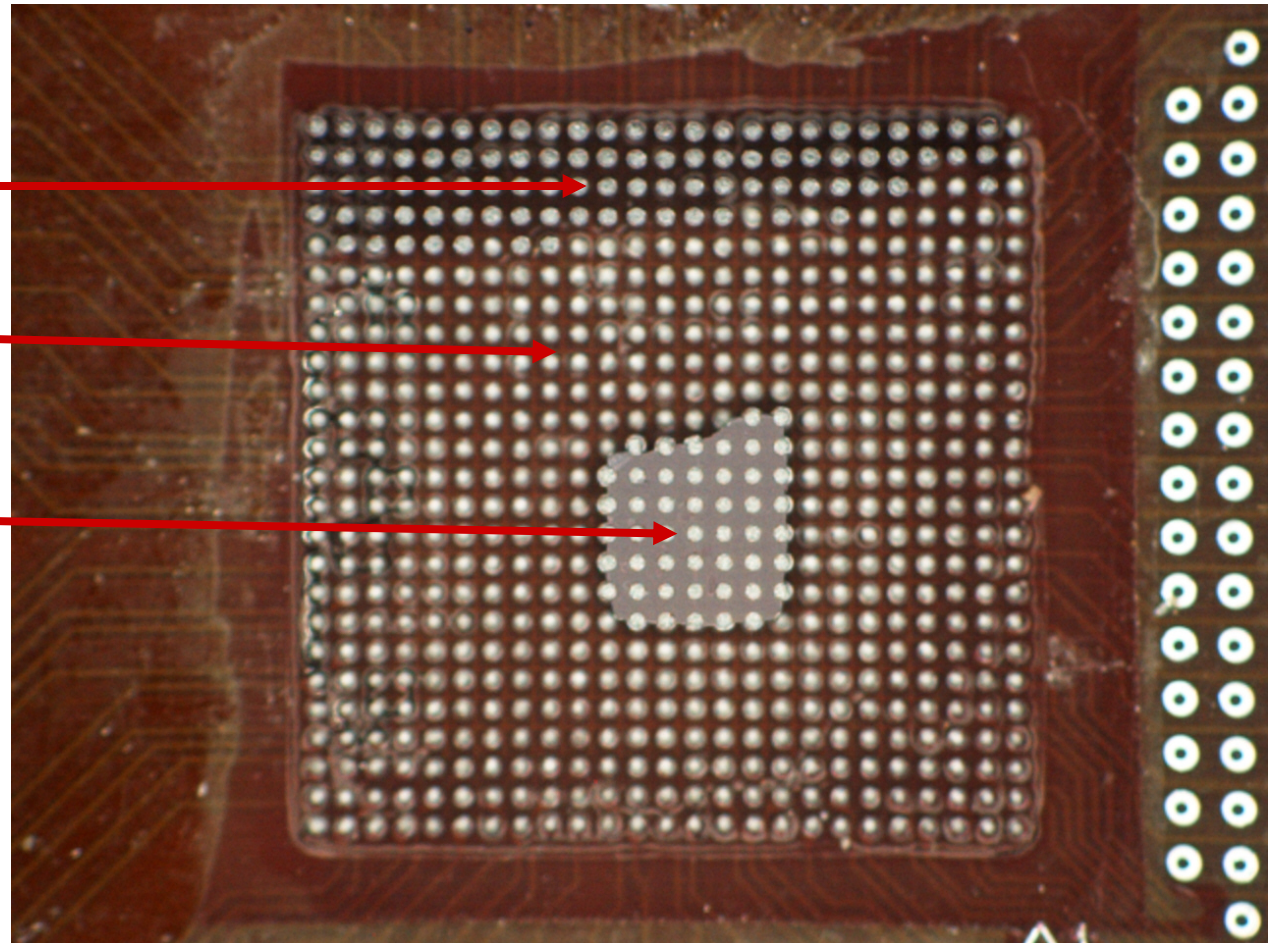
Dye Penetrant (1355)  
Picture of board After 200 cycles

Break at Pads  
on PCB

Break at  
Package  
pad

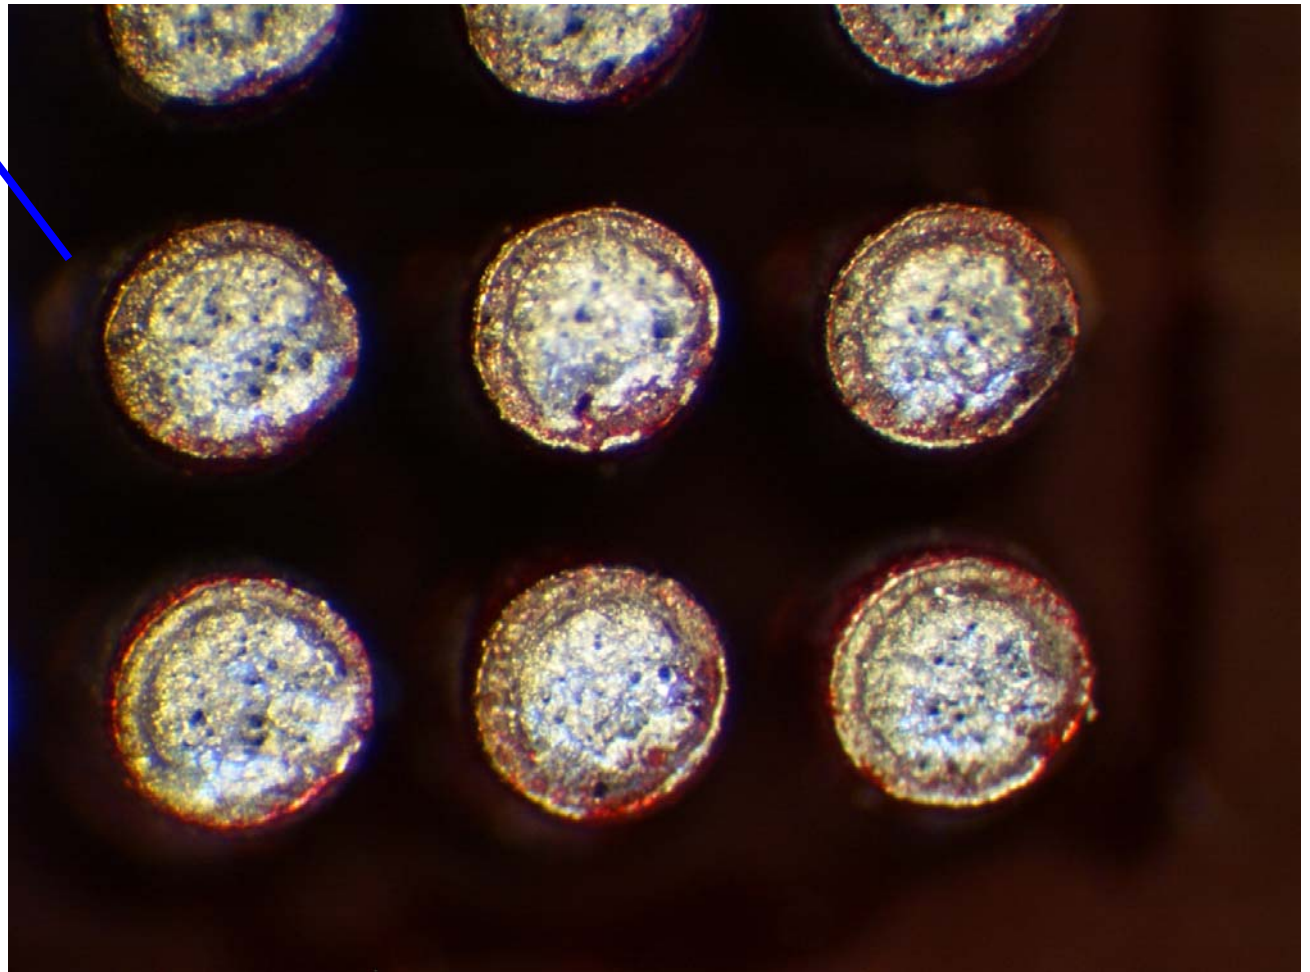
Dye Penetrant (1355)  
Board After 200 cycles

Corner picture  
Solder joint break  
at Interposer

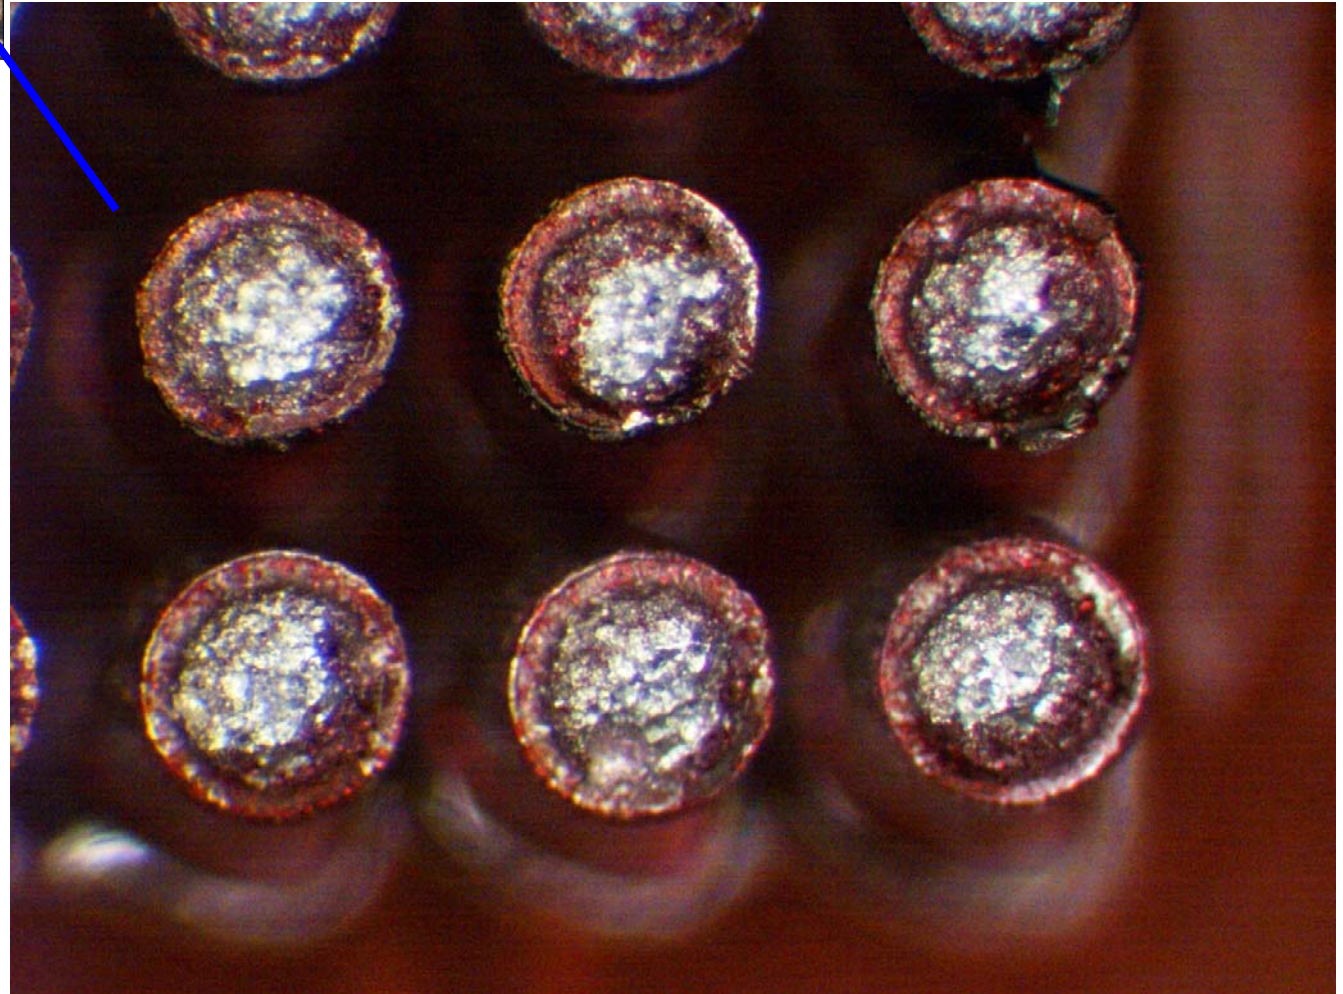
Dye Penetrant (1356)  
Picture of board after 500 cycles

Corner Picture  
Solder joint break  
at Interposer

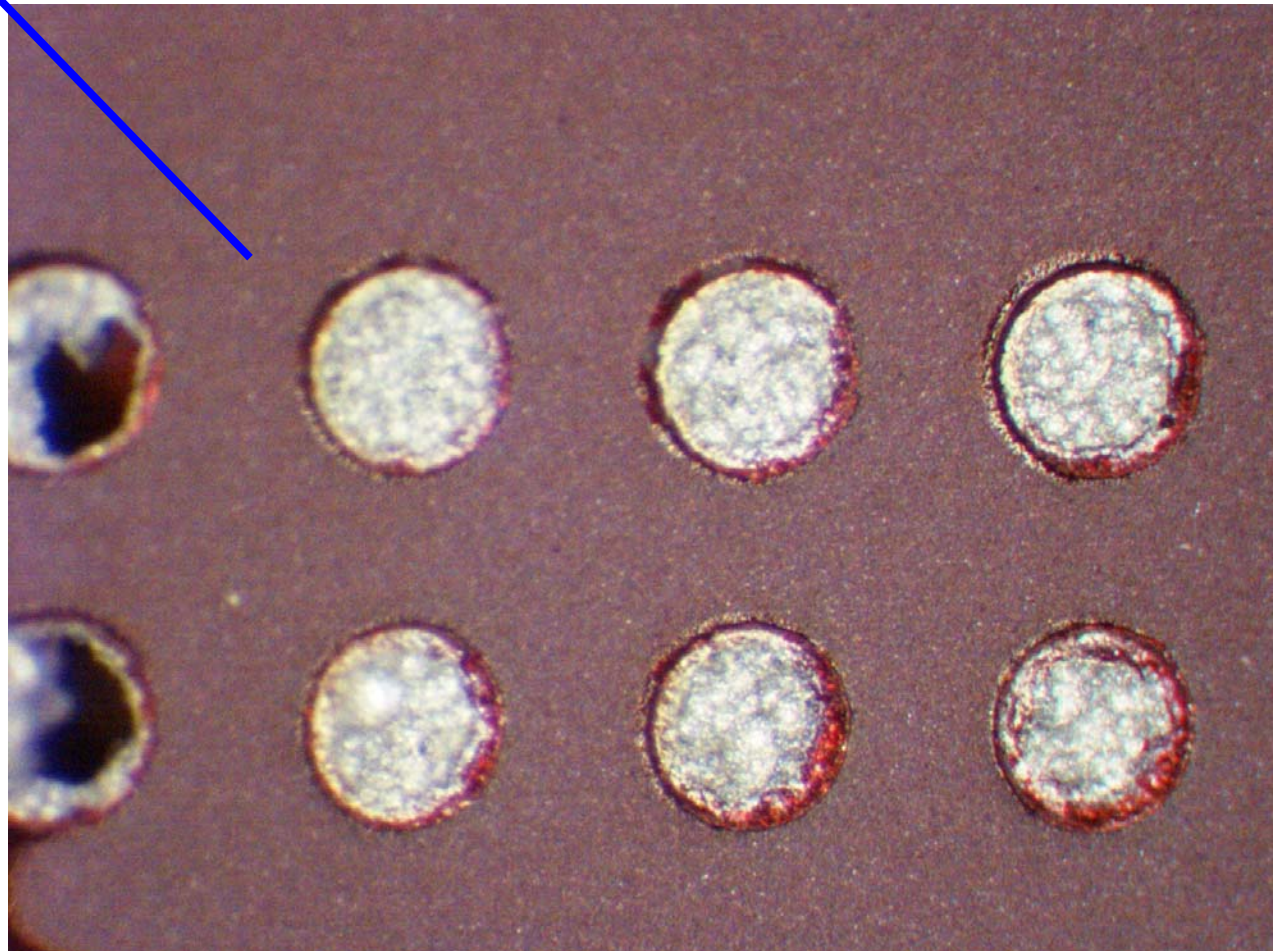
Dye Penetrant (1356)  
Picture of board after 500 cycles

Corner Picture  
Solder joint break  
at package pad

Dye penetrant difficult  
to flow between ceramic  
and package

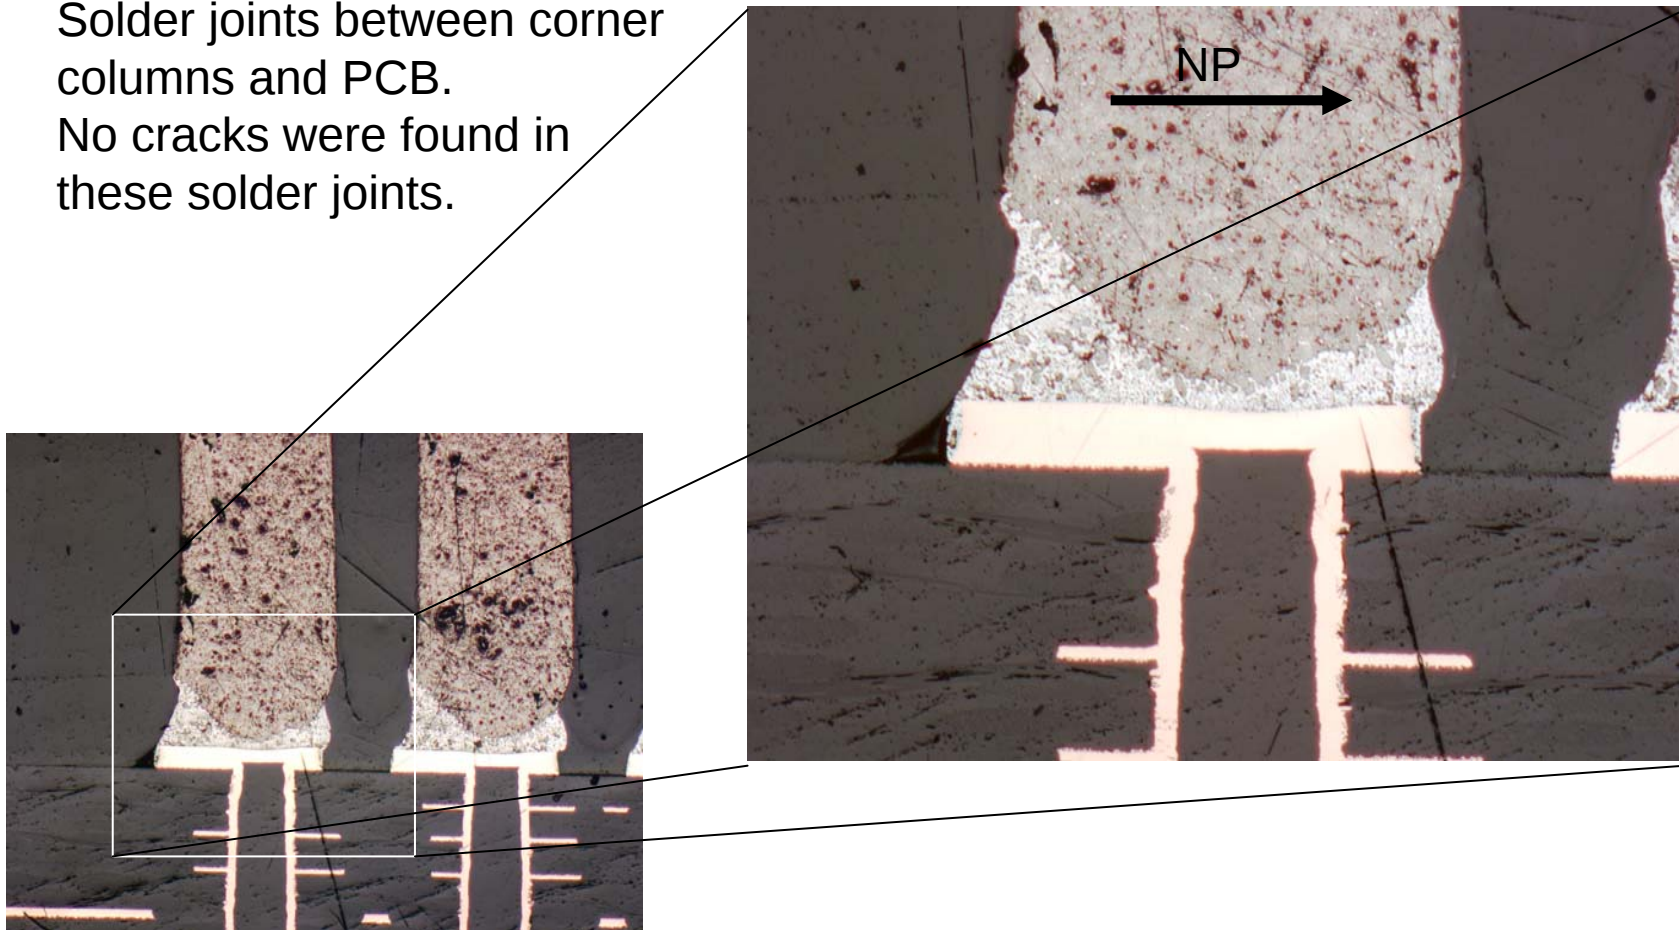
Micro Sectioning (1353)  
Picture of board after 500 cycles

Solder joints between corner  
columns and PCB.  
No cracks were found in  
these solder joints.

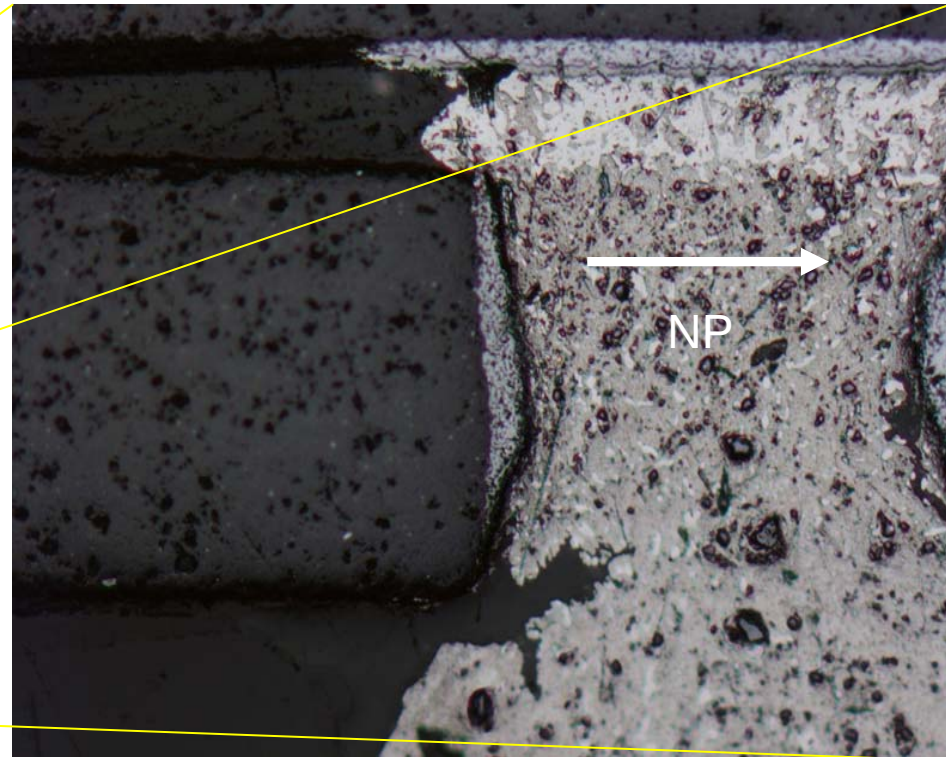
## Micro Sectioning (1353) Picture of board after 500 cycles

Solder joints between corner columns and package.  
Cracks (typical) were found along the interposer.

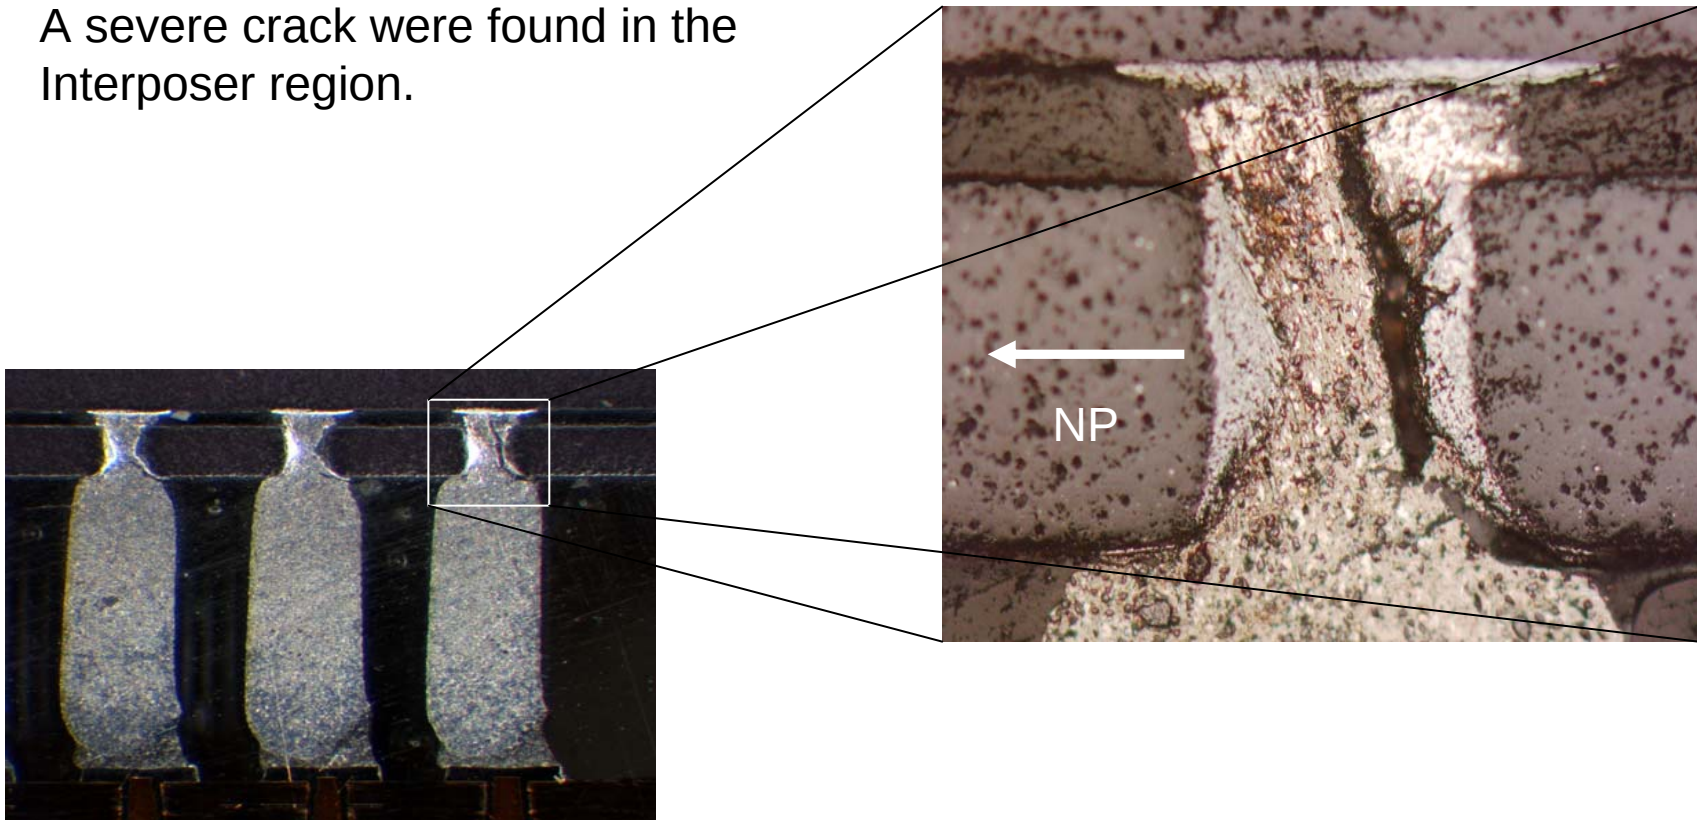
Micro Sectioning (1353)  
Picture of board after 500 cycles

Solder joints between corner  
columns and package.  
A severe crack were found in the  
Interposer region.
