# ■ Dye Penetrant

**L. Sollecchia**

May 4<sup>th</sup>, 2007

The aim of this activity is the research of suitable dye penetrant to be used to detect the cracks in Area Array Connections at the end of verification test made in accordance with the ECSS-Q-70-38. Indeed due to the configuration of connections a microsection will not allow the detection of size of the cracks. For these reasons the ECSS-Q-70-38 requires the use of dye penetrant testing, to identify the extension of the cracks at the end of verification testing. Based on the area of the cracks the assembly will be considered approved or not as per ECSS-Q-70-38 .

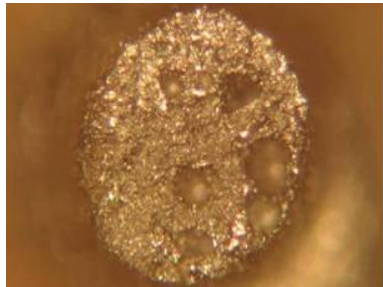
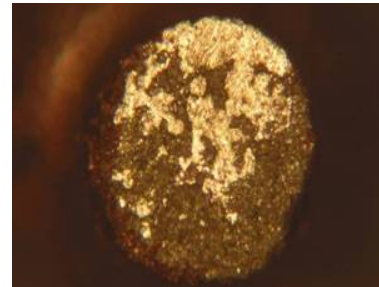
The first trial it has been done on DBGA 228 #1 with a traction velocity of 0.1 mm/min : the component has been pulled at 289.5 N but the inspection of soldered joint shown that the profile of dimple was deformed from circular to elliptical .

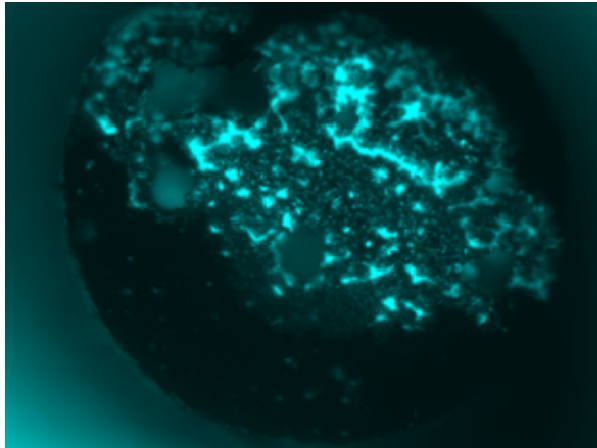
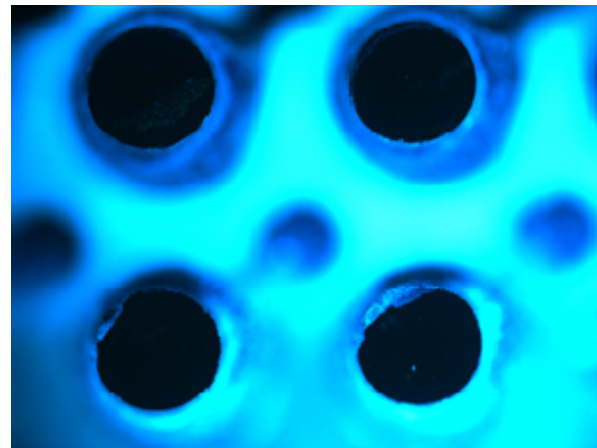
### DFDRY-C0

The Dye Penetrant Test has been performed on DBGA 444 #1 from Test Vehicle S/N 1

All the joints have been inspected with the exception of 12 joints not pulled-out

- ✓ The profile of cracked joint is well defined
- ✓ The penetration is good
- ✓ Visibility good

At this step the DFDRY-C0 has been considered suitable for crack detection

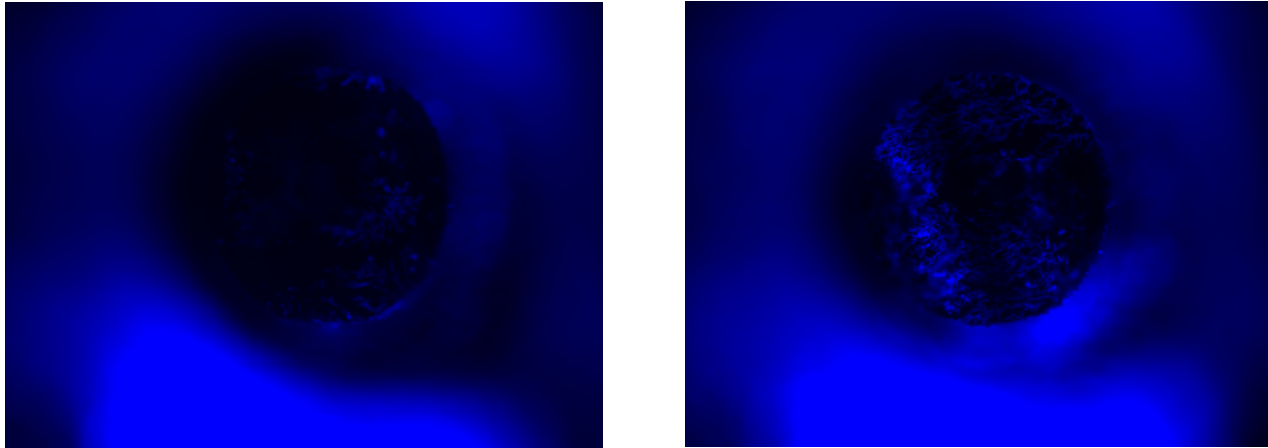
### DFSB-C0

The Dye Penetrant Test has been performed on DBGA 444 #1 from Test Vehicle S/N 2

All the joints have been inspected with the exception of 15 joints not pulled-out

- ✓ Low level of visibility
- ✓ The profile of cracked joint isn't well defined
- ✓ The penetration is good

At this step the DFSB-C0 has been considered not suitable for crack detection

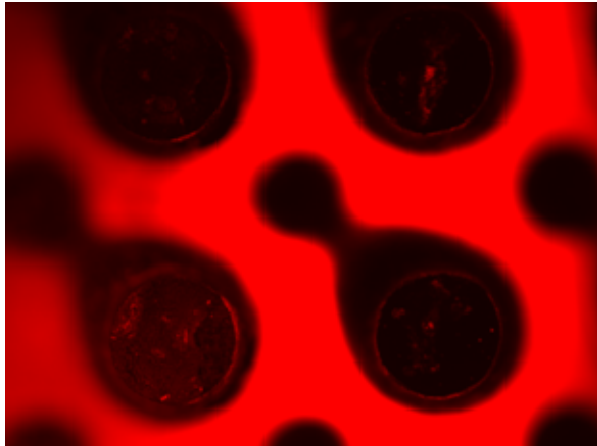
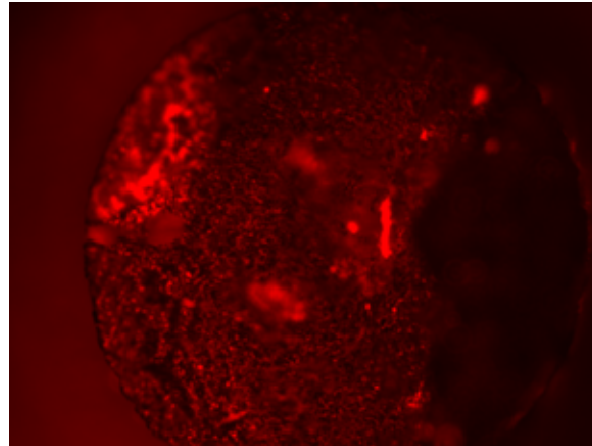
### DFSB-C7 ☹️

The Dye Penetrant Test has been performed on DBGA 444 #2 from Test Vehicle S/N 2

All the joints have been inspected with the exception of 8 joints not pulled-out

- ✓ Not sufficient visible
- ✓ The profile of cracked joint isn't well defined
- ✓ Presence of isolated traces (caused by contamination)

At this step the DFSB-C7 has been considered not suitable for crack detection

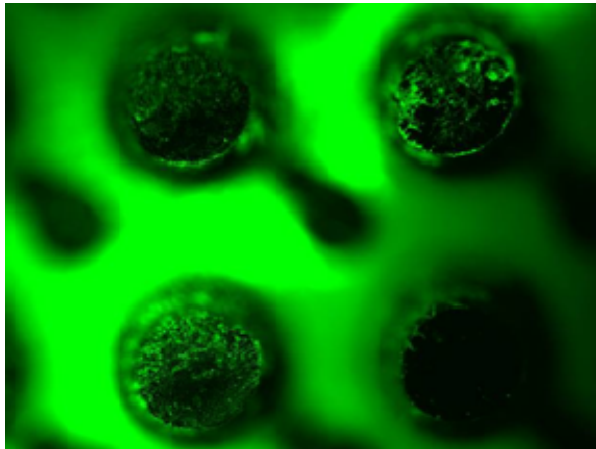
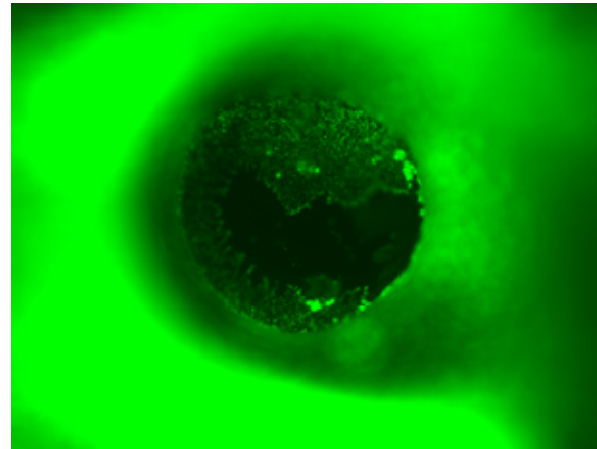
### DFSB-K43 ☹️

The Dye Penetrant Test has been performed on DBGA 444 #1 from Test Vehicle S/N 3

All the joints have been inspected with the exception of 13 joints not pulled-out

- ✓ Sufficient visible
- ✓ The profile of cracked joint quite well defined
- ✓ The penetration is good
- ✓ Presence of isolated traces (caused by contamination)
- ✓ Dusty traces in some cases (probably cause of contamination)

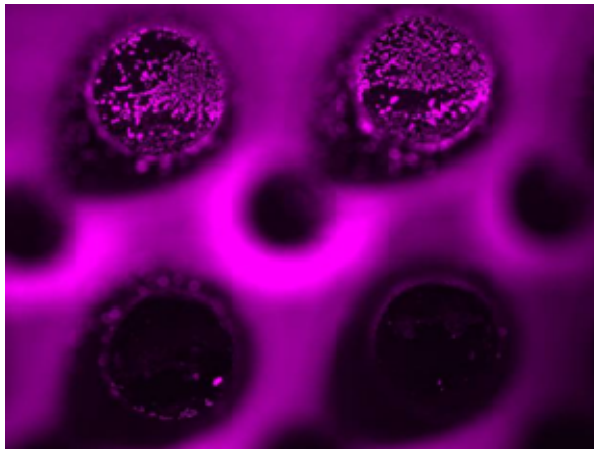
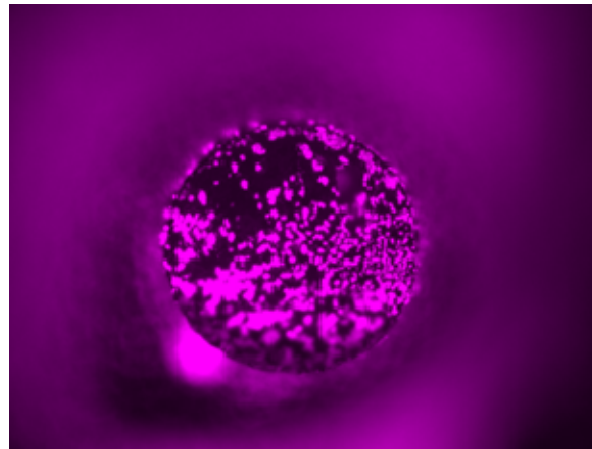
### DFSB-K61 ☹️

The Dye Penetrant Test has been performed on DBGA 444 #2 from Test Vehicle S/N 3

All the joints have been inspected with the exception of 21 joints not pulled-out

- ✓ The profile of cracked joint not defined
- ✓ The penetration is poor
- ✓ Dusty

At this step the DFSB-K61 has been considered not suitable for crack detection

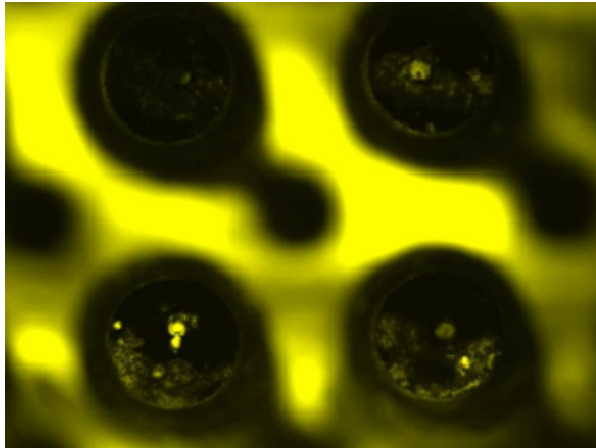
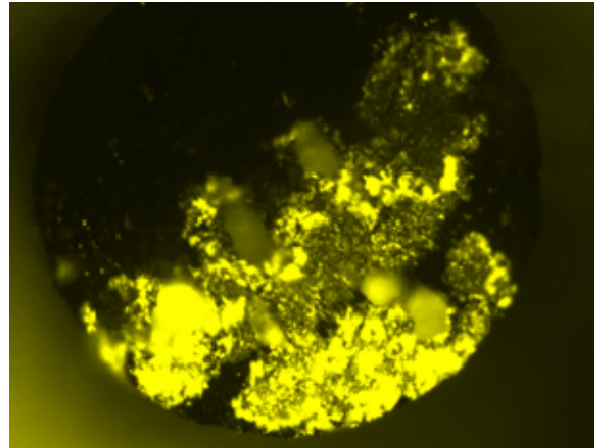
### DFSB-K87 ☹️

The Dye Penetrant Test has been performed on DBGA 444 #1 from Test Vehicle S/N 5

All the joints have been inspected with the exception of 17 joints not pulled-out

- ✓ The profile of cracked joint sufficient defined
- ✓ Traces not well marked
- ✓ Almost dusty

At this step the DFSB-K87 has been considered not suitable for crack detection

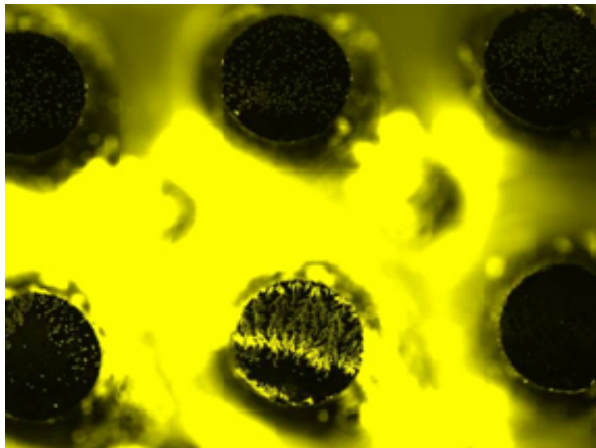
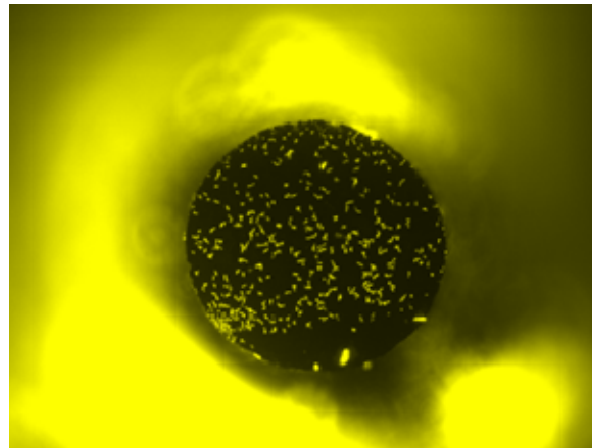
### DFPD-C2 ☹️

The Dye Penetrant Test has been performed on DBGA 444 #2 from Test Vehicle S/N 5

All the joints have been inspected

- ✓ The profile of cracked joint not defined
- ✓ Dusty
- ✓ Contamination

At this step the DFPD-C2 has been considered not suitable for crack detection

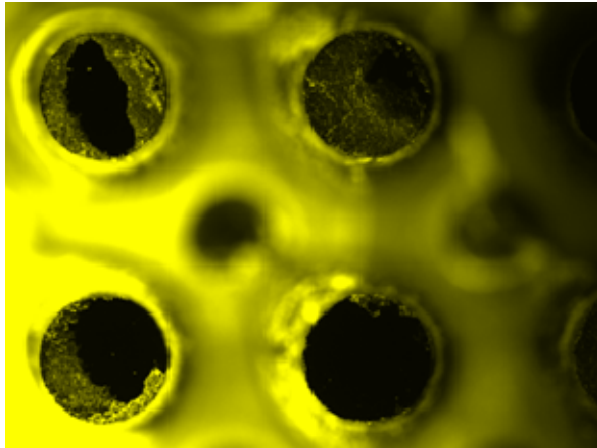
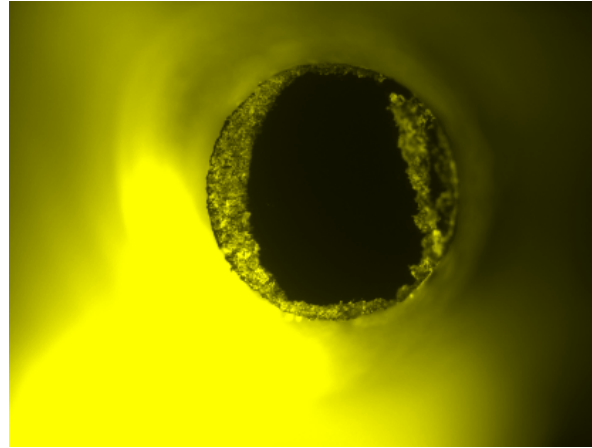
### IFWB-C2

The Dye Penetrant Test has been performed on DBGA 444 #1 from Test Vehicle S/N 4

All the joints have been inspected with the exception of 15 joints not pulled-out

- ✓ The profile of cracked joint well defined
- ✓ The penetration is good
- ✓ Good visibility

At this step the IFWB-C2 has been considered suitable for crack detection

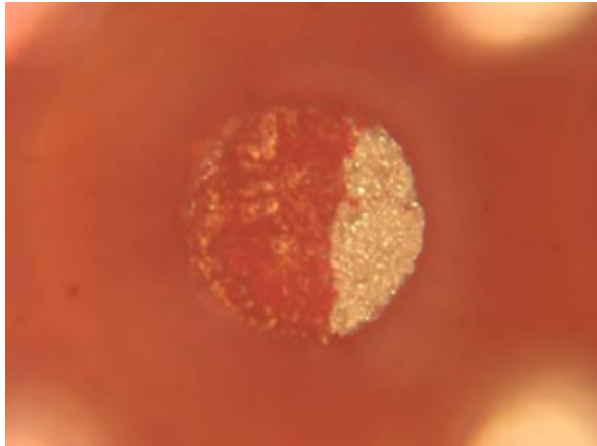
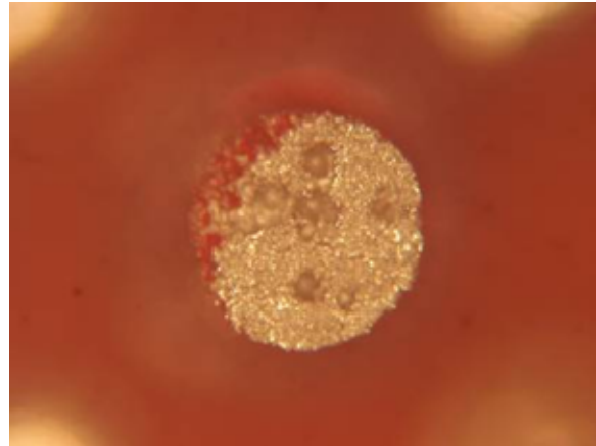
### RED STEEL 😊

The Dye Penetrant Test has been performed on DBGA 444 #2 from Test Vehicle S/N 4

All the joints have been inspected with the exception of 11 joints not pulled-out

- ✓ The profile of cracked joint well defined
- ✓ The penetration is good
- ✓ Good visibility in white light

At this step the RED STEEL has been considered suitable for crack detection

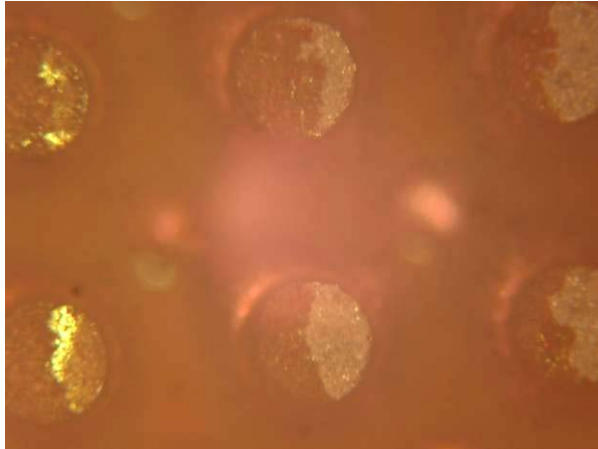
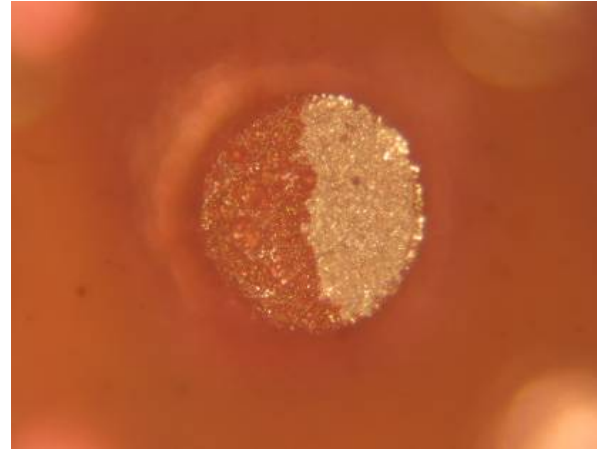
### EOSINA

The Dye Penetrant Test has been performed on DBGA 444 #2 from Test Vehicle S/N 1

All the joints have been inspected with the exception of 8 joints not pulled-out

- ✓ The profile of cracked joint well defined
- ✓ Excellent penetration
- ✓ Good visibility in white light

At this step the EOSINA has been considered suitable for crack detection

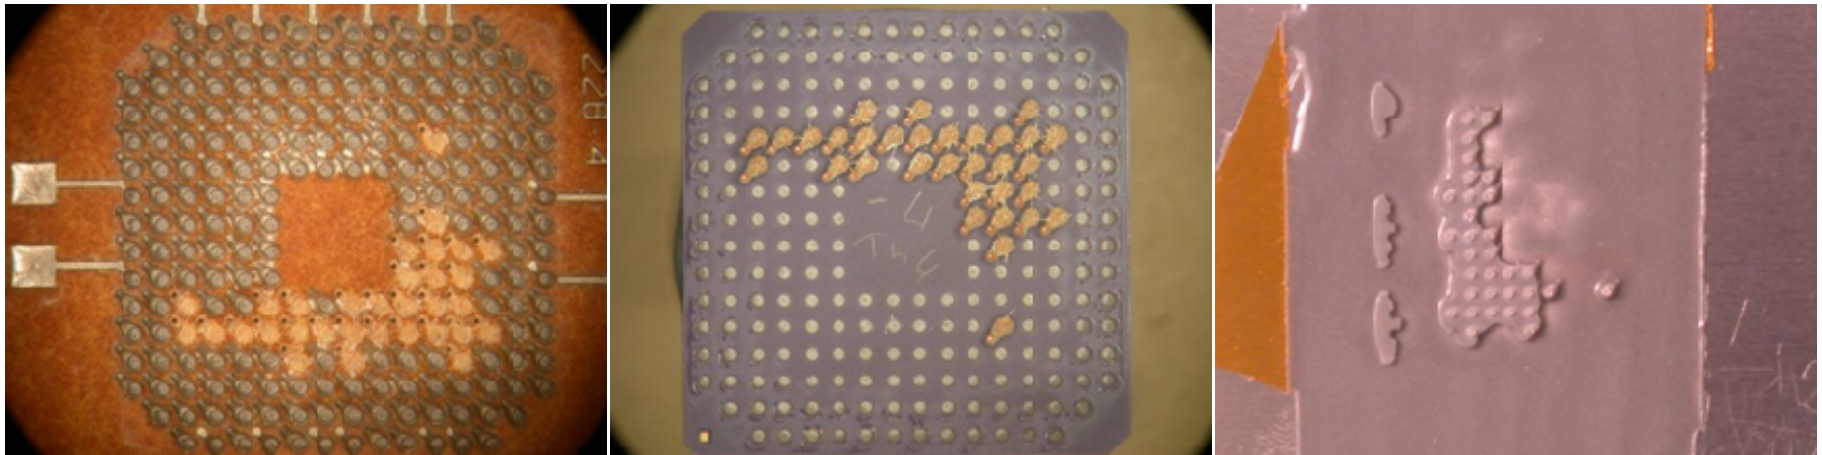
#### 1° & 2° Pull-Out Results

The Dye Penetrant Test has been performed on DBGA 228#2 from Test Vehicle S/N 3. After the first Pull-Out 197 soldered joints (86.4%) have been inspected and after the second Pull-Out 31 soldered joints (up to 100%).

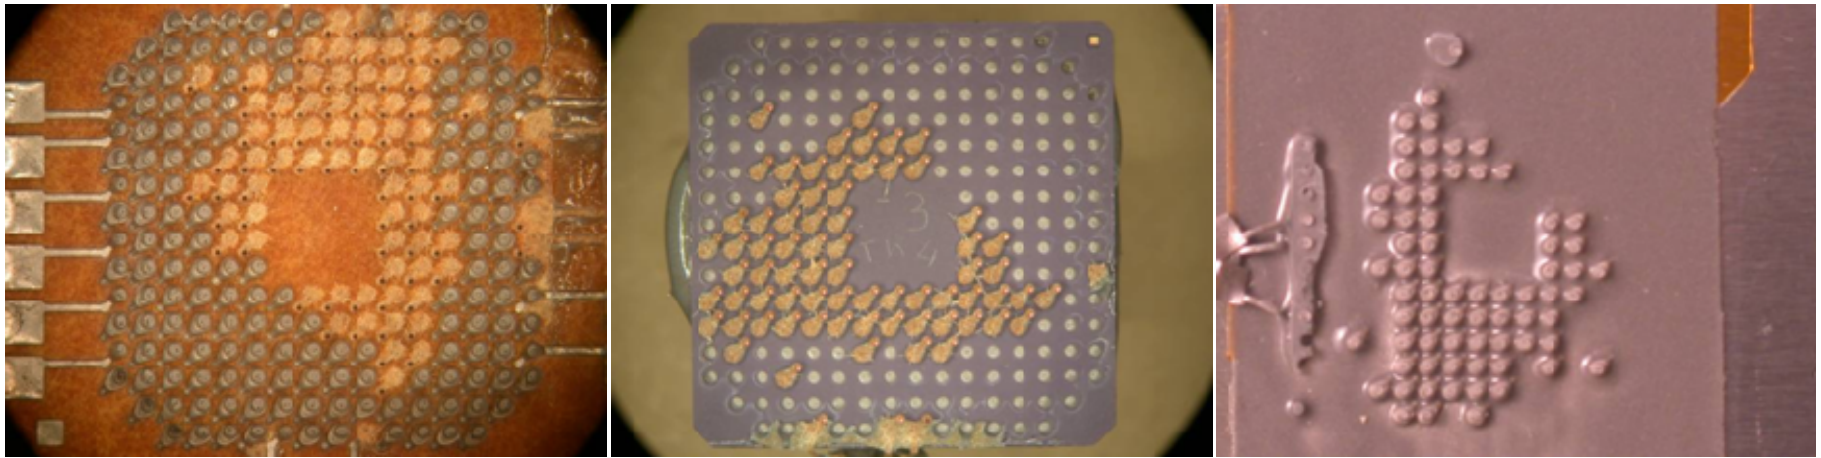
1° & 2° Pull-Out Results

The Dye Penetrant Test has been performed on DBGA 228#1 from Test Vehicle S/N 3. After the first Pull-Out 159 soldered joints (69.7%) have been inspected and after the second Pull-Out 69 soldered joints (up to 100%).

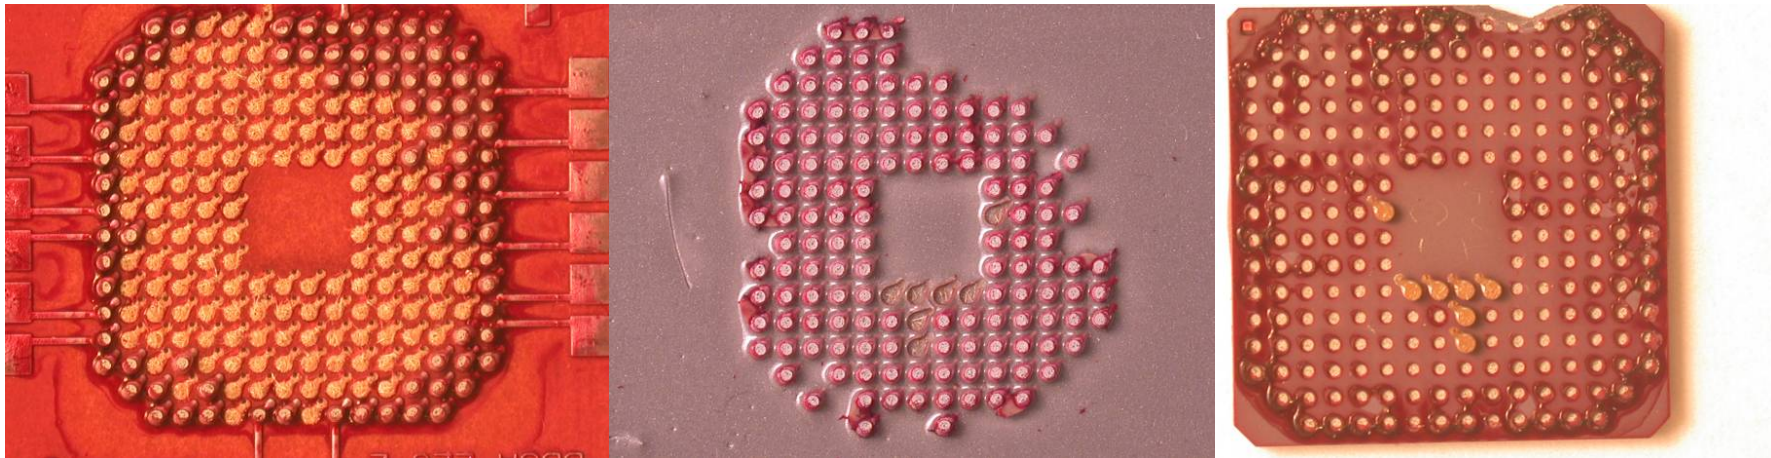
#### 1° & 2° Pull-Out Results

The Dye Penetrant Test has been performed on DBGA 228#2 from Test Vehicle S/N 4. After the first Pull-Out 78 soldered joints (34.2%) have been inspected and after the second Pull-Out 143 soldered joints (up to 96.9%) have been inspected, with 7 residual joints (3.1%) still attached to package.

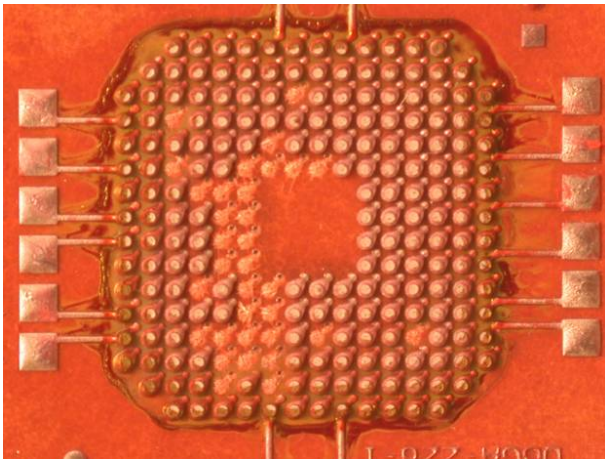
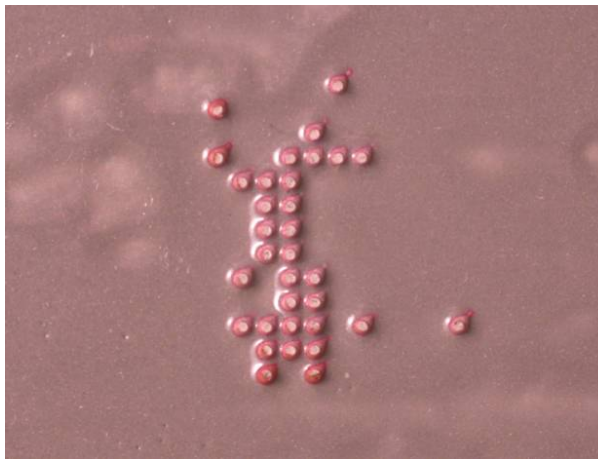
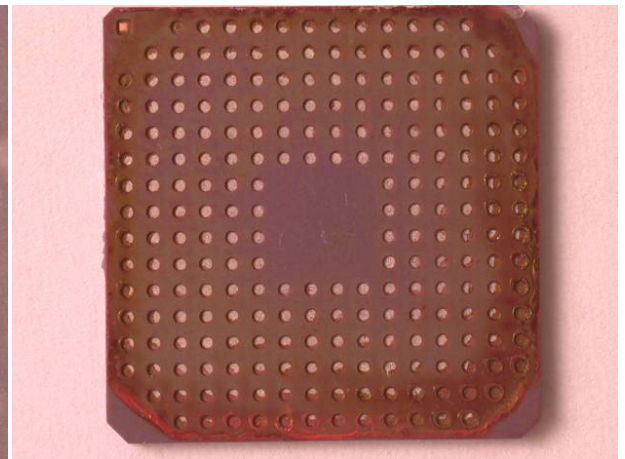
#### 1° & 2° Pull-Out Results

The Dye Penetrant Test has been performed on DBGA 228#2 from Test Vehicle S/N 4. After the first Pull-Out 195 soldered joints (85.5%) have been inspected and after the second Pull-Out 143 soldered joints (up to 100%).

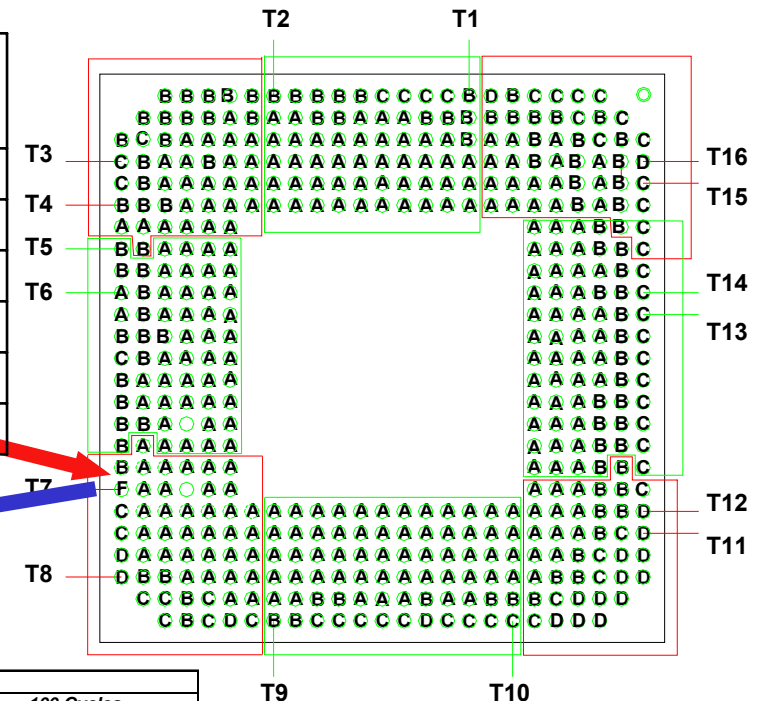
The Dye Penetrant Test has been performed on a DBGA444 with RED STEEL and some classes of crack percentage have been fixed, each one associated to a letter. These ranges aren't very close but it is possible to calculate exactly the percentage of crack area and repeat a similar analysis with a great number of classes with more accurate intervals.

From the visual inspection and from electrical data, it has been observed:

So basing only on Electrical Measurement at room temperature, it could be possible to take erroneous conclusions, because one open joints has not been detected and it is impossible to know the cracked percentage of each joint.

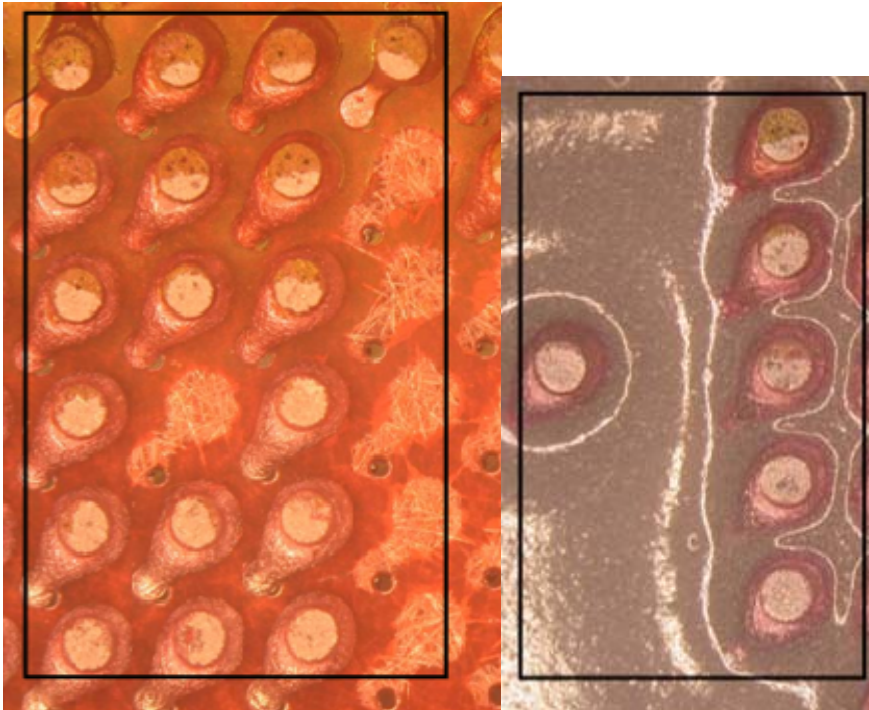
Daisy-ChainT1-T2

A DBGA228 has been submitted to the Dye Penetrant Test with EOSINA and the photos of each daisy chain have been reported later on to compare them with the electrical measurement at room temperature

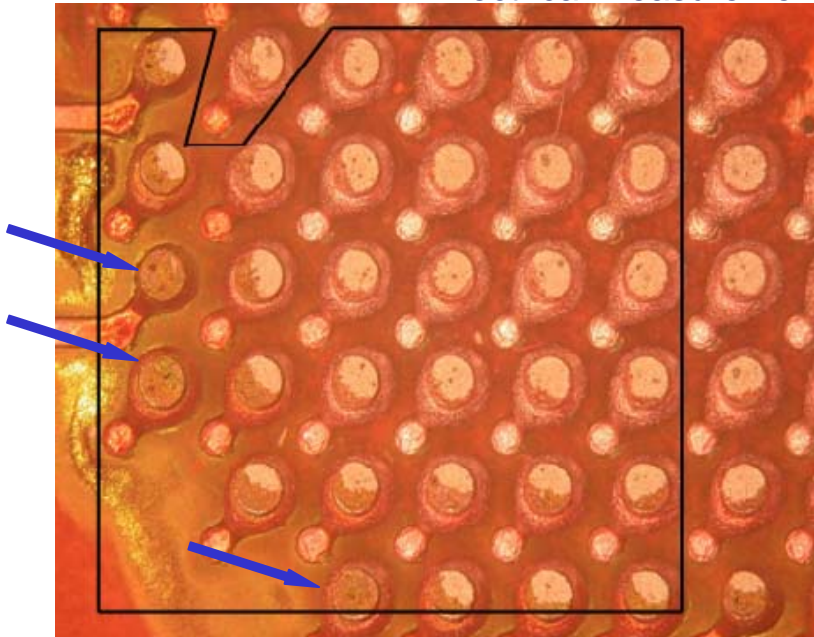
Daisy-Chain T7-T8

From the visual inspection and from electrical data, it has been observed :

So, in this case too, basing only on Electrical Measurement at room temperature, it could be possible to take erroneous conclusions, because 9 open joints haven't been detected and it is impossible to know the cracked percentage of each joint
