PLATED THROUGH RELIABILITY AND MATERIAL INTEGRITY RESULTS FOR 24 MATERIALS PROCESSED THROUGH LEAD FREE ASSEMBLY

Bill Birch, Jason Furlong
PWB Interconnect Solutions Inc.
Ottawa, ON, Canada

ABSTRACT

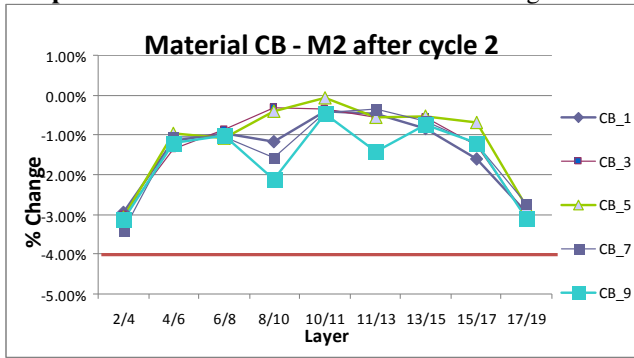
Graph 1b: Material CB - 2nd Reflow with Damage

Graph 1b illustrates the relative capacitance change measured in material “CB” after the 2nd pass through the reflow oven. The data shows a curvature conversion to the profile, with the outer layers exhibiting the highest change. Layers 8 to 10 measure a maximum of 2% reduction; layers 11 to 13 measured a 1% change. This small level of change is not classified as delamination, but it is an indicator that damage initiation has started. Graph 2b shows the measurements after the 3rd cycles, it confirms that the previous cycle damage initiation has now propagated into a delamination in 4 of the 5 coupons, between layers 8 and 10, compared to 1 coupon delaminating between layers 11 and 13.

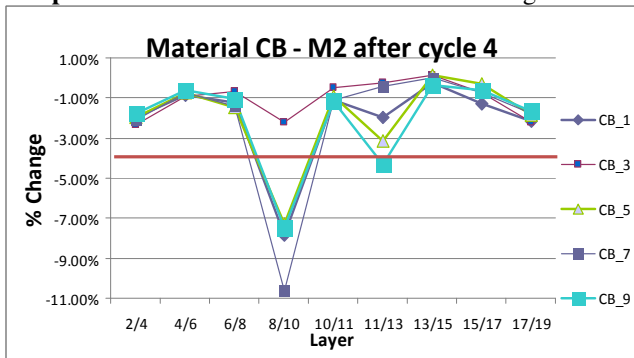
Graph 3b: Material CB - 4th Reflow with Damage

The 4th pass through the reflow oven (graph 3b) increased the maximum capacitance change from a level of 7% up to 11%, effectively quantifying the progressive damage accumulation within the dielectric. Interestingly, the dielectric between layers 11 and 13 were not showing an equal level of degradation, it is considered that the initial crack sites in layers 8 and 10 create a stress relieving influence within the remainder of the construction.

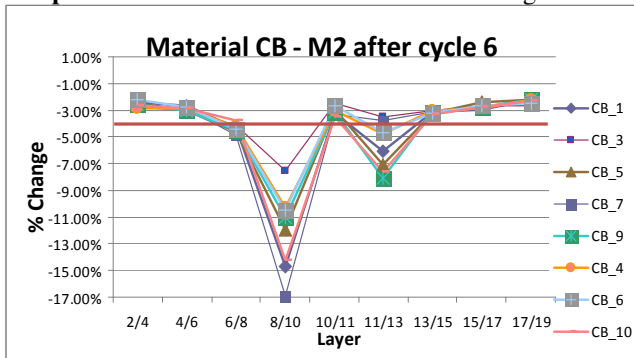
Graph 4b: Material CB - 6th Reflow with Damage

The results of the combined 5th and 6th pass through the reflow oven (graph 4b) confirmed that major material damage would be expected in layers 8 to 10 and lower levels between layers 11 and 13. The magnitude of damage increased to a maximum of 17% change, signifying a “massive” breakdown in the dielectric material. Subsequent microsection analysis confirmed 14 of the 15 dielectrics (between the 16 holes examined) confirmed the presence of major delamination between layers 8 and 10.

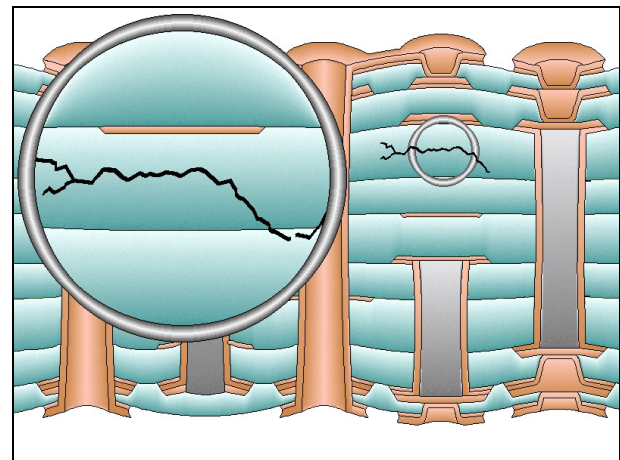
Figure 12. Cohesive Cracking Failure

Visual examination of the 15 materials from the 0.8mm/0.032" coupons that exhibited material delamination (electrically and in microsections) confirmed that all damage sites were caused by **cohesive** failures. No delamination was found to be caused by an adhesive failure at the bond line between the B and C stage materials, or between B stage and the copper foils. Cohesive cracks are produced within the epoxy, or phenolic C-stage and/or cured B-stage dielectrics layers, specifically at the junctions between the resin and the glass bundles. The crack sites tend to initiate in the central area between the PTH vias, they follow the direction of the glass fabric, but can frequently digress, resulting in multiple smaller cracks. See figure 12 for an animation of cohesive material. Note that the figure is not the same construction and via types used in this study.

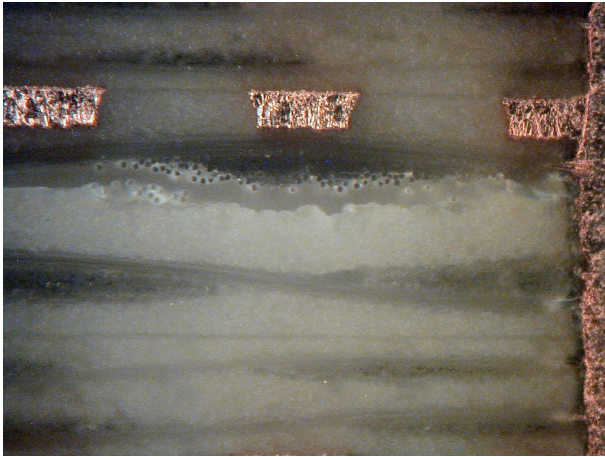
Figure 13: Cohesive Material Damage

Figure 13 shows a typical delamination in the cured B stage material between layers 11 and 13, from type "KB" (High speed). The fracture site is initiating in the central zone, on the outer edges of the glass bundles, the cracks are propagating toward the barrels. The two visible B/C stage bonding lines do not exhibit any indication of adhesive breakdown.

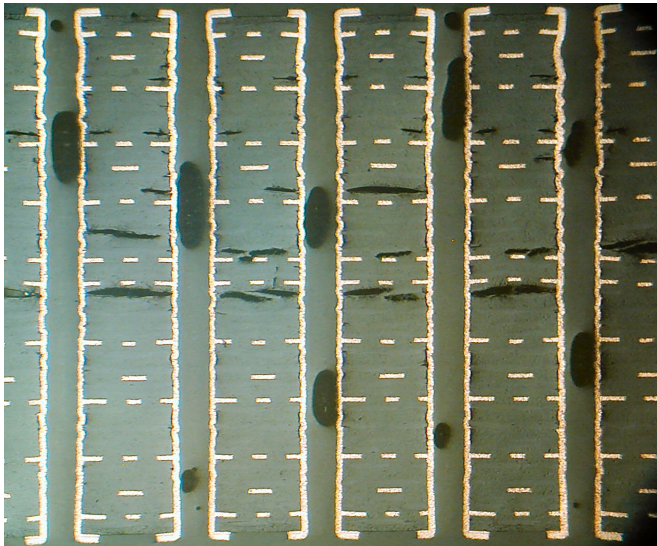
Figure 14: Material "FB" - 0.8mm/.032 Grid

In some materials cohesive damage was widespread throughout the construction, see figure 14 for an example of multiple locations exhibiting cohesive failures.

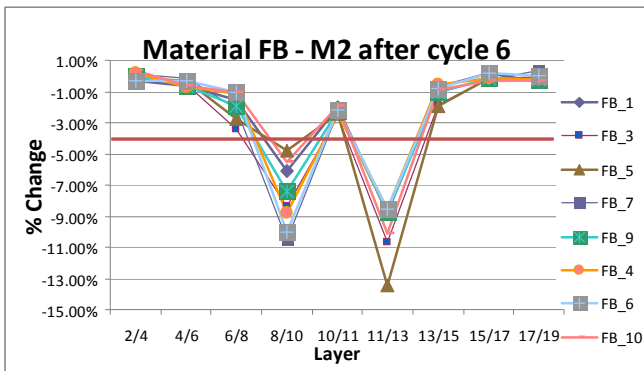
Figure 15: DELAM Data Showing Damage Locations

Figure 15 illustrates the results from DELAM testing after 6X 260°C. The data confirms multiple dielectrics exhibited reductions in measured bulk capacitance (up to 14%).

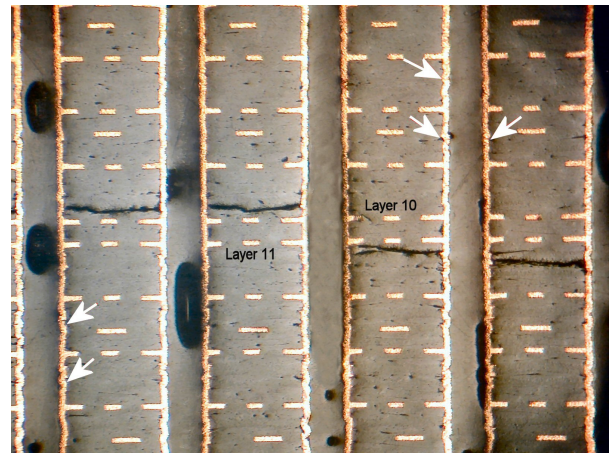
Figure 19 Material “CB”

Figures 19 and 20 show examples of how cracking in the copper plated barrels propagated on the opposite side of the construction, relative to the location of the cohesive material damage. Photo 2 is from a 0.8mm/0.032” grid coupon built with the “CB” construction (Halogen Free - 69% resin content), the cohesive damage is clearly evident on the upper and lower side the central C stage layers (L10 to

L11). If damage was not present copper cracking would be expected in the B/C stage layers on either side(L8 to L10 and L11 to L13). The image shows that the cracks moved outwards into dielectrics further from the central plane (L6 to L8 or L13 to L15).

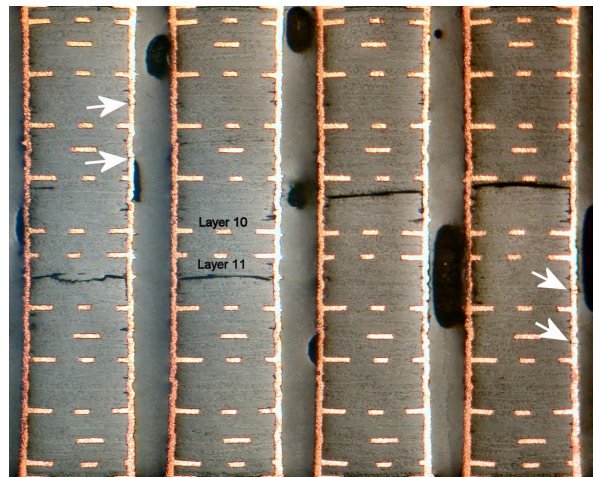
Figure 20 Material “GB”

Figure 20 is from a 0.8mm/0.032” grid coupon built with the “GB” construction (Also Halogen Free - 69% resin content), the pattern is repeated, showing a similar redistribution of barrel cracks relative to the location of the cohesive material damage.

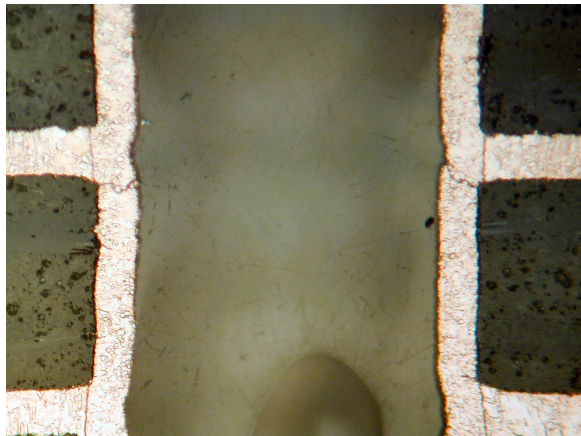
Figure 21

A secondary objective of failure analysis was to determine the failure modes and to help in the identification of any anomalous results. All the failed coupons were confirmed to contain barrel cracks, as shown in the examples in Figures 21 and 22. A total of 24 individual test reports were created and submitted to the HDPUG Pb free materials task group. Each report contained IST resistance graphs, plating thickness measurements, copper crack counts and images of failure sites.

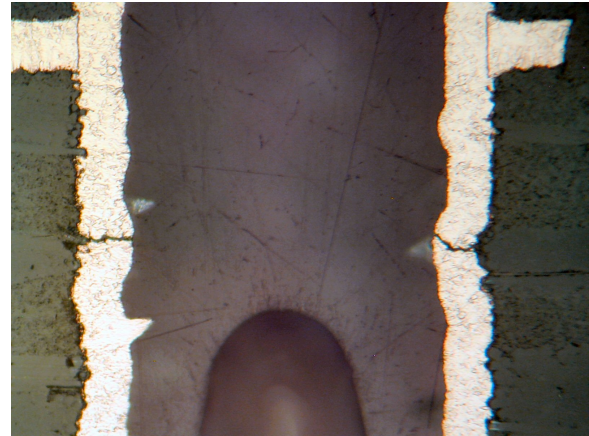
Figure 22

The second type of failure found was a barrel crack with plastic deformation of the dielectric material. In this type of failure mode the crack typically initiates at a glass fiber but go horizontally, progressing through copper crystals. One of the characteristics of this type of failure mode is that the crack is open at ambient and tends to propagate at 90° angle to the barrel. This type of failure was noted on material “H” only. The selected coupon failed after 1161 cycles, this is considered a much extended level of performance and should not be interpreted as a negative aspect of the material performance.
