TID Test of 4 Gbit DDR3 SDRAM Devices

Test report

ESTEC Contract No. 4000101358/10/NL/AF

Radiation hard memory, Radiation testing of
candidate memory devices for Laplace mission

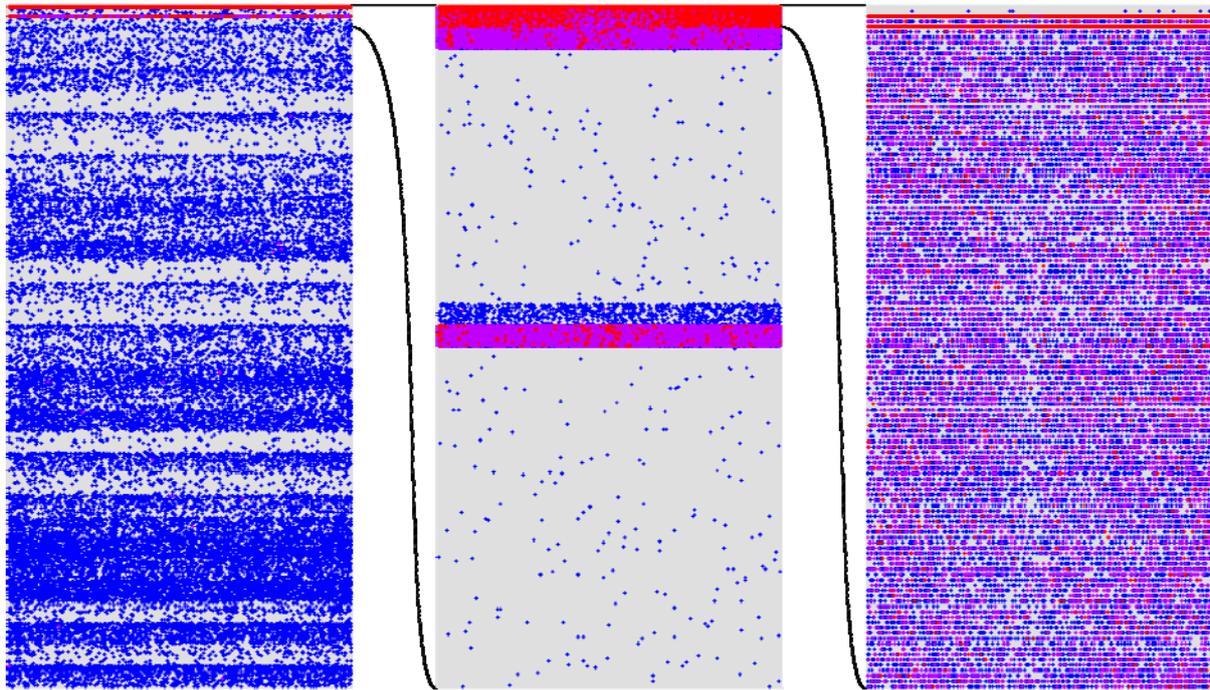
A detailed inspection of the error vectors reveals three distinct *error classes*, which can be recognized in figure 6:

1. randomly distributed errors
2. four regions, each 512 row wide, of errors
3. two single rows with a high number of errors close to the end of the device

Figure 6: error map at different zoom levels (Samsung 4 Gbit, unbiased). The horizontal axis shows the column address, the vertical axis shows the concatenated bank and row address. The last error map shows individual pages; the white space in between does not represent pages without errors.

The first class consists of randomly distributed bit errors, the majority of which are single-bit errors. In figure 6, these errors are visible in the first and second error map. They exhibit some banding with a period of $2^{14} = 16384$ (0x4000) pages.

For the “worst” DUT, that is, the one with the highest error count, about one percent of all bits were corrupted in the last error region. In figure 6, these errors can be recognized in the second error map.

The third class consists of the second and the fourth row from the end of the bank, row addresses 0xFFFC and 0xFFFE. In these rows, as many as 20% of all bits were corrupted. In figure 6, these rows can be recognized in the third error map.

Pending further investigation of the error pattern described in section 3.2, when operating a DDR3 memory device in a radiation environment, it is recommended not to keep rows open for an extended period of time. If the performance impact is acceptable, a closed page policy should be implemented by the controller, or banks should be explicitly precharged by the user logic as soon as they are no longer required active. It may be desirable to use a PHY which does not require periodic read operations.

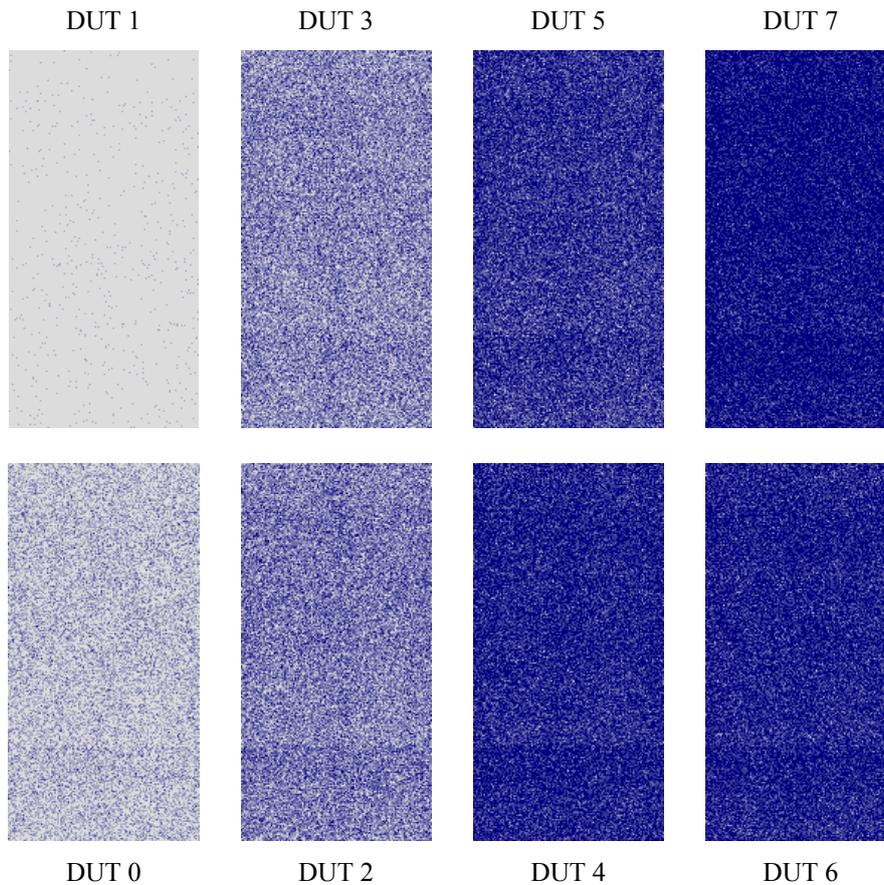
The result for cooling DUT 1 is shown in figure 8. DUT 1 has the lowest number of errors by far. The next higher error count is found in DUT 0 (opposite from DUT 1), DUT3 (adjacent to DUT 1) and DUT 2 (opposite from DUT3). The other DUTs are sufficiently far away from the cooled DUT to be unaffected.

Figure 8: error maps of 8 DUTs after 16 seconds without refresh. DUT 1 was cooled.

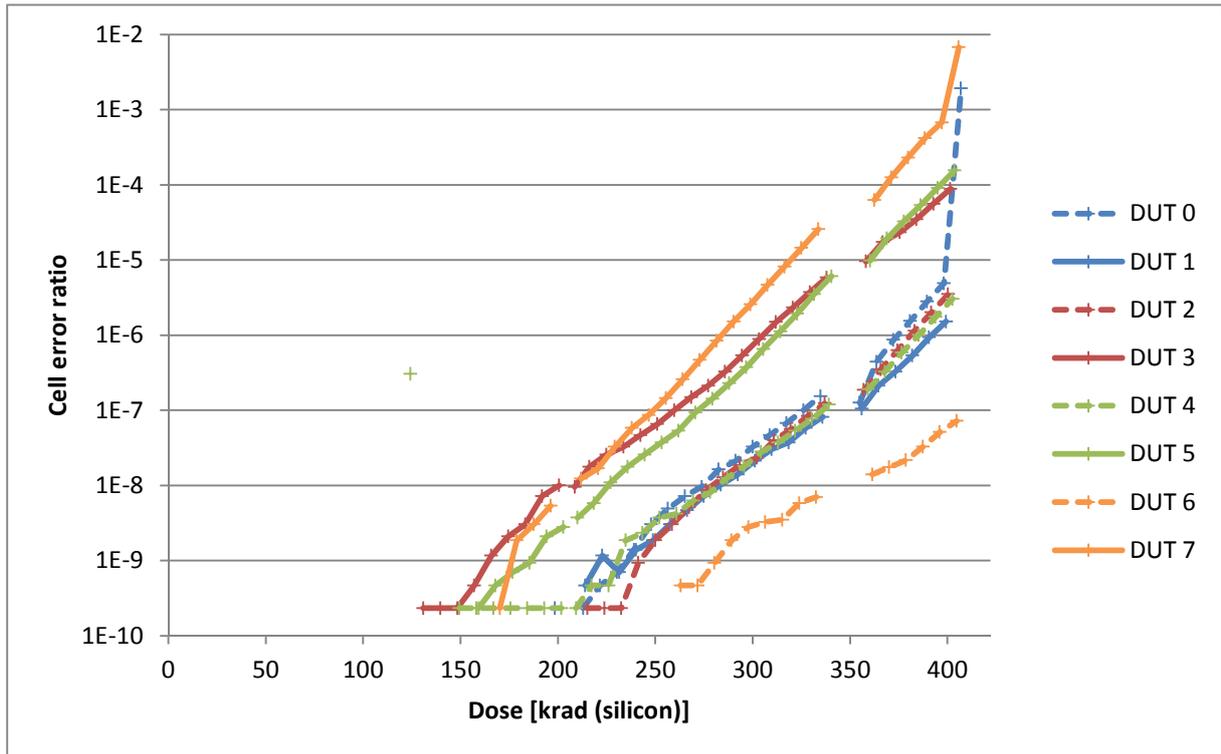
The values in figure 9 include the error regions described in section 3.2. Since these errors are believed to be, at least in part, an artifact of the mode of operation, we are also interested in the cell error ratio excluding these errors. Furthermore, the error regions are large enough to cause overflows of the error vector FIFO in some cases, making the total bit error count unreliable.

Figure 9: errors vs. dose, Samsung 4 Gbit, whole device

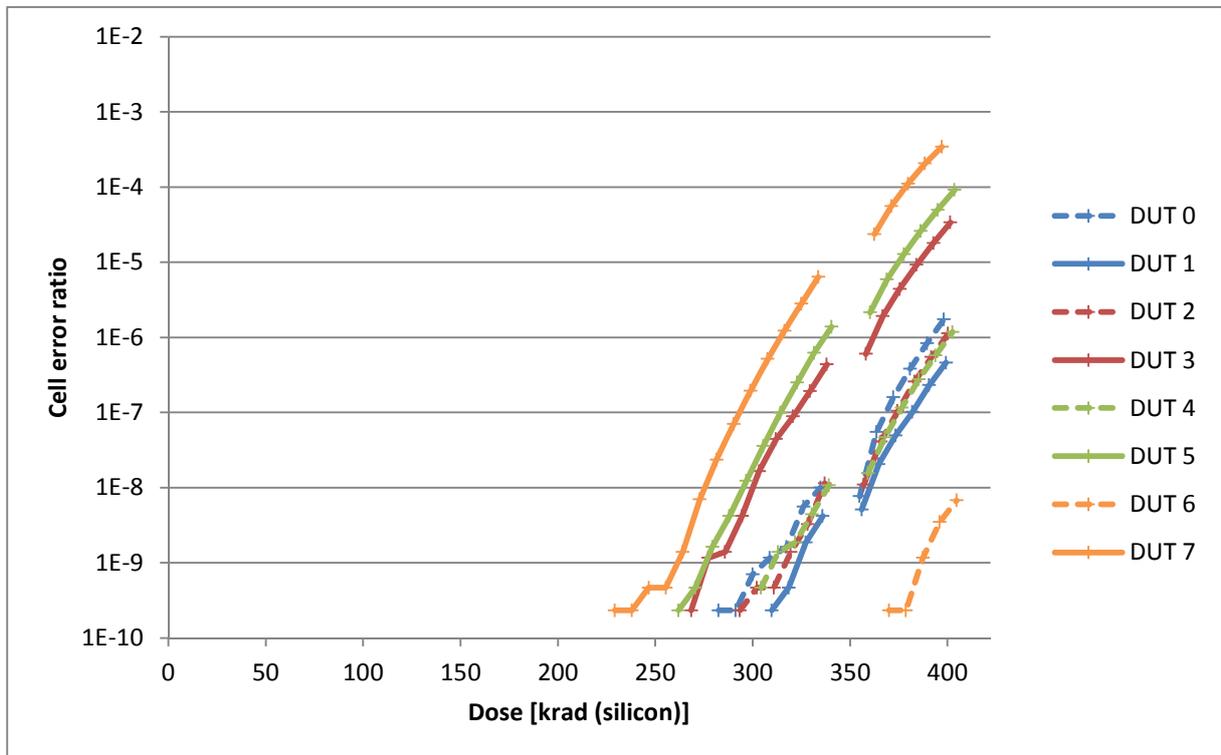
Since the aforementioned error regions always occur near the end of the device (for the relevant test runs), we can filter them out by only considering the first half of the device. The cell error ratio for this case is shown in figure 10.

Figure 10: errors vs. dose, Samsung 4 Gbit, first half of device

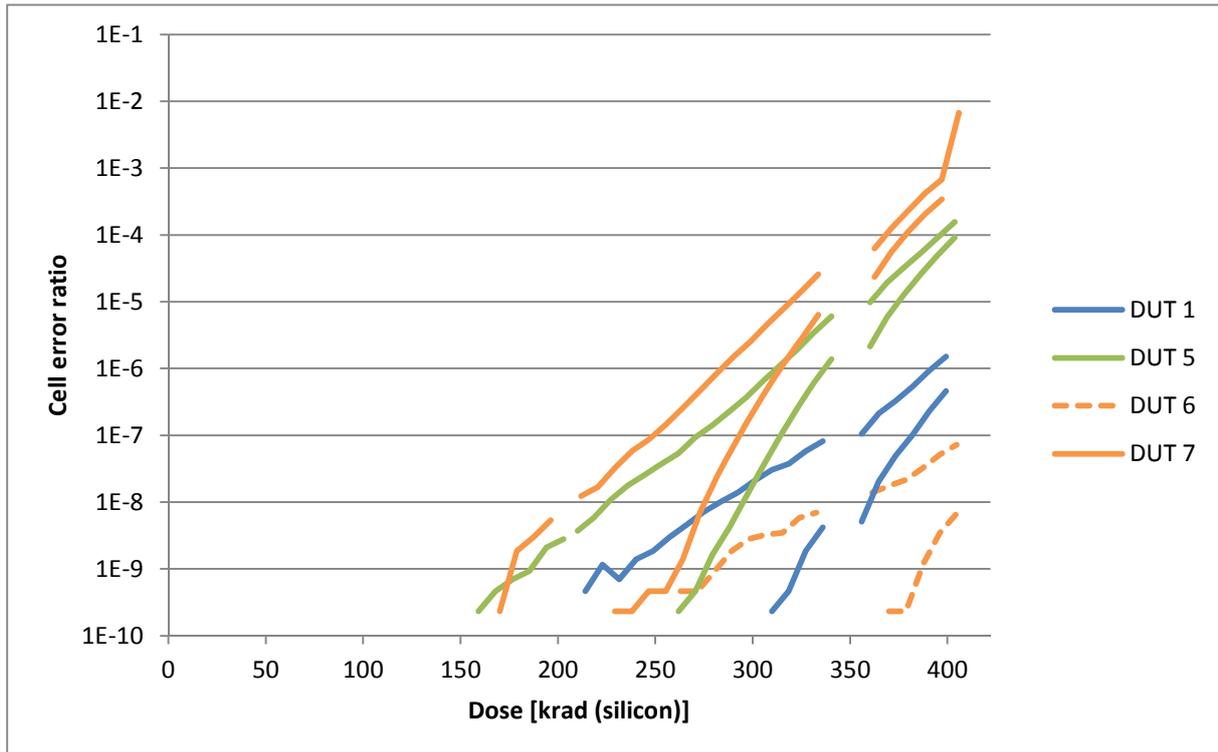
Figure 11 compares the unfiltered (from figure 9) with the filtered cell error ratio (from figure 10) for some selected DUTs. The influence of the error pattern is large low dose. As the dose increases, the influence of the error pattern decreases as the number of errors in the rest of the device increases.

Figure 11: errors vs. dose, Samsung 4 Gbit, comparison of whole device (higher values, from figure 9) with first half of device (lower values, from figure 10) for selected DUTs

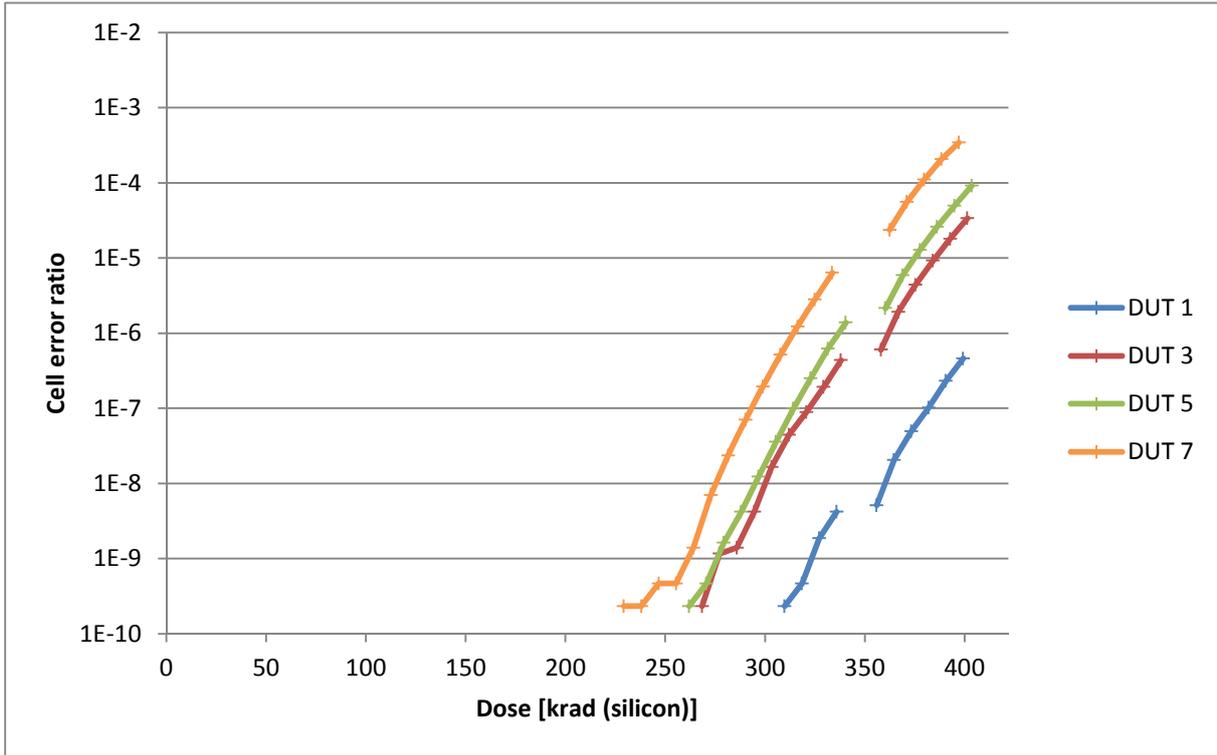
DUTs on the side facing the source have much more errors than DUTs on the side facing away from the source. This cannot be explained by γ radiation, which should not significantly be shielded by the SODIMM board or the DUTs. It is suspected that the difference might be caused by electrons, either from the β decay of ^{60}Co or from photon scattering in the test chamber.

Figure 12: errors vs. dose, Samsung 4 Gbit, DUTs facing the source

Concerning the discrepancy between DUTs (section 3.3.3), the DUTs should be shielded, for example with a thin (e. g. 2 mm) layer of aluminum, to decrease the effect of electrons. If the difference between the front and back sides of the SODIMM persists, it might be desirable to rotate the SODIMM by 180 degrees at some time during the test in order to determine whether the difference between the sides is caused by the test setup or is related to some property of the SODIMM, as suggested in section 3.3.3.

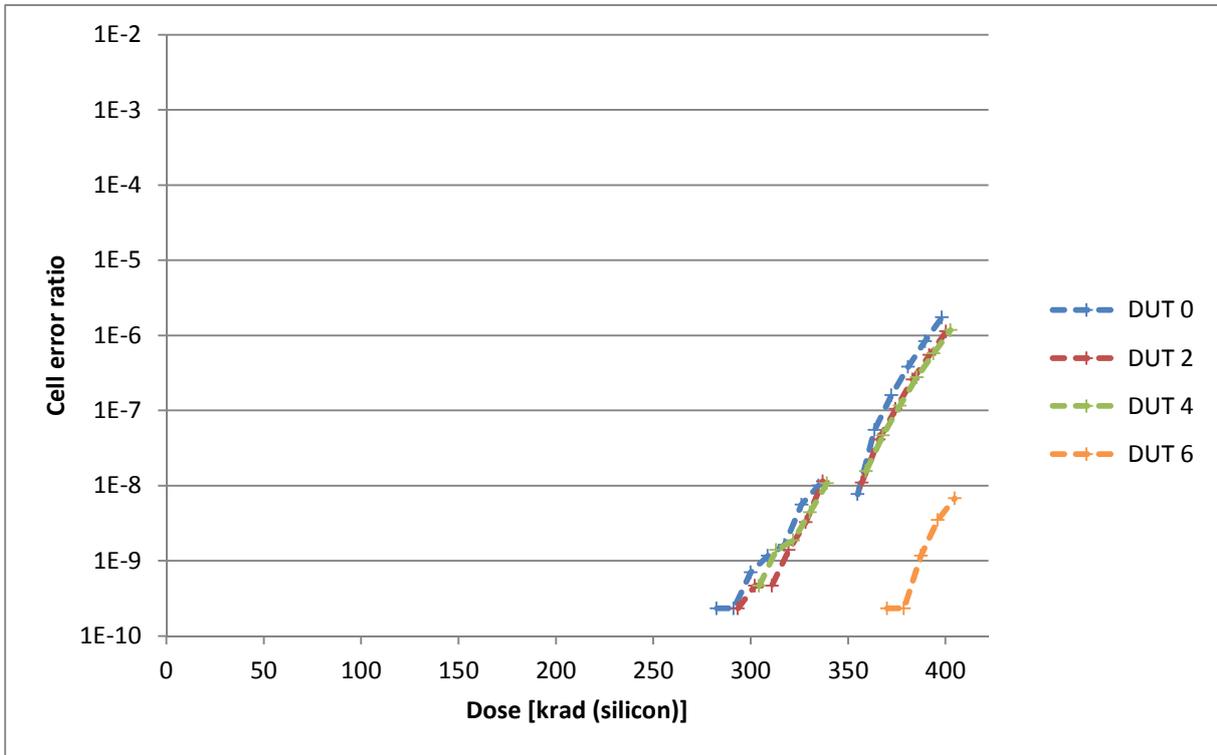
Figure 13: errors vs. dose, Samsung 4 Gbit, DUTs facing away from the source

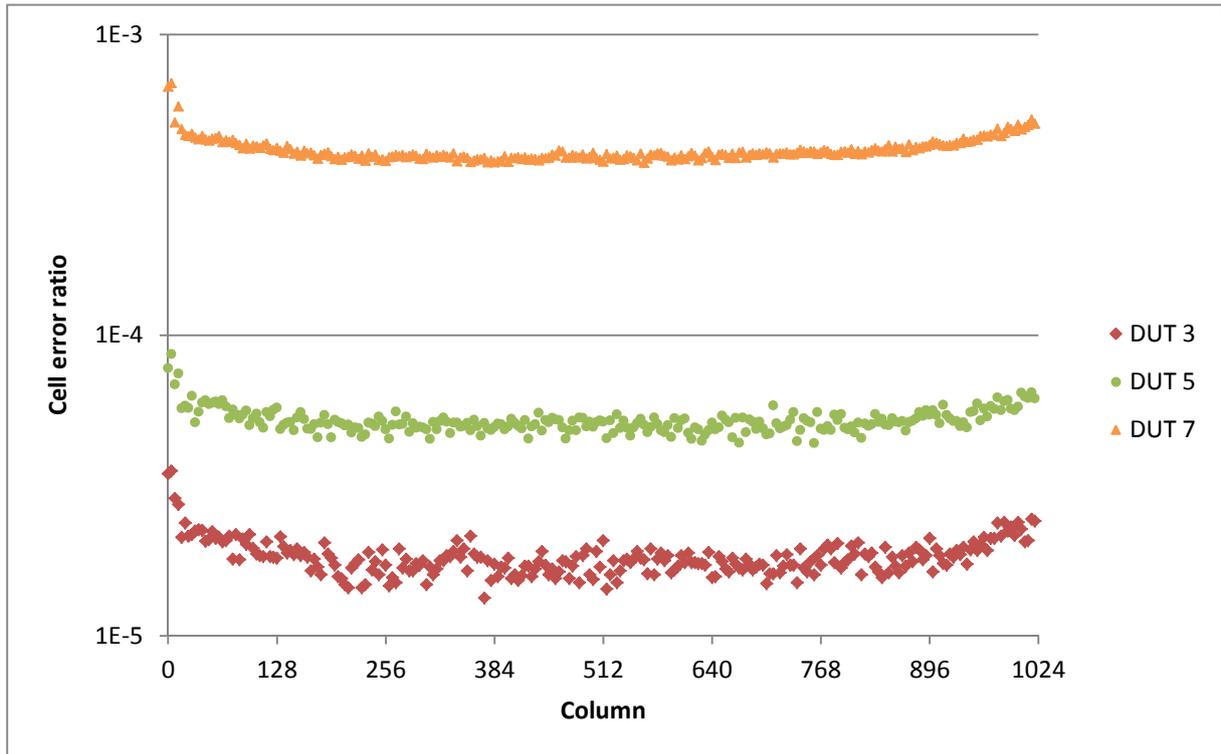
The number of errors in the middle of a device is slightly lower than in the columns towards the edges of the device. An example for three devices is shown in figure 14. More detail can be recognized when plotting the data on a linear scale, shown for one DUT in figure 15. Note in particular the steep rise of the error count towards column 0.

Figure 14: error count vs. column position, Samsung 4 Gbit, operated, ≈ 390 krad (silicon), logarithmic scale

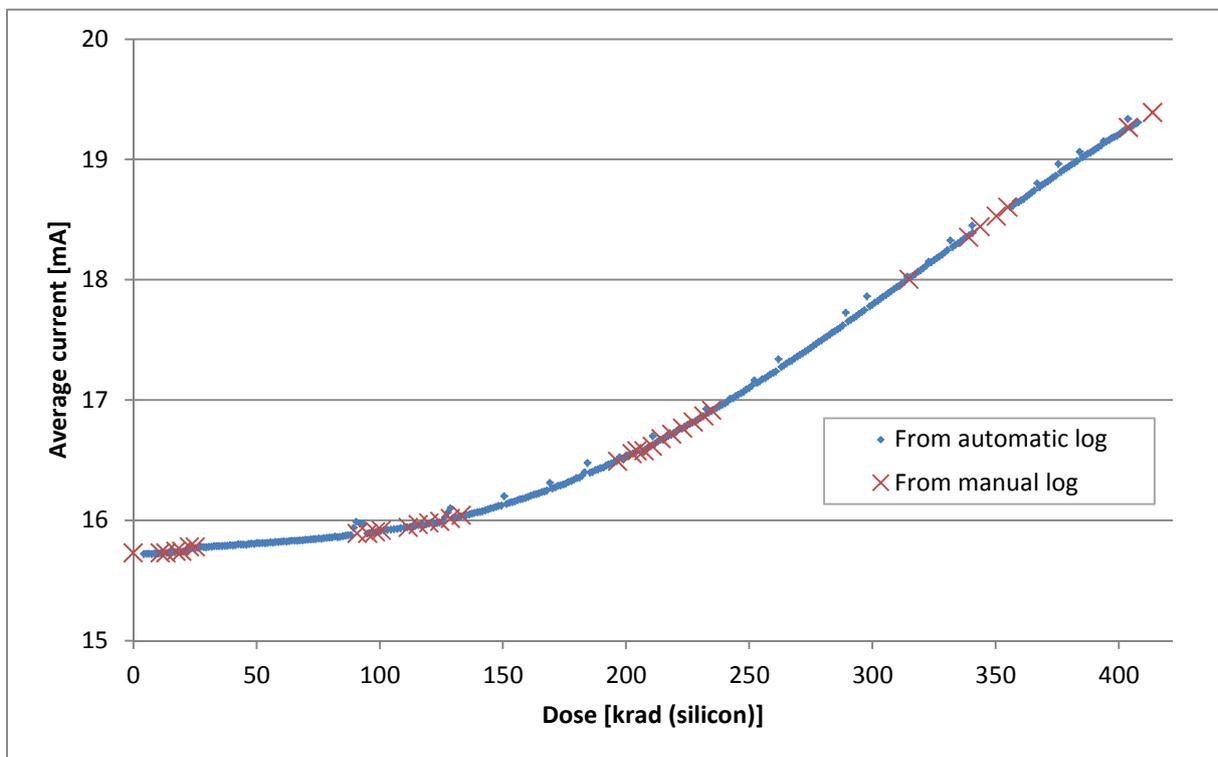
The current vs. dose is shown in figure 16. Over the course of ≈ 420 krad (silicon), the average idle current increased by less than 25% from 15.7 mA to 19.3 mA.

Figure 16: idle current vs. dose, Samsung 4 Gbit

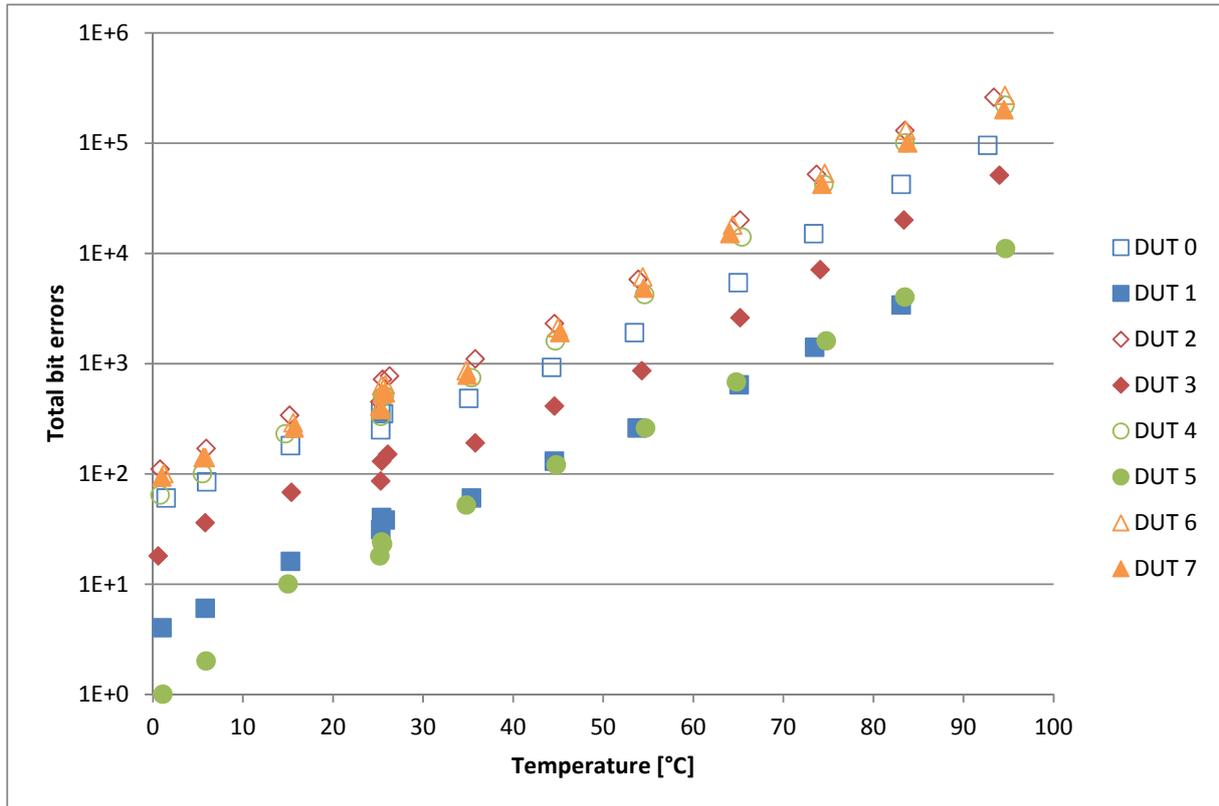
Figure 17 shows the total number of bit errors n in the whole device vs. the temperature T . This relationship is described approximately by $n \propto e^{T/12K}$. The number of errors thus doubles every 8 K or increases by a factor of 10 every 28 K in temperature change.

Figure 17: bit errors vs. temperature, Samsung 4 Gbit, unbiased, ≈ 420 krad (silicon), refresh rate $7.8 \mu\text{s}$
