TN-IDA-RAD-13/9B

**Unbiased TID Test of 2-Gbit and
4-Gbit DDR3 SDRAM Devices**
Test report
Proposal for Revision of the Test Strategy

Radiation hard memory, Radiation testing of
candidate memory devices for Laplace mission

Final issue: November 24, 2014

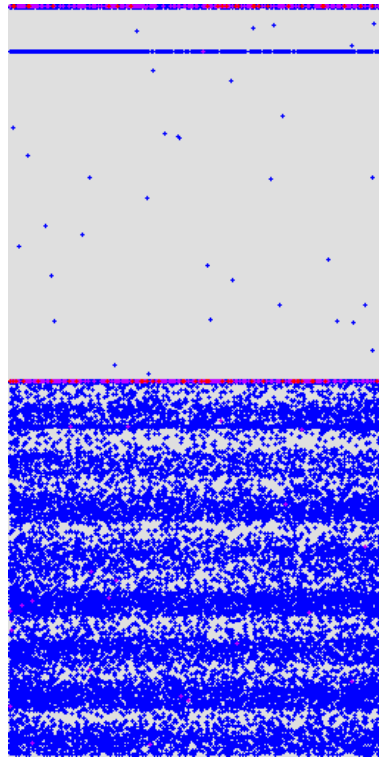
After that, at least 3 samples of each device type were operated at 85°C, the maximum allowed temperature for most of the devices, in our test bed. First, several write and read operations were performed without and, in case of errors, with precharge after periodic read. After that, intermittent operation was performed on the first half of the device and the whole device was read again (an example where intermittent operation has a strong effect is shown in figure 2).

Figure 2: after intermittent operation (2 Gbit Samsung, revision D, 85°C)

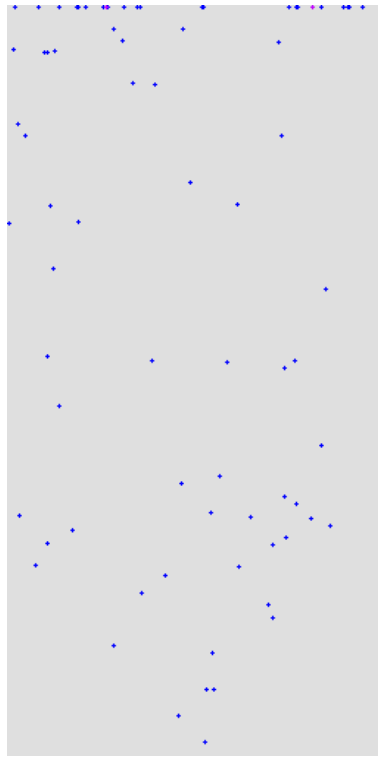
The results of the tests are summarized in table 5. Examples for the error intensities are shown in figures 3 to 5. A blue symbol indicates a 32-bit word with a single-bit error. A purple symbol indicates a word with 2 or 3 bit errors, and a red symbol indicates a word with 4 or more bit errors.

Figure 4: *significant* random errors and *weak* band error pattern (2 Gbit Micron, 85°C)

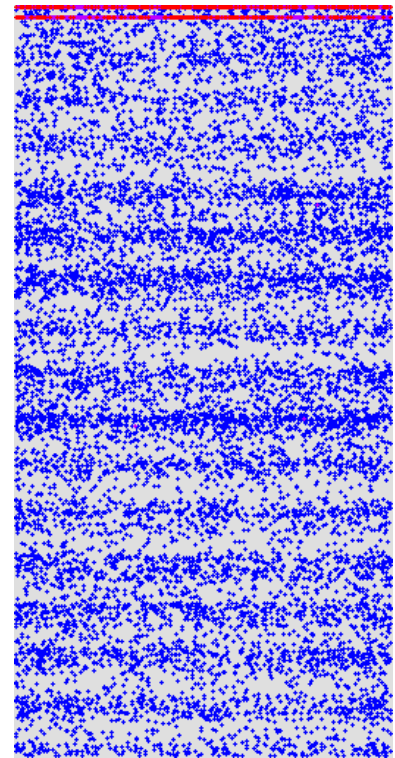
Figure 5: *severe* random errors and *strong* band error pattern (4 Gbit Samsung, 85°C)

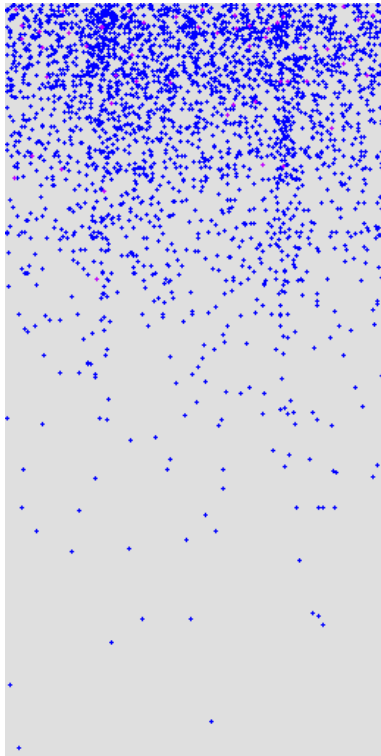
In an additional test, of the tested 2-Gbit Micron devices, one contained more random errors and the other showed a stronger band error pattern. Another 2-Gbit Micron device showed random errors in a pronounced gradient pattern (figure 6).

Figure 6: gradient pattern
(2 Gbit Micron, 85°C)

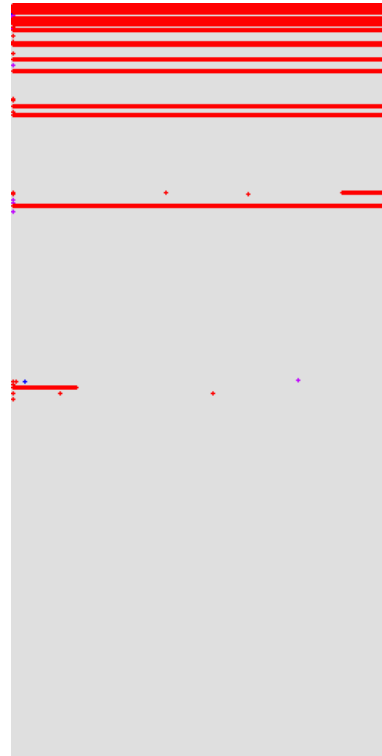
With only one of the 4 copies of the head station (head station #2), we observed severe row errors in 2 of the 22 tested 4-Gbit Hynix devices, starting at 65°C (figure 7). These devices also showed clusters of errors in the first column. This error pattern has not been observed for any other devices.

Note that this error pattern only appears with one of the 4 copies of the head station. With the other copies, the 4-Gbit Hynix devices behave as described in table 5. Furthermore, the error pattern only appears when the shunt is shorted. This is surprising, as the operating voltage should be closer to its nominal value in this case.

The effect was not further investigated. It may be due to small differences of the line impedance between the boards. All of the tests described above were performed with head station #3, where these errors did not occur.

Figure 7: row errors and first col-
umn cluster (4 Gbit Hynix, 85°C)
