ESTEC's Materials and Electrical Components Laboratory capabilities on testing passive components

12-14 October 2016
ESA/ESTEC, Noordwijk, The Netherlands

Joaquín José Jiménez Carreira ⁽¹⁾,
⁽¹⁾EEE component engineer, ATG EUROPE B.V. on behalf of ESA/ESTEC
Keplerlaan 1, PO Box 299, 2200AG Noordwijk (The Netherlands)
Email: Joaquin.jimenez@esa.int

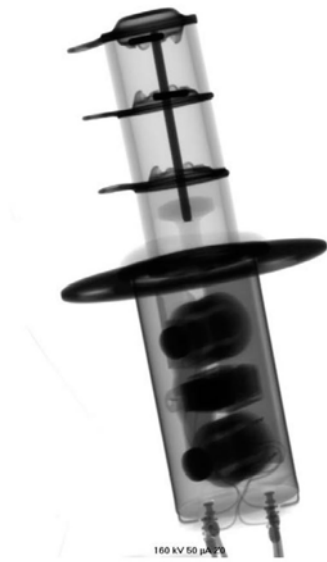
Fig. 1 X-ray view of a high voltage relay

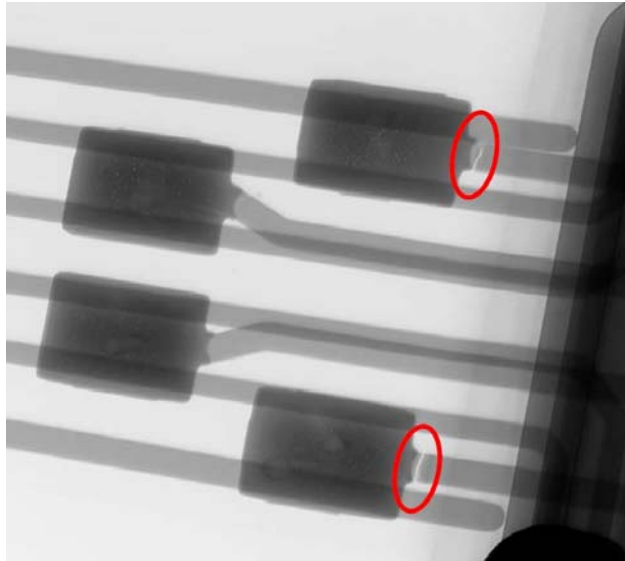
Fig. 4 Quick identification of failure mode thanks to x-ray

A view of a flex circuit soldered onto a connector is shown in Fig. 4: the fillet formed onto the flexible circuit by the epoxy resin around the connector reaches very close to the first row of soldering pads on the flexible circuit, concentrating any bending stress on a length of flexible circuit only. The x-ray image in Fig. 4 clearly shows open circuits at the location where they exit the soldering pads, close to the epoxy resin fillet.

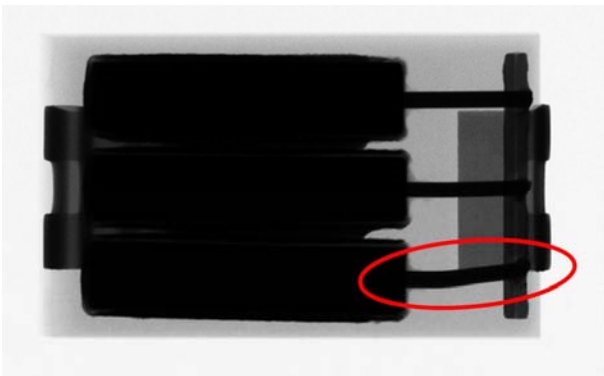
Some interesting unexpected features were found when performing x-ray investigations in a set of tantalum capacitors submitted to the lab for a constructional analysis. Fig. 5 illustrates anode risers in the multi-slug design that were found to be bent. Furthermore, Fig. 6 shows that some slugs in the multi-slugs designs were bent too. These matters were not considered to constitute an immediate threat on the part, but it was recommended to discuss them with the manufacturer in order to fully understand their origin and long term potential reliability effects.

Fig. 5 Anode risers in tantalum capacitor

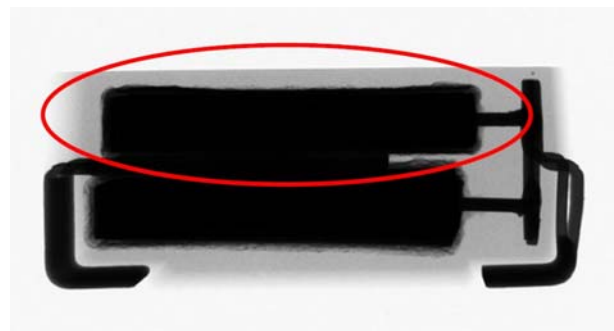
Fig. 6 Bent slugs in the same type of tantalum capacitor

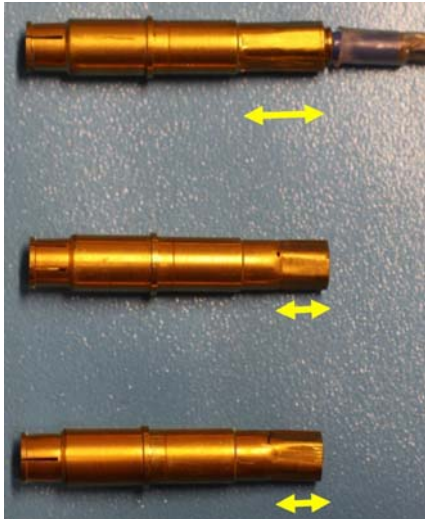
The real power of the X-ray tool lies on the possibility of performing computerized tomography (CT) scans. For instance, three connectors were delivered to the laboratory for performing a failure analysis investigation, mentioning a loose centre contact assembly which was recessed too deeply in the shell. These parts were triaxial connectors designed to be inserted into round multi-pin connector assemblies. One of the samples had an external crimp length of 11mm, where the specification states only 6mm. Fig. 7 illustrates the wrong crimp length on the first part (at the top) and a correct crimp length of 6mm on the other two parts (at the bottom). This wrong long crimp caused several cracks on the connector outer shell (see Fig. 9). In addition to this, this same sample had a centre assembly set back in the body by 0.38mm (see Fig. 8).

Fig. 7 Wrong crimp length on top part

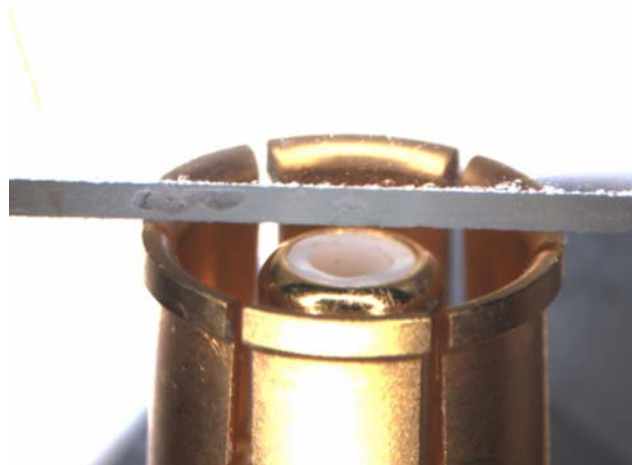
Fig. 8 Recessed centre assembly on top part of Fig. 7

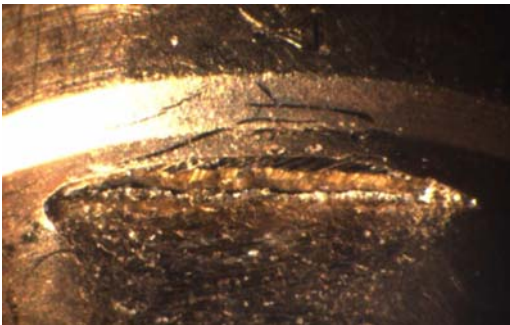
Several CT scans were performed on this part, focussing on its front-end and rear-end (or cable end, Fig. 10 refer). One of the big advantages of this technique is the possibility of doing virtual sections of the parts. Fig. 11 illustrates the body cracking associated with the over-long crimp in the reference sample, labelled as “Indicator 1”. Note that a 6mm long correct crimp would have been confined to an end region of the body with a deliberately reduced wall thickness to facilitate the deformation (see the red arrows in Fig. 11). By extending the crimp length, a much thicker wall was deformed and immediately next to the outer surface section change, the forces used resulted in through cracks.

Fig. 9 Cracks on the outer shell of the connector

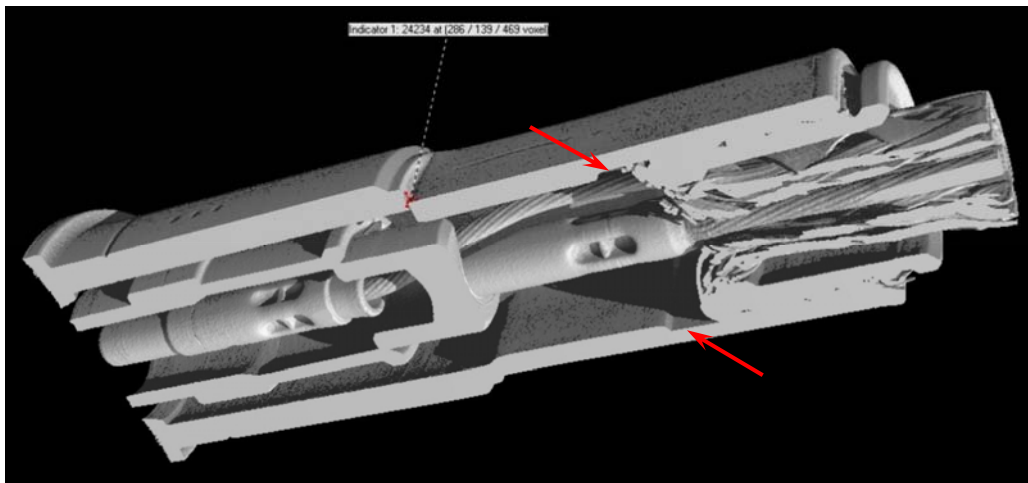
Fig. 11 Red arrows show the correct location for end of crimp length

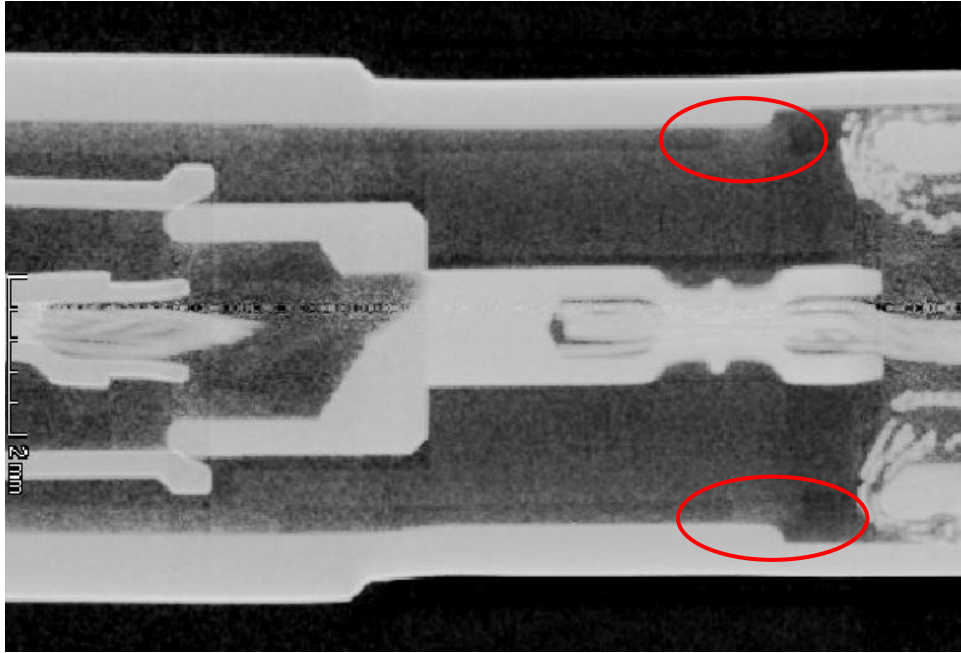
Fig. 12 Red circles highlight the PTFE insulator flange incorrectly positioned

Obviously, X-ray techniques are not suitable to show images of internal non-metallic components of any part. However, with a proper setup of the x-ray instrument and of the reconstruction techniques, it is not impossible to see interesting features. This way, the CT scans revealed that a split polytetrafluoroethylene (PTFE) insulator used to assemble the connector was incorrectly placed inside the connector. The flange on this insulator faced the rear-end of the assembly, which is simply the opposite direction outlined in the specification. Fig. 12 shows a contrast enhanced image of the section in Fig. 11 in which the flange of the PTFE insulator can be identified. This caused the rearward displacement of the centre pin assemble. Subsequent destructive testing exposed the PTFE insulator. Fig. 13 illustrates that the flange was deformed from the original circular form into hexagons. This demonstrated that the insulator flange was incorrectly placed within the crimp deformation area.

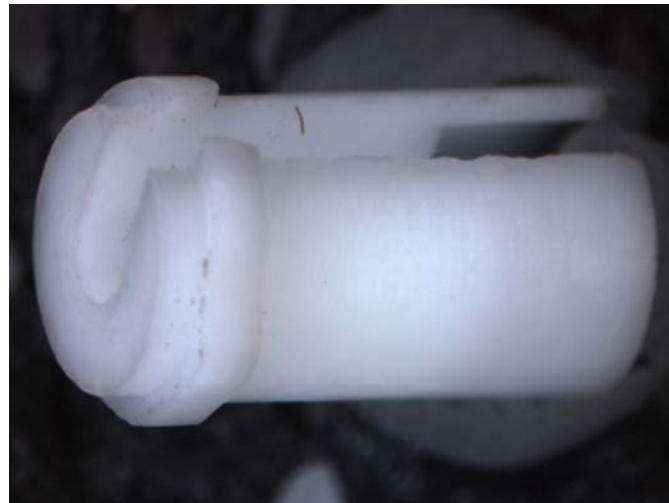
Fig. 13 The PTFE insulator exposed

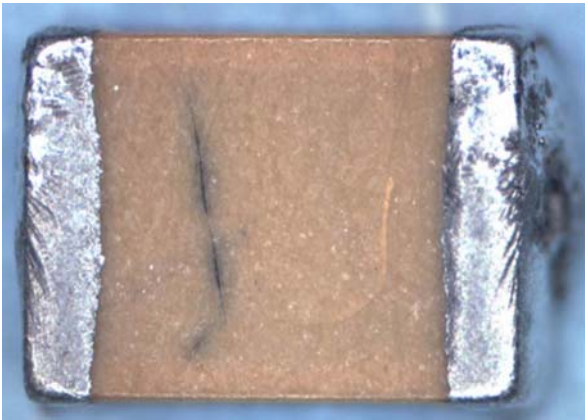
The CT scan tool has also proven to be a big help while investigating the failure mode of a multilayer chip capacitor that was submitted to the lab together with three unused samples of the same batch and date code as the failed one. The failed part was massively cracked and the lab was asked if the cracking caused the electrical failure or was only a consequence.

An optical microscope image of the crack seen on the top surface of this capacitor is illustrated on Fig. 14. CT scan allows for virtual sections of the part, one of which is shown in Fig. 15, where a plan view tomographic section on the principal delamination plane can be identified. The main cracks of this capacitor are illustrated in the tomographic model in Fig. 16.

Fig. 14 Top view of the failed capacitor

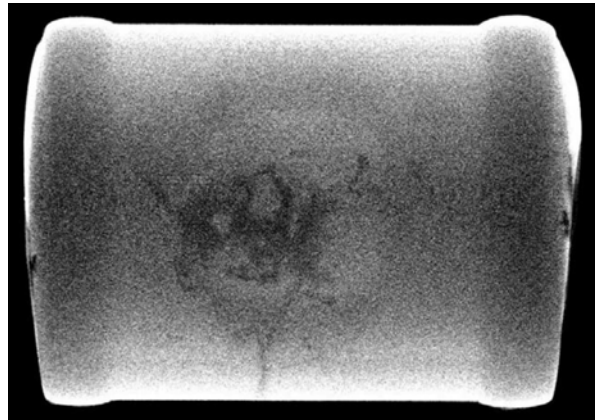
Fig. 15 A tomographic section on the delamination plane

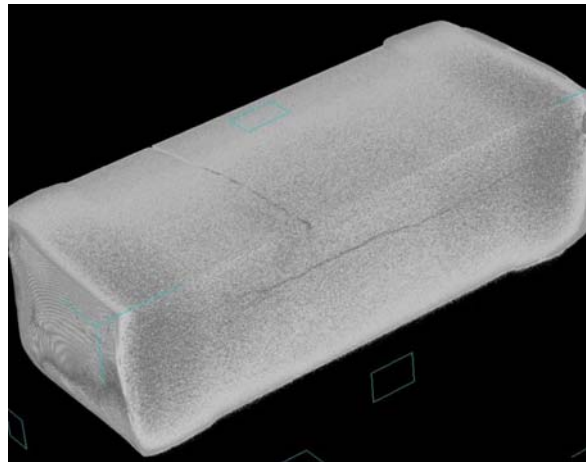
Fig. 16 Main cracks in the capacitor

In any case, most likely the parts contained porosity on a scale sufficient to cause failures by moisture, short circuiting between electrodes. So it was the electrical failure that caused the crack.

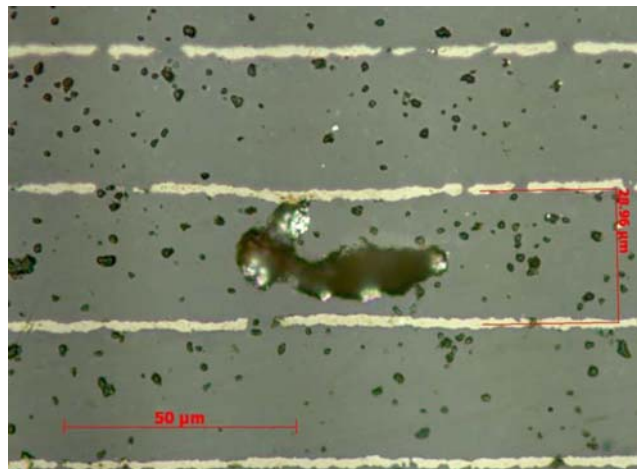
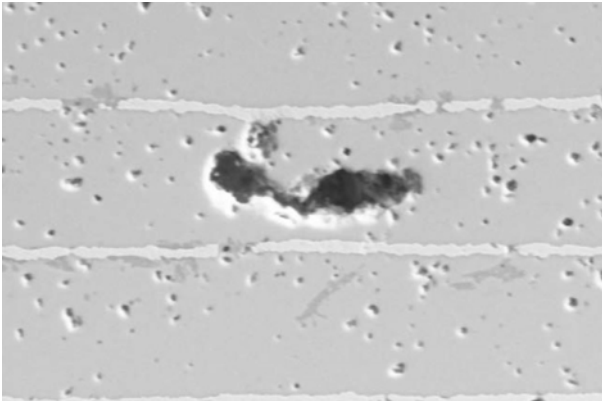
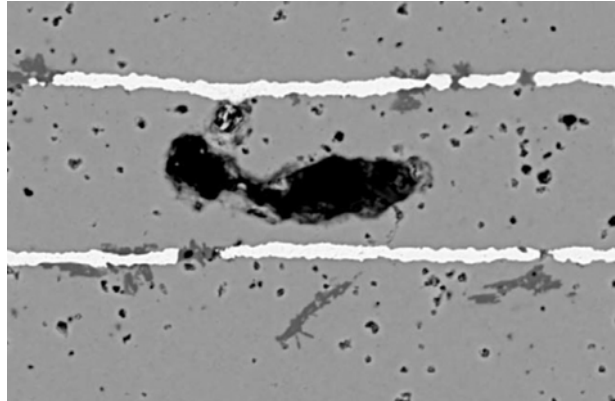
As other unused parts were provided with this failed capacitor, these were also sectioned, and some relatively large pores were discovered between the electrodes. Some of them were larger than the requirements expressed by the procurement specification: dielectric thickness shall not be reduced by more than 50% by voiding.

Fig. 17 Optical microscope section of a void found in an unused capacitor

Fig. 18 Secondary electrons SEM view

Fig. 19 Backscattered electrons SEM view

An optical microscope image of one particularly large pore, a secondary electron SEM image of the same pore and a backscattered electron SEM image of it are shown, respectively, on Fig. 17 to Fig. 19. The Everhart-Thornely Detector (ETD) image gives an impression of the depth of the void. The Backscattered Detector (BSD) image shows the edges of the void more clearly and gives more materials contrast. This pore is comparable in size to the inter-electrode spacing. In case an internal void reaches between adjacent plates, that would guarantee eventual failure. This information produced enough evidence to provide two possible explanations of the cracking pattern:

- 1) The cracks originated from an electrical short circuit associated with excessive porosity close to the parts centre causing layer delamination followed by a top surface crack as the internal stress resulted in surface strain sufficient to exceed the ceramics mechanical elongation limits.
- 2) The crack from the top surface to the centre was the original fault possibly caused by a worn pick and place tool. This crack extended to the capacitors neutral axis and electrical failure by moisture access and short circuit occurred later causing the delamination effect.

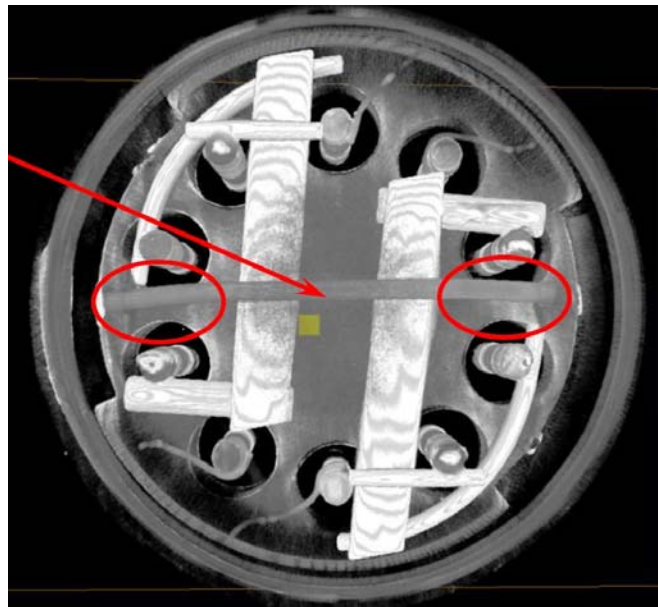
To illustrate the power of the CT scan tool, Fig 20 illustrates a CT scan of a relay. This model allowed for a quick detection of the pivot bar being bent (Fig 21 refer). All this information can be gathered without performing any destructive testing.

Fig. 21 Tomographic section of the relay

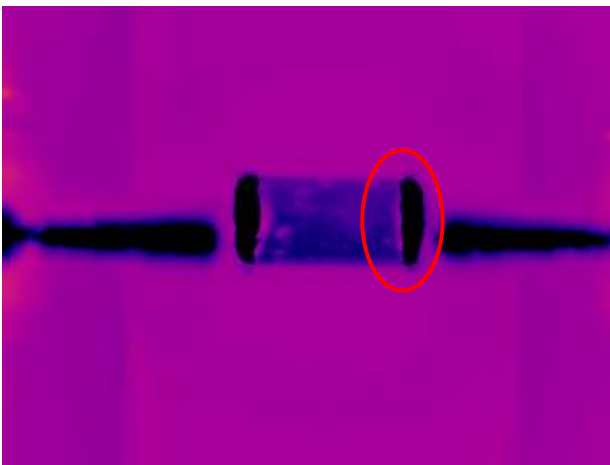
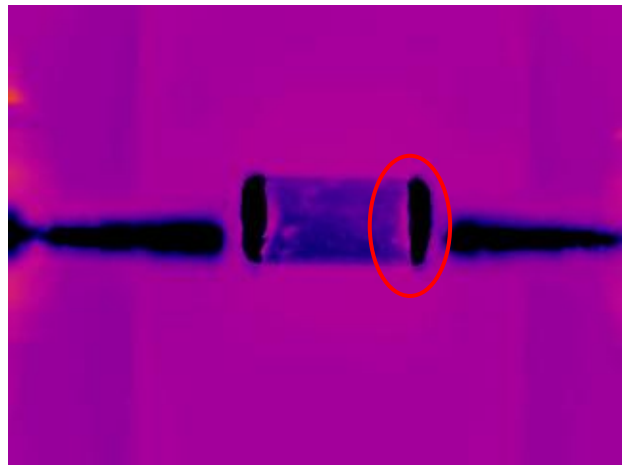
Failure of a ceramic chip capacitor: for instance, a ceramic chip capacitor was delivered to the lab for failure analysis. It failed producing a short circuit when installed in an instrument. The first action was to check the part electrically. The short circuit was confirmed and submitted to hot spot detection test. Fig. 22 shows the IR image of the part when unbiased, as opposed to Fig. 23 when the part is biased. The red circle highlights the spread of lighter colour.

Fig. 22 IR image of the unbiased capacitor

Fig. 23 IR image of the biased capacitor

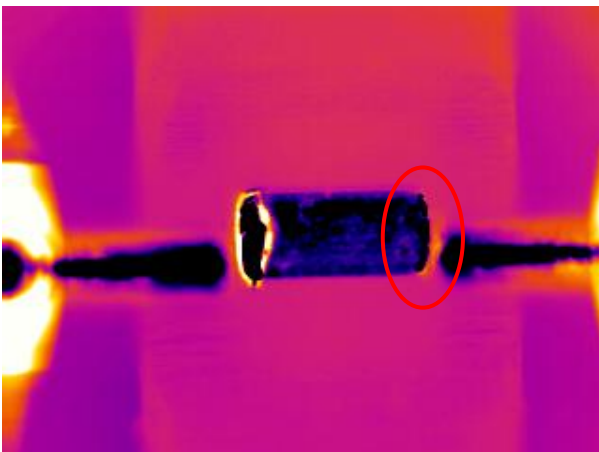
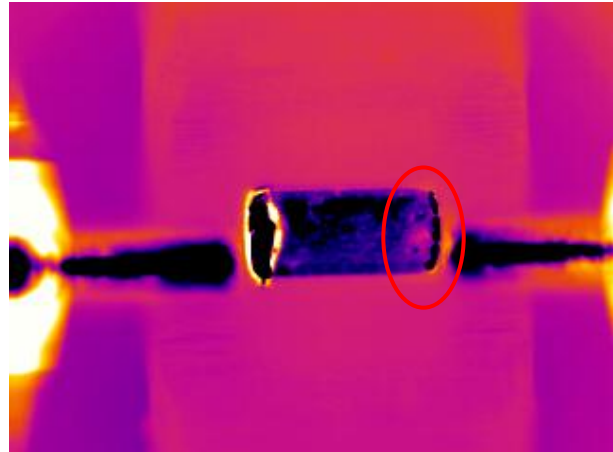
The IR technique has some limitations. It was decided that it was best to remove the termination metal, in order to get better IR images. Only the metal from the sides was removed. The end metal was left in place to provide continued electrical contact. Fig. 24 and Fig. 25 show a clearer breakdown area, highlighted in the ovals.

Fig. 24 Termination metal removed: unbiased

Fig. 25 Termination metal removed: biased

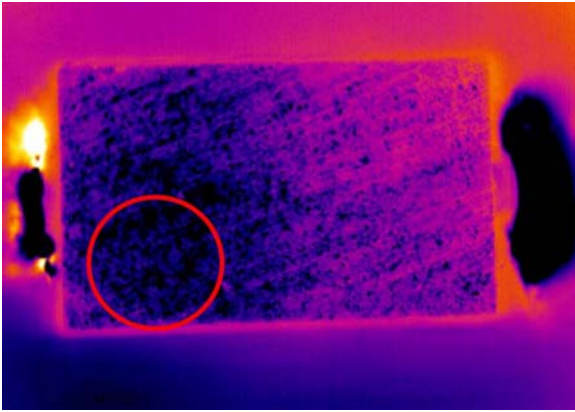
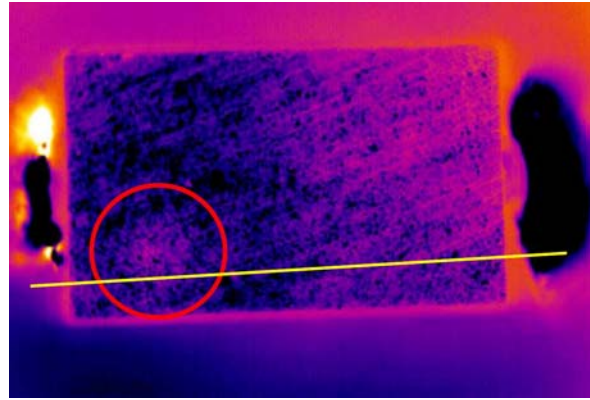
temperature of the part could be seen to rise, but a barely perceptible early warming point could be detected in the top surface. The top surface was therefore thinned to remove the concealing plastic. Fig. 26 and Fig. 27 show the results of repeating the IR images with the top plastic thinned. The bottom edge was then thinned to the point indicated by the yellow line in Fig. 27. The edge view is shown in Fig. 28 and Fig. 29, unbiased, and then biased, after the thinning of the edge. The circled area shows the target area for the next sectional plane. Fig. 32 shows an optical view corresponding with the IR image of Fig. 30 and Fig. 31. The failure was then located and exposed in the area pointed by the IR images. With the help of SEM and EDX analysis, a point of contact between the silver cathode metal and the bulk Tantalum was found (see Fig. 33).

Fig. 26 Top surface thinned - unbiased

Fig. 27 Top surface thinned - biased

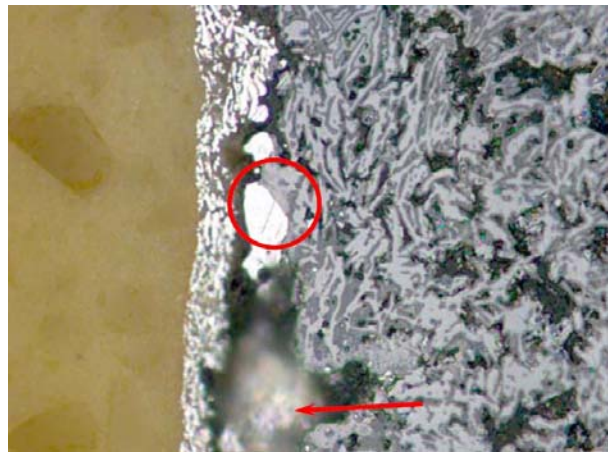
Fig. 33 Short circuit path between cathode and tantalum

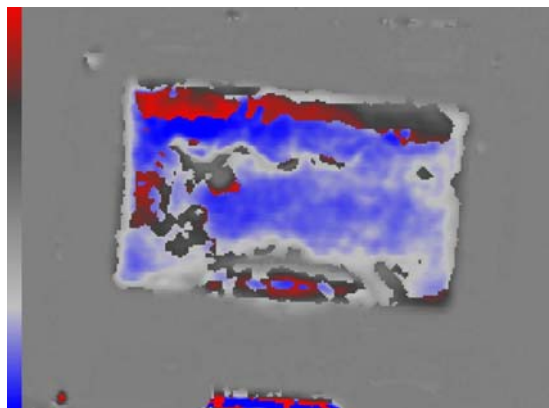
Red areas in Fig. 39 illustrate the CSAM image of the interface between the tantalum and the moulding resin. Instances of poor adhesion and delamination in this interface are clearly visible. This is not uncommon, though, in resin moulded parts. No evidence that such defects extended along the entire part body was found during C-SAM analysis.

Fig. 39 Delaminations at the resin to tantalum core interface (red areas)

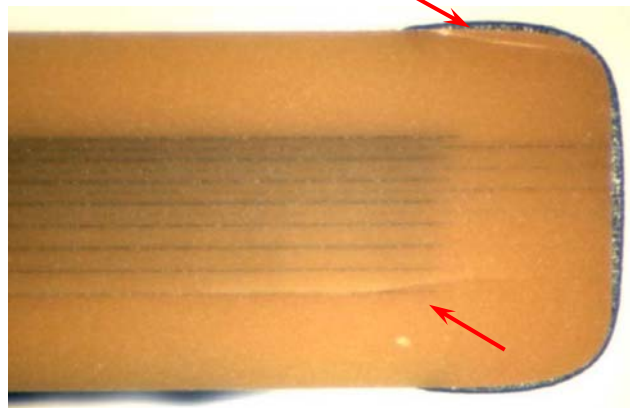
One multilayer chip capacitor was delivered to the lab for failure analysis investigation. Electrical measurements demonstrated an anomaly in the capacitor at lower frequencies. The part (Fig. 40) was potted in epoxy resin and microsectioned (Fig. 41). Two different cracks can be seen in this section (see red arrows in Fig. 41):

- 1) One crack on the top left corner, a typical of the type of crack normally associated with thermal stress cracking, but is thought to have no effect on the performance degradation noted in this instance.
- 2) A defect characterised through a delamination of the bottom plate which made a transition to the next plate up in the structure, by way of a crack, and was effectively continuous from terminal to terminal. This is also thought to be a possible thermally generated defect.

Fig. 41 Cracks (red arrows) detected in sectioned part

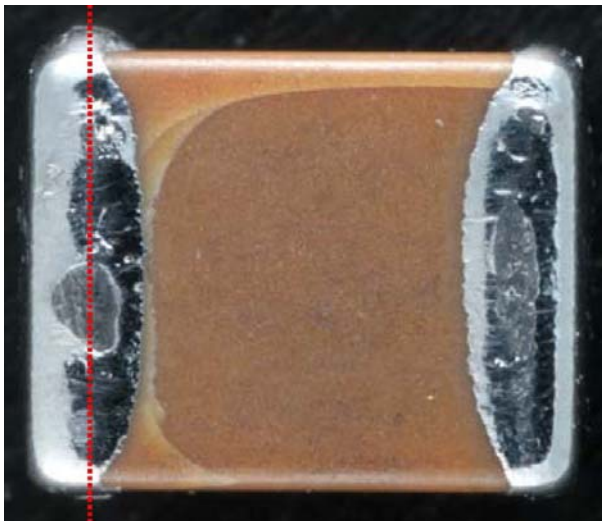
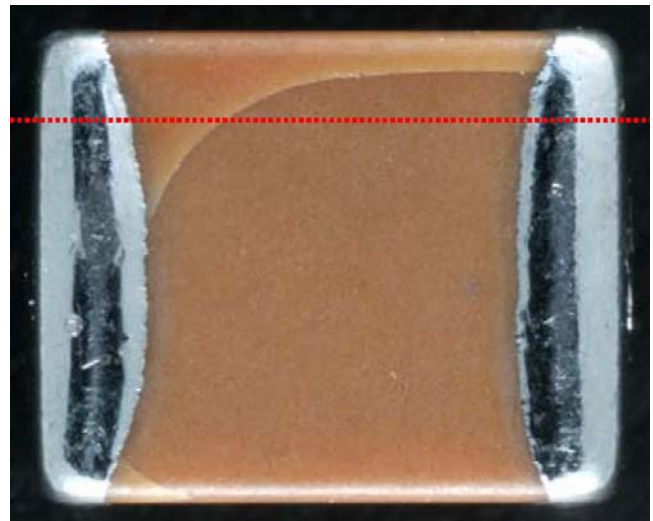
Two other capacitors, unrelated to the one mentioned above, were sent for failure investigation to the lab. Some cracks were observed on their surface (Fig. 42 and Fig. 43 refer):

Fig. 42 Capacitor 1 general view

Fig. 43 Capacitor 2 general view

The shape of the cracks observed in the received samples is typical of thermal-shock induced damage, no external mechanical damage (like dents or scratches) could be observed in correspondence with the cracks. These two parts were potted in resin and cross sectional views of the samples were obtained by grinding and polishing along the red dotted line indicated in Fig. 42 and 43.

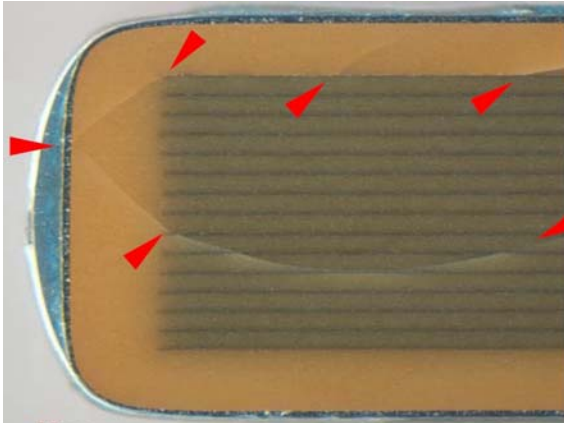
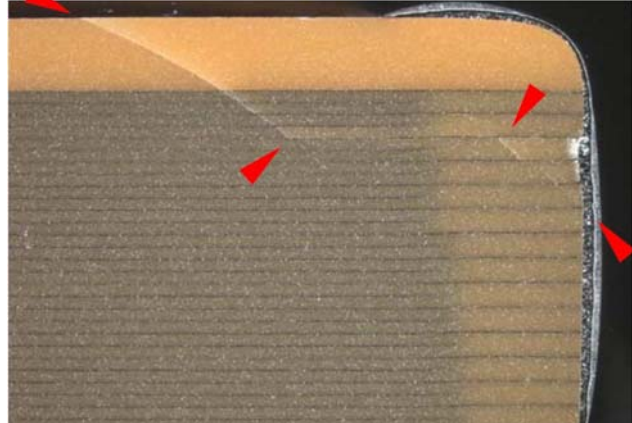
The cross-sectional views (Fig. 44 and 45) proved that the cracks observed during the visual inspection are not just cosmetic, since they connect two or more electrodes, and these electrodes to the surface, and to one of the terminations.

The shape of these cracks are typical of thermal-shock induced damage and strongly supports the conclusion that these cracks have been induced by some thermal shock experienced during the pre-tinning process. The fact that no external mechanical damage (like dents or scratches) could be observed in correspondence with the cracks is also in line with this conclusion. Moreover, the micro-section evaluation showed that these cracks are not just cosmetic surface damage but they reach to the plates and the termination, and they can be hidden under the metallization of the terminations, thus potentially affecting components without showing on the surface.

Fig. 44 Cross-sectional view of capacitor 1

Fig. 45 Cross-sectional view of capacitor 2

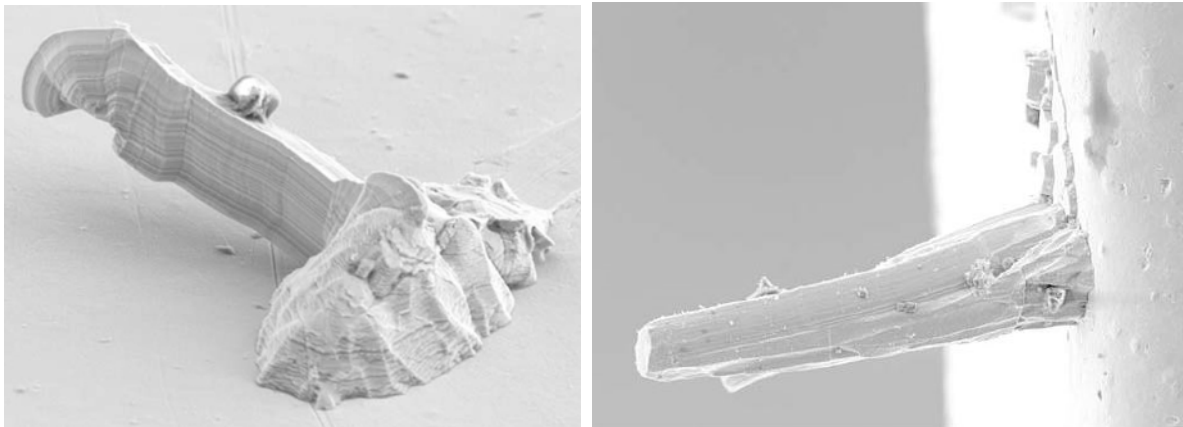
The inspection revealed several tin whiskers at different growth stages (Fig. 46):

Fig. 46 Examples of tin whiskers found in the capacitor

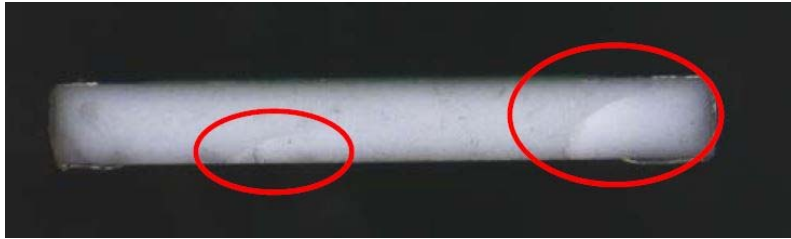
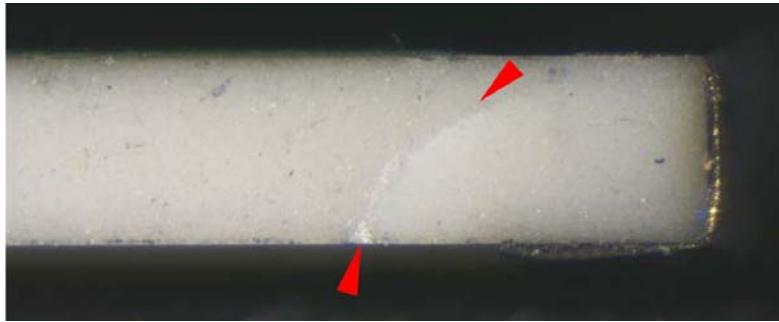
On another investigation, three thin film resistors were submitted to the lab for qualification testing. One of these resistors (Fig. 47 refer) showed two cracks on its substrate the length of which exceeded the maximum allowed by the specification.

Fig. 47 Cracks along the side of the substrate of the thin film resistor

Fig. 48 Zoomed view of the longest crack in Fig. 47

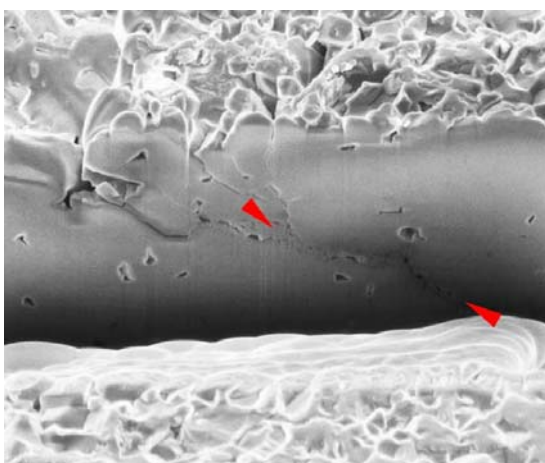
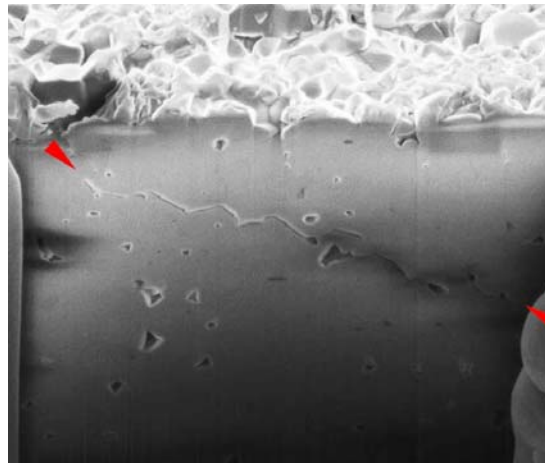
Fig. 50 SEM view of FIB section A

Fig. 51 SEM view of FIB section B

The red arrows in Fig. 50 and 51 indicate the crack propagating within the bulk material. This demonstrates that the crack is propagating inside the bulk material and allowed for a precise measurement of its length, which is out of the specification limits.

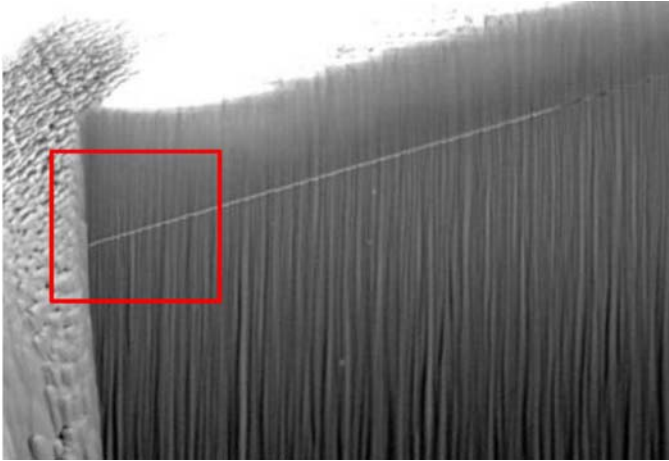
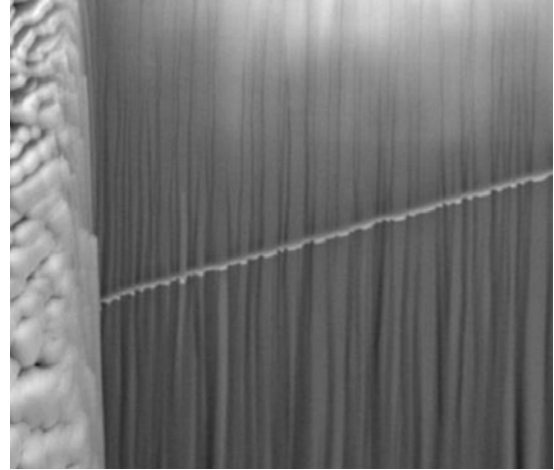
Nickel is the external layer of the leads inside the glass seal. Some of these packages presented a crack in the glass seal. Time and a proper chemical activator caused a linear growth of the nickel through the crack in the glass seal: a dendrite. Eventually, this led to a short circuit in the package and a subsequent component failure. The mechanism causing the cracks in the glass seal could not be discovered.

Fig. 54 FIB cut exposing the dendrite

Fig. 55 Zoomed image of dendrite in Fig.54
