## RELIABILITY ANALYSIS OF COTS WITH AS-DELIVERED DELAMINATIONS UNDER THERMAL SHOCK TO FUNCTIONAL FAILURE

Alexander Curre, Federica Ferrarese, Alberto Moreno

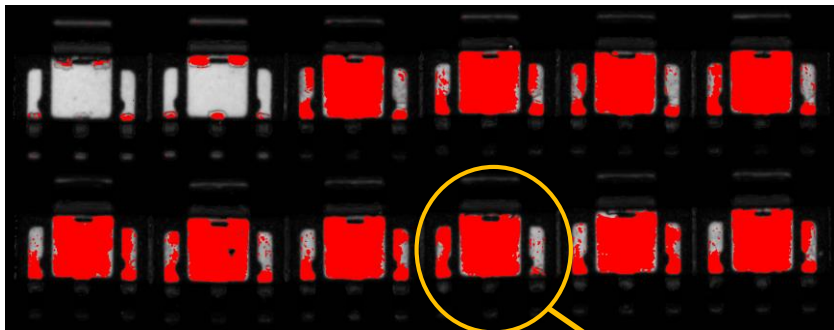
Bottom echo post preconditioning  
DC9D2251

SN08 Electrical failure: ICB0, ICES

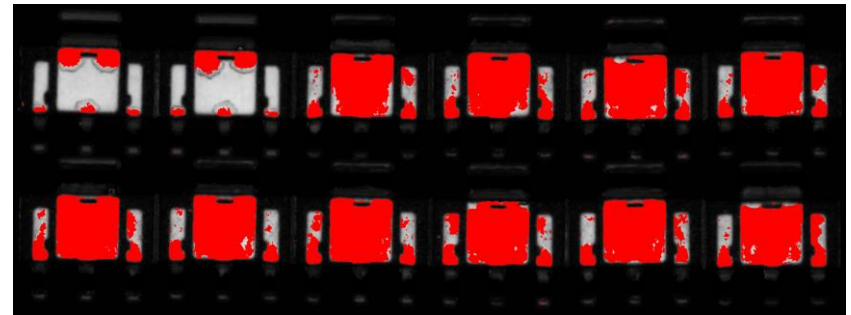
Bottom echo post preconditioning  
DC2224

No electrical failures

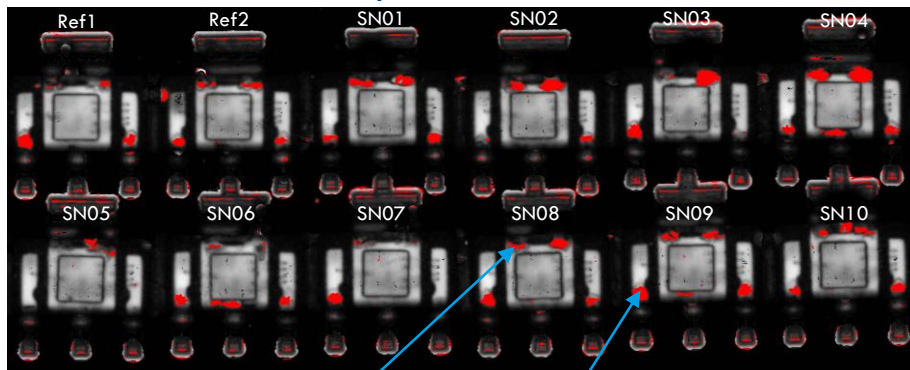
## Top echo - T0

Delamination on die paddle/tie bar

Delamination on lead fingers

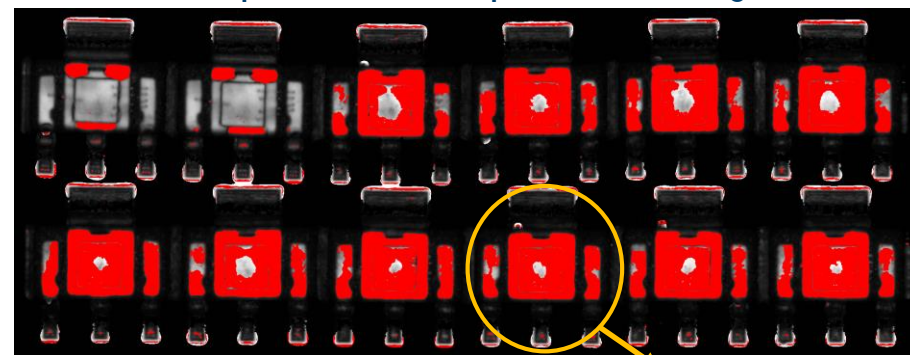
## Top echo - after preconditioning

SN08 Electrical failure: ICB0, ICES

Die paddle and lead fingers almost completely delaminated

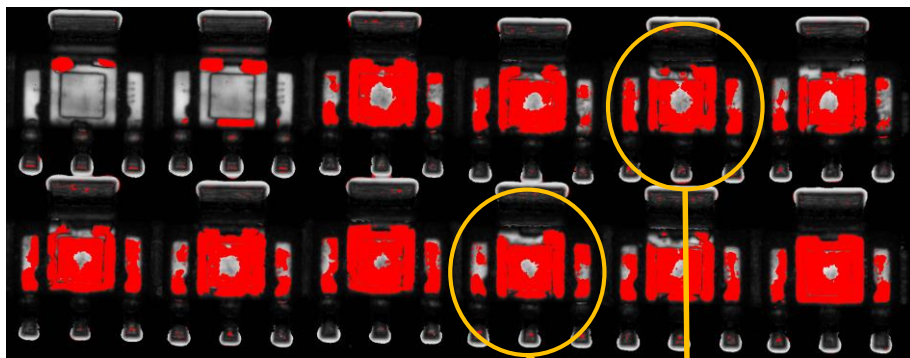
## Top echo - 10 TS

SN3 + 8 - Electrical failure: ICB0, ICES

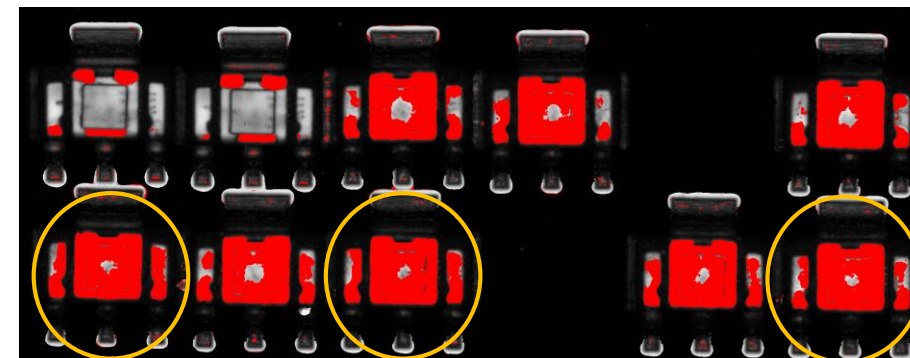
## Top echo - 30 TS

SN05, SN07 and SN10: Electrical failure: ICB0, ICES, IEB0, hfe

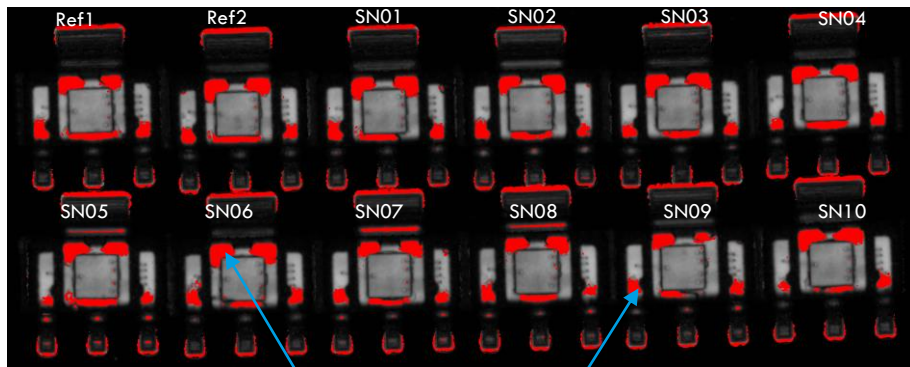
### Top echo - T0

Delmination on die paddle/tie bar

Delmination on lead fingers

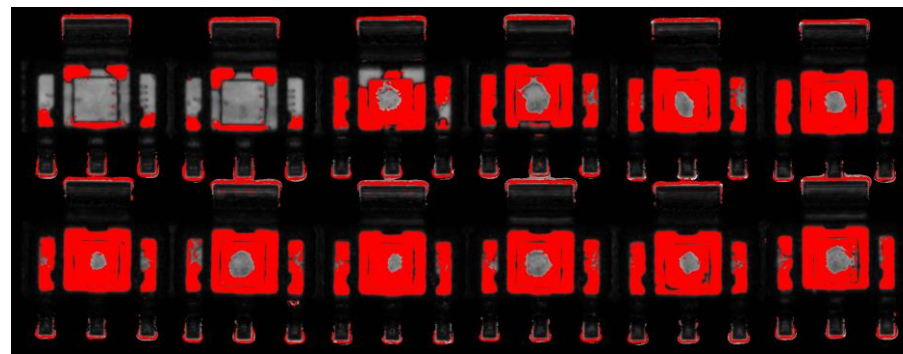
### Top echo - after preconditioning

Die paddle and lead fingers almost completely delaminated, no electrical failures

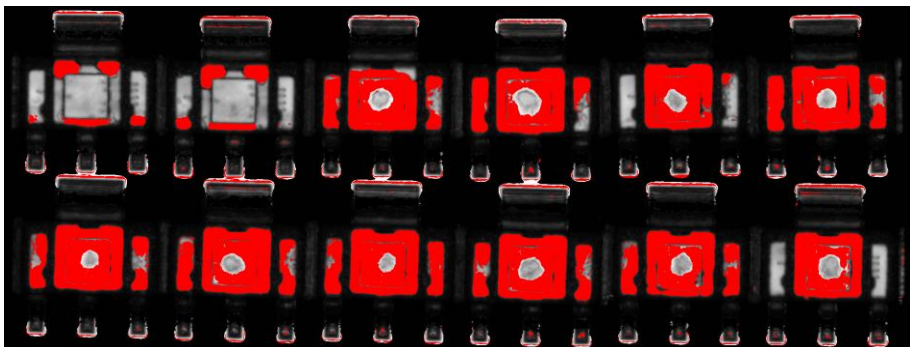
### Top echo - 10 TS

Die paddle and lead fingers almost completely delaminated, no electrical failures

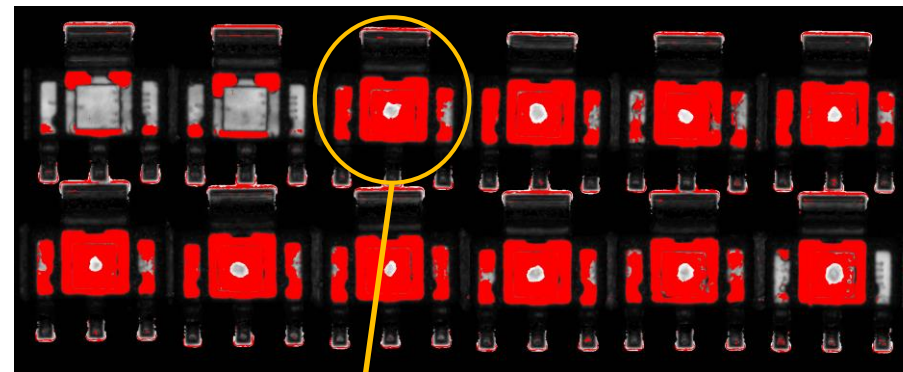
### Top echo - 1000 TS

Electrical failure: IC80, IC85

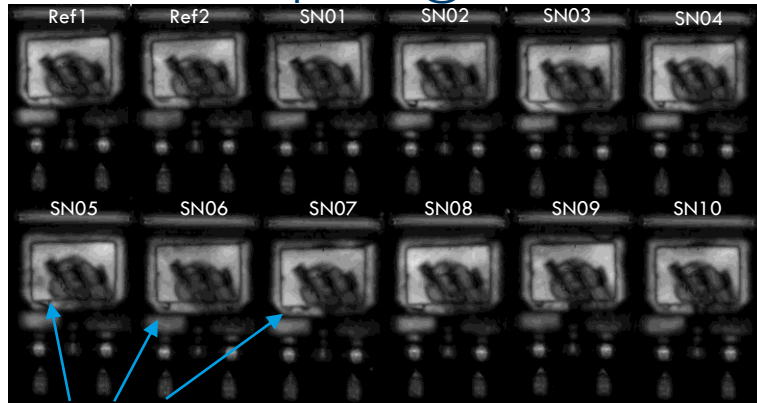
### Top echo @ T0

Delamination on die paddle

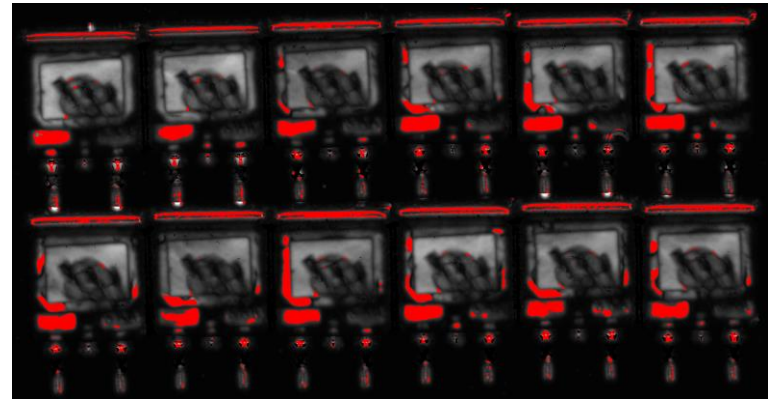
### Top echo - after preconditioning

Increase of delamination on die paddle

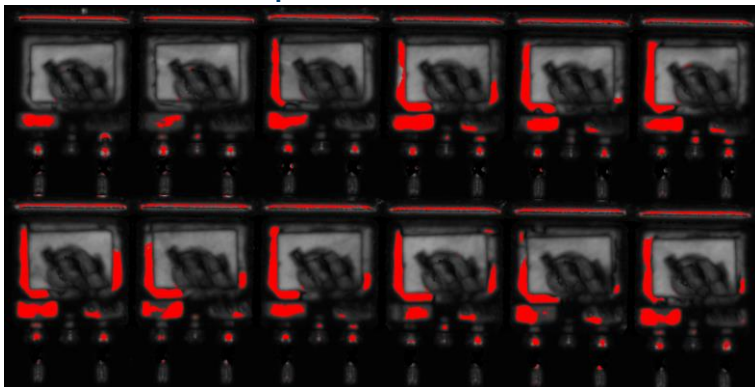
### Top echo - 100 TS

No significant evolution of delamination after 100 cycles

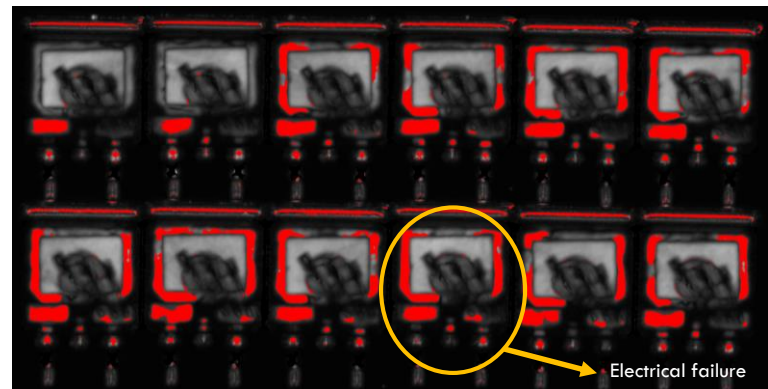
### Top echo - 4000 TS

No significant evolution of delamination after 4000 cycles

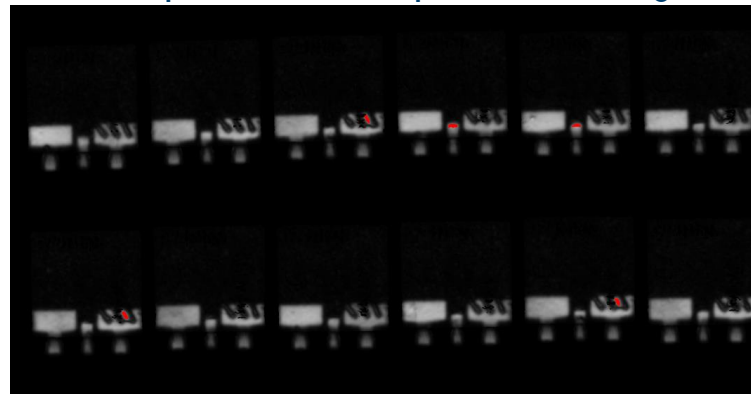
### Top echo - after preconditioning

Gate post in SN8 starts to delaminate

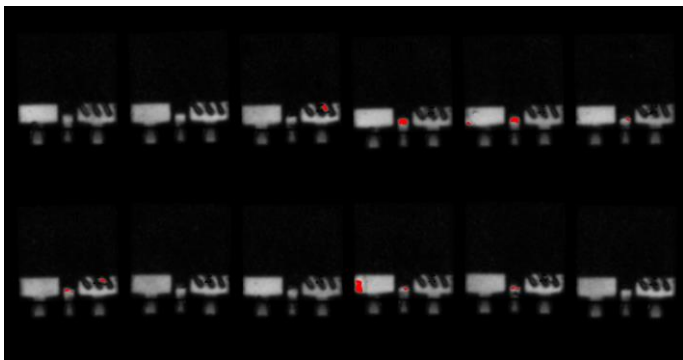
### Top echo - 10 TS

Gate post in SN8 delaminated

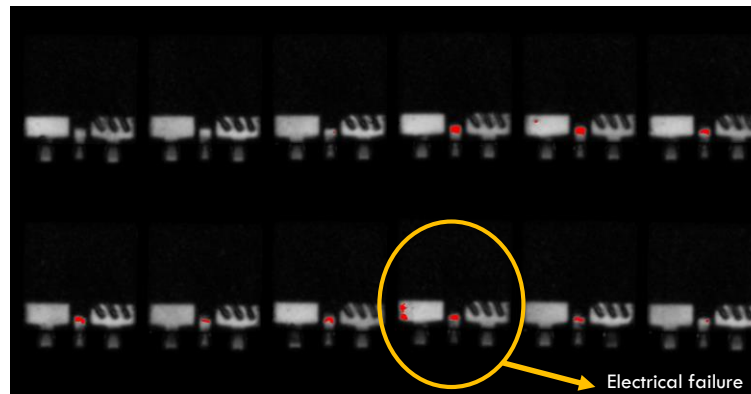
### Top echo - 4000 TS

No significant evolution of delamination after 4000 cycles

Electrical failure

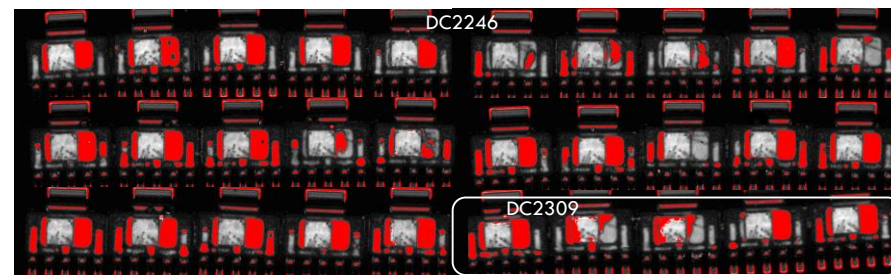
### Top echo - after preconditioning

Increase of delamination on die paddle topside and lead finger in both DCs

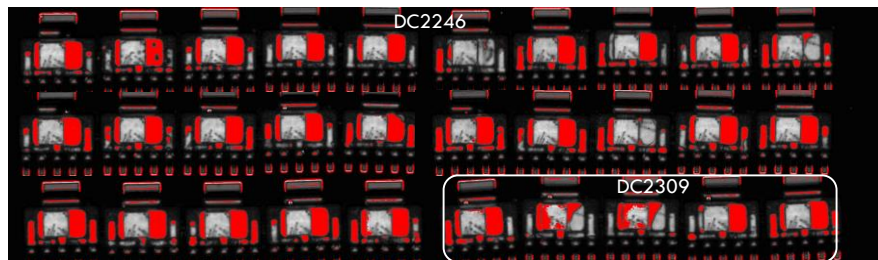
### Top echo - 100 TS

Increase of delamination especially on the bottom side (see next slide)

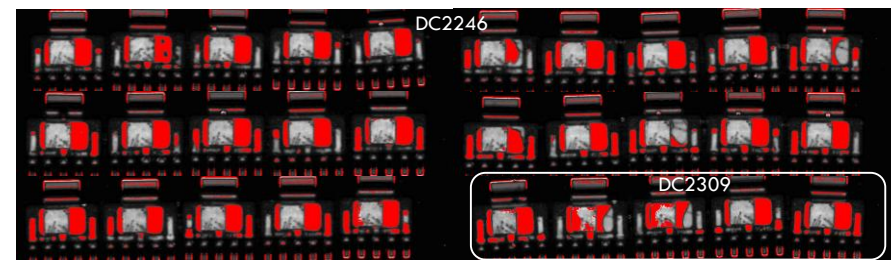
### Top echo - 600 TS

No significant increase of delamination.

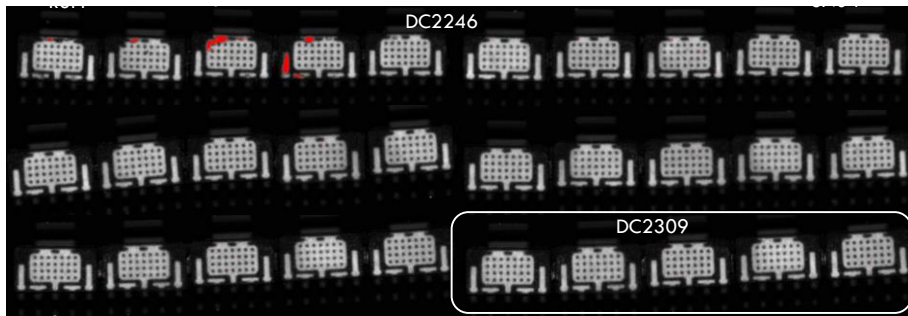
### Bottom echo - T0

Mainly no delamination

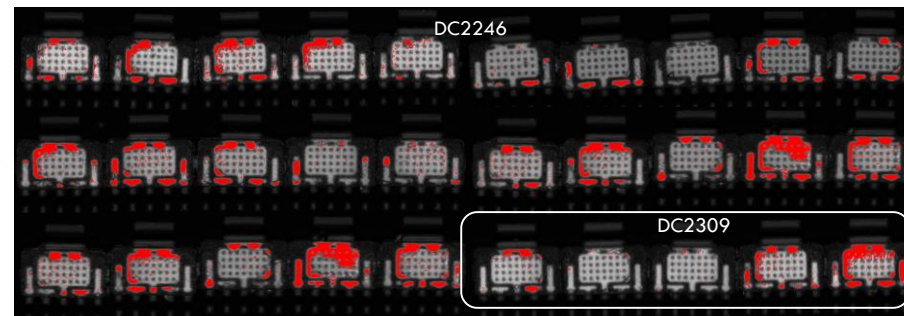
### Bottom echo - after preconditioning

Increase of delamination on bottom side

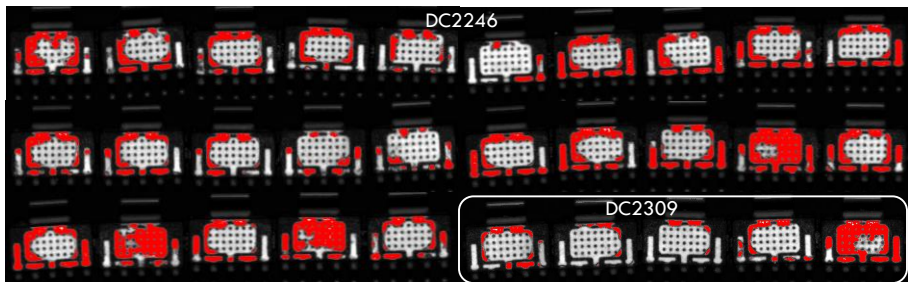
### Bottom echo - 100 TS

Increase of delamination.

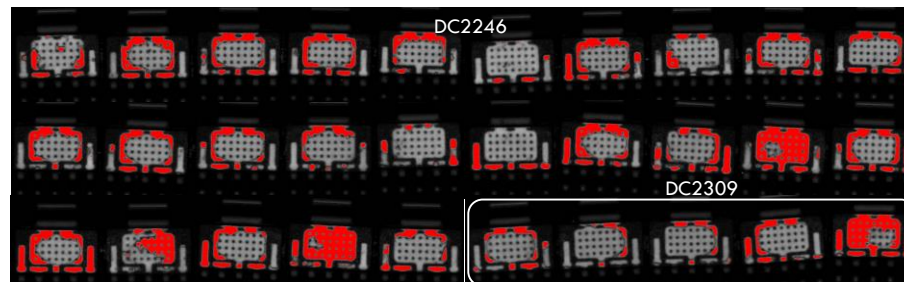
### Bottom echo - 600 TS

No significant increase of delamination.

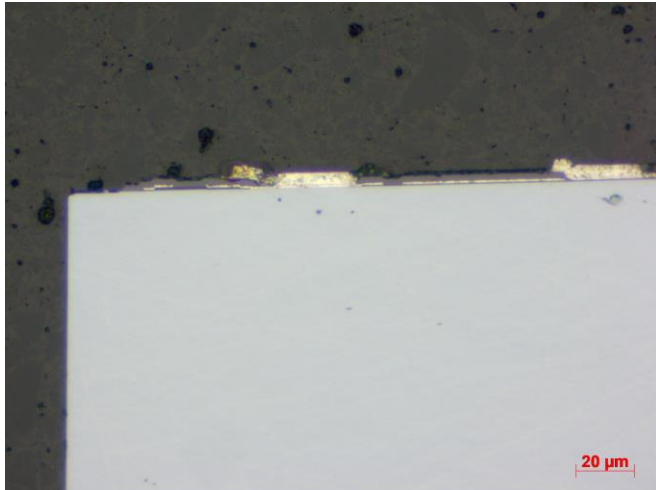
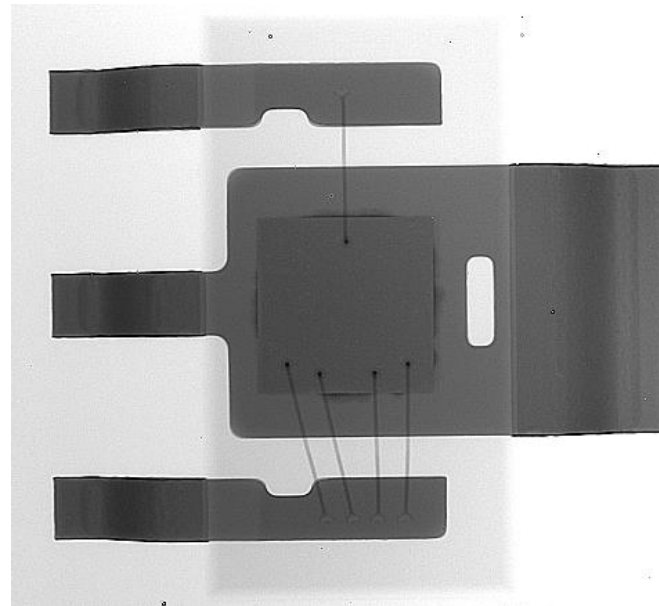
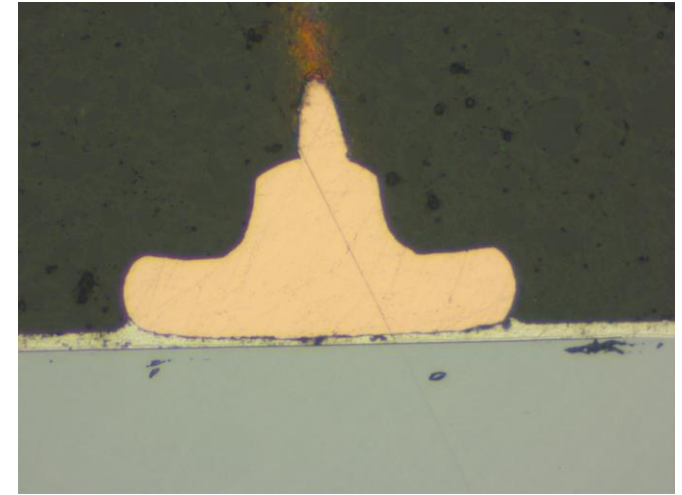
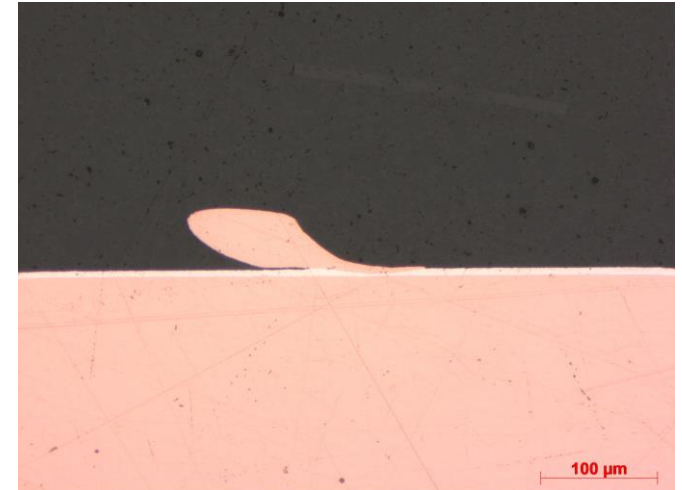
- » So far, microsections on DC 1830 SN1 and DC 9D2251 SN5
- » Die top delaminations are very significant
- » Post bonds seem fine
- » Some die bonds may have been lifted

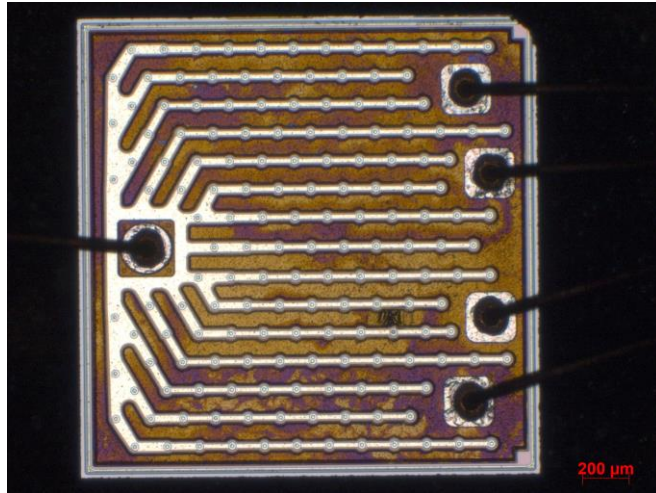
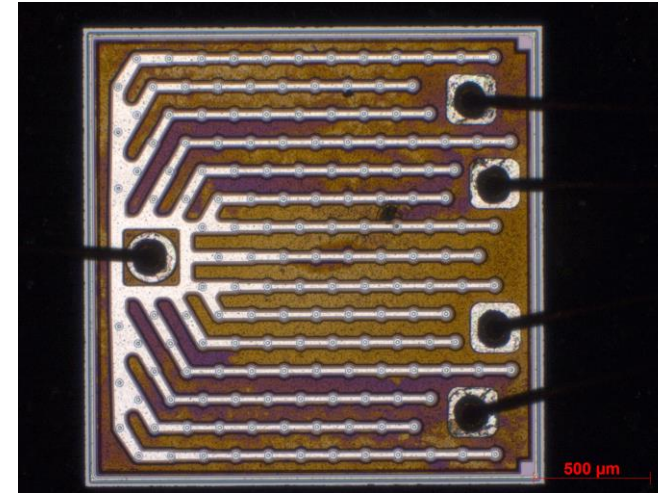
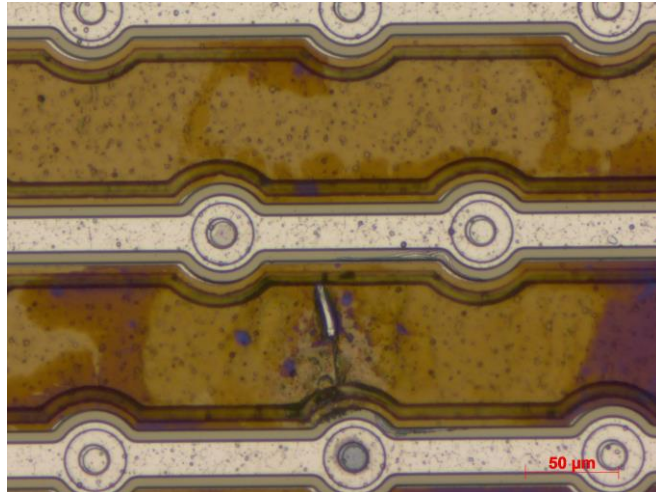
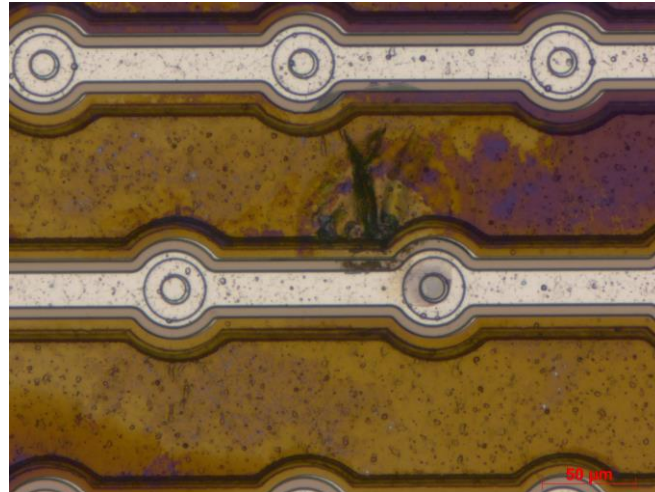
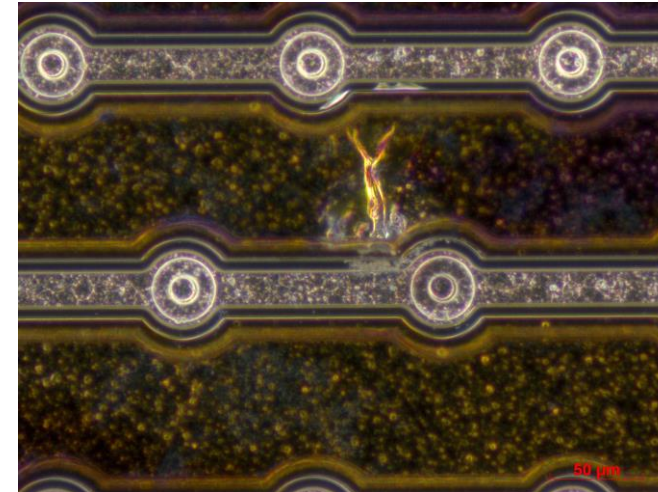
- » Decapsulation of DC2224 SN3 (left) and DC 9D2251 SN3 (right)
- » Short-circuits are clearly visible

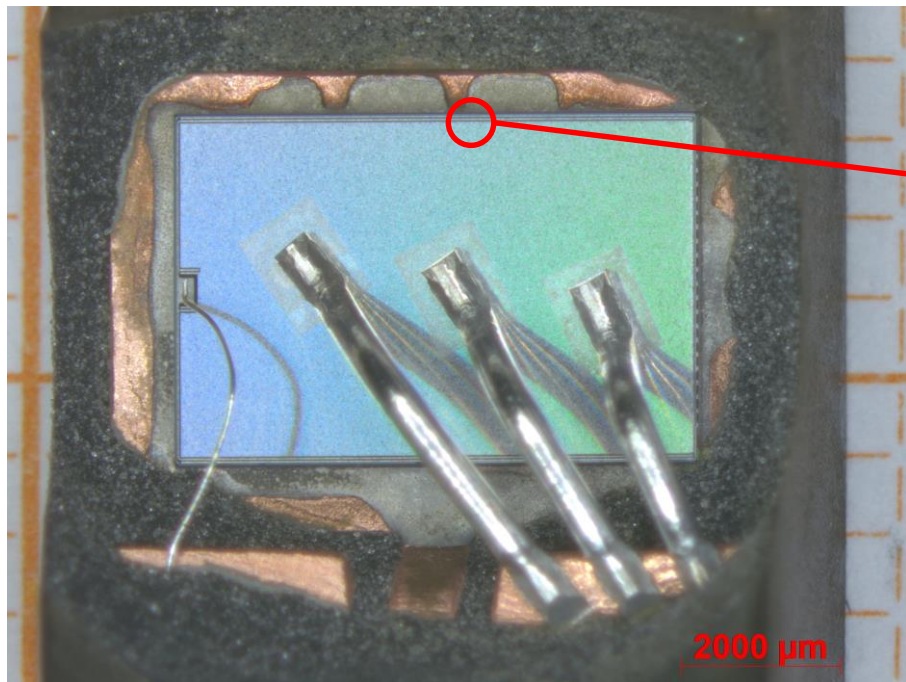
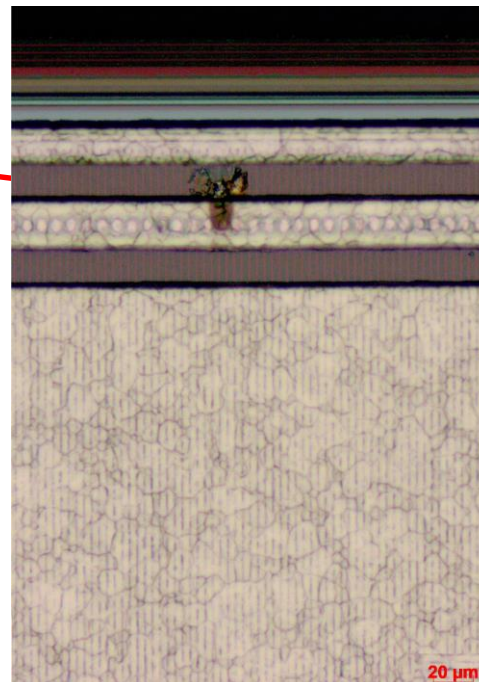
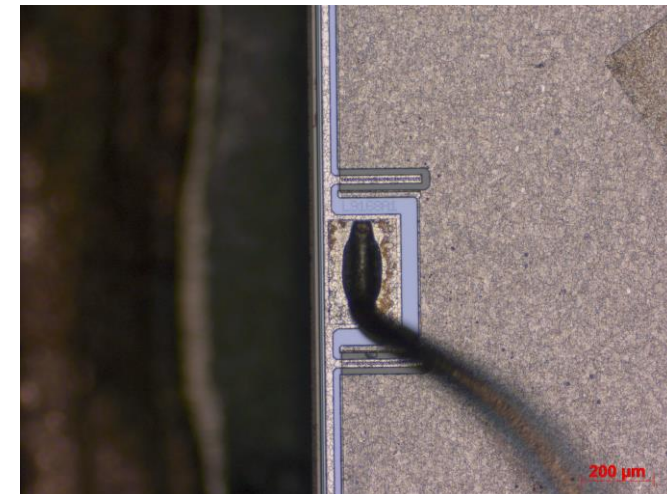
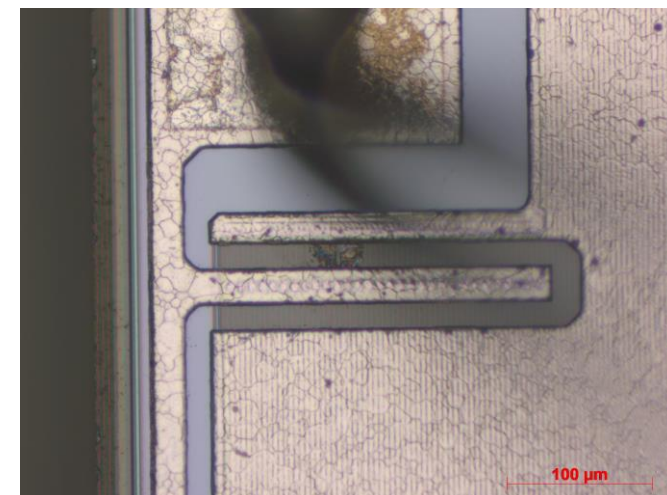
- » DC 2222 SN8 and DC 2236 SN3 have been decapsulated
- » The short-circuits are clearly visible. They are at different locations.
