## Experience and lessons learned from HALT

Aarón Nercellas Ventas, Electronics Area Manager

- Software defined radio developed by Alén Space (TRL9 - 2018)
- Core architecture based on SoC - TRX
  - Zynq-7000 SoC (28 nm) Xilinx, Linux OS
  - AD9364 Transceiver from Analog devices, 70MHz - 6 GHz
  - DDR3L 1GB, NAND Flash 1GB, 4Mb MRAM
  - PC104 form factor
  - 1TX and 1RX RF ports
  - Power consumption: 2.5W in TX mode

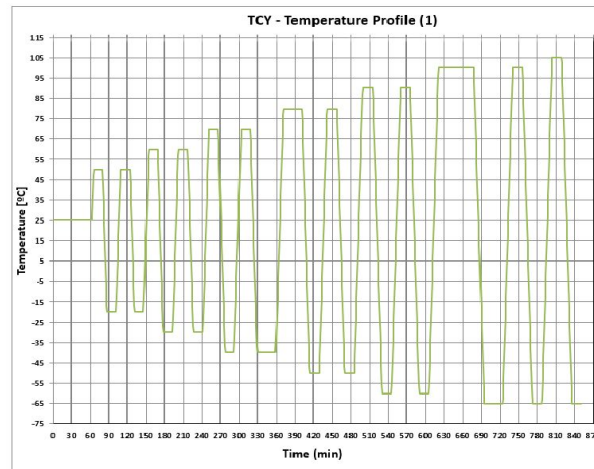
- Perform the test plan
- Adaptation to new conditions and lessons learned
  - Temperature and vibration limits were modified based on the results
    - Maximum temperature was decreased from +120°C to +105°C
      - ...too much
    - Minimum temperature was increased from -65°C to -50°C
      - After VIB + TCY, as all 4 boards failed destructively under -65°C
      - +9 cycles added to remaining board with max range to find new failure modes
    - Maximum vibration was increased from 20 gRms to 22.5 gRms

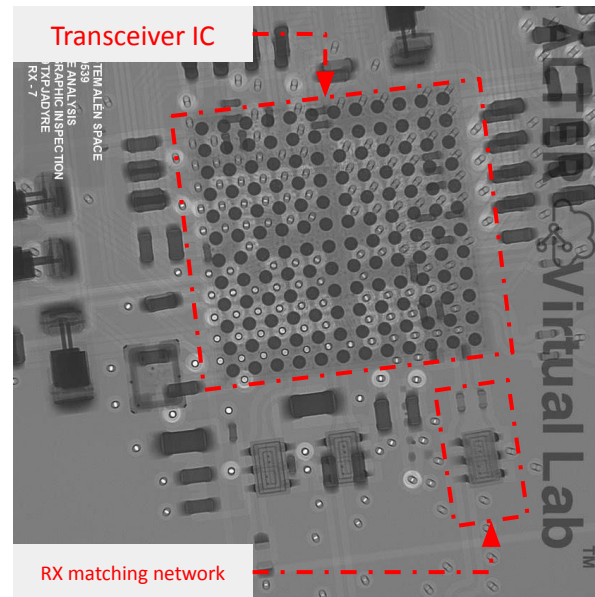
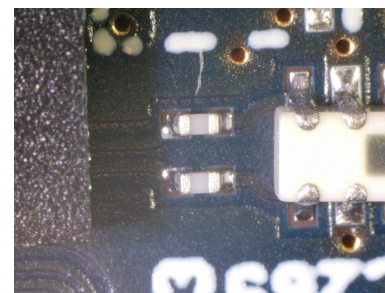
**Failure description:** The DUT does not receive packets under - 60 dBm, while the expected sensitivity level is -100 dBm **Test:** VIB + TCY and CSS test at -65°C.

- Confirmation of the anomaly with test in the laboratory
  - Destructive anomaly. Neither removing stress condition no power cycle solves de anomaly
- Hypothesis
  - Component failure before the transceiver IC.
  - Failure of the transceiver IC
- Visual inspection
  - X-ray analysis: solder cracks in BGA pads, components...

Conclusions: The transceiver IC brakes under such extreme conditions. Since this failure was systematic in multiple boards, the minimum temperature level for the test was increased from  $-65^{\circ}\text{C}$  to  $-50^{\circ}\text{C}$ .

- Replace rx matching network → Replace of transceiver IC
  - Sensitivity level is restored.
    - **Anomaly solved**

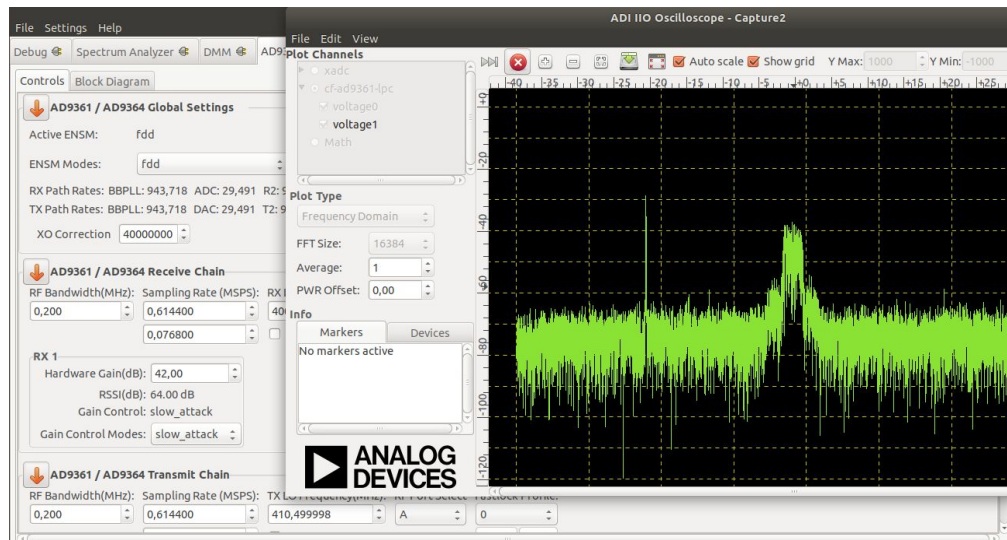
Failure description: FE\_AN\_IN0 outside of range while the rest of parameters are in range. Several boards affected.

1. Confirmation of the anomaly in the laboratory
  - a. Non destructive anomaly that cannot be replicated in the laboratory
2. Investigation analysis
  - a. Replication of set up
  - b. Extend test operational time to make TOTEM heat up
  - c. Exchange all data from the test with ALTER and try to correlate the out of range condition with other parameters
3. Conclusions
  - a. The anomaly could not be replicated in the lab. Data analysis did not yield valuable insight.
  - b. Possible causes
    - i. Set up: this specific analog value was read with a loopback
