ALTER |   **ACCEDE | ESCCON**  
**2025** Seville - Spain  
25 to 27<sup>th</sup> March

**ATCOS GSTP Study: Alternative Test Methods for COTS – Test Results**

# Study goal

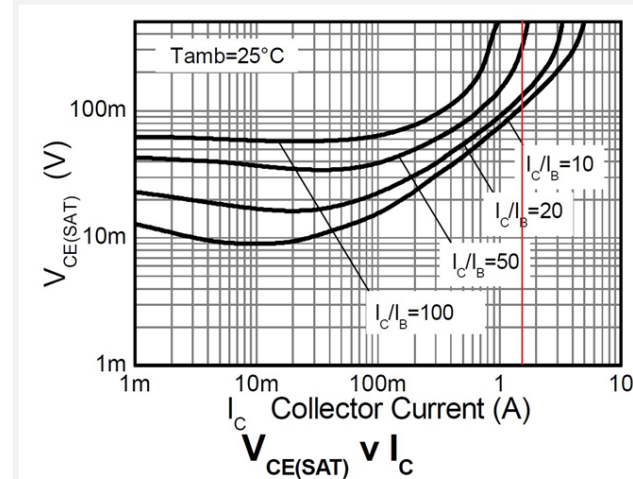
- **Results of electrical testing:**
  - No failures found
  - Found error in one transistor data sheet:  
VCE(sat)(max) listed as 200 mV in one place, 300 mV in another

All parts are fail at the last VCE(sat) parameter, for which a maximum of 200 mV, measured with I<sub>C</sub> = 1.5 A, I<sub>B</sub> = 20 mA, I<sub>C</sub>/I<sub>B</sub>=75, is given in the "Electrical Characteristics" table in the data sheet.

However, according to the "Typical Electrical Characteristic Diagram" in the data sheet, a typical value much higher than 200 mV is given. (See below, test condition I<sub>C</sub> = 1.5 A is marked in red). The typical value for I<sub>C</sub>/I<sub>B</sub>=75 should be higher than 300 mV.

Measured values of VCE(sat) at these conditions vary between 0.692 and 1.373 V, which is a typical, inconspicuous range of values.

We suspect the limit of 200 mV is erroneous.

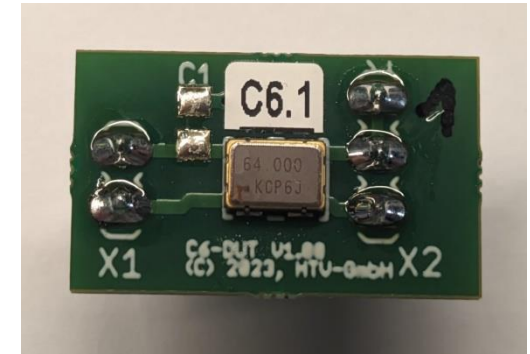
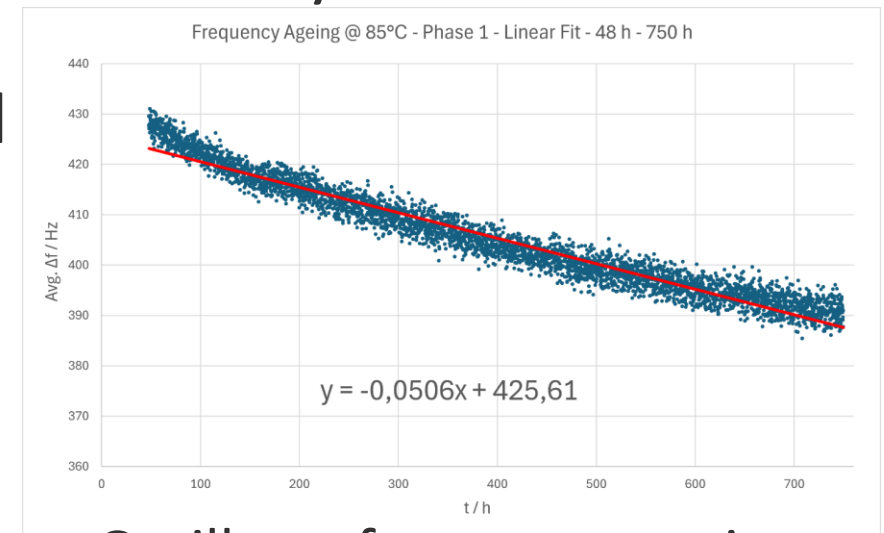
Oscillator frequency ageing

- No catastrophic failures
- Sometimes, large tolerance windows listed in data sheets – component performance generally well within range
- Parametric failure of inductor – inductance increased by ~ 12% during test, exceeds max limit
- Line regulation of power module not as good as expected from data sheet “typical value”
- Oscillator (64 MHz, specified as +/- 50 ppm) performed very well
  - <1 ppm change during 1500 h @ 85°C
  - <2 ppm change during shock and vibration

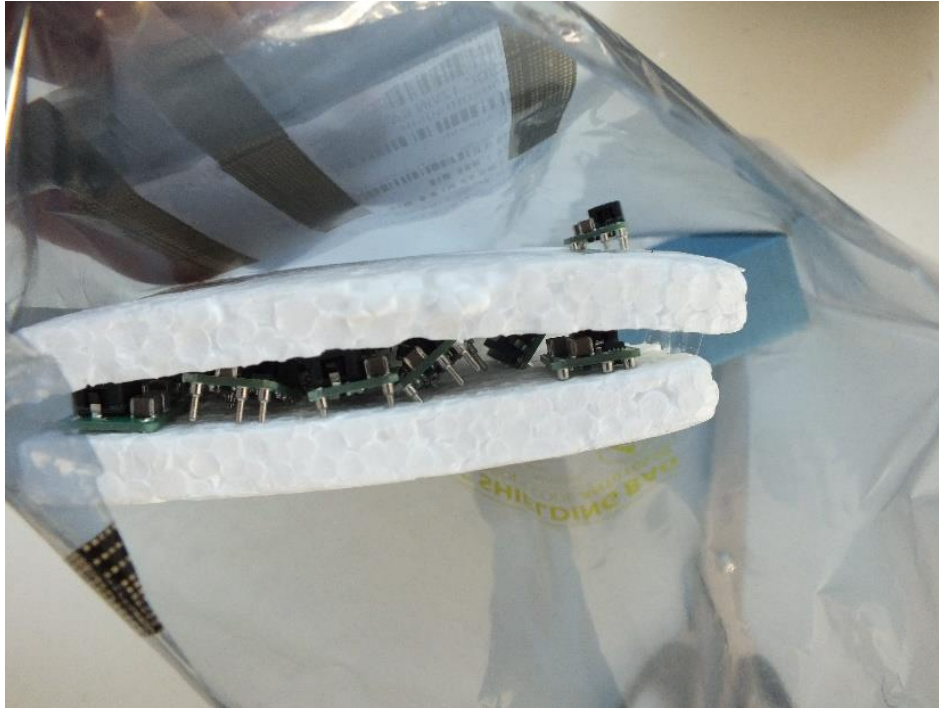
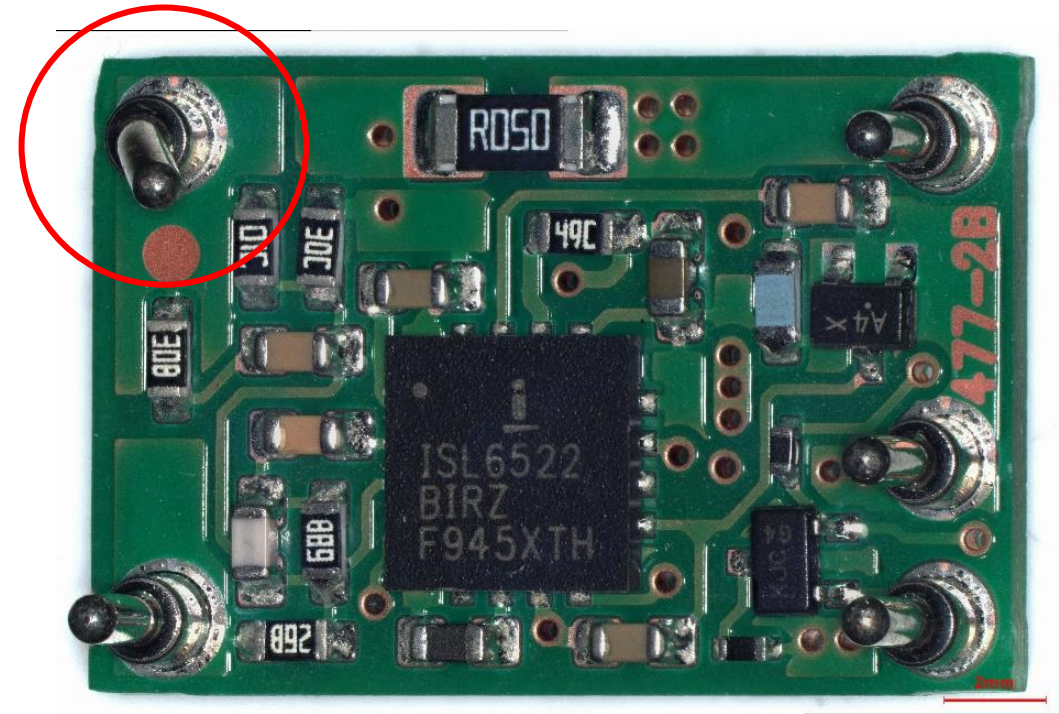
Styrofoam packaging is not ESD safe

-

and leads to bent pins

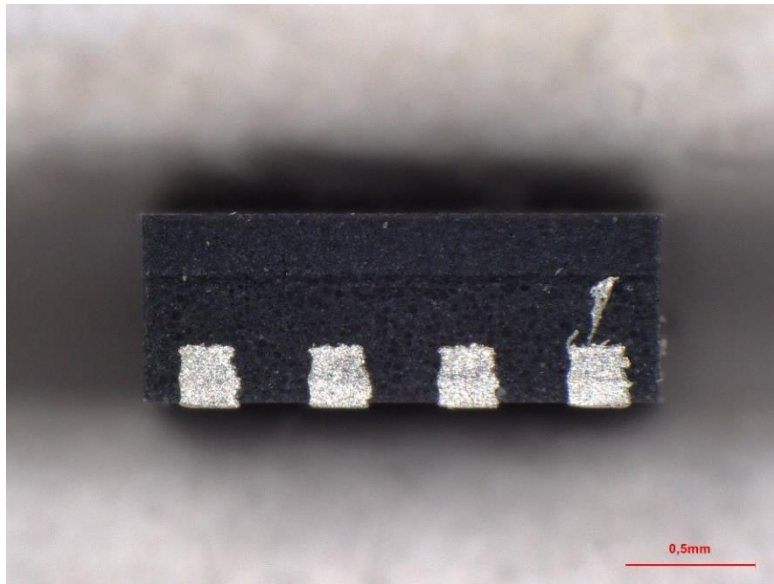
Metallisation particle

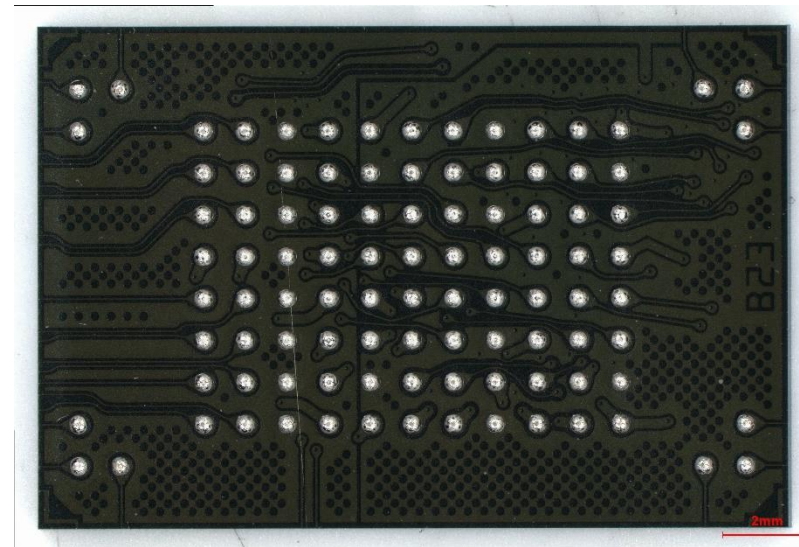
scratch

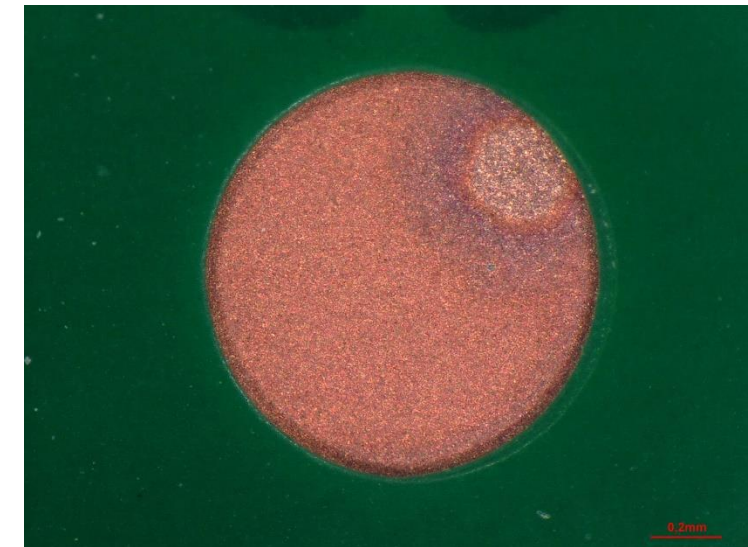
corrosion

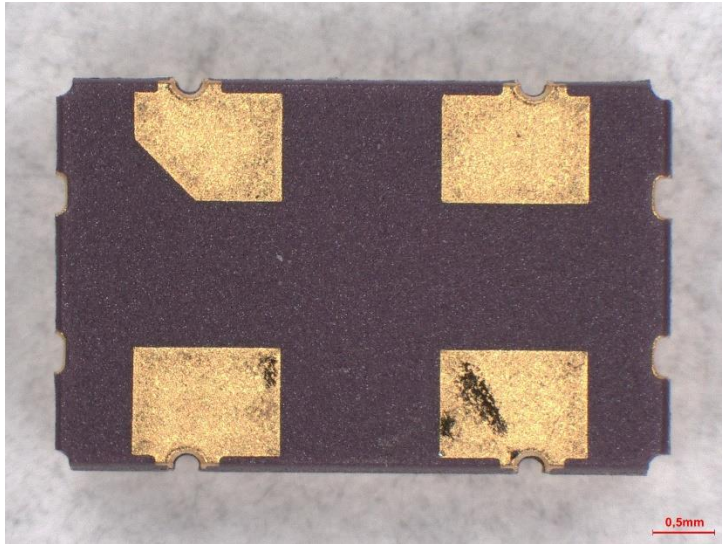
contamination

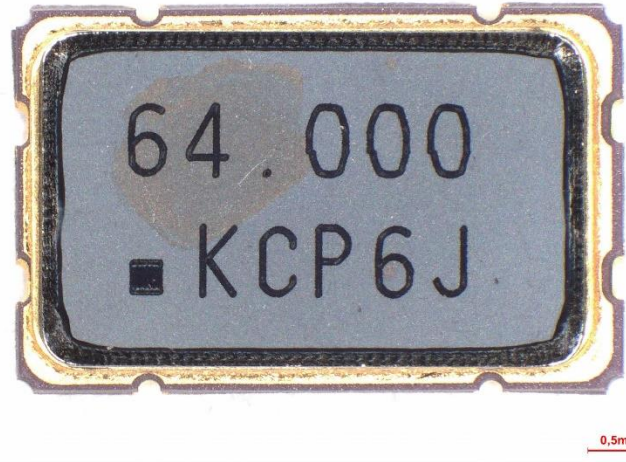
discoloration

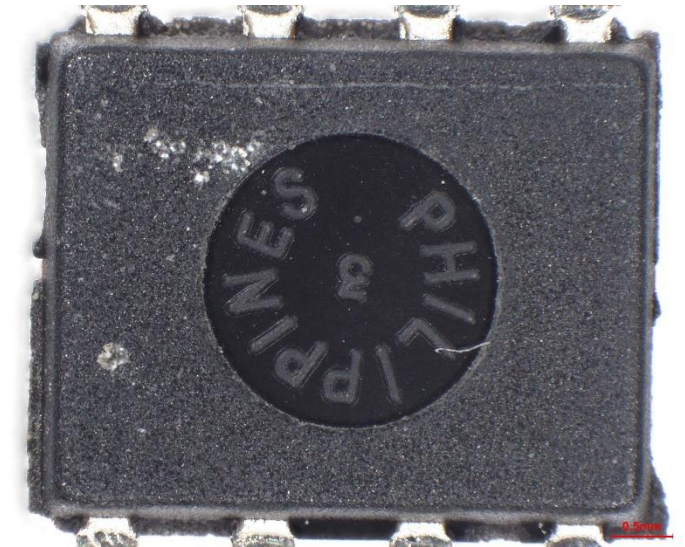
contamination

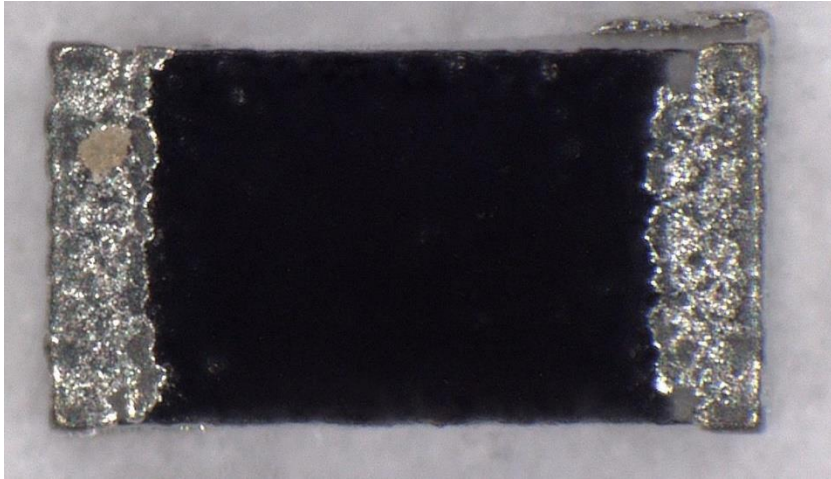
contamination

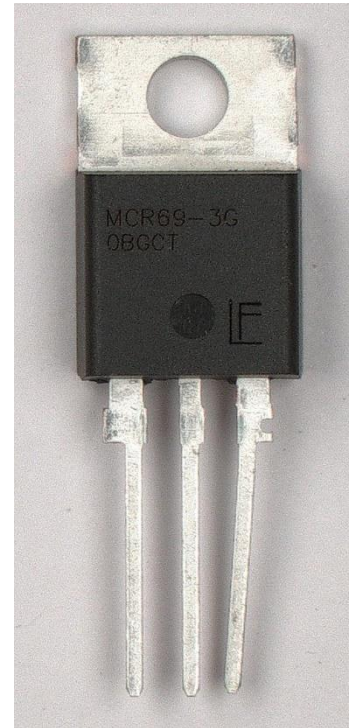
Bent pin

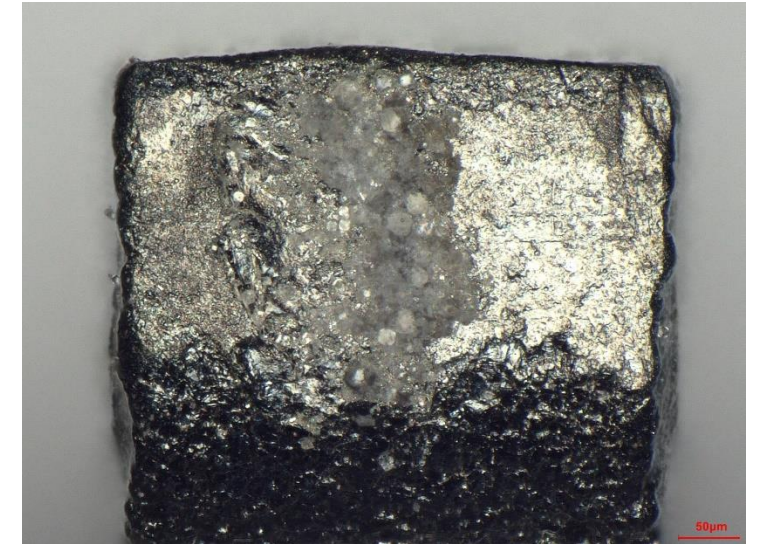
Corrosion on pin

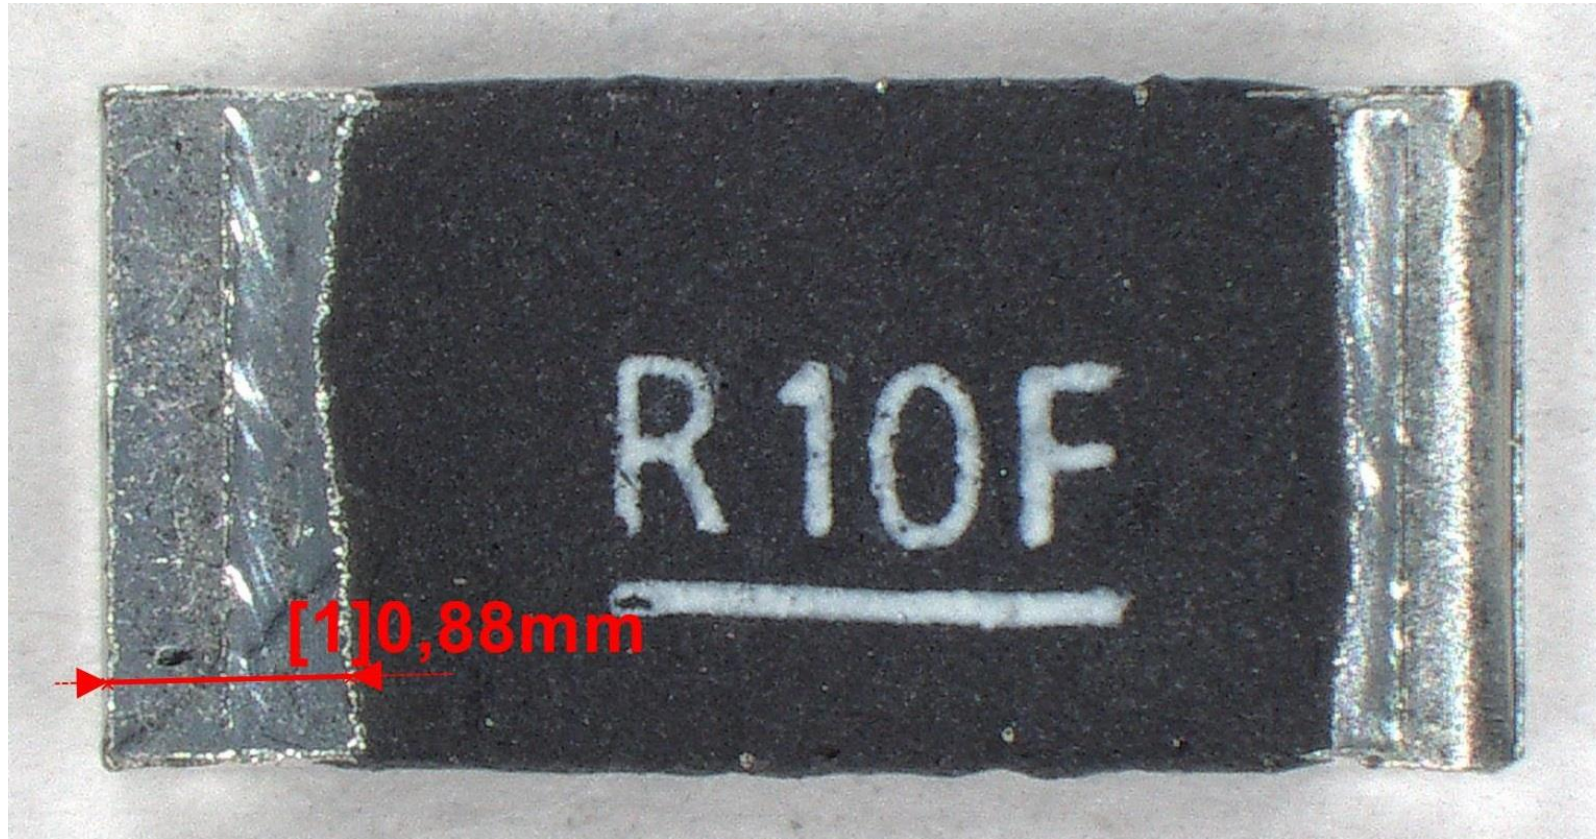
Cap metallization exceeds data sheet limit -  $T_{max}=0.762$  mm
