## **ESA/ SCC QUALIFICATION REPORT FOR**

### **NTC THERMISTOR PART TYPES:**

**ESA/SCC      4006/013 & 4006/014**

**Actual Causes of Non Conformance – NCCS. 2IEBET901**

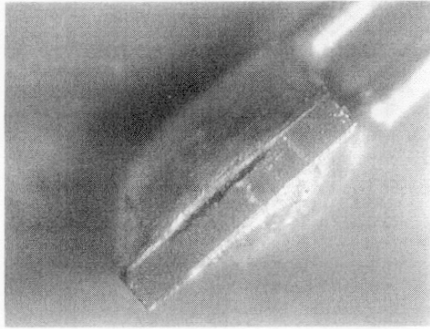
**SAMPLE A**

#### **Sample A : (Void in centre of edge )**

This part has the void in the centre of the chip along the edge of the ceramic / metallisation bond. Where the ceramic meets the metallisation there are eight edges. One of these edges shows a void. It appears that the metallisation has partially lifted away from the ceramic.

It is possible that the void was caused by damage to the metallization / ceramic layer during dicing . This would have been further exaggerated during the soldering process. However due to the limited inspection equipment it was not possible to determine fully what caused these defects. It was agreed to send these two parts to the Component Laboratory in ESTEC for further analysis.

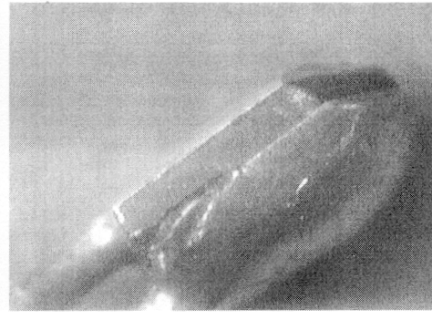
**SAMPLE B**

#### **Sample B: (Void at corner of chip)**

This part has the void at the corner of the chip along the edge of the metallisation / ceramic.
