Total Dose and Single Event Effects in Commercial PWM's and Gate Drivers

Contract 11407/95/NL COO10 RUAG Report No: D-P-RAD-01218-SE ESA Report No: ESA_QCA0822S_C

RUAG Aerospace Sweden

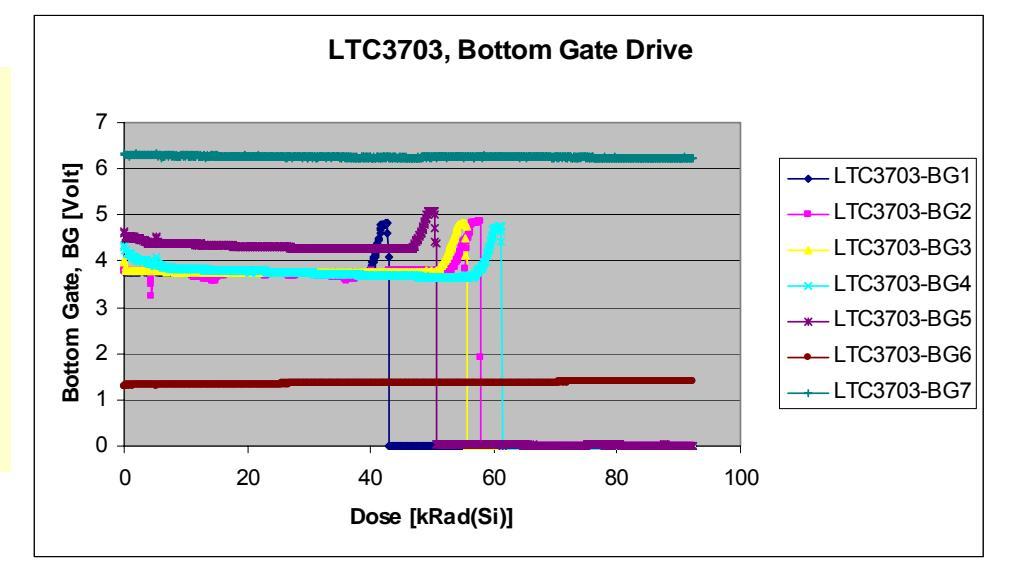
> LTC3707 BiCMOS

Biased; failed ~ 40-60 krad(Si), no recovery during high temperature anneal

Unbiased: no degradation to 80 krad(Si)

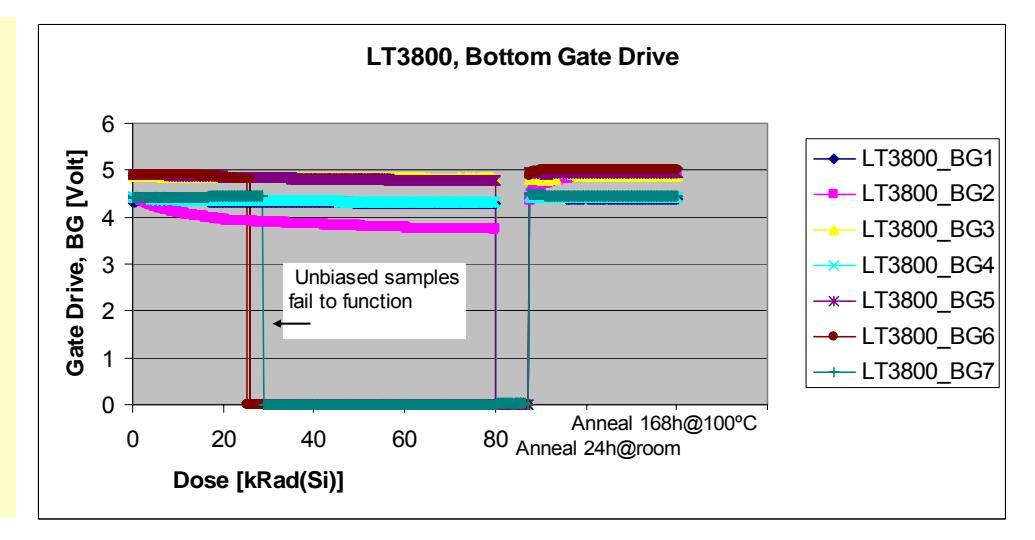
•LT3800 Bipolar

Biased; worked up to 80 krad(Si), fail to start after power-off at end of irradiation

Unbiased; fail to function ~ 25 krad(Si)

Biased & Unbiased samples recovered during high temperature annealing.

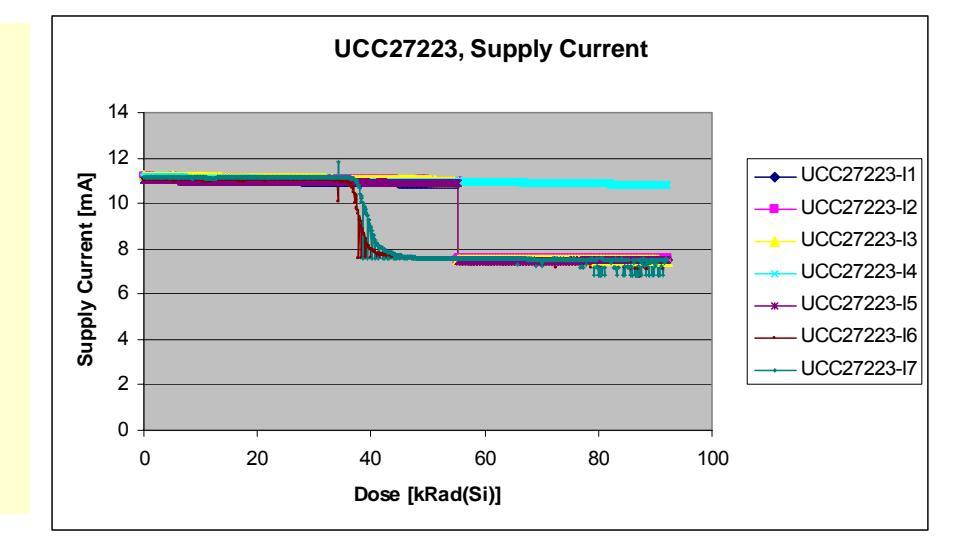
UCC27223 BiCMOS

Biased; functioning up to 55 krad, after planned power break, 4 of the 5 samples failed to work.

Unbiased; failed before 40 krad

No samples recovered in high temperature anneal

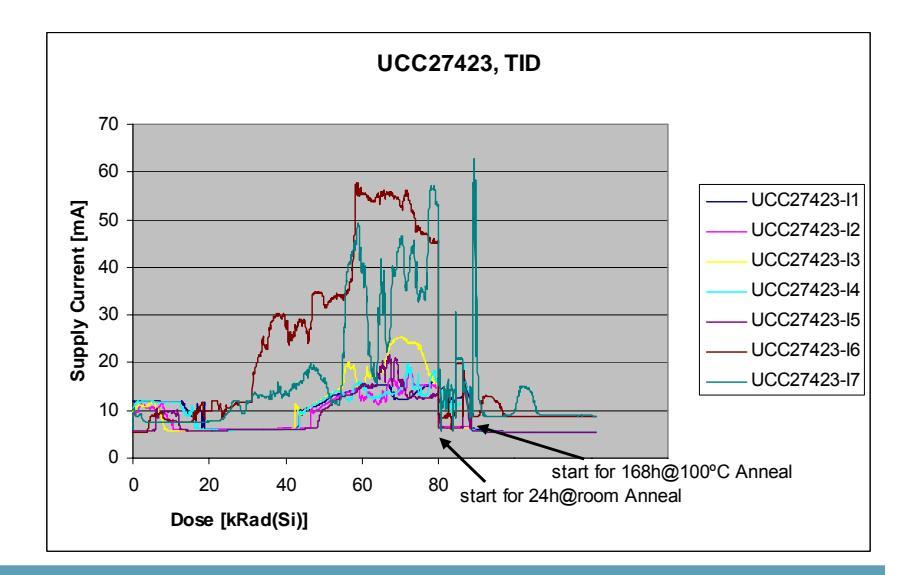
•UCC27423 BiCMOS

Biased; current increase, no failure up to 80 krad

Unbiased; current increase, failure ~75 krad

All samples functioned after anneal

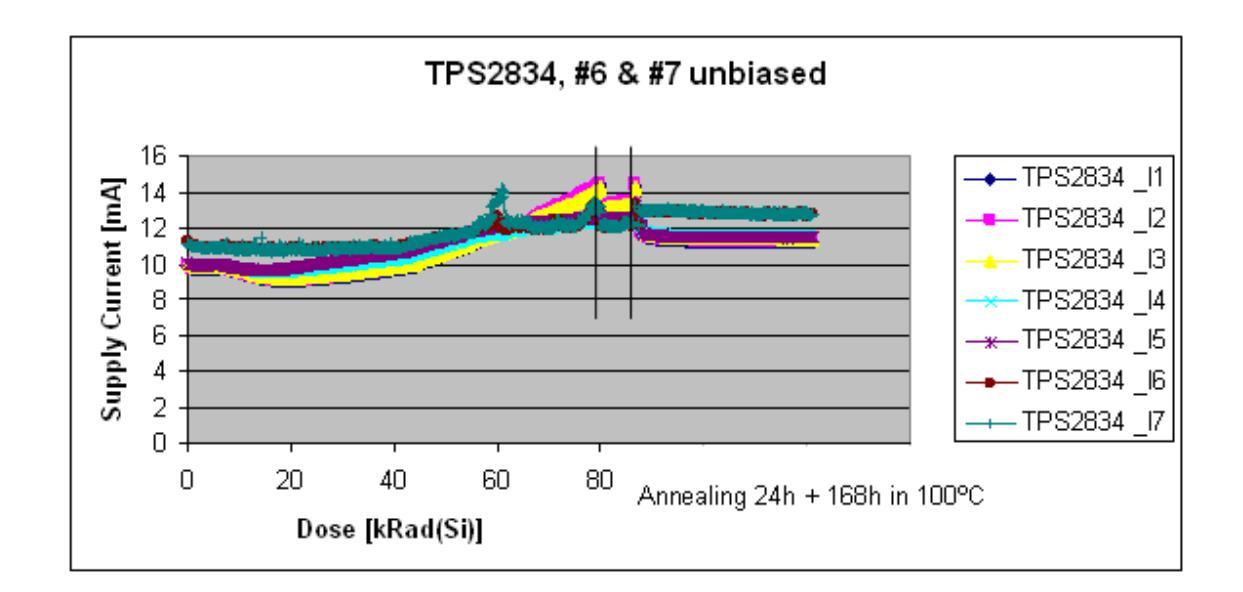
• TPS2834 BiCMOS

Biased; current increase, functioning up to 80 krad

Unbiased; current increase, functioning up to 80 krad

Current recover after high temp anneal

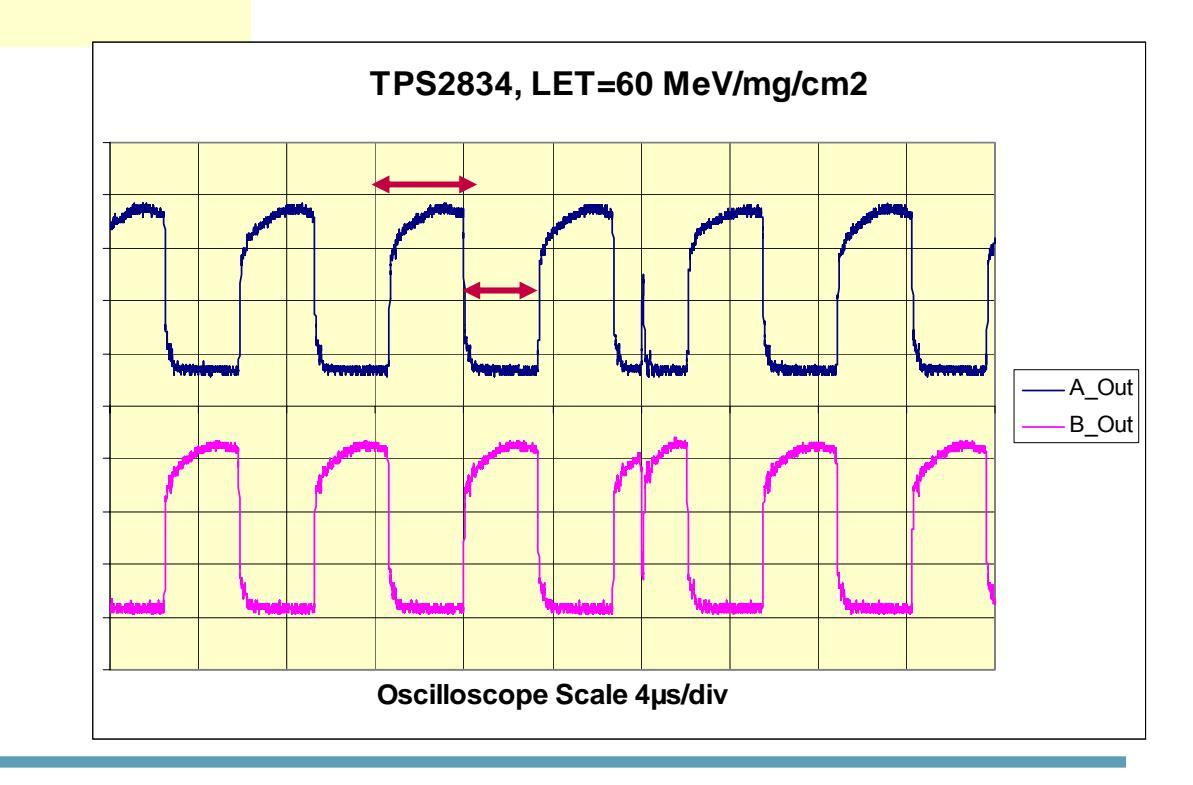
> **TPS2834**

No LU (LET=80 MeV/mg/cm2)

Only very short glitches observed up to LET=80 MeV/mg/cm2

Only narrow glitches were detected for TPS2834

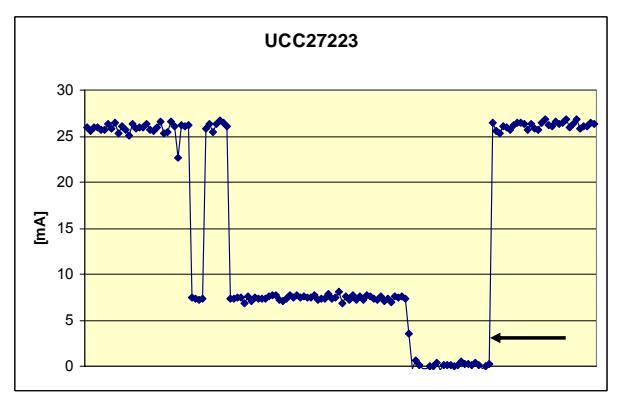
> UCC27223

LU observed at LET=32 MeV/mg/cm2

SEFI first detected at LET=3,6 MeV/mg/cm2

Very SET sensitive with long periods of lost pulses

Current jumps caused by irradiation. The arrow indicates where a reset has been performed by switching off - on the pulse generator to the input

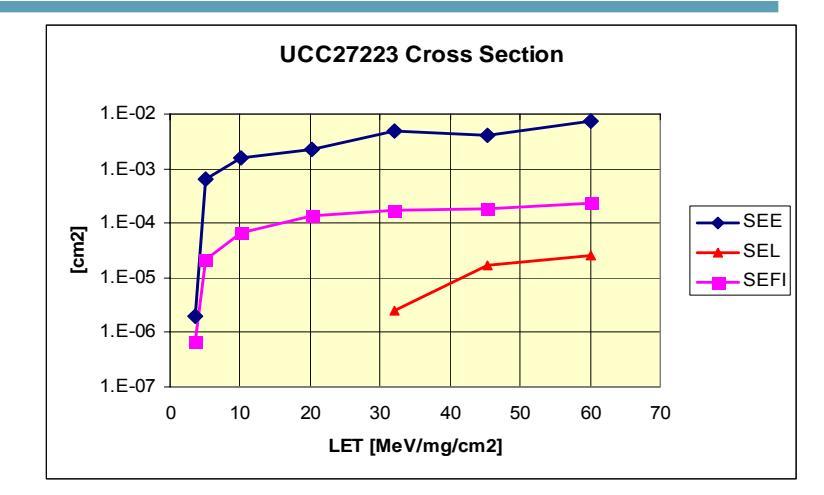
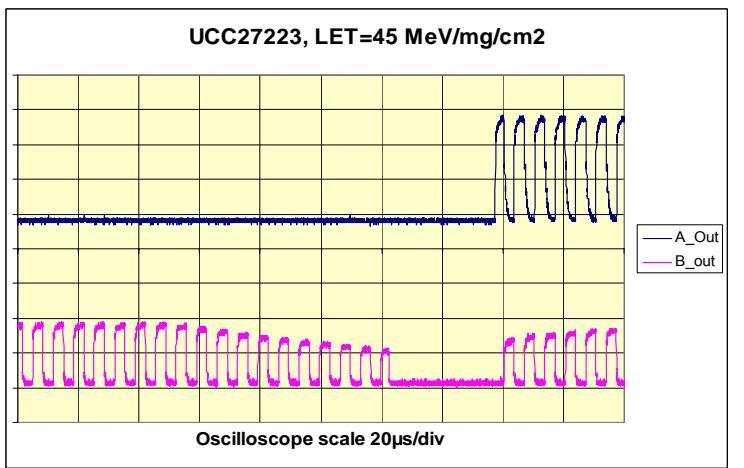
Oscilloscope picture of output A and B showing worse case errors observed during irradiation with Kr-ions tilted at 45° (Let=45.4 MeV/mg/cm2).

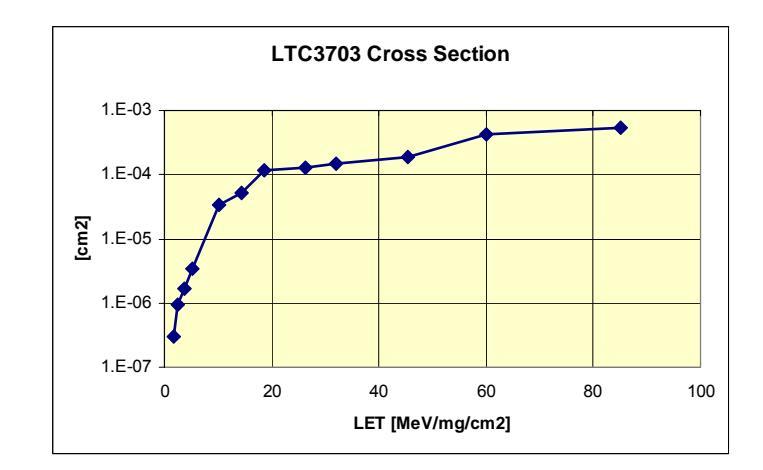
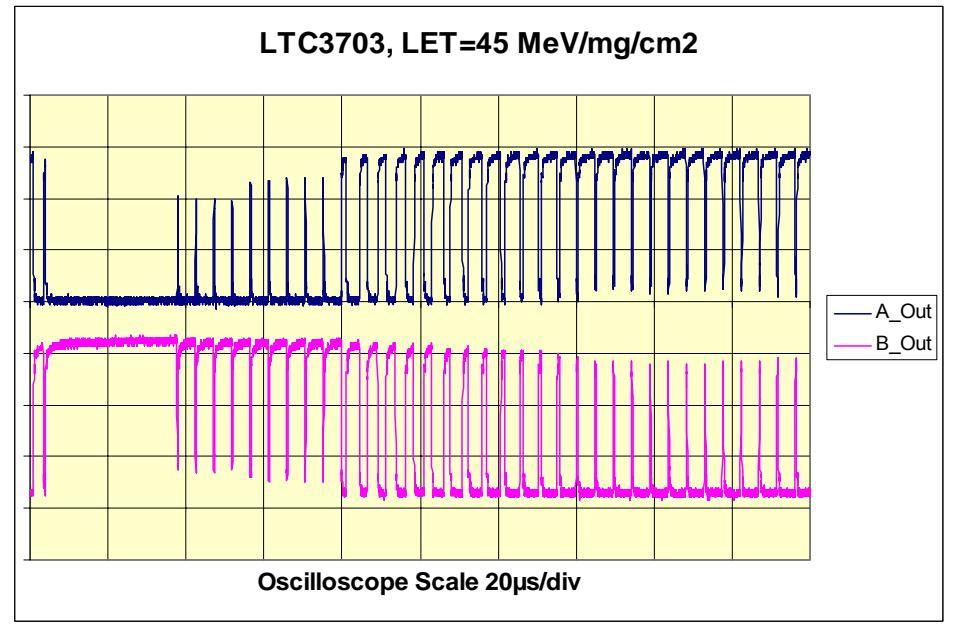
> LTC3707

No LU (LET=80 MeV/mg/cm2)

Very SET sensitive with long periods of lost pulses

Typical oscilloscope picture, data at 82Kr tilted at 45°, similar behaviour observed for 40 Ar (LET=10 MeV/mg/cm2).

The period time for the PWM was 4.6 $\mu s.$ oscilloscope triggered on A Out OFF-time criteria too long

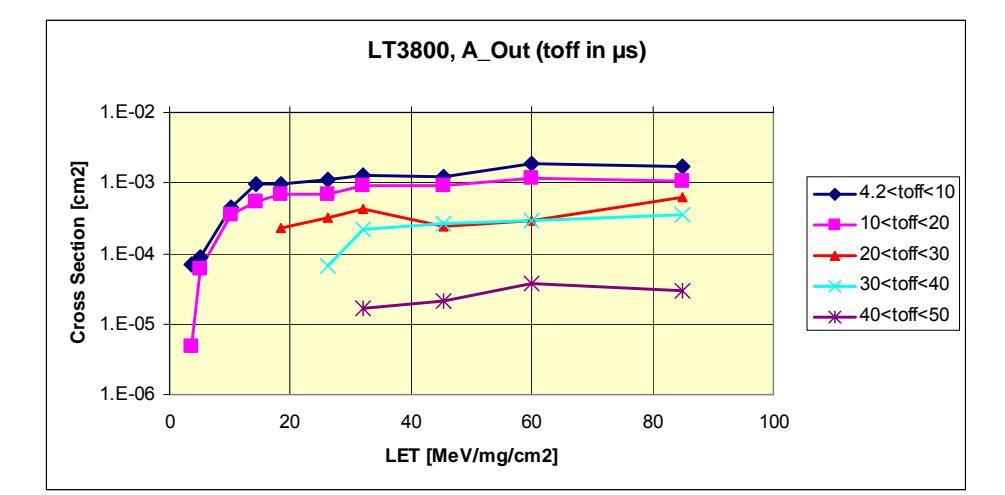
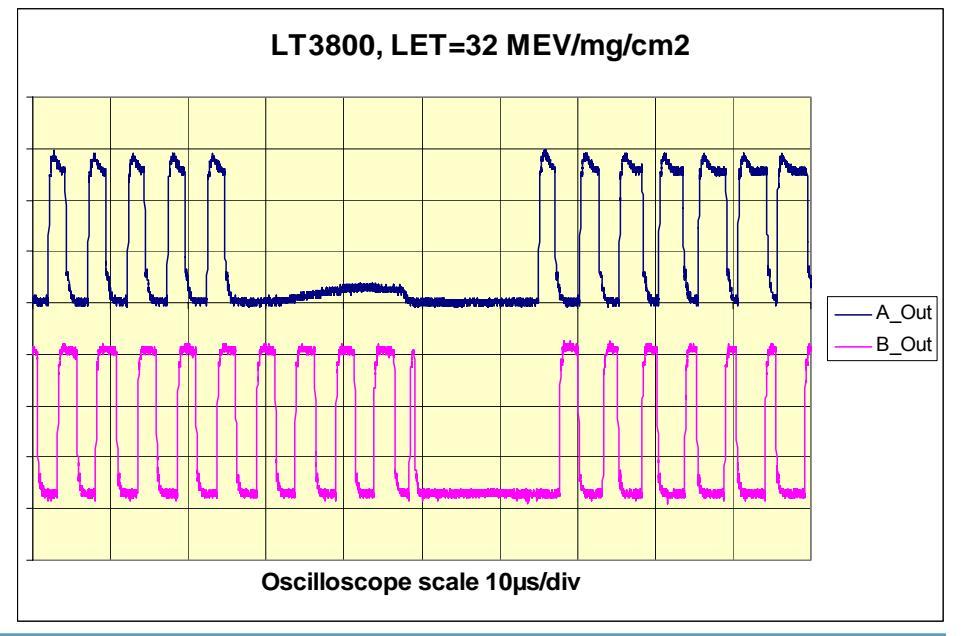
> LT3800

No LU (LET=80 MeV/mg/cm2)

Very SET sensitive with long periods of lost pulses

Typical oscilloscope picture for OFF time too long on output A and B at the same time. Oscilloscope triggered on A Out

The period time for the PWM was 4.8 μ s.
