Plated Through Reliability and Material Integrity Results for 24 Materials Processed Through Lead Free Assembly

Bill Birch PWB Interconnect Solutions Inc.

5th EMPPS Workshop

May 20, 2014

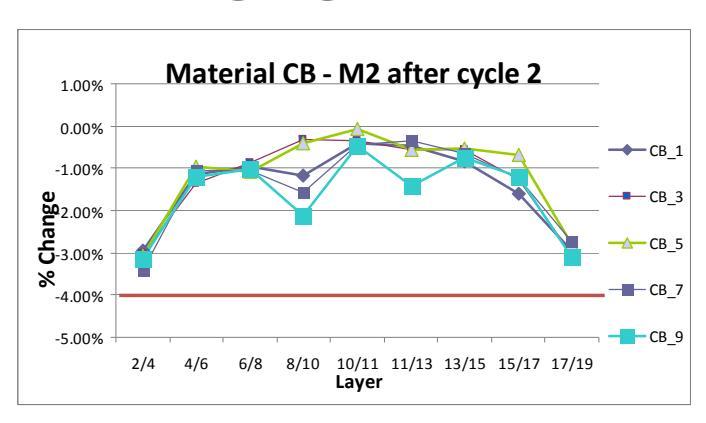
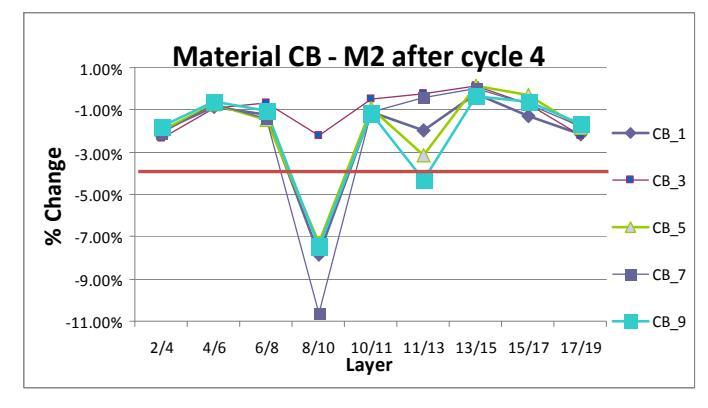
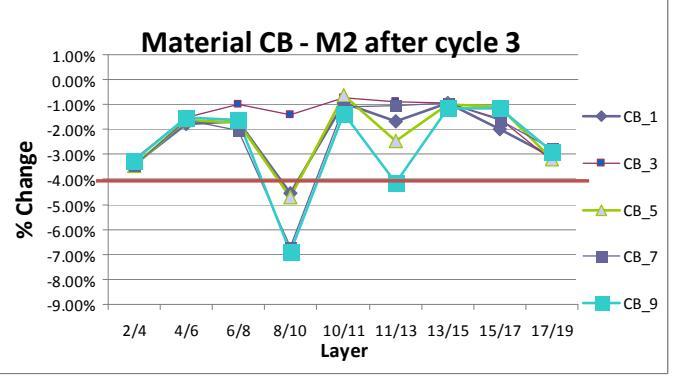
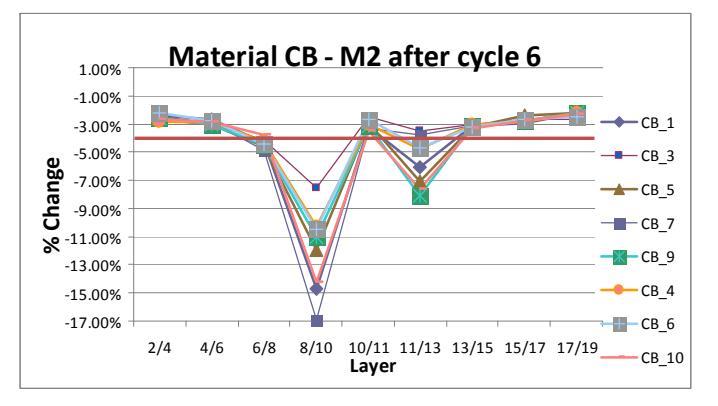
Non-Robust Material Through 6X 260°C

Reflow #2

Reflow #4

Reflow #3

Reflow #6

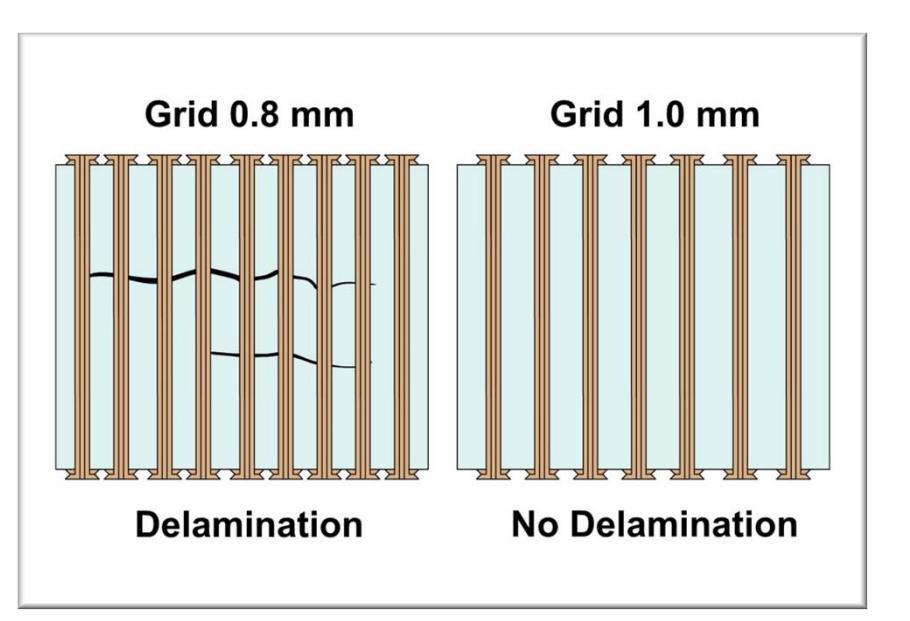
Material Damage After 6X 260°C

Presence of Material Damage												
Material Type	.032" Grid	.040" Grid										
	FR4:											
А	None	None										
AB	None	None										
В	None	None										
BB	None	None										
H	Halogen Free FR4:											
С	Present	None										
CB	Present	None										
D	Present	None										
DB	Present	Present										
E	None	None										
EB	Present	Present										
F	Present	Present										
FB	Present	Present										
G	Present	None										
GB	Present	Present										
Н	None	None										
HB	None	None										
Hig	gh Speed Materials:											
Ι	Present	None										
IB	Present	Present										
J	Present	None										
JB	Present	Present										
K	Present	None										
KB	Present	None										
L	None	None										
LB	None	None										
Damaged Material	15/24	8/24

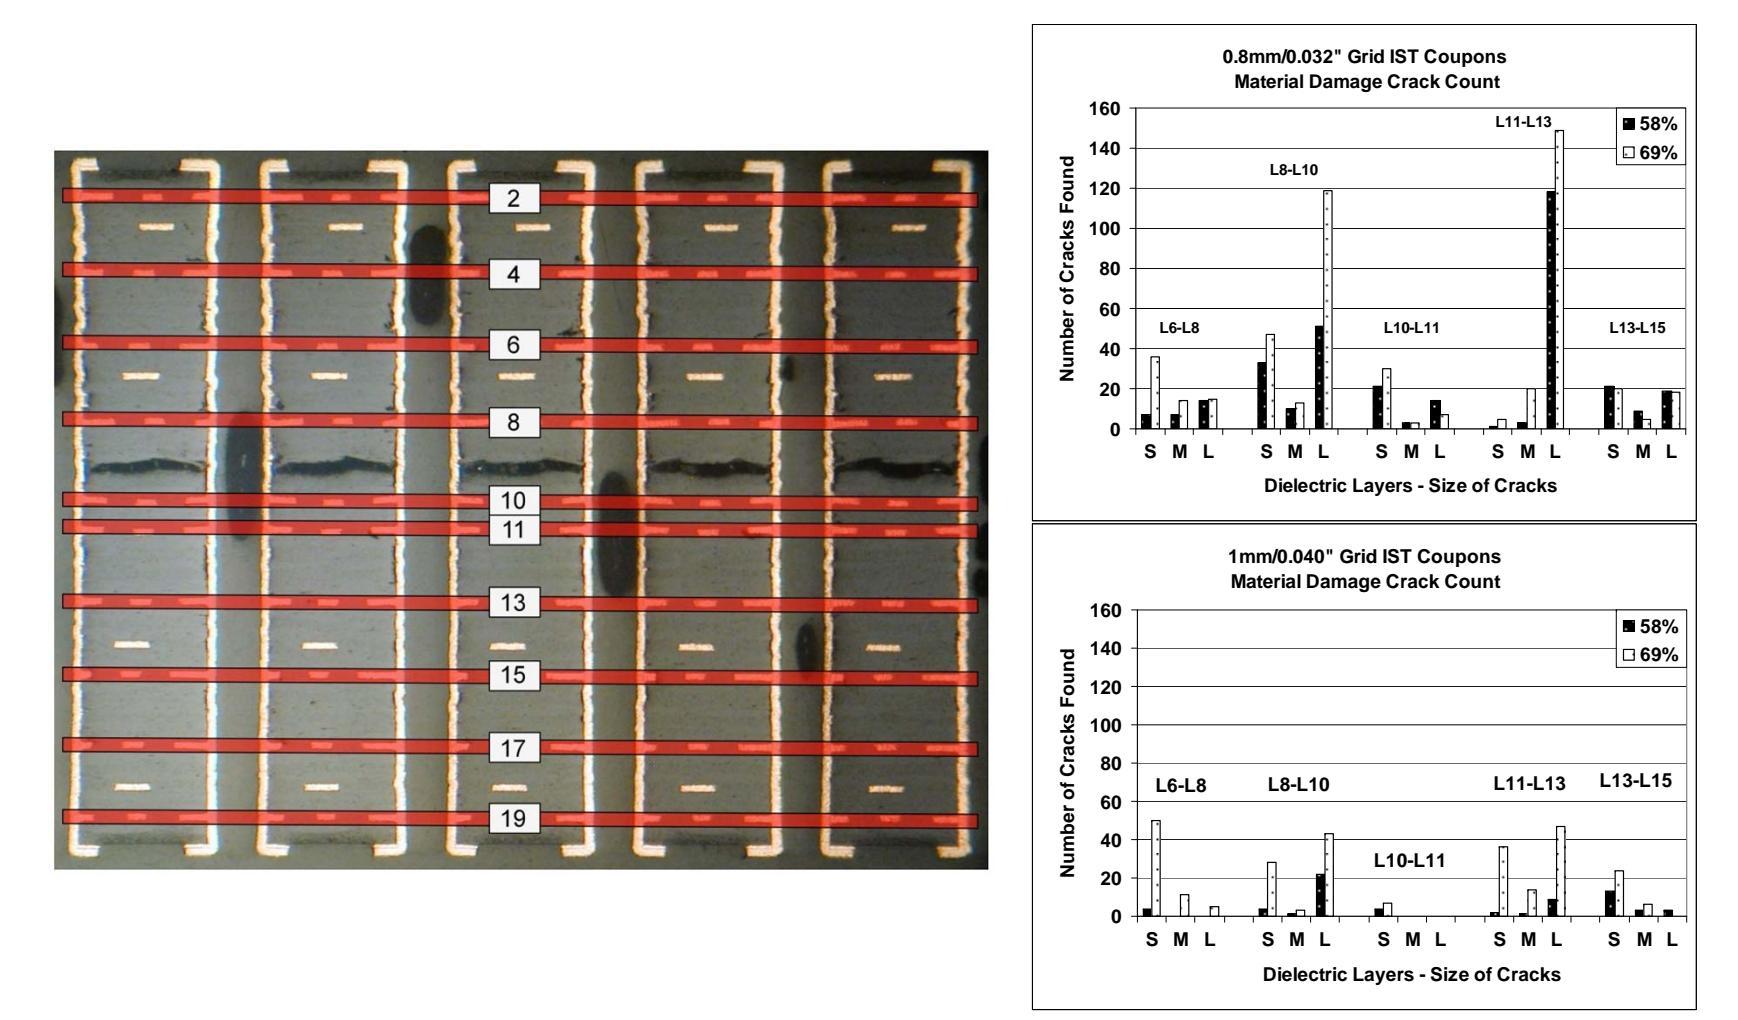
Material Damage Crack Count

Crack Count vs. Electrical Data on .032"/0.8mm Grid Coupons																																			
Layer		2/4				4/6				6/8			5	8/1	0		1	0/1	1		1	1/1	.3		1	3/1	5		1	5/1	.7		1	7/1	9	
R32 Coupons	S	М	L		S	М	L		S	М	L		S	М	L		S	М	L		S	М	L		S	М	L		S	М	L		S	М	L	
А	0	0	0		0	0	0		0	0	0		0	0	0		0	0	0		0	0	0		0	0	0		0	0	0		0	0	0	
AB	0	0	0		0	0	0		0	0	0		0	0	0		0	0	0		0	0	0		0	0	0		0	0	0		0	0	0	
В	0	0	0		0	0	0		0	0	0		0	0	0		0	0	0		0	0	0		0	0	0		0	0	0		0	0	0	
BB	0	0	0		0	0	0		0	0	0		0	0	0		0	0	0		0	0	0		0	0	0		0	0	0		0	0	0	
С	0	0	0		0	0	0		0	0	0		0	0	8	>	1	0	0	>	0	0	23	>	0	8	0	>	0	0	0		0	0	0	
СВ	0	0	0		0	0	0		2	0	2	>	0	1	28	>	0	0	0		2	0	1	>	0	0	1	>	0	0	0		0	0	0	
D	0	0	0		0	0	0		6	1	0	1	0	2	10	✓	0	0	10	✓	1	0	3	>	0	0	0		0	0	0		0	0	0	
DB	0	0	0		0	0	0		0	1	0	>	0	2	14	>	0	2	3	✓	0	5	16	>	0	5	1	>	0	0	0		0	0	0	
E	0	0	0		0	0	0		0	0	0		0	0	0		0	0	0		0	0	0		0	0	0		0	0	0		0	0	0	
EB	0	0	0		0	0	0		0	4	4	>	0	0	18	>	0	0	0		2	0	19	>	5	0	9	>	0	0	0		0	0	0

F	0	0	0		10	0	0	x	0	6	7	1	0	3	12	✓	0	0	0		0	0	32	>	12	0	0	✓	0	0	0		0	0	0	
FB	13	0	0	X	22	2	0	X	13	0	3	>	0	2	14	>	0	0	0		0	3	20	>	4	0	0	>	0	0	0		0	0	0	
G	0	0	0		0	0	0		0	0	0		0	5	9	>	0	3	4	>	0	0	7	>	2	1	2	>	0	0	0		0	0	0	
GB	0	0	0		0	0	0		12	4	1	1	0	2	25	✓	0	1	3	✓	0	12	7	✓	7	0	0	✓	0	0	0		0	0	0	
Н	0	0	0		0	0	0		0	0	0		0	0	0		0	0	0	0	0	0	0		0	0	0		0	0	0		0	0	0	
HB	0	0	0		0	0	0		0	0	0		0	0	0		0	0	0	0	0	0	0		0	0	0		0	0	0		0	0	0	
I	0	0	0		0	0	0		1		1	>	0	0	5	>	0	0	0	0	0	3	10	>		0	5	>	0	0	0		0	0	0	
IB	0	0	0		0	0	0		0	4	5	>	0	6	18	>	7	0	1	✓	0	0	28	>	2	0	0	>	0	0	0		0	0	0	
J	0	0	0		0	0	0		0	0	6	>	27	0	0	>	19	0	0	✓	0	0	31	>	7	0	0	>	0	0	0		0	0	0	
JB	0	0	0		0	0	0		8	1		>	32	0	0	>	23	0	0	>	1	0	27	>	0	0	7	>	0	0	0		0	0	0	
К	0	0	0		0	0	0		0	0	0		6	0	7	✓	1	0	0	✓	0	0	12	-	0	0	12	✓	0	0	0		0	0	0	
КВ	0	0	0		0	0	0		1	0	0	✓	15	0	2	✓	0	0	0		0	0	31	✓	2	0	0	✓	0	0	0		0	0	0	
L	0	0	0		0	0	0		0	0	0		0	0	0		0	0	0		0	0	0		0	0	0		0	0	0		0	0	0

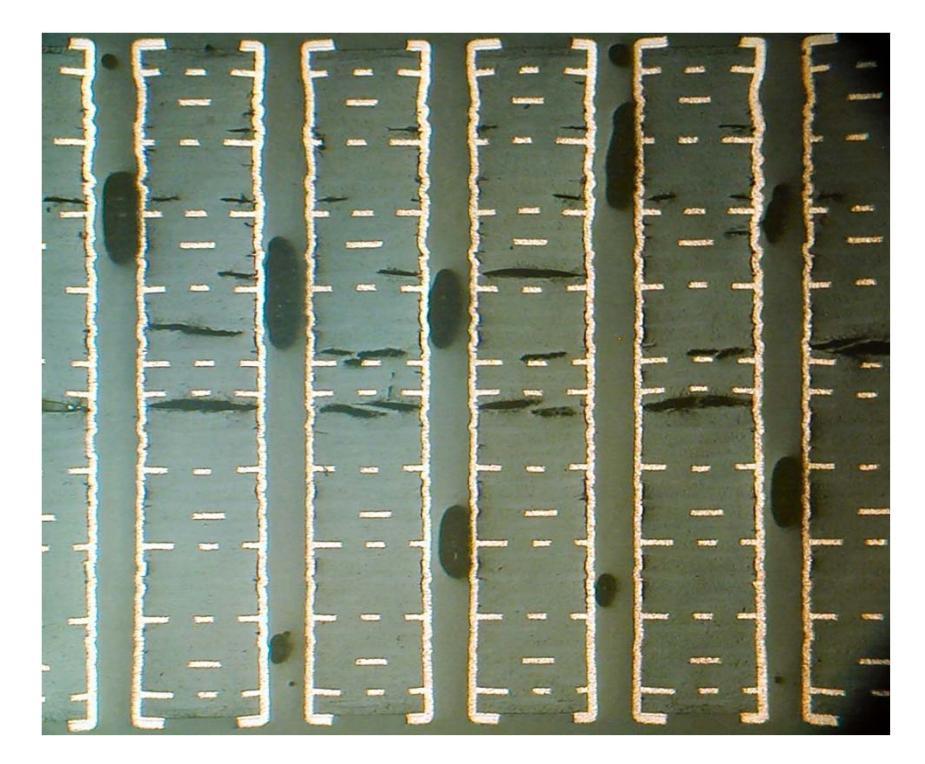
Cohesive Damage by Glass Style/Type

Material	5	8%	69	9%
Туре	C=1X 2116	B= 2X 1080	C= 2X 106	B= 2X 1080
С		x		
СВ				x
D	x			
DB			x	x
EB			x	
F		x		
FB				x
G	x	x		
GB			x	x
	x	x		
IB			x	х
J		x		
JB				x
K		x		
KB				x

•Material damage through Pb free assembly was dominated by cohesive failure, primarily across the central zone of the construction.

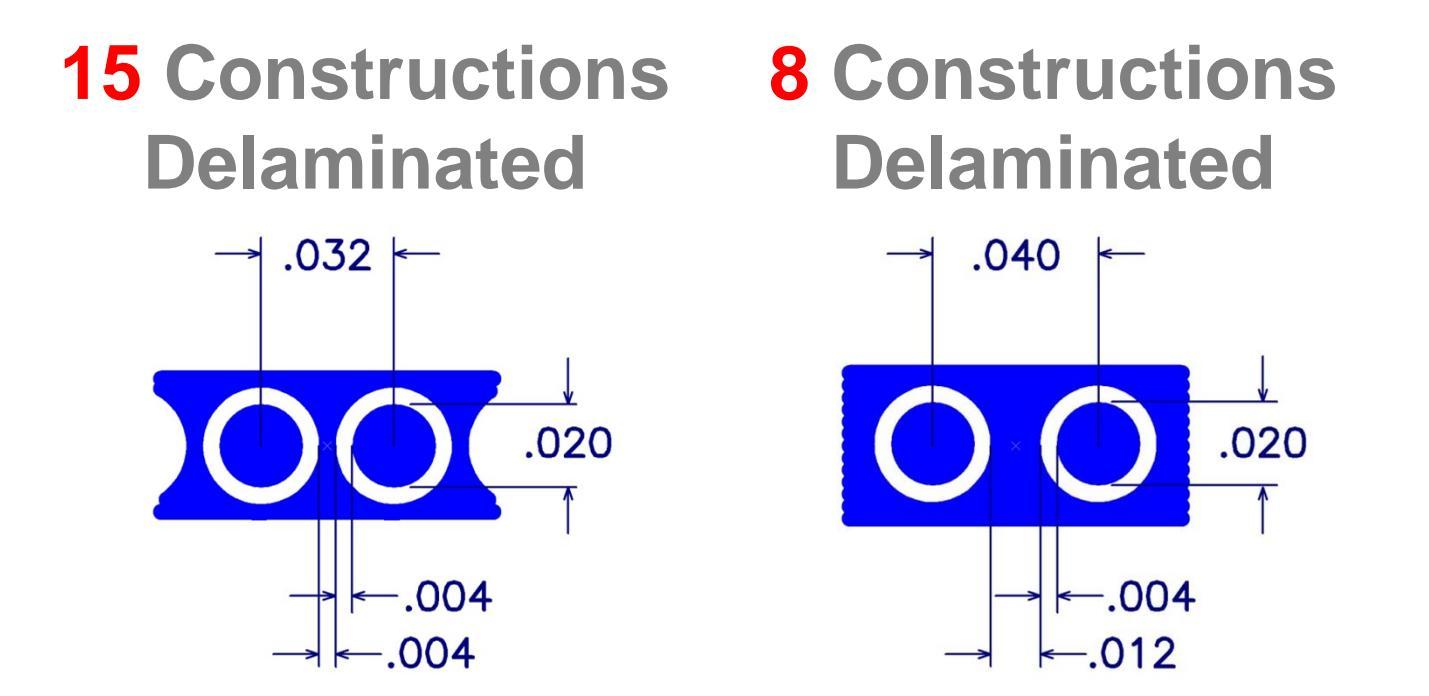
Impact of 0.8mm Vs 1mm Grid Size

Note: The severity of damage found on 0.8mm was 2X the level found on 1mm

When the structure of the composite materials reaches a specific temperature an internal shear stress is generated by the mis-match of CTE. The CTE mismatch is caused by the combination of the strength of the glass restricting the x axis expansion, versus the non-restricted expansion of the resin in the y axis. The focal point of this CTE mismatch is located at the "knuckle" between the woven glass fabrics, this is premised on the examination of microsections that consistently exhibit material cracks at the cross-over point between the warp and the weft glass directions.

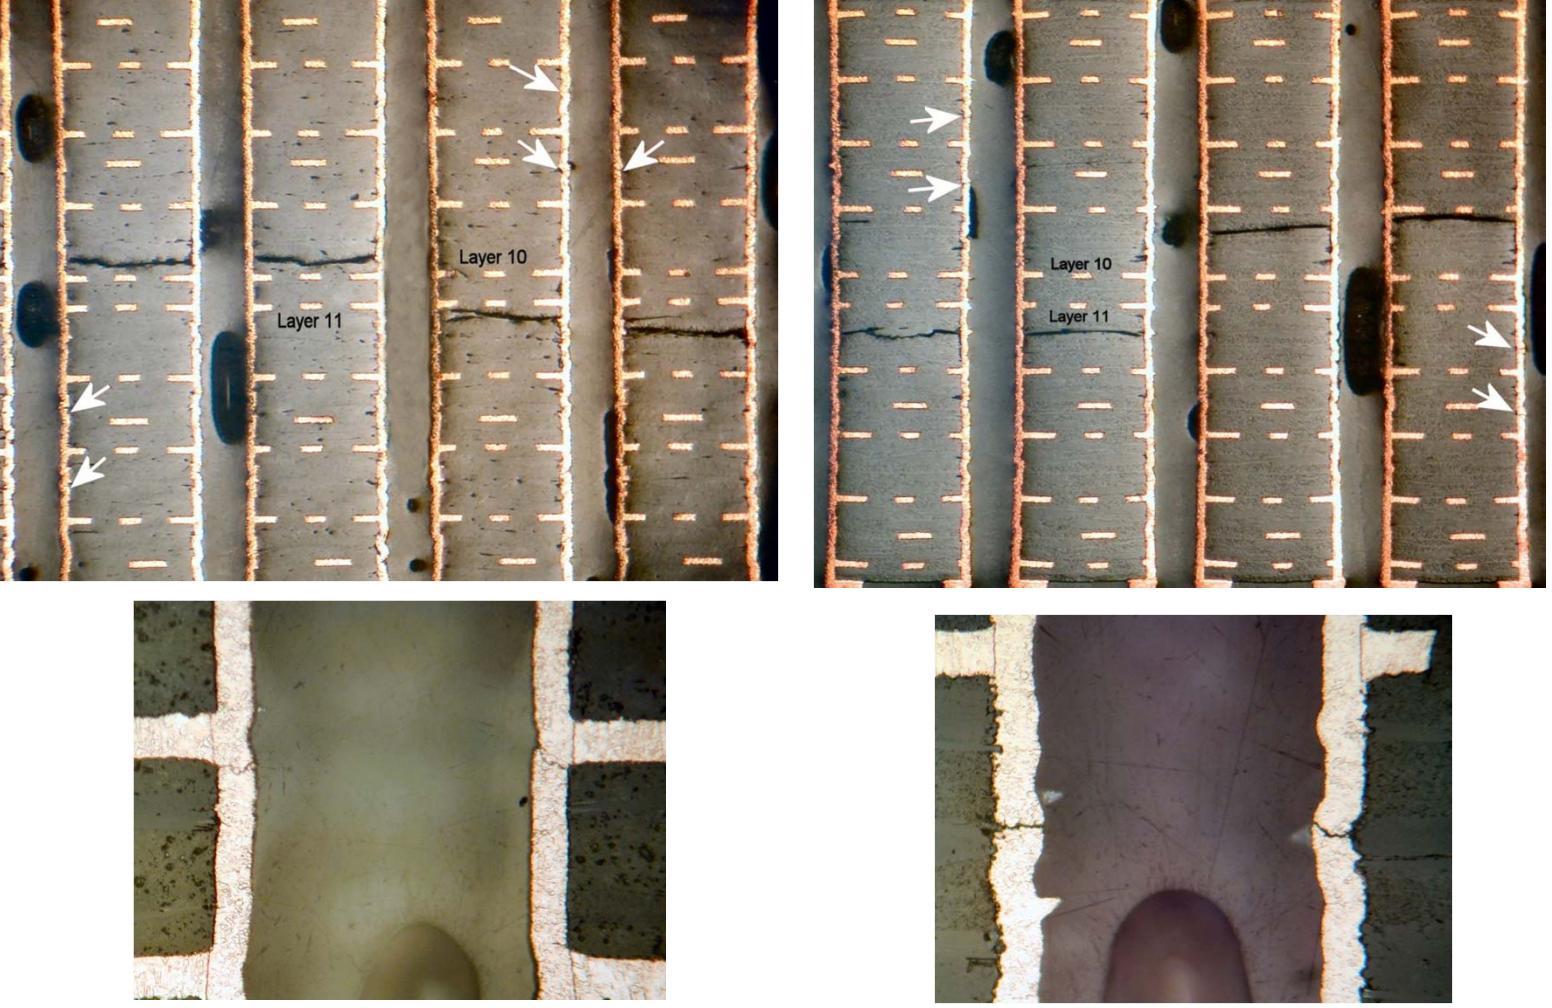
Cu Fatigue Cracks Moved Away From Damage!

• Cohesive material damage was demonstrated to be stress relieving, the areas of copper cracks, effectively redistributing the strain into different locations within the construction.
