## **INTERNAL VISUAL INSPECTION OF ELECTROMAGNETIC RELAYS**

**ESCC Basic Specification No. 2043600**

Issue 3	October 2025
---------	--------------

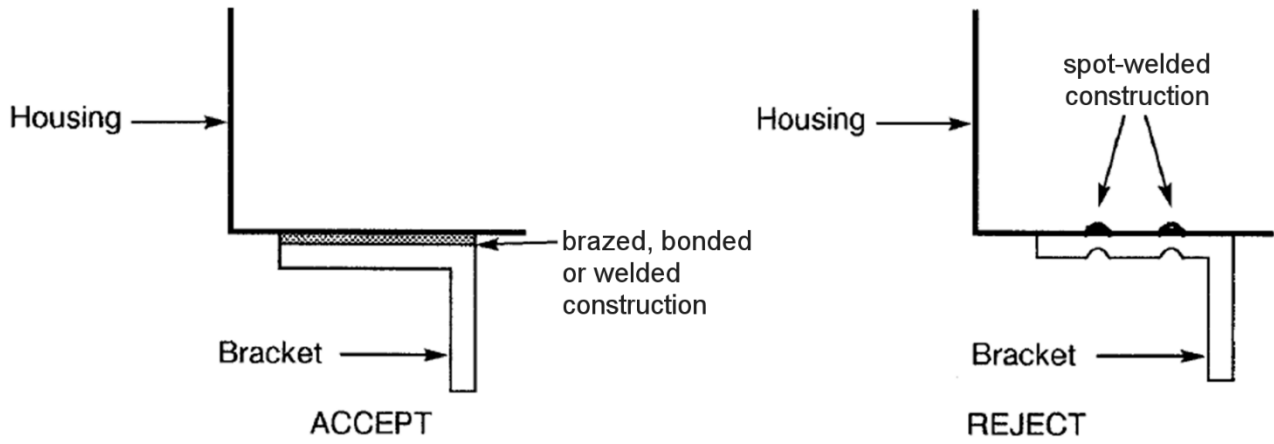
5.23 FIGURE 23: BRACKET TO HOUSING WELD

- (f) Mounting brackets which are spot-welded (electrically) to the housing (see Figure 23 in Para. 5.23).
- (g) Incorrect position of mounting brackets (see PID).
- (h) Excess brazing alloy on bracket, causing change of dimensions.
- (i) Granular brazing alloy.
- (j) Microholes in brazing alloy.
- (k) General lack of alloy around bracket/housing.
