# HDI DEMONSTRATOR MODULE WITH CSP AND BGA PACKAGES

3<sup>rd</sup> Technical Presentations Day / ESTEC

Noordwijk, 3<sup>rd</sup> May 2006

DAD 5.02.05

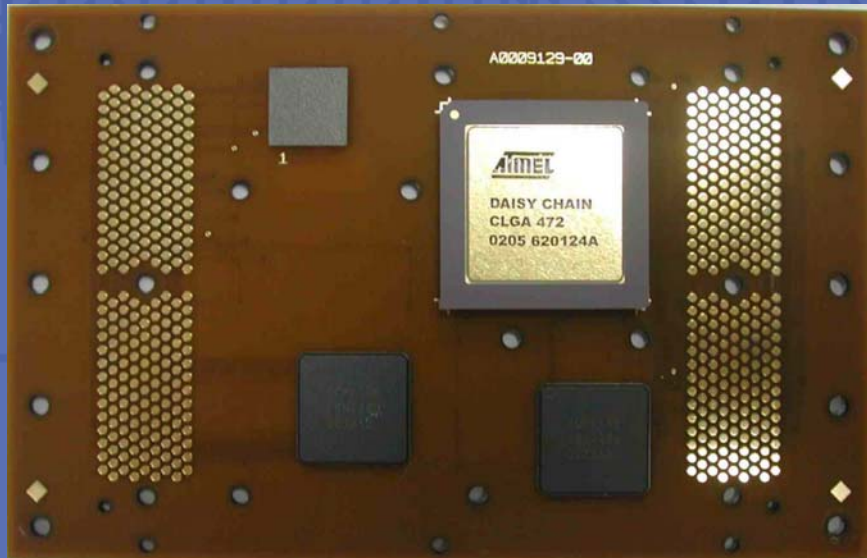
- Assembly of HDI boards for demonstrator 1 :
  - Boards with MCGA 472 package / quantity : 9
    - All packages were assembled except the CCGA 717
    - Assembly was achieved with the standard tin lead process

*Top view*

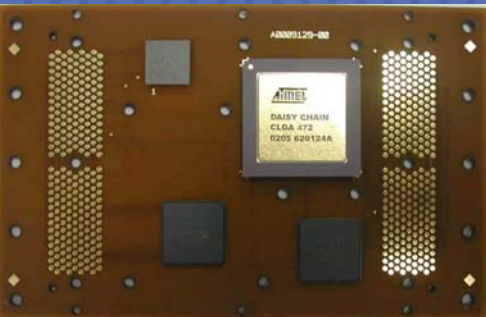
- » For testing daisy chains of each assembled package, assembled HDI boards were mounted on motherboards with IHD 250 interposers

*Demonstrator 1*

- one open circuit was detected on one of the MCGA 472 characterized by non soldered column
- all CSP packages (except CSP 256) were characterized by electrical continuity despite bridges observed on CSP 144 on two boards (bridges coincide with daisy chains)

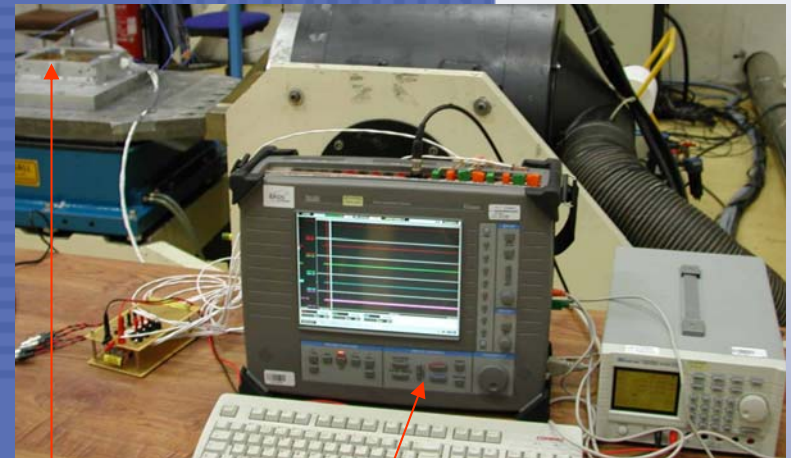
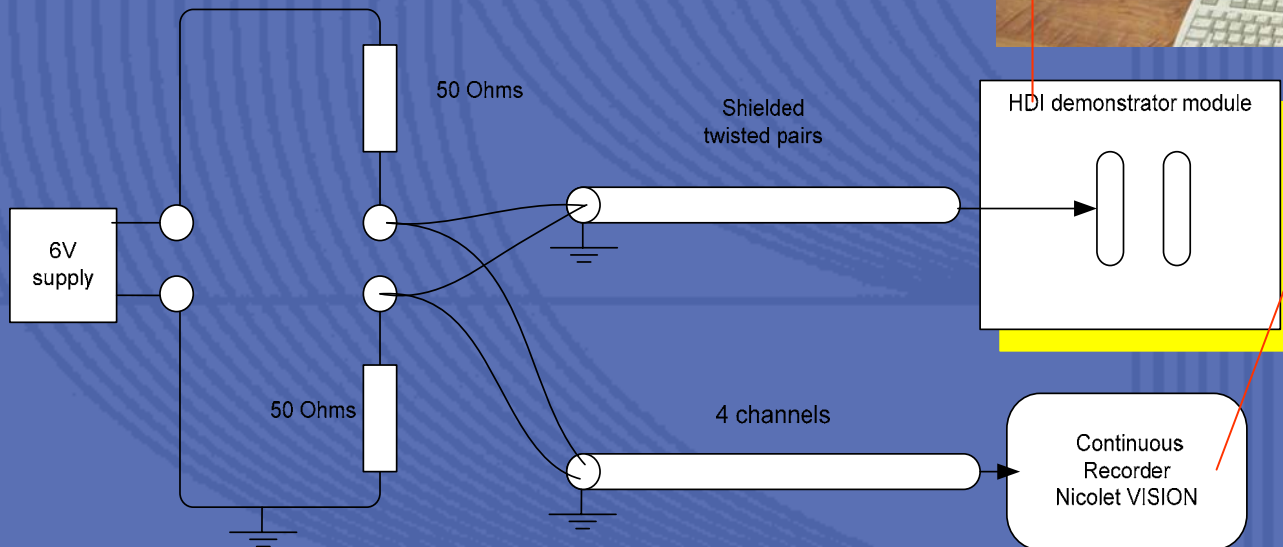
- Results of random vibration :
  - Electrical monitoring test bench
    - Sampling : 100kS/sec
    - Resolution : 10 $\mu$ sec on 4 channels

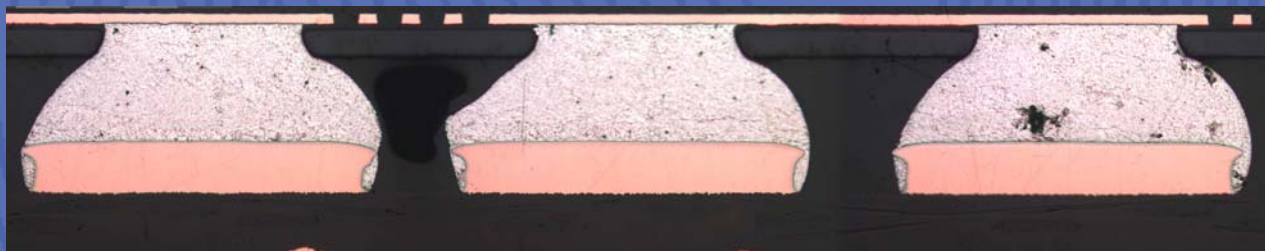
- » No crack was noticed on fBGA280

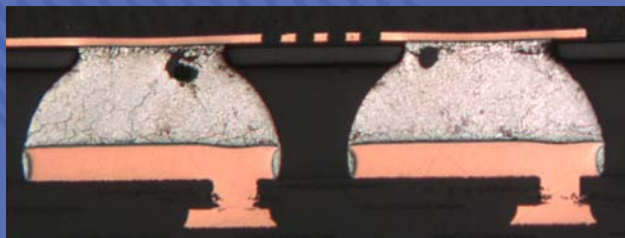
- » On fBGA 280 : cracks were also observed on package side

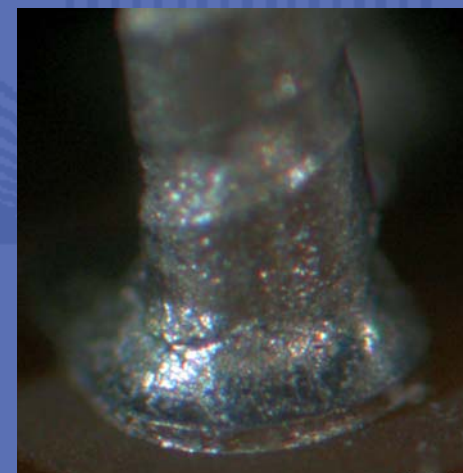
- » Ageing of solder joints of the CCGA 717 was noticed
- » Initiation cracks were observed on a few columns
- » Limited visual inspection on CSP packages

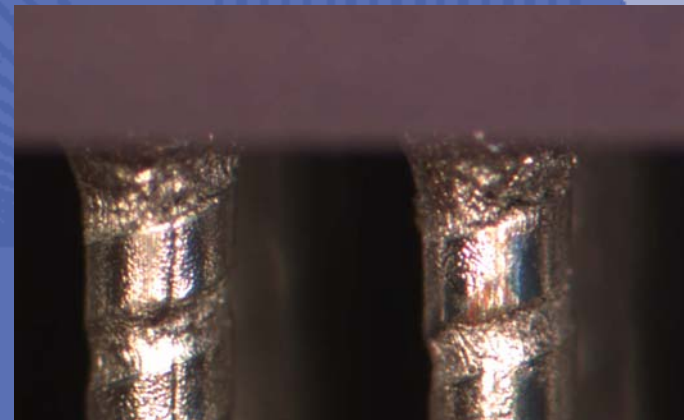
- » Ageing of solder joints was noticed on the whole external rows
- » Some cracks were observed in the columns on the package side
- » Initiation cracks observed on board side after 200 cycles did not evolve that much
