SO/PHI
POLARIMETRIC AND HELIOSEISMIC IMAGER
FOR SOLAR ORBITER

ISPFI CF-252 TEST RESULTS

reference	SOL-PHI-MPS-TD3000-RP-5
issue	1(prel)
revision	0
release date	2012-04-24
prepared by	J. Piqueras, S. Werner
approved by	K. Heerlein

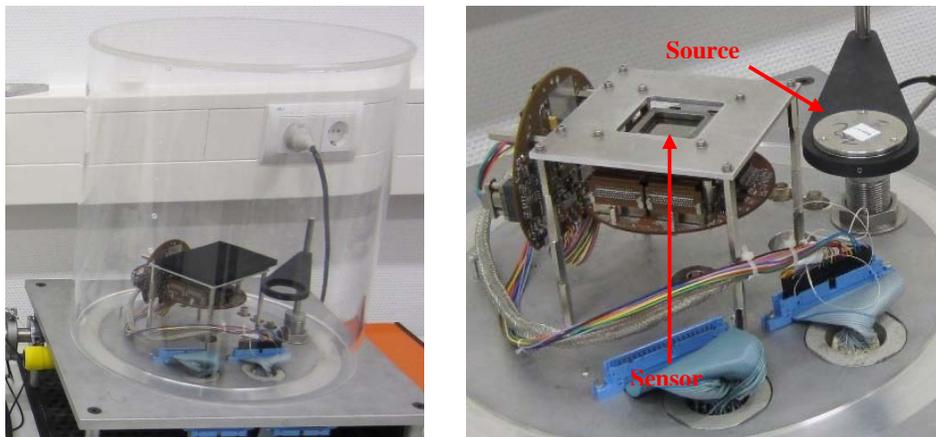
Figure 2-1 Vacuum jail with camera inside (left) and camera electronics with sensor and Cf-252 source (right).

The irradiation setup is shown in Figure 2-1 and Figure 2-2. On the first picture, the camera electronics with the sensor on it is placed inside the vacuum jail where the test shall run. The right side includes a closer look where the source is already placed on its holder and the image sensor is visible. The test cable, specifically built for this experiment, is also connected to the jail feed-through. The source holder can be moved to hit specific parts of the sensor, or to place it apart. Note that the irradiated area is smaller than the physical size of the detector. Therefore, the source shall be moved during the test to get guarantee that every part of the detector receives particle radiation.

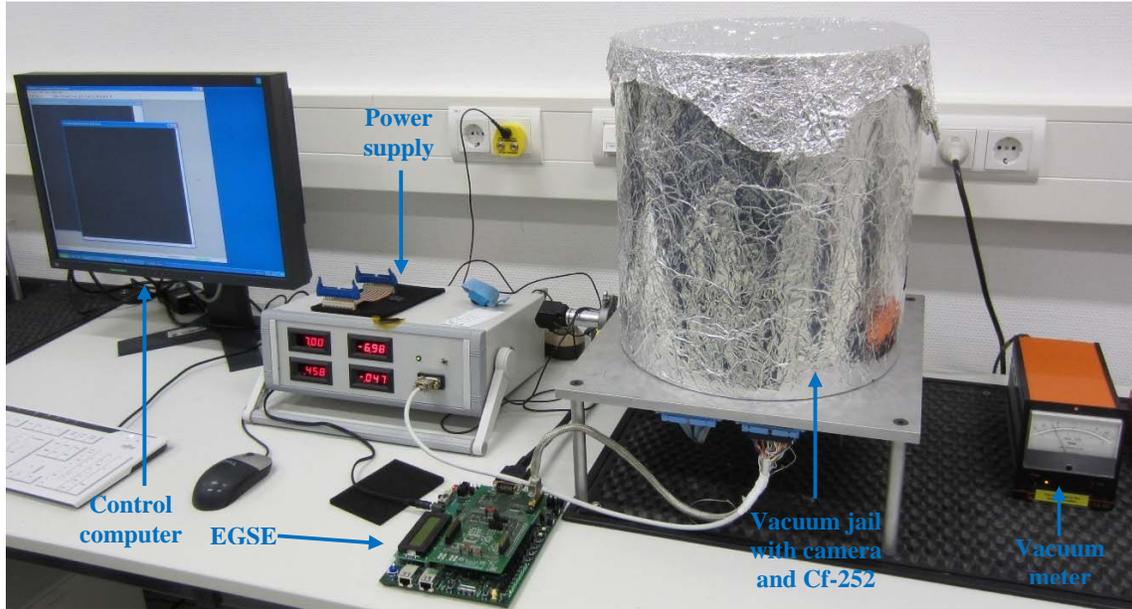
Figure 2-2 Experimental set-up while test is running.

The second figure displays an overview of the test while running, where the control computer, the power supply and EGSE can be seen. The vacuum jail is covered during the test to block the light and get dark images on the detector. On the right side, the vacuum meter measures the pressure level inside the jail, which is created by an external vacuum pump.

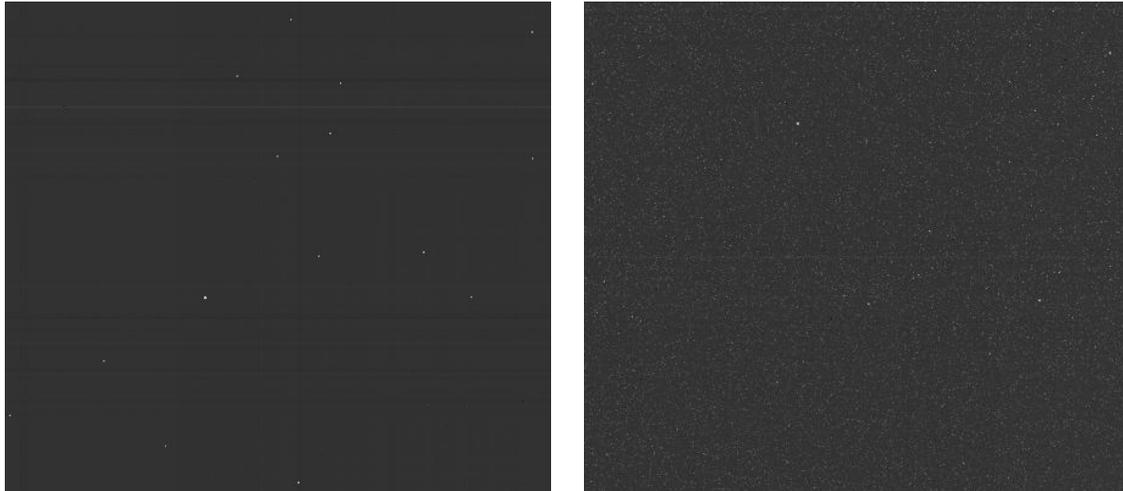
Figure 3-1 Dark image (sub-area) during irradiation: Beginning (left) and end (right) of test. White dots appear across the whole array, and at the end of the test, the induced non-uniformity forms a background fixed pattern noise.

The first noticeable effect after placing the radioactive source over the sensor was that random white dots appeared across the whole array. These spurious pixels vary from image to image, and are related to the generation of electron-holes induced by the irradiated particles. On the left side of Figure 3-1, a set of white dots can be distinguished over the dark background. After the sensor had been exposed to radiation for a while, the white spots continue appearing but a fixed pattern noise emerges on the background of the dark images. This gradual increase in fixed pattern noise is a long-term effect, thus it will be analyzed in Section 4. In general, the temporal white pixels on the image are a regular consequence of the semiconductor nature of the sensor, and not a damage provoked by radiation.

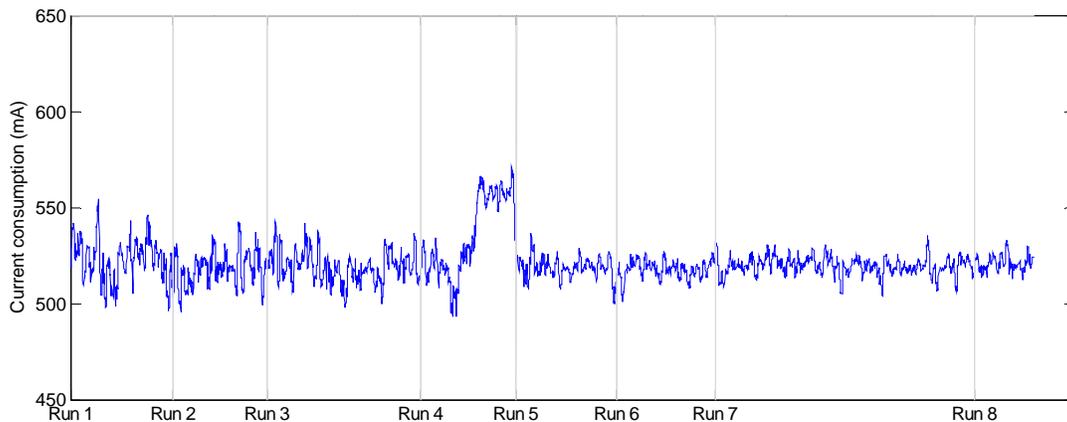
Figure 3-2 Current consumption HK versus irradiation run. The x-axis' run numbers define the start of that irradiation period.

One of the regularly acquired HK is the total current consumption, which is displayed in Figure 3-2 for complete campaign (eight runs). This current corresponds to the 5V main supply, meaning that on average the consumption is of about 2.6W. The high frequency fluctuations of the measured current are due to the fact that

the housekeeping acquisitions are synchronized by the software, therefore not all were acquired during the same state of the acquisition (for instance, the consumption is higher in the middle of one image than in the transition between frames). In any case, it can be clearly seen that during run 4 the consumption suffered a sudden rise that does not disappear until the run is finished and the camera is power cycled. The increase is about 200mW. As we will see after analyzing the image statistics, this event corresponds to a SEE.

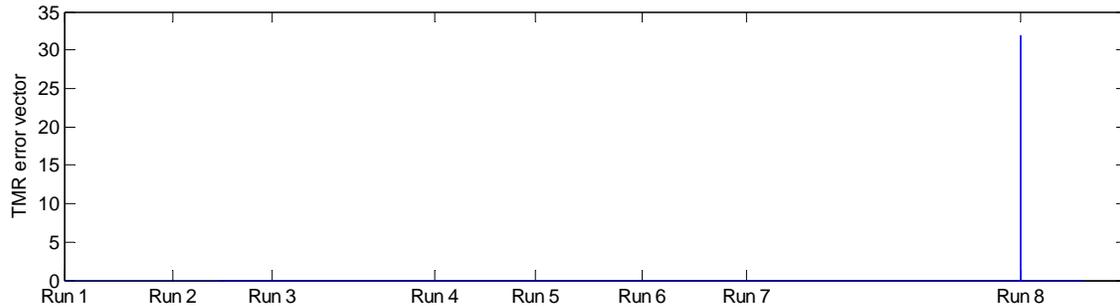
Figure 3-3 TMR error vector recovered via HK. The x-axis run numbers defines the start of that irradiation period.

As it was explained in Section 2, the remote TMR functionality allows the detection and correction of SEUs on the SPI register of the sensor when this option is enable. During runs 4, 5 and 6 it was disable, and during runs 1 and 2 it was enable but HKs were only acquired every 10 frames. This means that the SEU correction was working but it is possible that the HK containing the error vector of that correction was not acquired. From Figure 3-3, we can see that only one SEU was reported via the TMR error detection at the beginning of run 8. This event corresponds to the register number 32, which is the CMREFLV (reference level of the sensor output). The later analysis of the image statistics, together with the known effect of changing this register value, will confirm the existence of such an event.

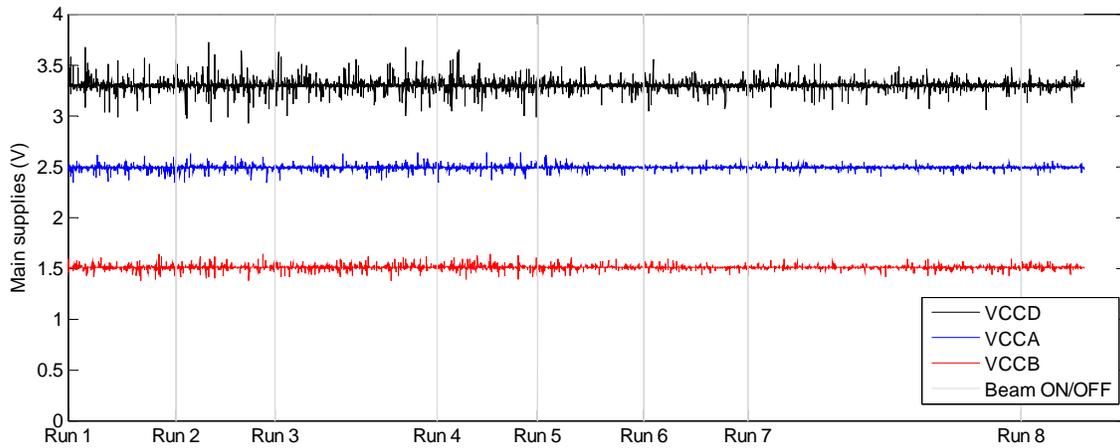
Figure 3-4 Camera main supplies during irradiation.

The main and pixel supplies' housekeepings are shown in Figure 3-4 and Figure 3-5, respectively. It can be observed that no abnormal variations can be identified on those voltage levels.

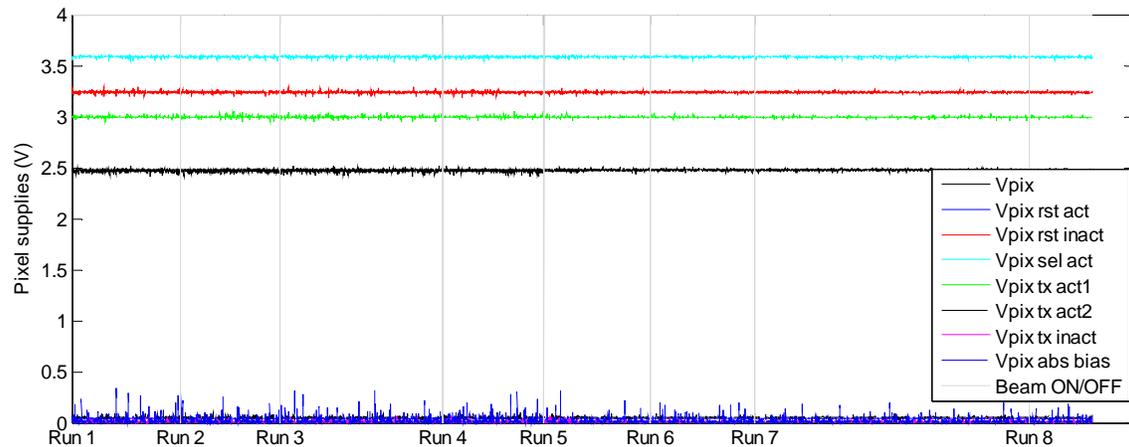
Figure 3-5 Pixels supplies during irradiation.

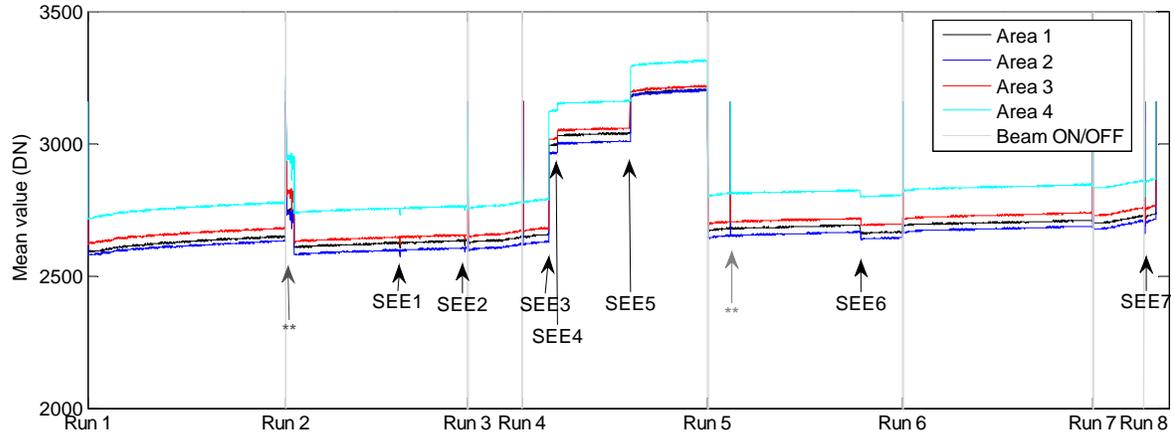
Figure 3-6 Monitoring of the mean value of the acquired dark frames during irradiation. The mean value is calculated separately for the four areas that correspond to different output stages of the sensor. The identified SEEs are marked, as well as two events (**) that respond to external reasons (illumination changes).

Most of the SEEs will be extracted from Figure 3-6. This graph shows the image mean value during the sequence of irradiations for every area of the image sensor. Every sudden change or peak is susceptible of being a single event effect. The only exceptions are during the test images taken after one run finishes and before the next one starts, and those mark with (**), which correspond to on purpose change on the darkness of the camera environment. The rest of highlighted events are sudden changes on the mean value, and are thus labeled as SEEs. Some of them are confirmed by the previous analyzed graphs, as for example the SEE5, which correspond to the

increase in current consumption seen in Figure 3-2, and SEE7, which matches the TMR SEU reported on Figure 3-3. The actual values of the changes vary from 15 DN in SEE2 to more than 130 DN in SEE5. The visual analysis of the images ratifies that the variations on the mean value are over the complete array, and not due to some transient of pixels or bright area. This last remark suggests that they are probably related to SEUs.

Also important is to check that SEE1, SEE2 and SEE7 appear as a peak change that only affects a single frame, whereas SEE3, SEE4, SEE5 and SEE6 are a sudden change which effect continues until the run finishes and/or the camera is power cycled. This is because runs 2 and 8, where SEE1, SEE2 and SEE7 occur, have the TMR enable, and therefore the SEU is automatically corrected before the next image is acquired. However, the TMR is disabled for the rest of events where the effect is not recovered until the end of the run.

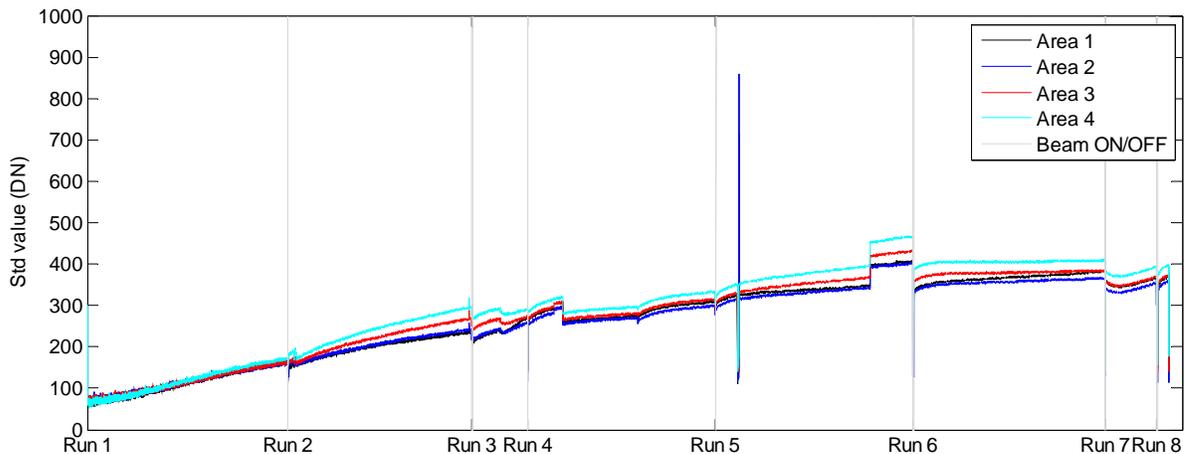
Figure 3-7 Monitoring of the spatial standard deviation of the acquired dark frames during irradiation. The std value is calculated separately for the four areas that correspond to different output stages.

The same statistical analysis is done with the standard deviation of the four areas of the sensor. Some of the previously identified events (SEE2, SEE4, SEE6 and SEE7) appear also as a change on the std graph. As in the mean value examination, those events appearing with TMR enable recovers automatically whereas those without TMR only recovers at the end of the run.

Apart from the temporal events, a smooth increase on the image noise (or non-uniformity) is found from the beginning of the radiation test until the end. It is classified as a long-term effect and will be analyzed in Section 4.

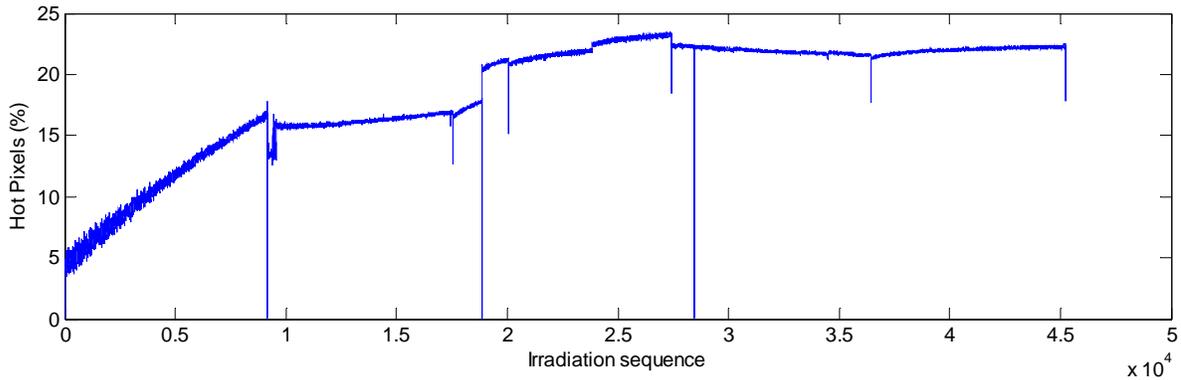
Figure 3-8 Monitoring of the number of hot pixels during irradiation. The used criterion is that a pixel is hot if its value is, at least, six times higher than the standard deviation.

Finally, the number of hot pixels on the images is analyzed during the irradiation sequence on Figure 3-8. Though this is more related to long-term effects, and the increase (except for the test images in the transitions and some known illumination changes) is smooth, the graph is included in this section because the live images have been used to generate it. The pre and post characterization also will deal with this analysis.

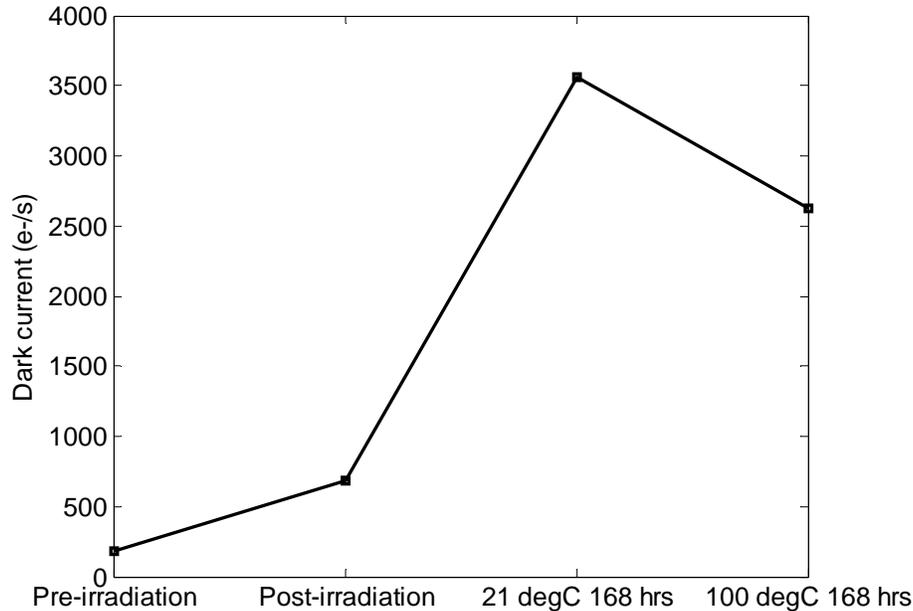
Figure 4-1 Dark current: Measurements before and after irradiation/annealing.

The measured dark current variation before, after irradiation and after annealing is shown in Figure 4-1. The level after irradiation is about 500 e⁻/s higher than the one measured before. Although this behavior is expected, the DC continues increasing during the first week of annealing at 21 degC until reaching a top level of more than 3500 e⁻/s. This last increase was not expected and the reason is not clear yet. After the annealing at 100 degC, the DC recovers a little bit, but it is still high compared to the initial value.

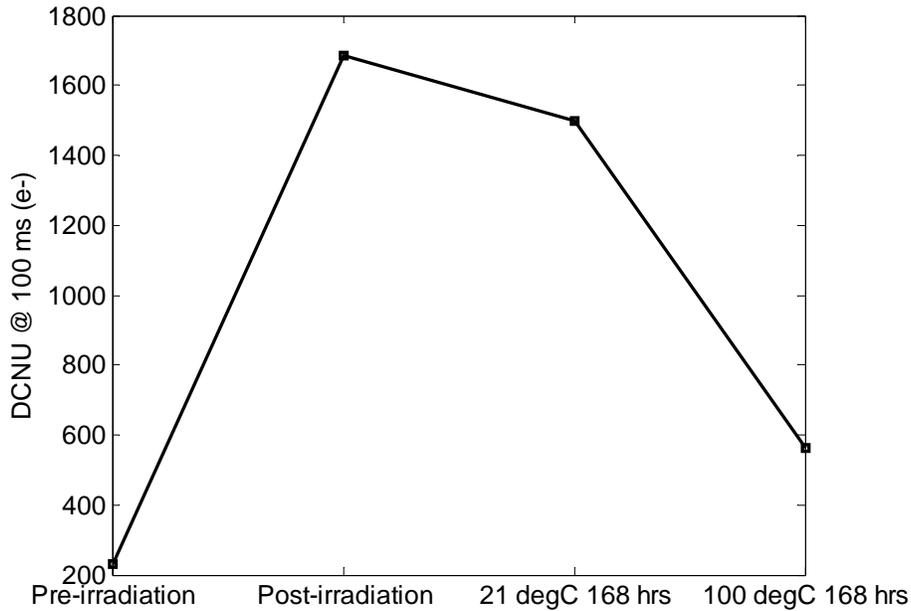
Figure 4-2 Dark current non-uniformity at 100 ms of exposure time: Measurements before and after irradiation/annealing.

The non-uniformity on the dark current is displayed in Figure 4-2. It can be observed how after irradiation the value increases significantly, which agrees with the fixed pattern noise that was shown in Section 3 at the end of the test. After the first week of annealing at room temperature, the DCNU recovers a little bit, and after the annealing at high temperature the recovery is more pronounced. However, the initial value is not reached.

The DCNU has been measured as the standard deviation of a group of 800 x 800 pixels across a 10 frames averaged image. The bad pixels above 20 times the standard deviation were not included in this calculation.

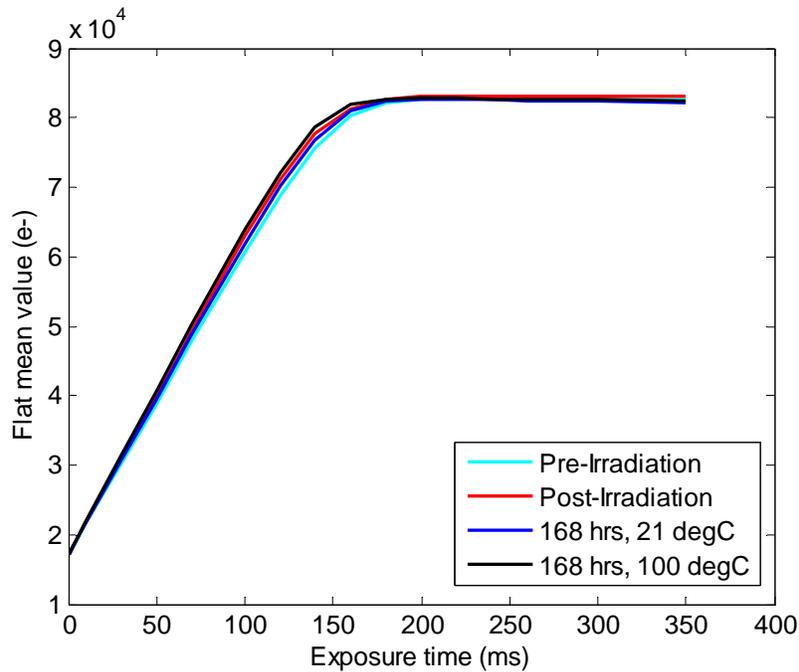
Figure 4-3 Mean flat level before and after irradiation/annealing.

The level of the flat images is analyzed in Figure 4-3. Though there is a small variation on the response for the different measurements, it does not follow any pattern (for example, it is not better before irradiation). Therefore, it might be that the observe differences come from changes on the illumination or conditions (e.g. temperature) during measurements instead of real radiation effects. However, this is TBC.

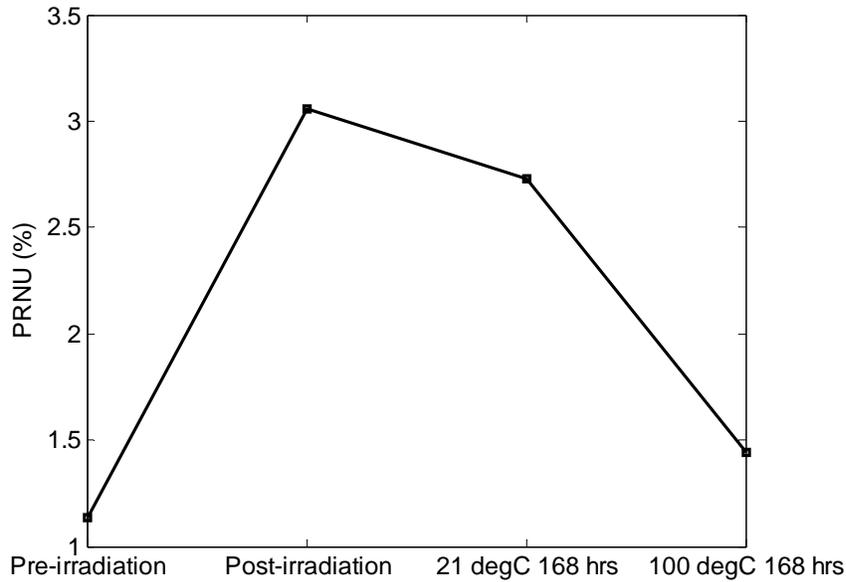
Figure 4-4 Pixel response non-uniformity: Measurements before and after irradiation/annealing

The results of the PRNU are very similar to the ones obtained for the DCNU. An increase appears after irradiation and then the annealing partially heals it.

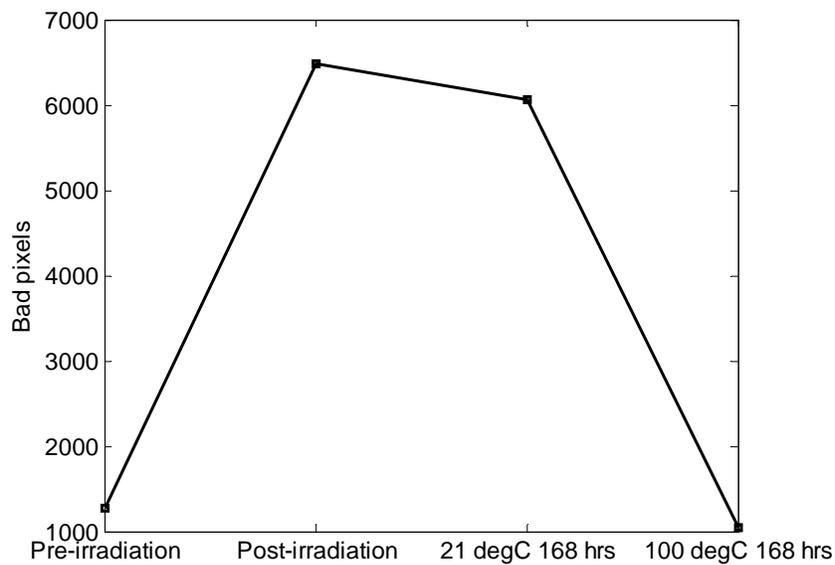
Figure 4-5 Bad pixels on the flat images at 100 ms of exposure time. The measurement criterion is above or below 6 times the standard deviation.

The analysis of the bad pixels shows an increase after irradiation and a recovery after annealing, especially at high temperature (Figure 4-5). The value after the final annealing step is lower than the initial value.
