Sn whiskers and their mitigation for space, aerospace and defence electronics

Martin Wickham, Kate Clayton, Chris Hunt
- National Physical Laboratory, UK

- **EMPPS_5, Noordwijk**
- **20 - 22 May 2014**

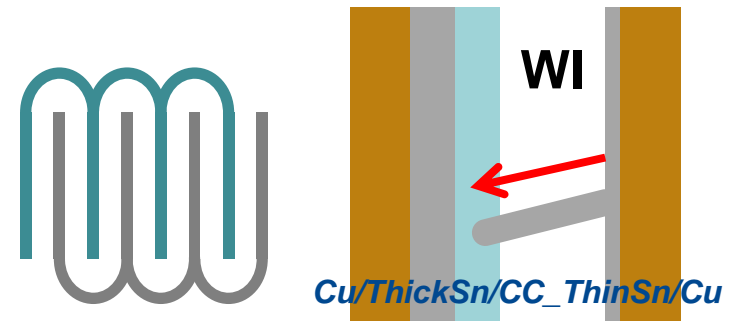
Type 2: Monitors whisker penetration in through coating

Plate 1: Thick Sn, conformally coated

Plate 2: Thin Sn, no coating

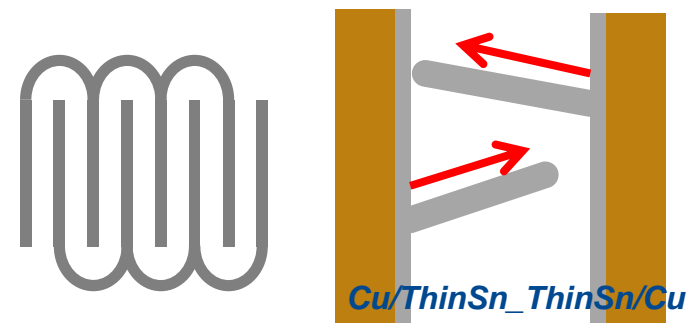
Type 4: Control

Plate 1: Thin Sn, no coating

Plate 2: Thin Sn, no coating

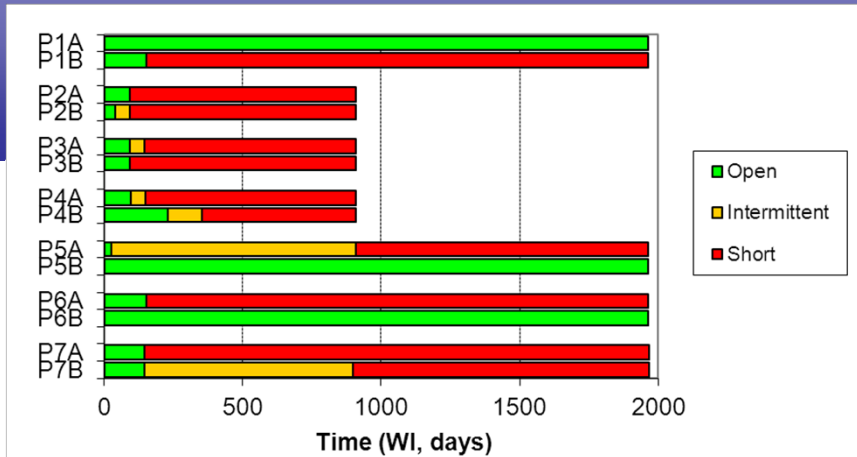
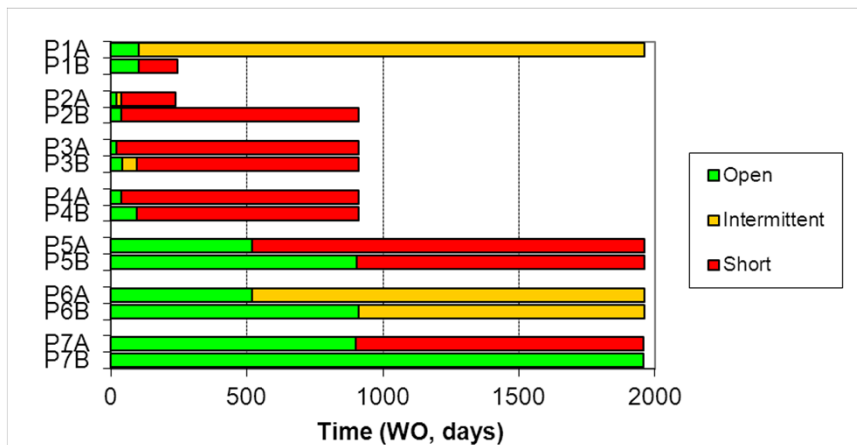
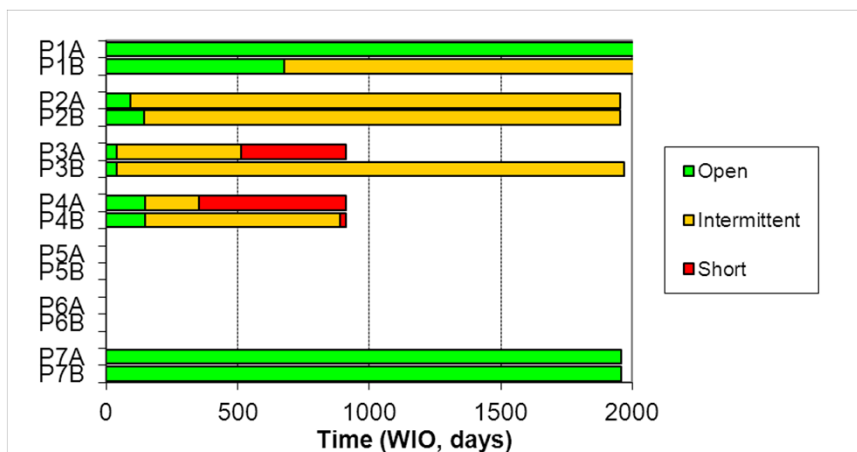
Polyurethane Coatings

- All seven coatings showed shorts during testing
- One polyurethane coating did not short when coating was applied to both surfaces of test vehicle

P1	P2	P3	P4/5/6	P7
Whiskers In Shorts	Yes	Yes	Yes	Yes	Yes
Whiskers Out Shorts	Yes	Yes	Yes	Yes	Yes
Whiskers I/O Shorts	Yes	Intermittent	Yes	Yes	No
Edge Whiskers	Yes	Yes	Yes	Yes	Yes

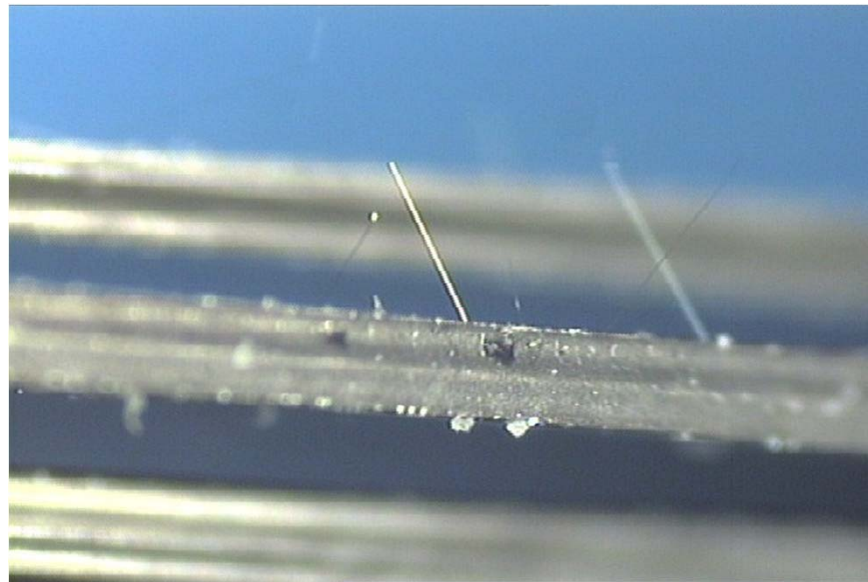
Silicone Coatings

- All seven coatings showed electrical shorts at some point during testing and whiskers at edges of plates
- No erupting whiskers were noted

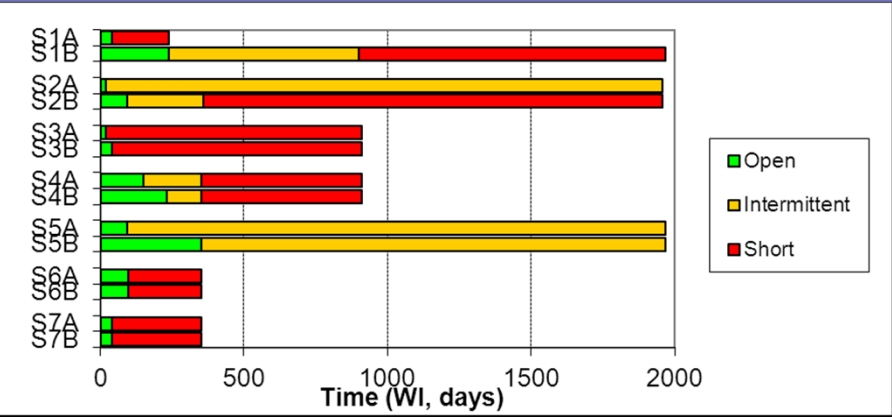
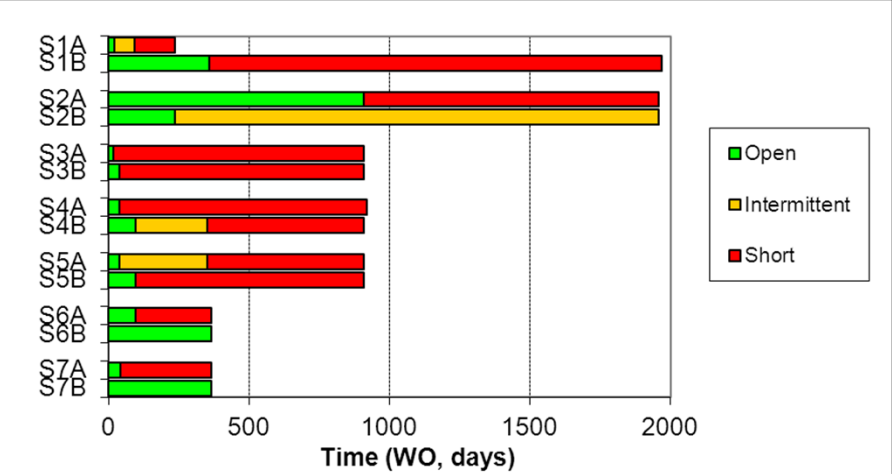
Silicone Coatings

- All seven coatings showed shorts during testing
- One silicone coating did not short when coating was applied to both surfaces of test vehicle
- Second coating OK after 12 months (trial ended by partner)

S1	S2	S3	S4	S5
Whiskers In Shorts	Yes	Yes	Yes	Yes	Intermittent
Whiskers Out Shorts	Yes	Yes	Yes	Yes	Yes
Whiskers in/out shorts	Yes	No	Yes	Intermittent	Yes
Edge Whiskers	Yes	Yes	Yes	Yes	Yes

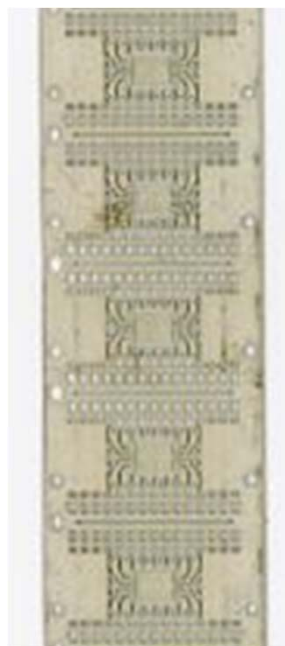
Time to first whisker – components vs lead frame scrap

- Confirmation of delay in whiskering due to bend and crop operation (~30 days)

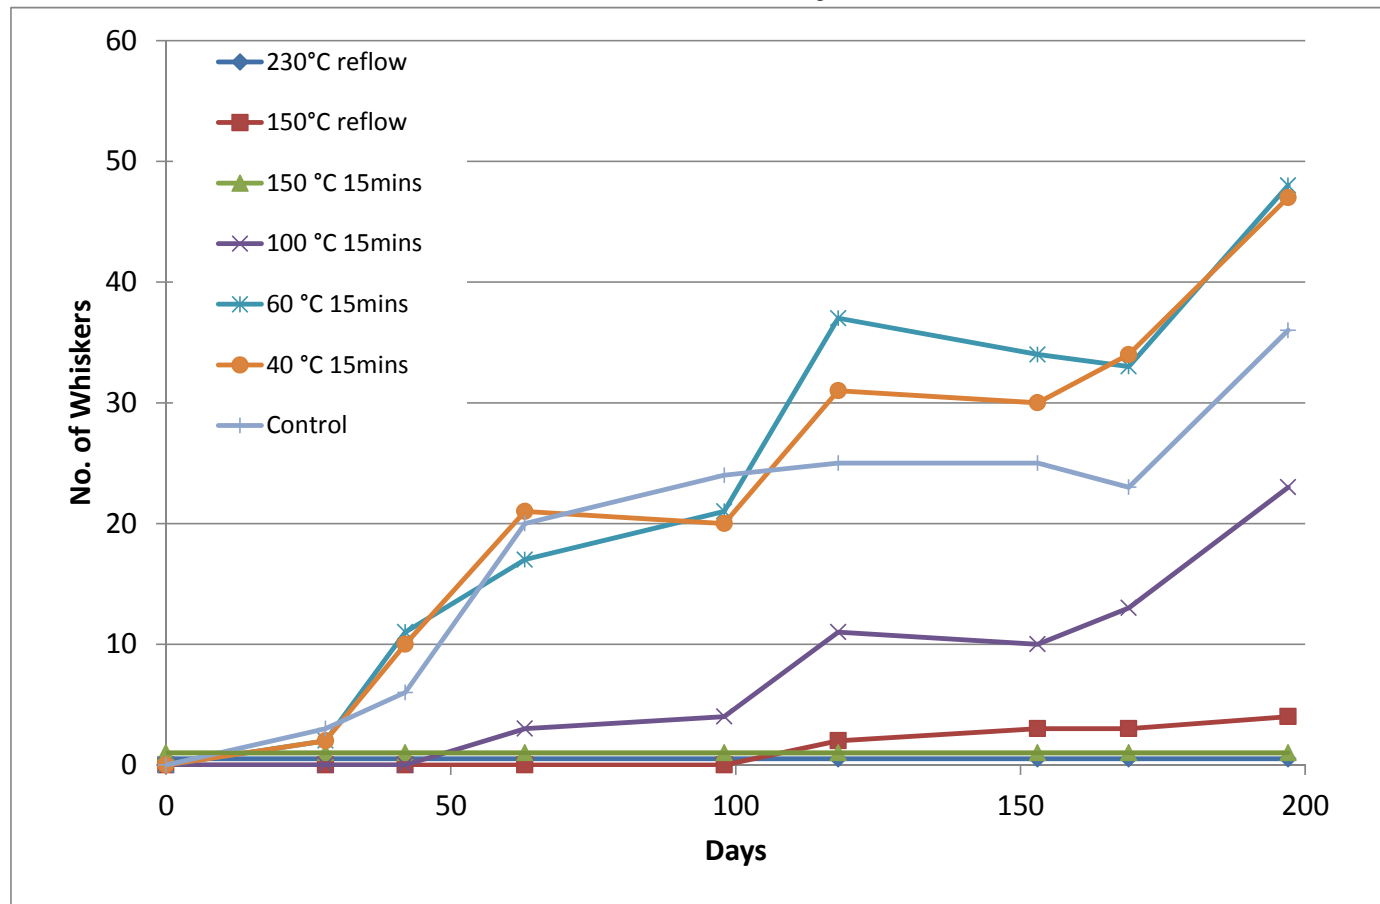
Whisker Growth Trial Unassembled Components

- No whiskers after 200 days for 230° C/reflow or 150° C/15minutes
- Limited whiskers after 200 days - 150° C/reflow

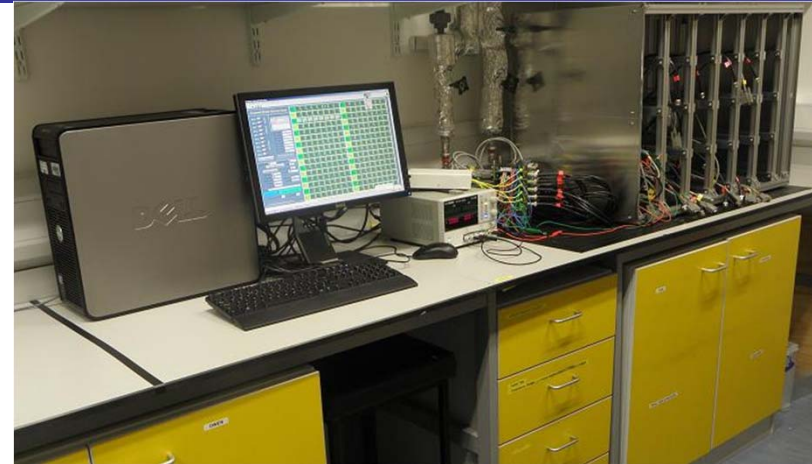
Hardware

- Build of mother boards completed
- Build of switching modules completed
- Docking bay build to hold all test boards.

- Currently 170 assemblies but can be expanded if necessary
- Current total of 65000+ leads
- Each component tested every 15 minutes
 - Higher frequency possible but currently felt to be unnecessary
- Test voltage = 15V
- 1M Ω resistor in series to limit current to 15 μ A
- System will detect a whisker short at 1M Ω or below on any one of 4080 components (each individually addressed)
