ENEPIG FINISH: AN ALTERNATIVE SOLUTION FOR SPACE PRINTED CIRCUIT BOARDS

A. Chaillot¹, P.-E. Tegehall², N. Venet³, J. Hokka⁴

¹Airbus Defense and Space, ²Swerea IVF, ³Thales Alenia Space, ⁴ESA

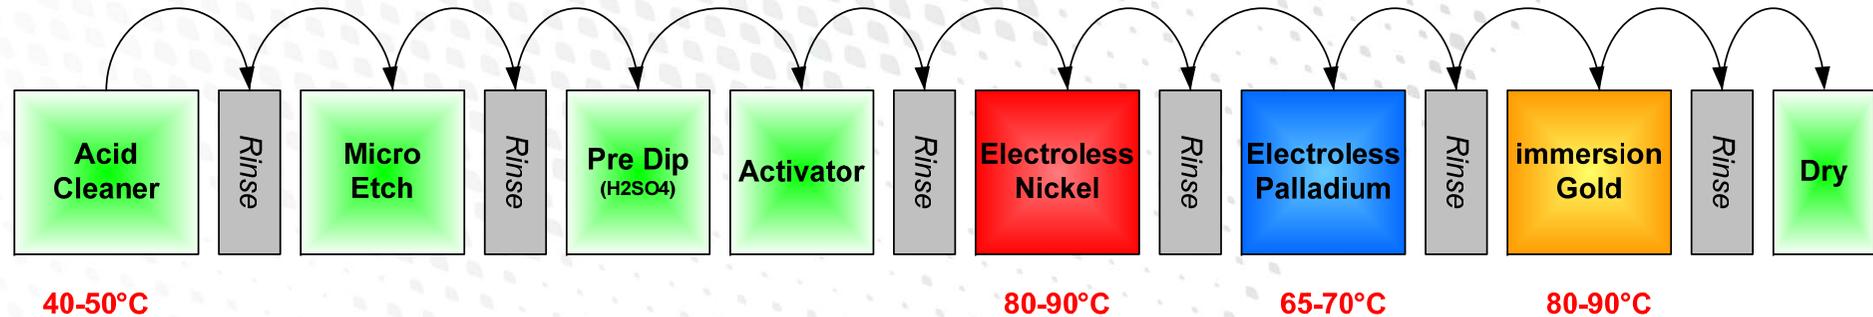
ENEPIG

- ✓ **Electroless Palladium** deposited onto **Nickel Phosphorus** layer and finished with **Immersion Gold**

- ✓ Chemical deposition of nickel and gold performed with the **same plating baths as the ENIG finish**
- ✓ Electroless palladium plating similar to electroless nickel process
- ✓ **Low corrosion** effect at the nickel interface preventing black pad, poor solder wetting and weak solder joints

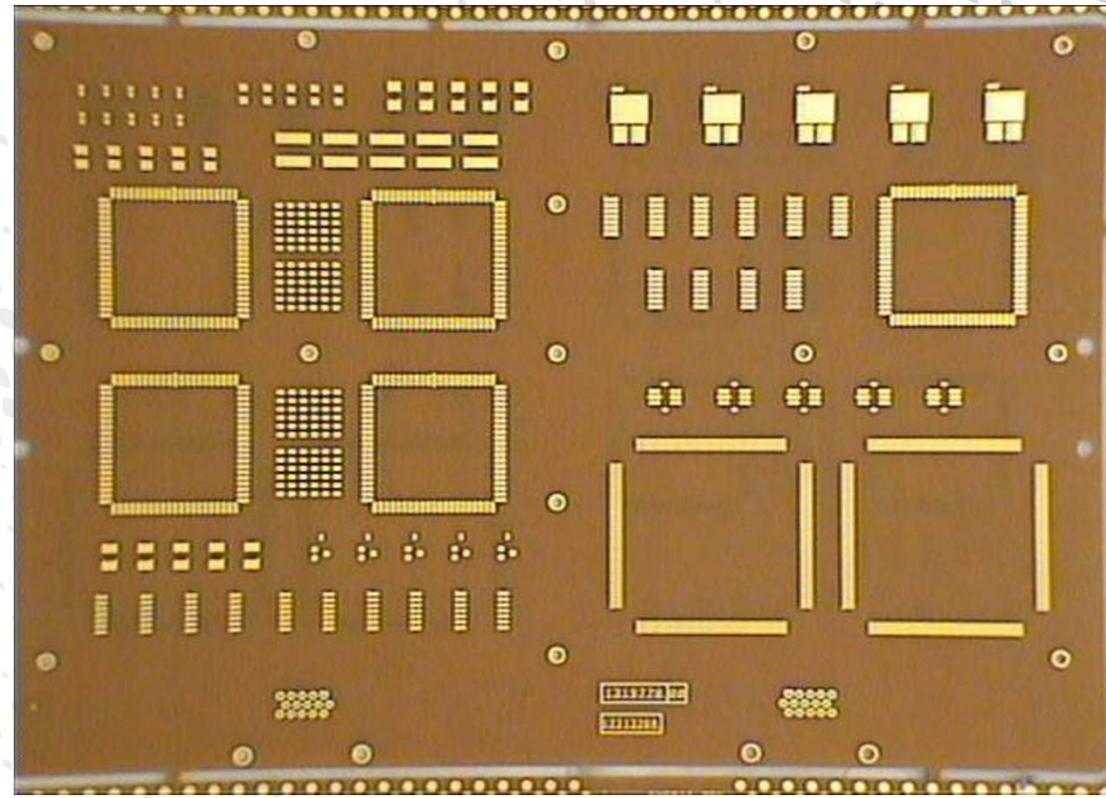
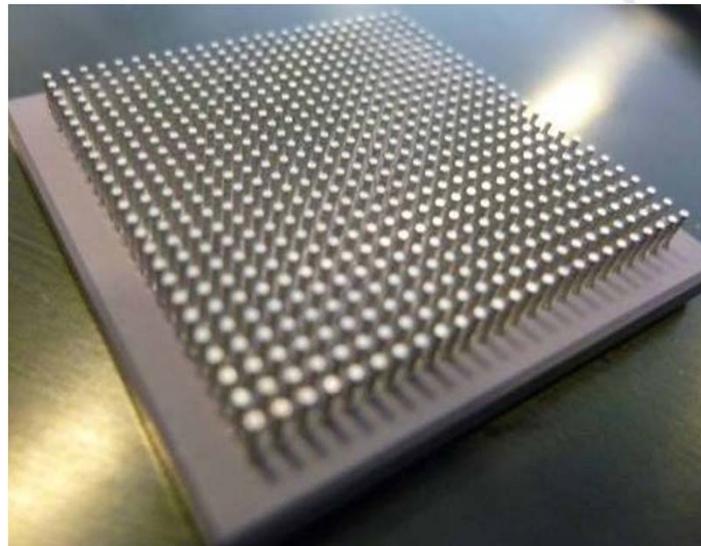
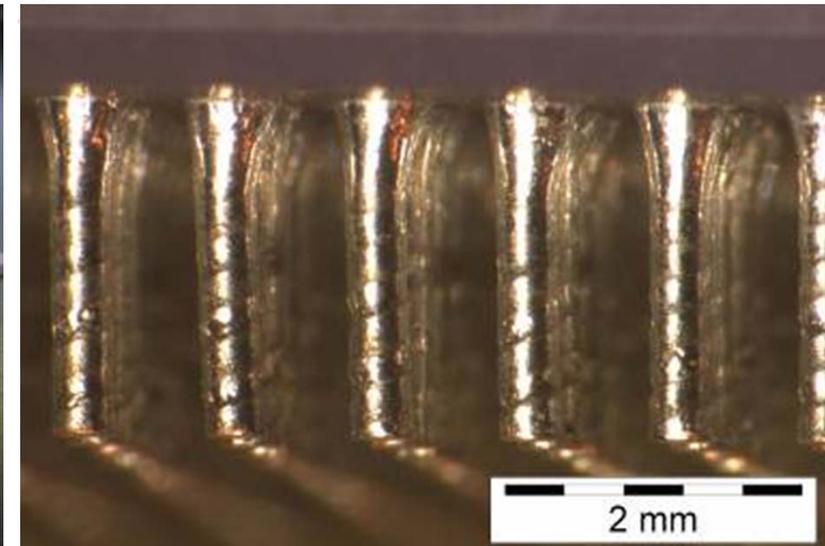
Test vehicles

- ✓ Diodes DO213 AB, D5A
- ✓ Connector SUB-D 15 points
- ✓ Resistors 0402, 0603, 0705, 1206, 2512
- ✓ Capacitors 0603, 0805, 1210, 1812, 2220, 2225, CRW11B
- ✓ LCC3, LCC6
- ✓ SMD0.5
- ✓ FP14
- ✓ JLCC84
- ✓ CQFP256
- ✓ TSOP54
- ✓ CCGA625

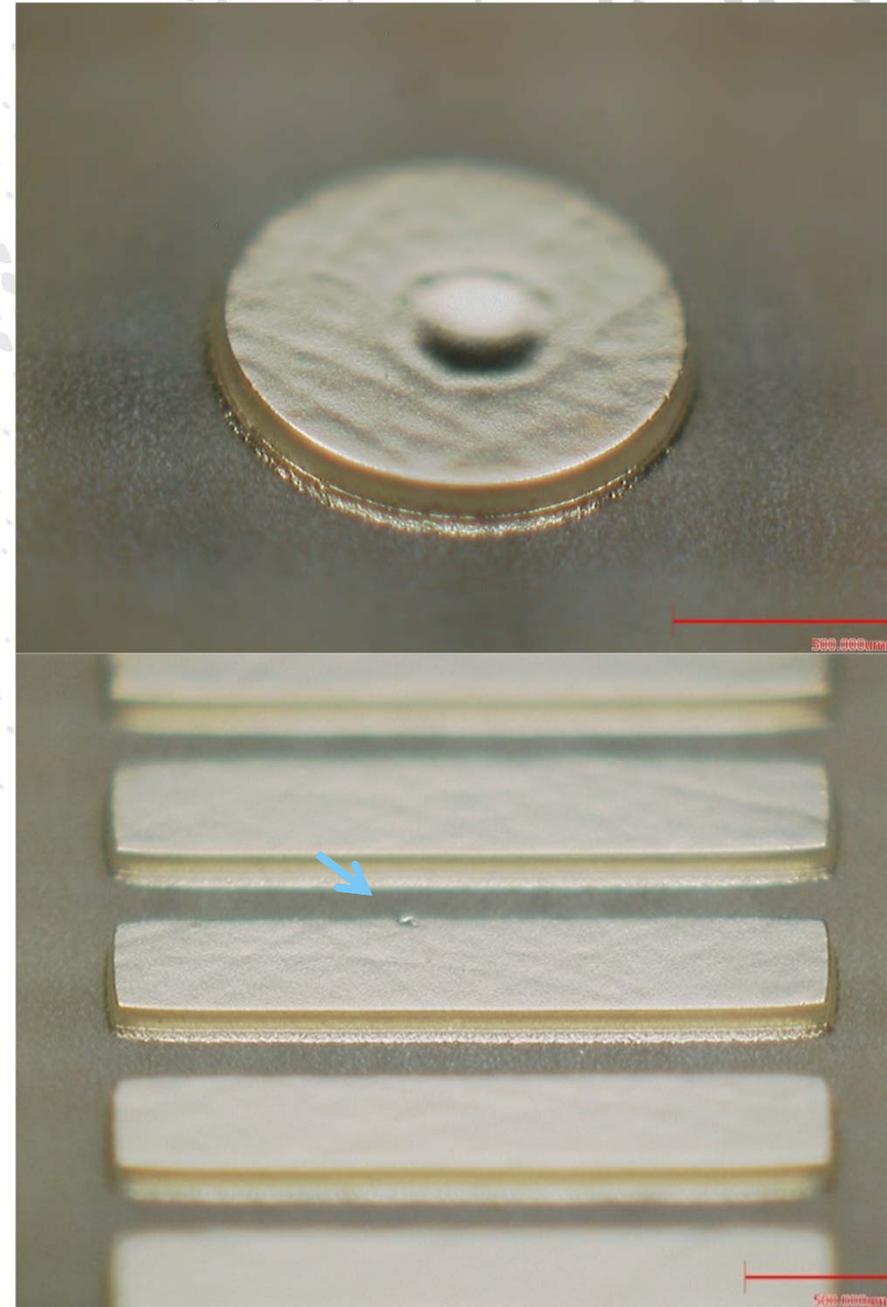
- ✓ Patterns compliant with IPC-4556
- ✓ Rough golden appearance
- ✓ Complete coverage
- ✓ Pads more flat than with fused SnPb
- ✓ Finish uniform on the plated surfaces
- ✓ No shortcuts noticed
- ✓ No differences between the finish suppliers

- ✓ Roughness and dimples which are reflections of the original copper surface

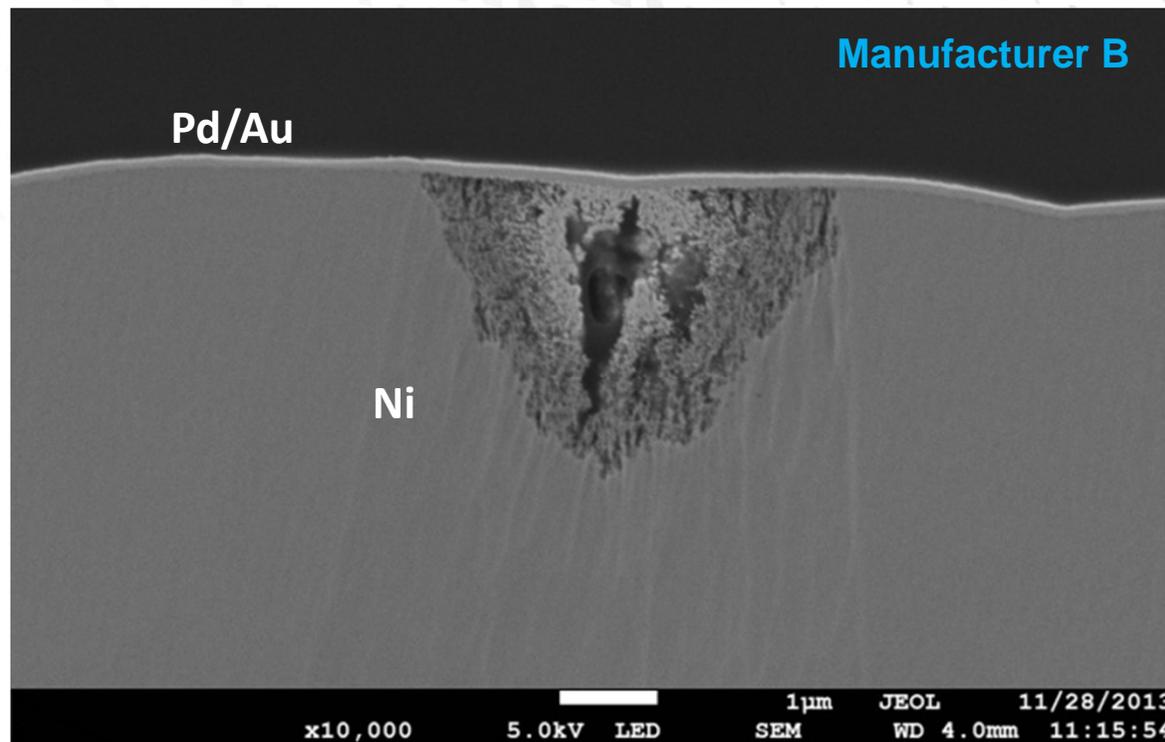
Corrosion spikes

- ✓ Observed in the Ni layer from 1 supplier (not using partly reductive gold-electrolyte)
- ✓ ENEPIG may not be completely immune against the black pad defect.
- ✓ Small number of spikes
- ✓ Not likely to affect the reliability of the solder joints

- Rather few defects on bare boards
- Boards all accepted for the assembly phase

- ✓ Adaptation of IPC standard on ENEPIG still needed
- ✓ One board showed a few “corrosion spikes” in the Ni layer indicating that ENEPIG may not be completely immune to the black pad defect.
- ✓ No problem related to the ENEPIG finish reported during the assembly of test vehicles with vapour phase, manual or repair process
- ✓ Optical and X-rays observations just after assembly fully compliant with ECSS-Q-ST-70-38C
- ✓ SEM/EDS analyses of the IMC layers performed to evaluate the impact of ENEPIG finishes manufacturers as well as on assembly processes
 - After vapour phase soldering and for most of the component types, the IMC layer had almost completely spalled off because of SnPb

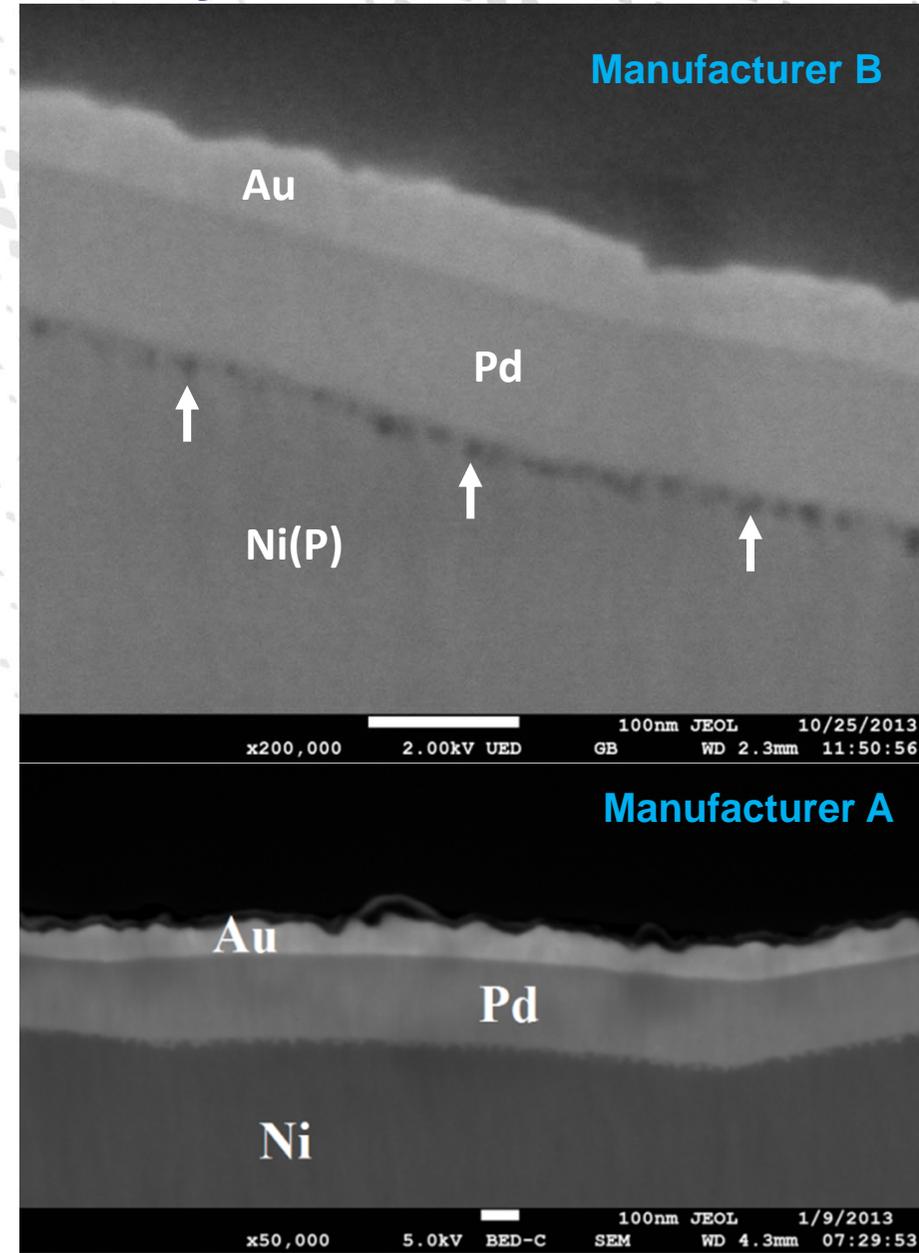
With larger magnification (up to x 200 000)

- ✓ Very thin dark band with inclusions of micro-voids
- ✓ Detected at the Ni/Pd interface on PCB from supplier and chemistry B (standard and CCGA types)
- ✓ Appearance similar to the dark band formed between Au and Ni in ENIG finishes consisting of Ni_3P
- ✓ Rather smooth interface on PCB from supplier and chemistry A
- ✓ Differences linked to the chemistries or to the process parameters (time and temperature)

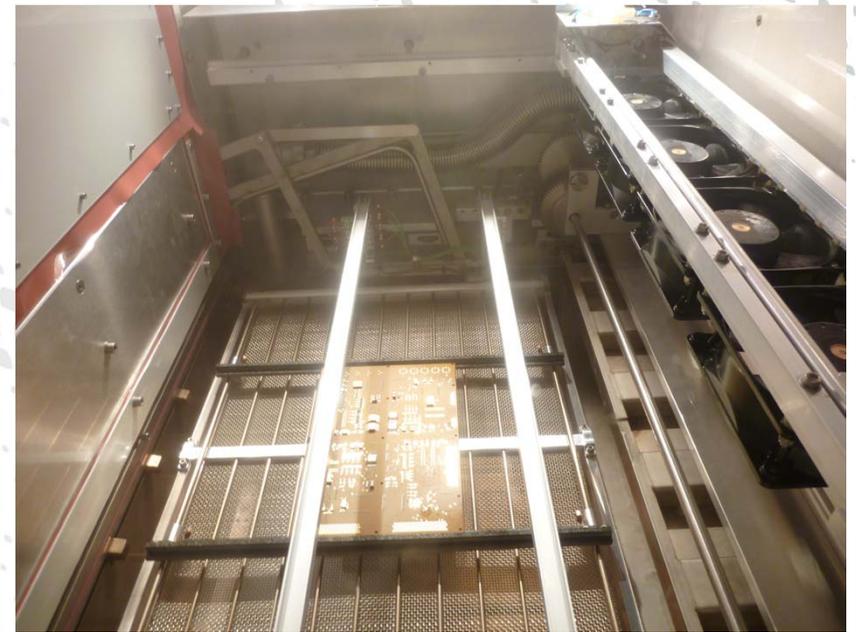
Processes

- ✓ Vapour phase soldering
- ✓ Hot air process for CCGA 625 repair plus some of the SMD0.5
- ✓ Manual soldering for CQFP plus connectors
- ✓ Manual repair or touch-up
- ✓ Thermal shocks on pads

Visual inspections after assembly

- ✓ No soldering defect (shortcut, de-wetting, cold solder joint or solder balls)
- ✓ Wettability of SnPb solders easier to observe with ENEPIG
- ✓ No great differences in the appearance between ENEPIG and fused SnPb finishes, neither for different packages
- ✓ Short reduction of stand-off

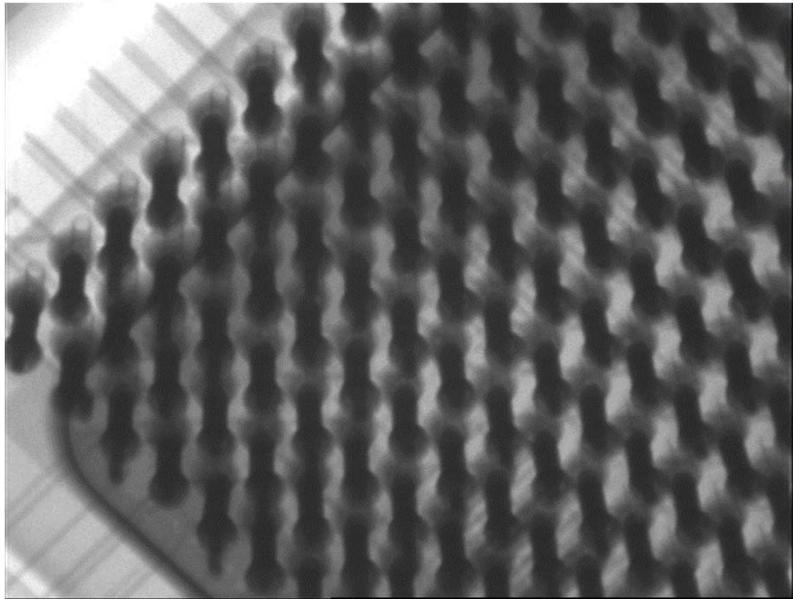
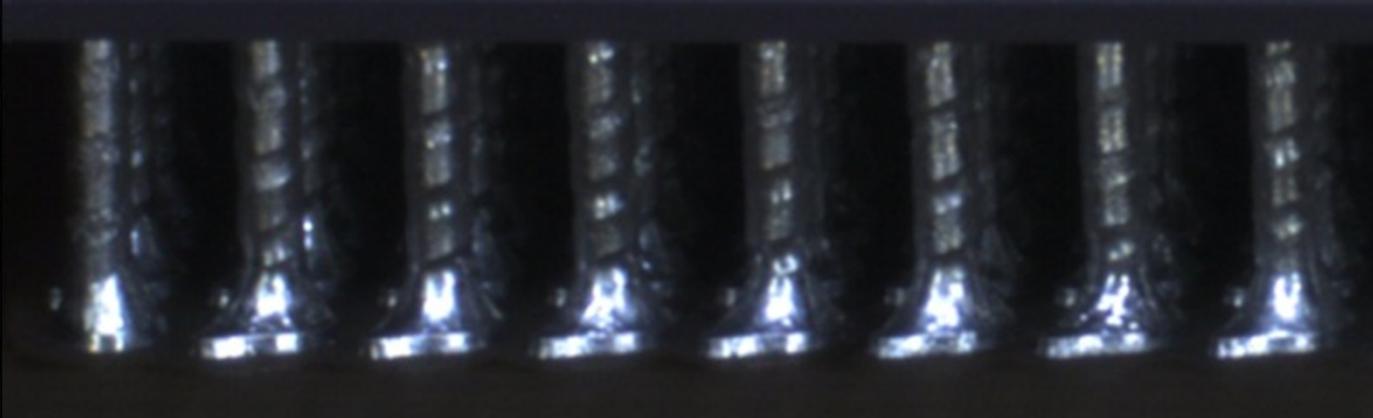
After assembly: Comparison ENEPIG / SnPb

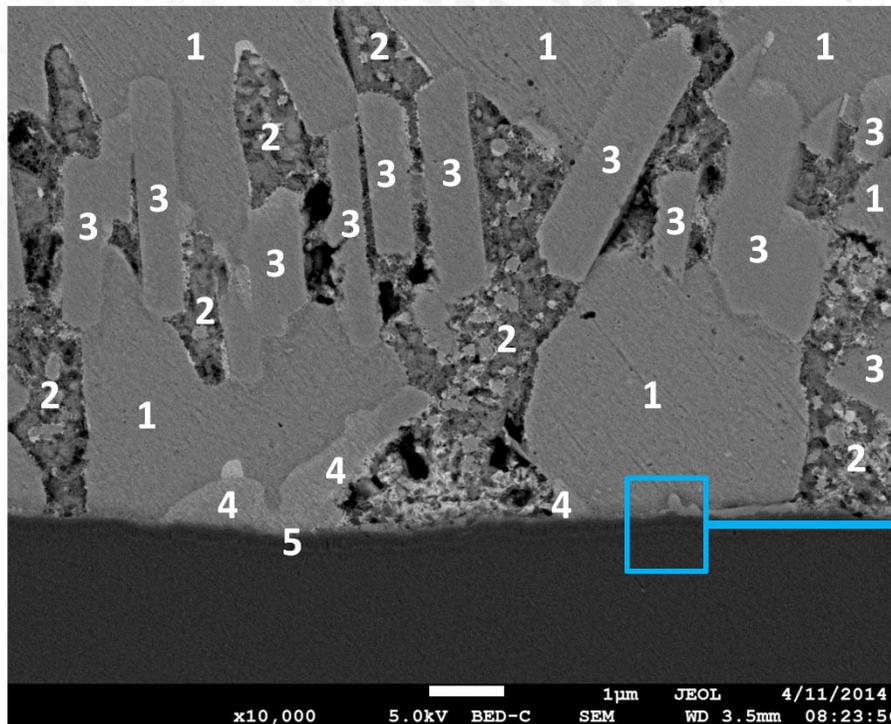
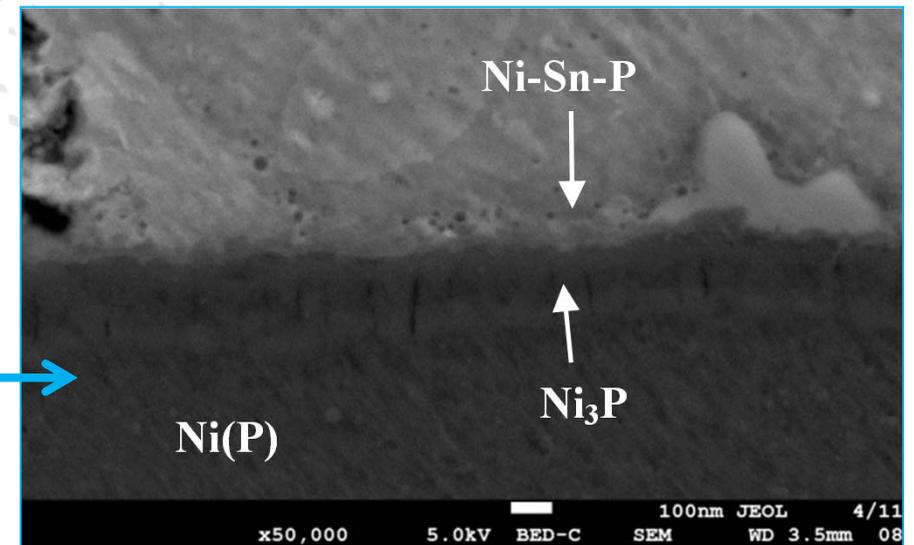
- ✓ Similar appearance for all components on the reference board
- ✓ IMC layer almost completely spalled off because of SnPb assembly
- ✓ Layer of Ni_3P with a thickness of about 200 nm observed at the uppermost part of the Ni(P) layer
- ✓ Thin layer (<50 nm) of nanocrystalline Ni-Sn-P on top of the Ni_3P layer
- ✓ No other IMC layer on top of the Ni-Sn-P layer except some AuSn_4 at some locations

2220 capacitor on ENEPIG from manufacturer A. 1) Sn, 2) Pb, 3) $(\text{Pd,Ni})\text{Sn}_4$, 4) AuSn_4 and 5) Ni_3P

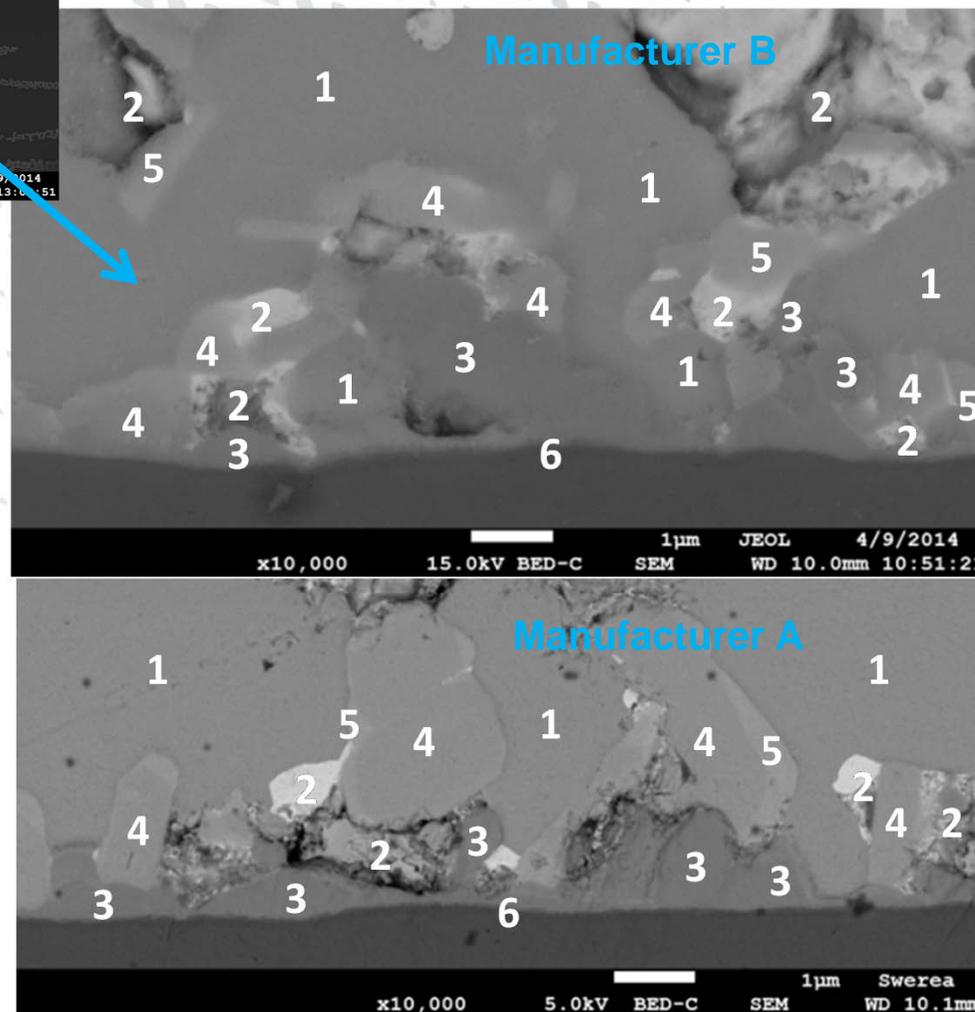
- ✓ Very similar for the two components from 2 different OEMs
- ✓ IMC layers are a complex mix of at least 3 phases: $(\text{Cu,Ni})_6\text{Sn}_5$, PdSn_4 and AuSn_4
- ✓ Ni-Sn-P and Ni_3P layers beneath these IMC layers with mixed IMC phases
- ✓ the Cu from the copper ribbons (or from the repair process) has prevented the spalling of the IMC layer that occurred for the other types of components

SEM/EDS analysis after 500 TC on CCGA 625 boards from manufacturers A and B
1) Sn, 2) Pb, 3) $(\text{Cu,Ni})_6\text{Sn}_5$, 4) PdSn_4 , 5) AuSn_4 and 6) Ni_3P

- ✓ Assembly of the CCGA 625 packages successful equally for the two OEMs.
 - All the parts still OK up to 1500 cycles
 - Nominal and equivalent ageing of the solder joints after vibrations (shocks) plus 500 thermal cycles
 - No critical defects likely to question the assembly of the columns on the package or on the board
 - No damages at PCB level.
- ✓ Detailed IMC analyses on CCGA 625 after vibrations, shocks and 500 cycles
 - No significant changes compare to t0
 - Same kind of interfaces for both manufacturers
 - IMC layers had not spalled off as for the other component types
 - Cu dissolved from the Cu ribbon in the solder columns seems to have a very beneficial impact on the IMC layers

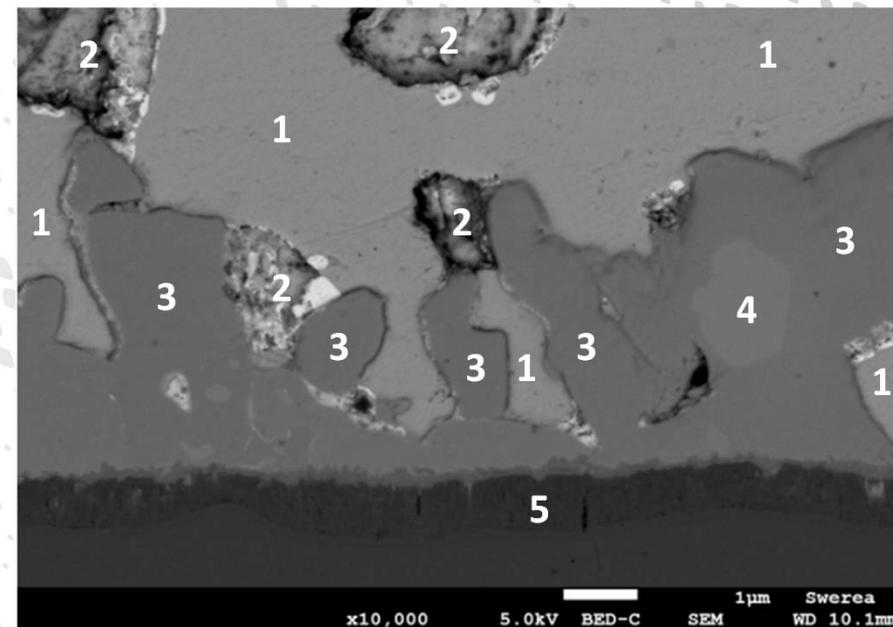
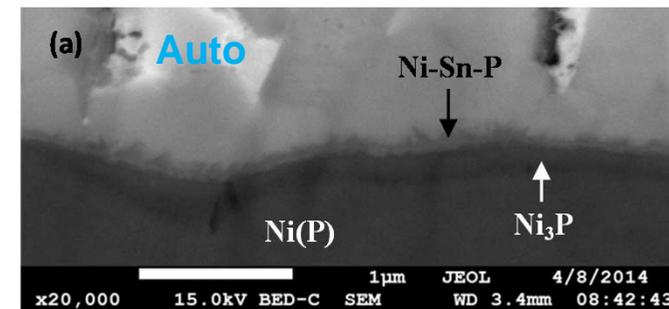
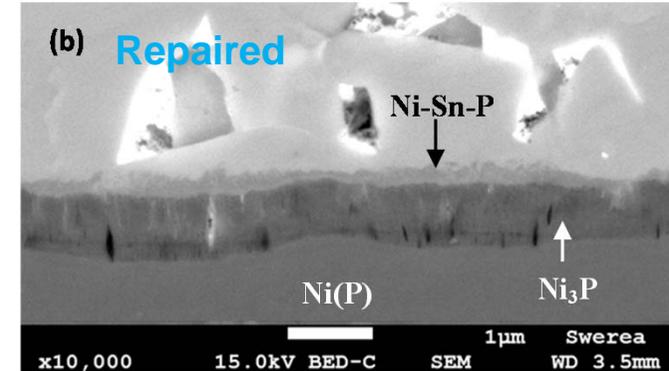
- ✓ Pd and Au completely missing in the IMC layer (removed while stripping using a Cu solder wick braid)
- ✓ Considerably more copper in the IMC layer on the repaired sample (origin determination in progress)
- ✓ Ni₃P and Ni-Sn-P layers considerably thicker for the repaired CCGA 625 component
- ✓ Lot of crevices between the columns in the Ni₃P layer for the repaired component, of which some are filled with Sn

SEM/EDS analysis after 500 thermal cycles of repaired CCGA 625 board.
1) Sn, 2) Pb, 3) (Cu,Ni)₆Sn₅, 4) (Ni,Cu)₃Sn₄ and 6) Ni₃P

- ✓ Detailed IMC analyses on CCGA 625 repaired after vibrations, shocks and 500 cycles
 - Repair increases considerably the thickness of the Ni₃P and Ni-Sn-P layers
 - Also increases the amount of crevices in the Ni₃P layer.
 - It does not seem to have affected the reliability of the CCGA components but it might do that for components if the IMC layer is spalled off.
- ✓ The impact of the spalling of the IMC layers on the reliability during the environmental tests for the other component types than CCGA has **not yet been evaluated but this evaluation is ongoing.**
