Latent short circuit failure in high-rel PCB caused by lack of cleanliness of PCB processes and base materials

Stan Heltzel
European Space Agency

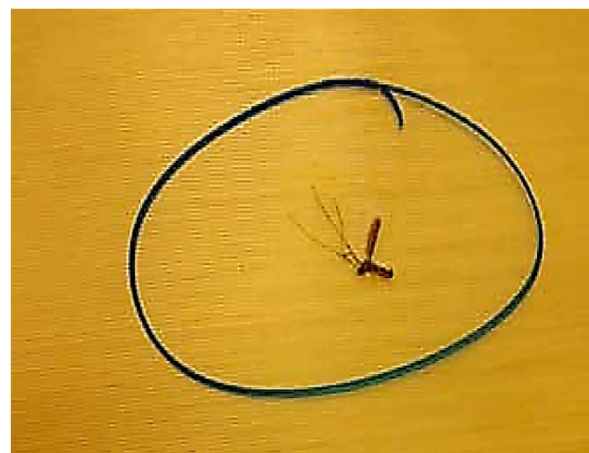
1. Latent short circuit - Contamination

Sources:

- PCB manufacturing processes
- Base material supply

Types:

- Cl-bearing particles
- Metallic debris
- Organic residue
- Dust
- Fibers
- FR4 resin dust in polyimide
etc

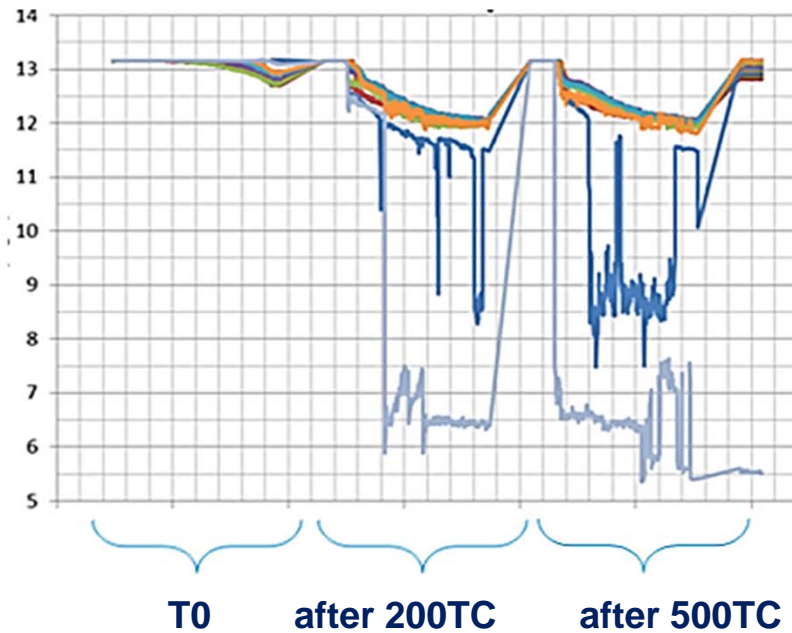
fiber contaminated

- 1 kV/mm provide adequate insulation after TC in absence of contamination
- Fiber contamination provides pathway for electromigration
- In this case, PCB manufacturing is the origin of fiber contamination.

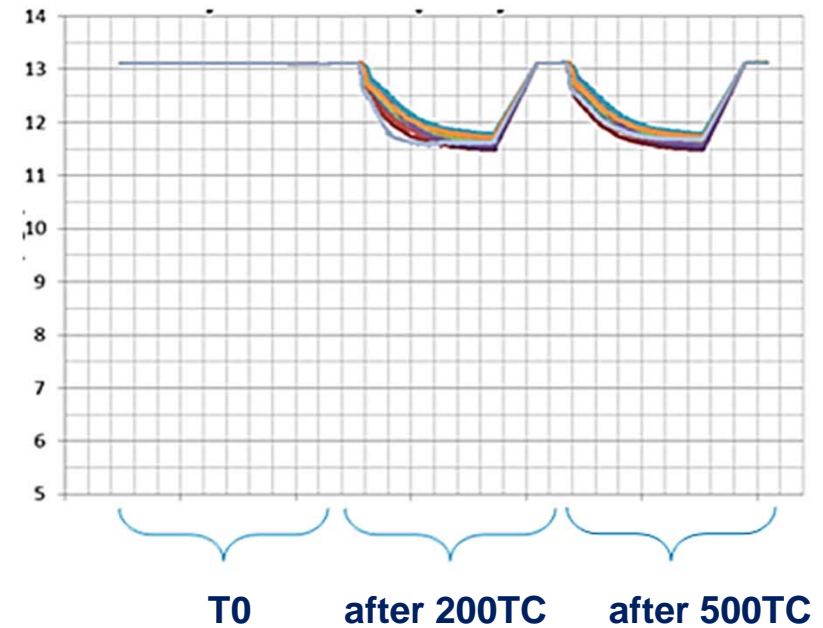
breach of insulation after TC

no contamination observed

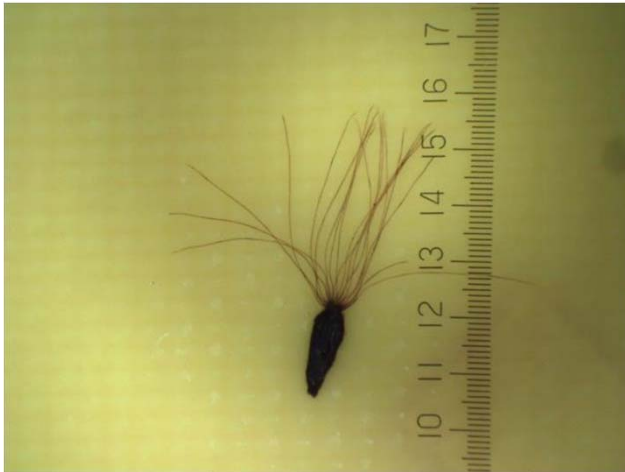
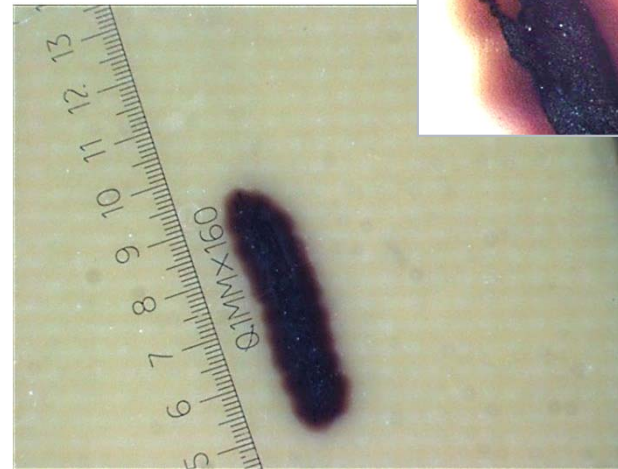
2. Risk mitigation – PCB manufacturer

a) Incoming sample inspection on base laminate

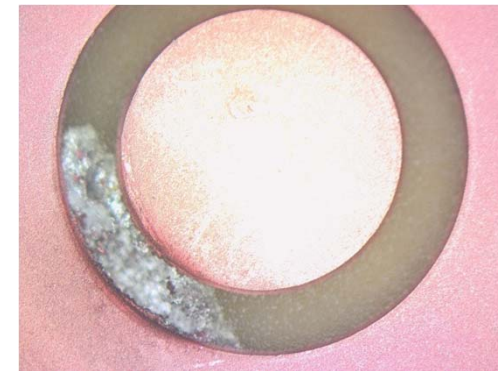
2. Risk mitigation – PCB manufacturer

b) Inspection on etched inner layers:

AOI

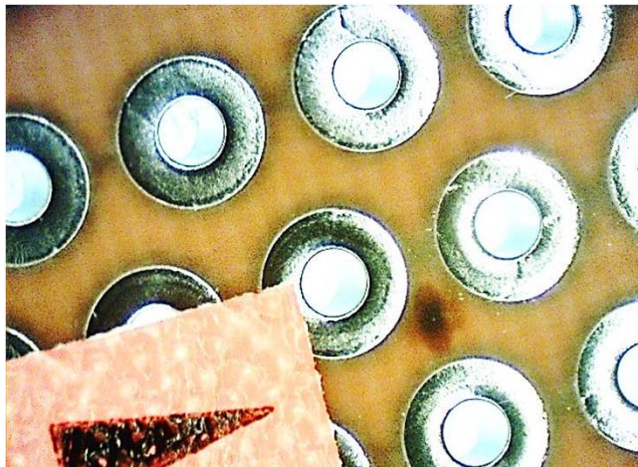
2. Risk mitigation – PCB manufacturer

e) Inspection on external layers

Note: these are laminates, not prepreg
