# Investigation into cause and effect of tin lead diffusion into copper plated through hole barrels during accelerated high temperature testing

PWB Interconnect Solutions Inc.

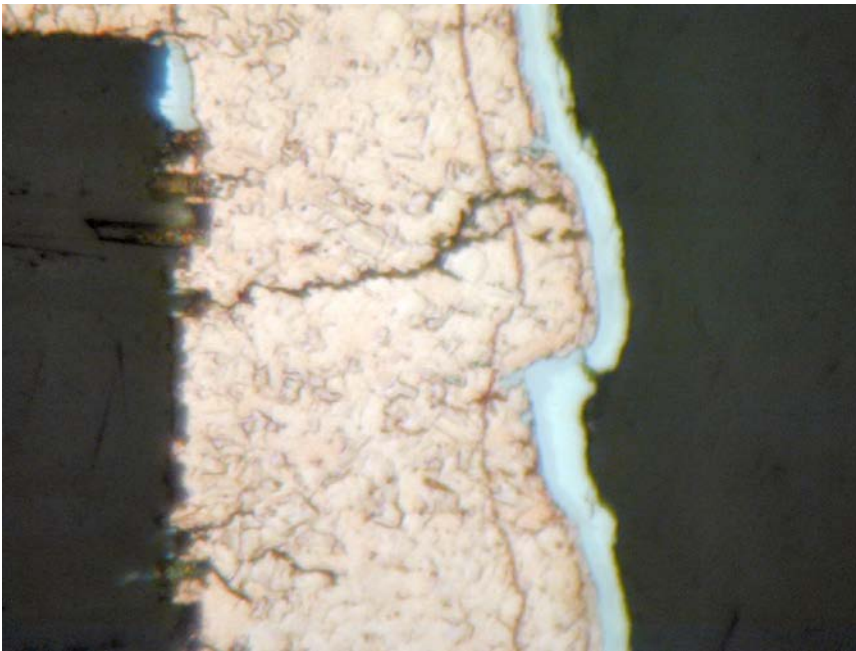
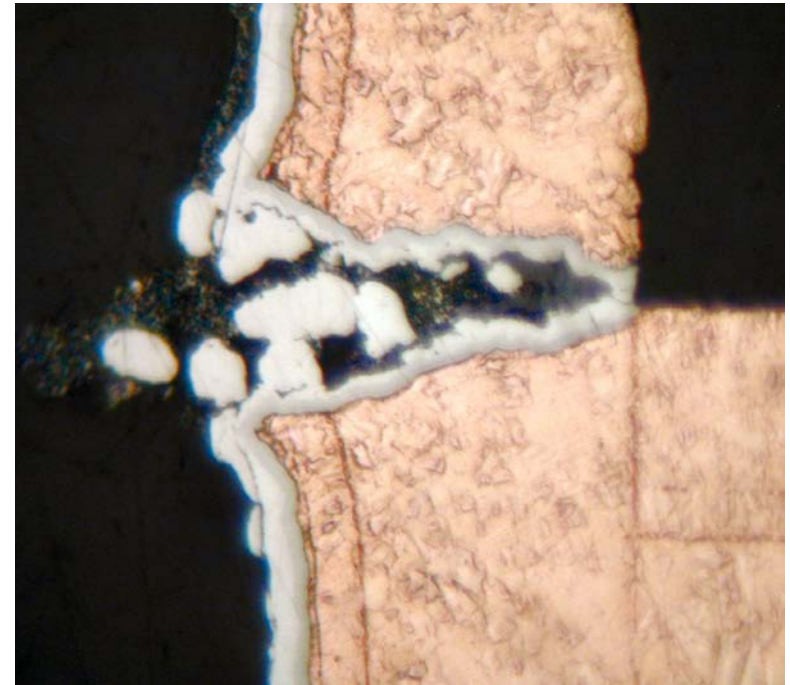
- Remove Simulated Preconditioning from test, cycle at 170°C
