# *Latent short circuit failure in high-rel PCBs caused by lack of cleanliness of PCB processes and base materials*

**Abstract**— Latent short circuit failures have been observed during testing of Printed Circuit Boards (PCB) for power distribution of spacecraft of the European Space Agency. Root cause analysis indicates that foreign fibers may have contaminated the PCB laminate. These fibers can provide a pathway for electromigration if they bridge the clearance between nets of different potential in the presence of humidity attracted by the hygroscopic laminate resin. PCB manufacturers report poor yield caused by contamination embedded in laminate. Inspections show that fiber contamination is present on prepreg and etched inner layers. Further fiber contamination may be attracted in the manufacturing environment due to static charging. The requirements for cleanliness that are specified for final PCBs are orders of magnitude more stringent than those specified for base materials. This paper describes inspections performed on base materials, manufacturing processes and final PCBs. It describes test methods that detect reduced insulation caused by contamination and electromigratio

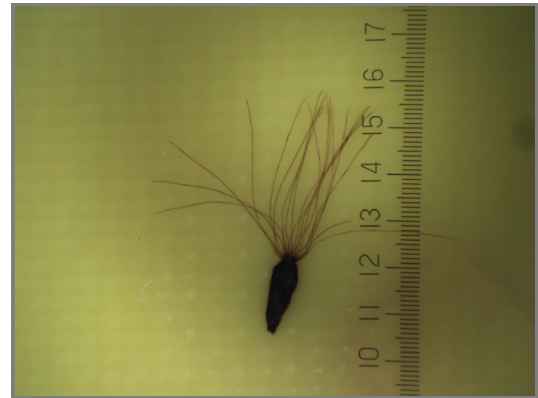
Fig. 8. Top view of a laminate after etching of copper cladding, showing a plant seed embedded in the dielectric material, probably carried into the clean room on clothes of personnel. The scale is in mm.

IPC-4101 [8] specifies sample frequency and criteria for acceptability of sub-surface imperfections. Some PCB manufacturers use this as a test method for incoming inspection of batches of base laminates. The method may be inefficient, since copper cladding needs to be etched from the laminate before inspection is possible, after which the laminate cannot be used anymore for PCB manufacture. Furthermore, the sample size needs to be significant to provide reliable statistics due to the probabilistic nature of contamination. Nevertheless, this method is a useful addition to the total package of risk mitigations, as it provides the PCB manufacturer with a simple quantification of cleanliness. In case of non-compliance to IPC-

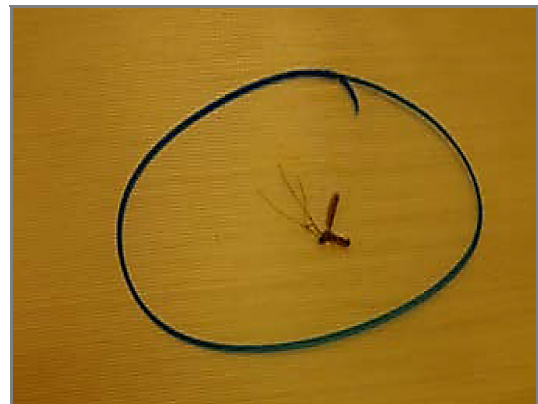
Fig. 9. Top view of a prepreg showing an embedded insect.

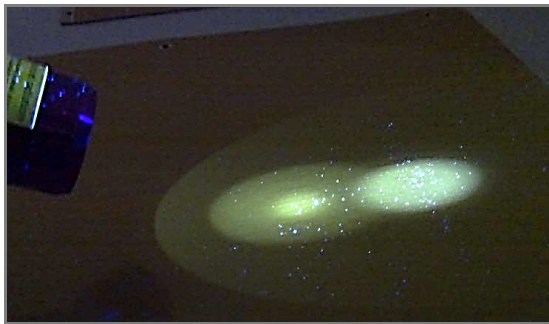
Fig. 12. Inspection of a sealed bag of polyimide prepreg showing UV fluorescence of particulate contamination.

Verification of the efficiency of the cleaning can be done by visual inspection under bright light and ultraviolet (UV) light. UV flash lights as well as bright lights are readily available in various wavelength ranges. Using UV light inspection it was shown that sealed bags of polyimide prepreg are occasionally contaminated as delivered from the base material supplier. Polyimide resin dust was shown not to be fluorescent, whereas epoxy resin as well as dust fibers do show UV fluorescence. Either source of contamination is unacceptable in polyimide production processes at high temperature.

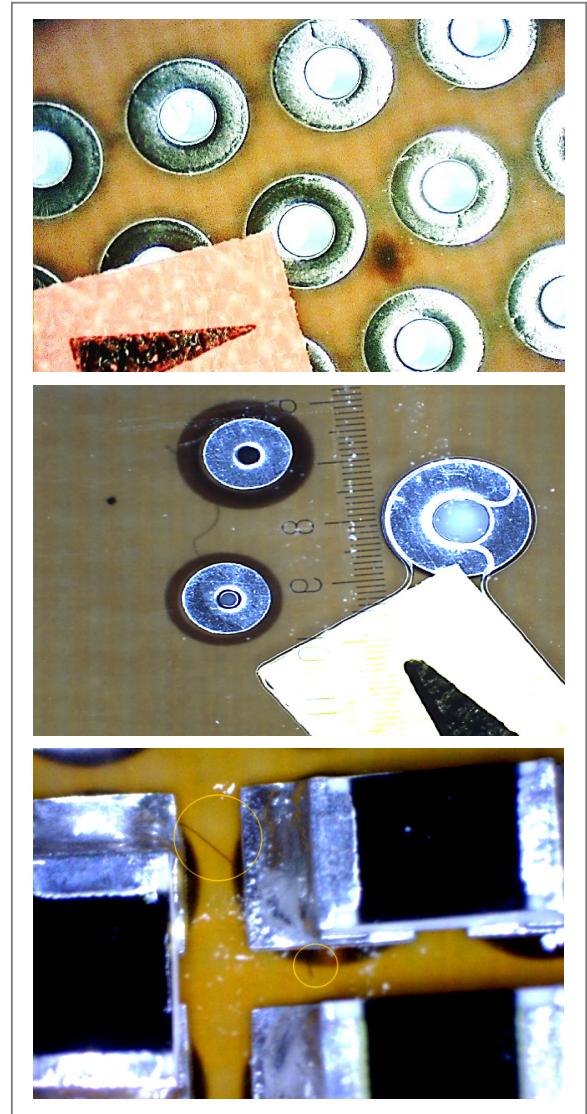
Fig. 13. Contamination embedded in base laminate on external layers bridging the insulation between pads, at outgoing inspection and after assembly.

In some recent cases, small but critical fiber contamination remained undetected at outgoing inspection as well as incoming inspection at the customer, which is described as NC#1 as part of ESA Alert EA-2014-EEE-3-A. Only after assembly and conformal coating, it was discovered that fiber

contamination was embedded within the outer layer laminate and bridging the gap between pads. Waiving such non-conformance by repair and testing under careful assessment by NRB was performed but requires high effort and cost, in particular when the delivery of the PCB assembly is on the critical path of satellite integration.
