2nd SPCD 12-14 October 2016

Passive components :
Feedback of 5 years of analysis
From all Electronic Sectors

Eric ZAIA (Material Engineer)

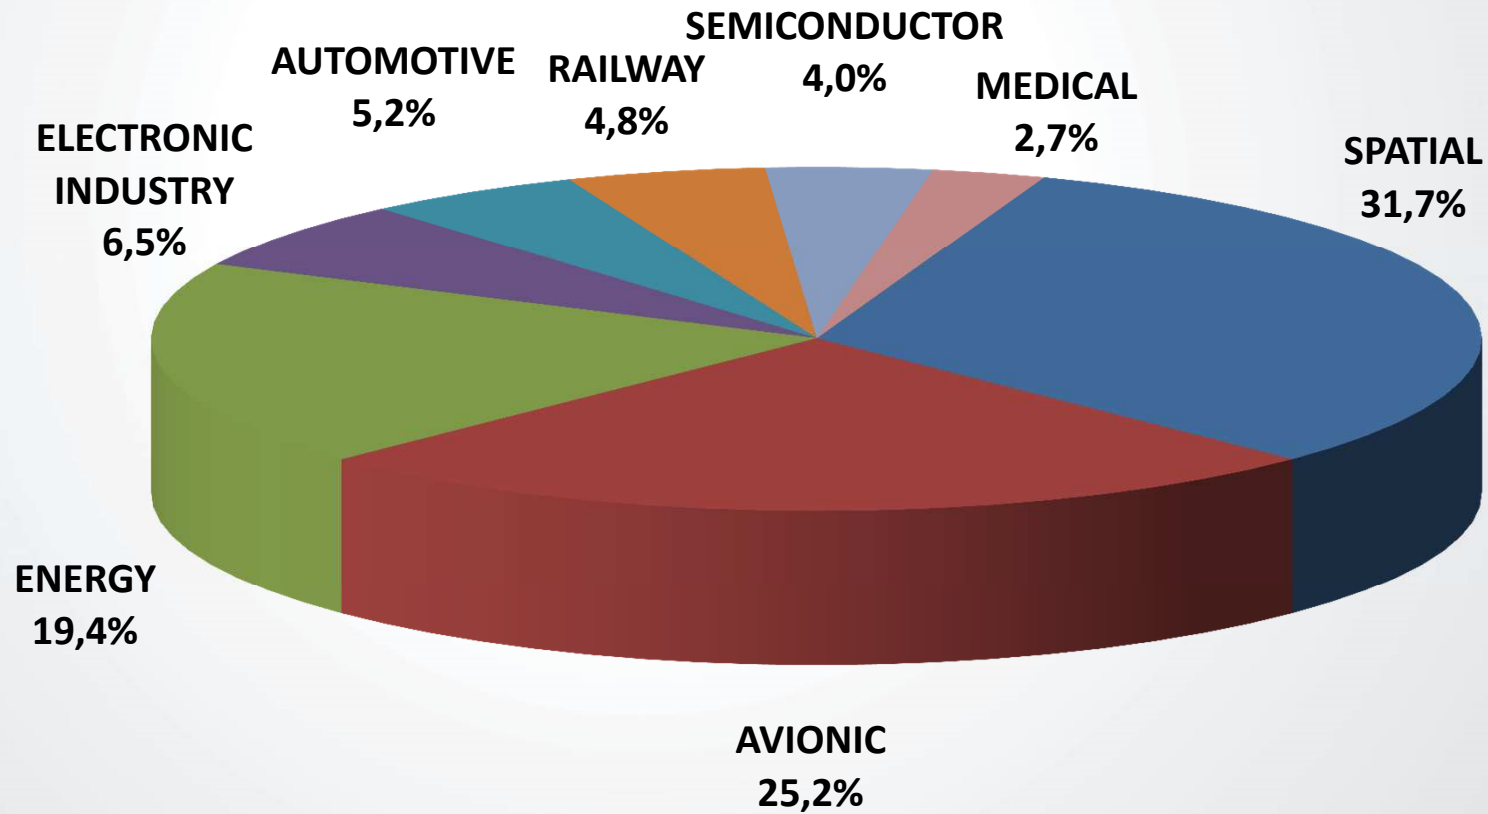
Physical Expertise Main sectors (by Turnover)

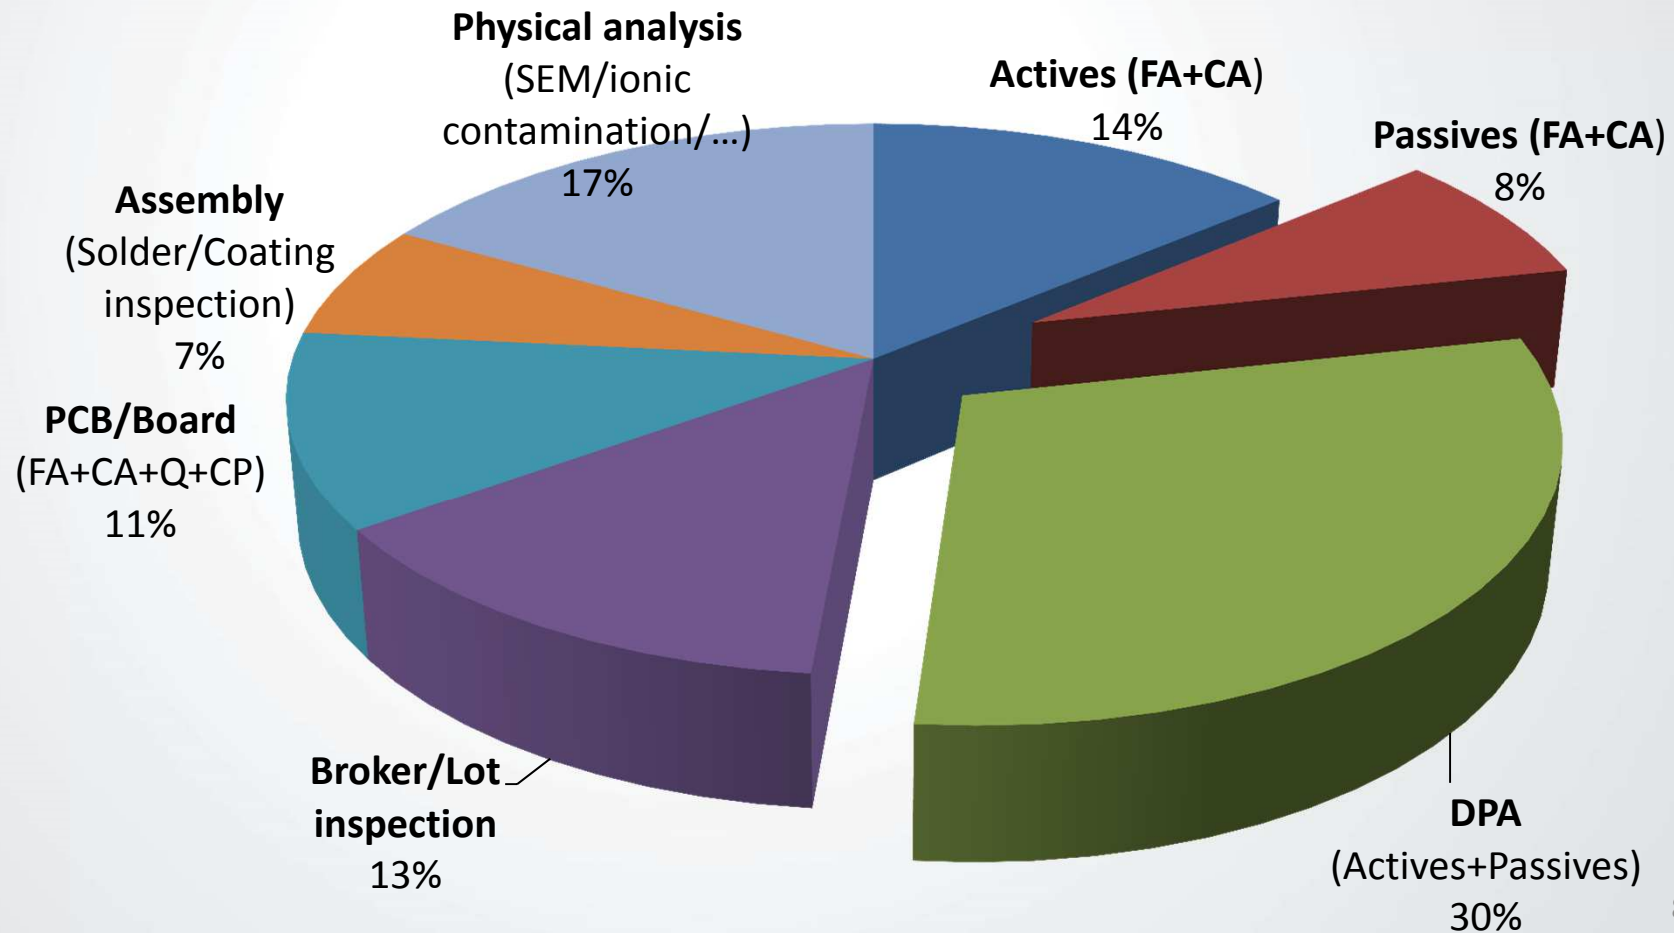
Physical Expertise Type of analysis (by quantity)

- From 2011 to 2015: 19 700 analysis

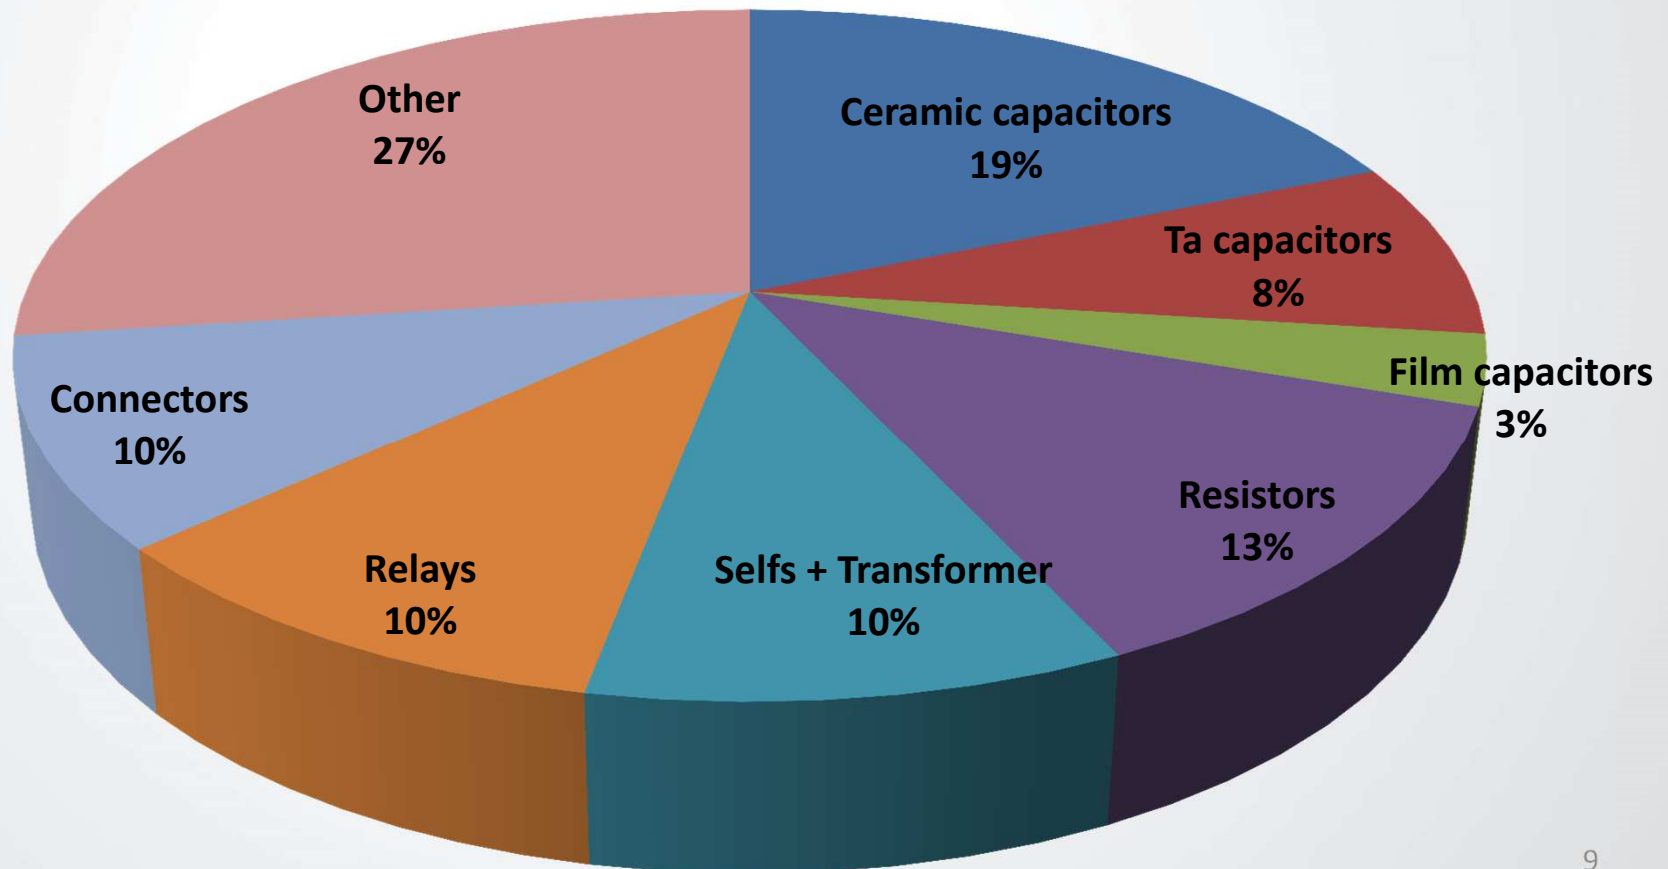
Type of component (by quantity)

- From 2011 to 2015: 1 200 failures analysis on passive components

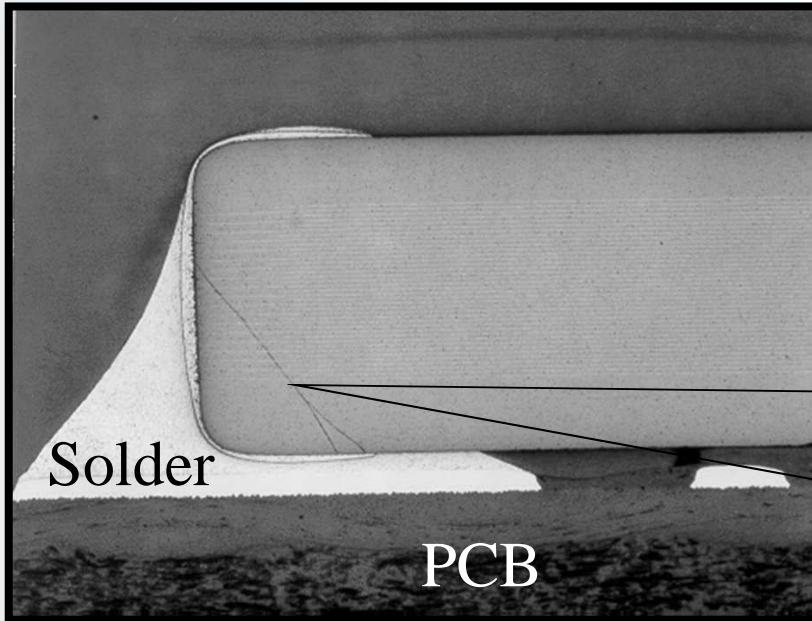
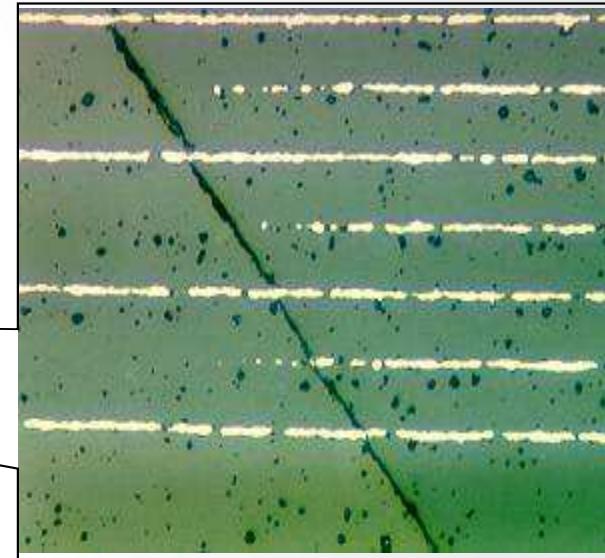
Diagonal cracks (@45°) due to Thermo and/or Mechanical stresses soldering/testing/depanelization/handling...

→ **Short circuit when opposite electrodes are cracked**

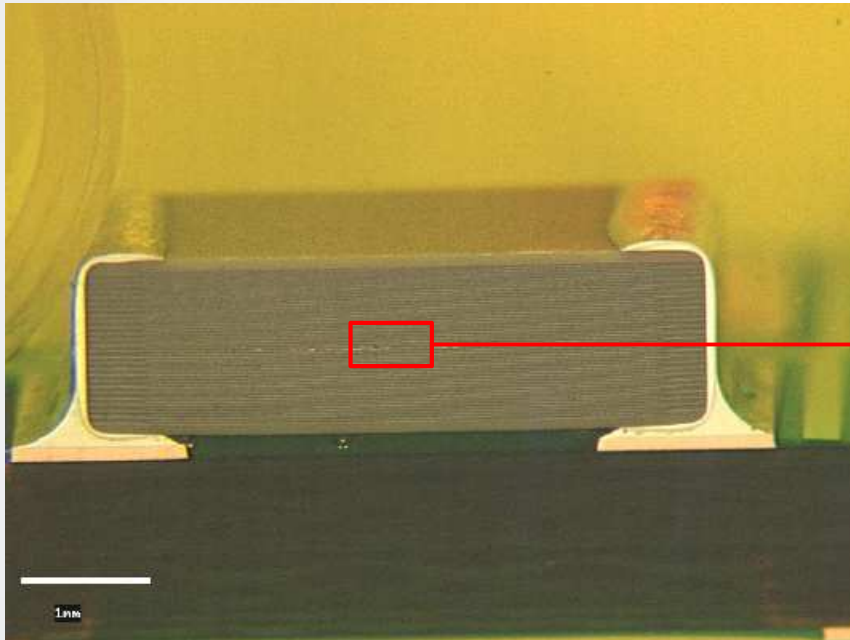
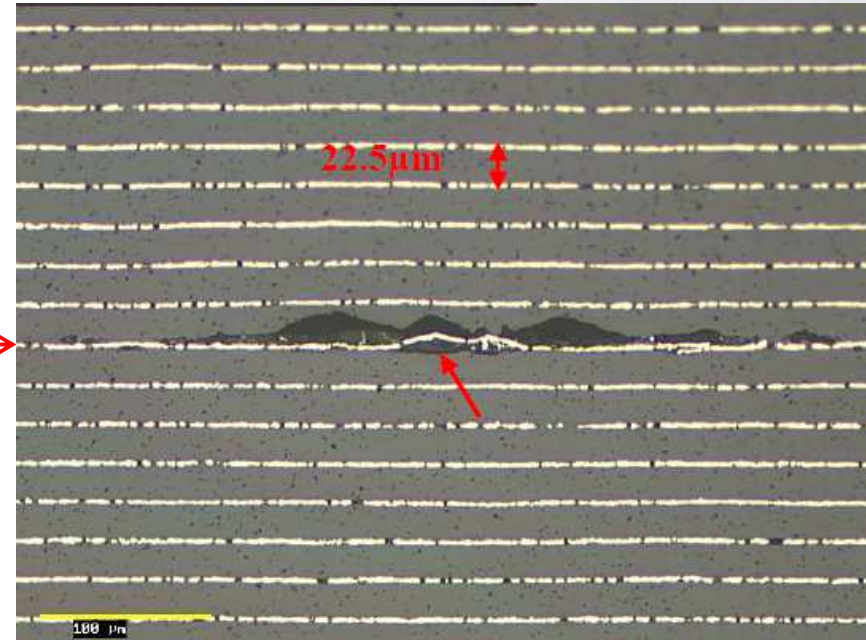
Ceramic Capacitors Delamination: Electrode/Ceramic

Delamination relative to the component process: Sintering
→ **Insulation reduction up to Short circuit**

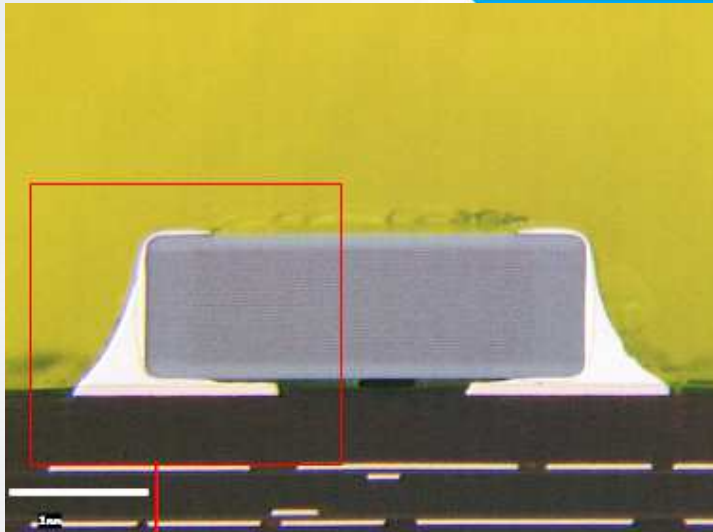
Ceramic Capacitors Delamination Electrodes/Termination

Soldering process + Component Weakness
→ **Loss of capacitance up to Open circuit**

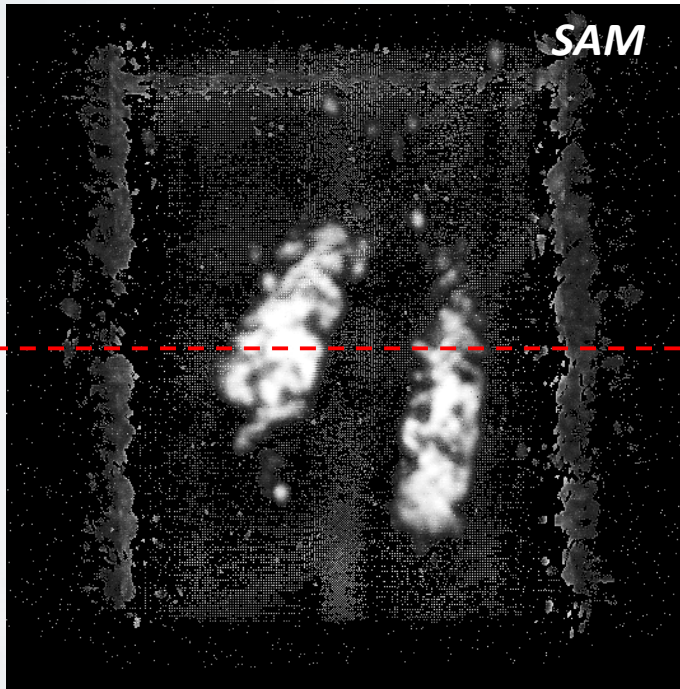
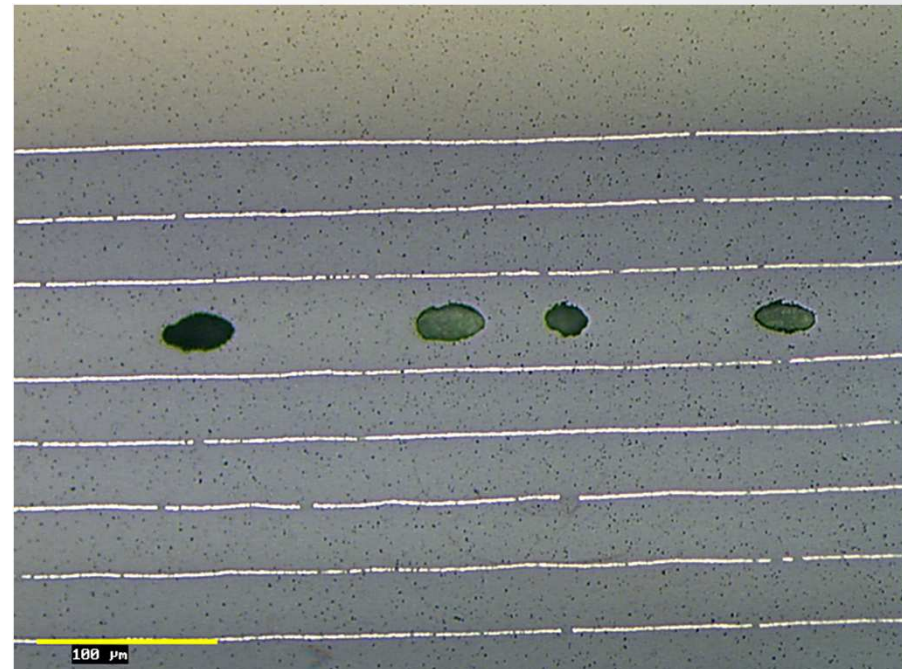
- Component quality
 - Ceramic preparation issue or organic/inorganic contamination
- Insulation reduction up to short circuit**

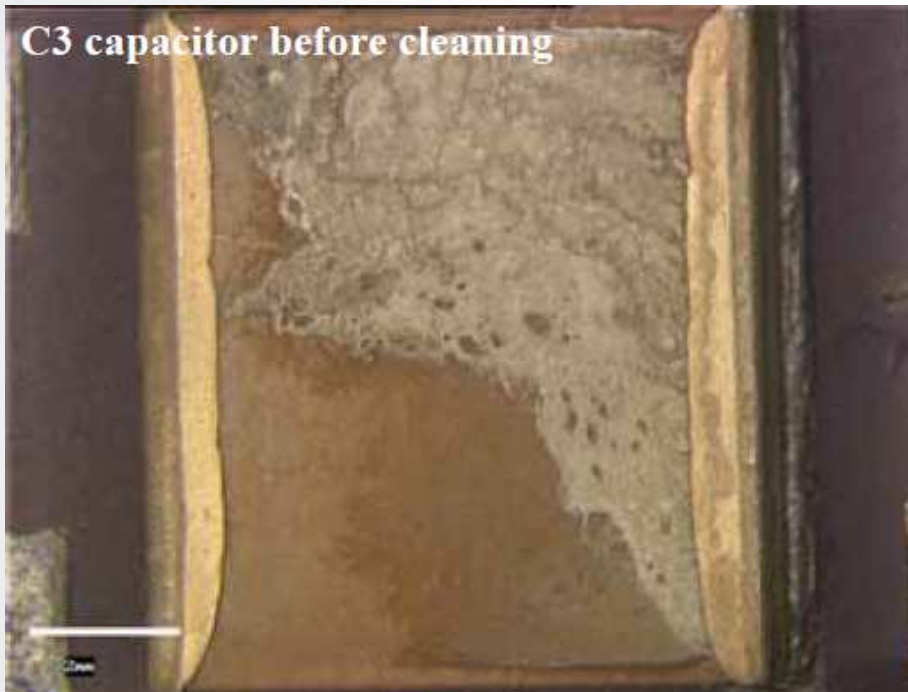
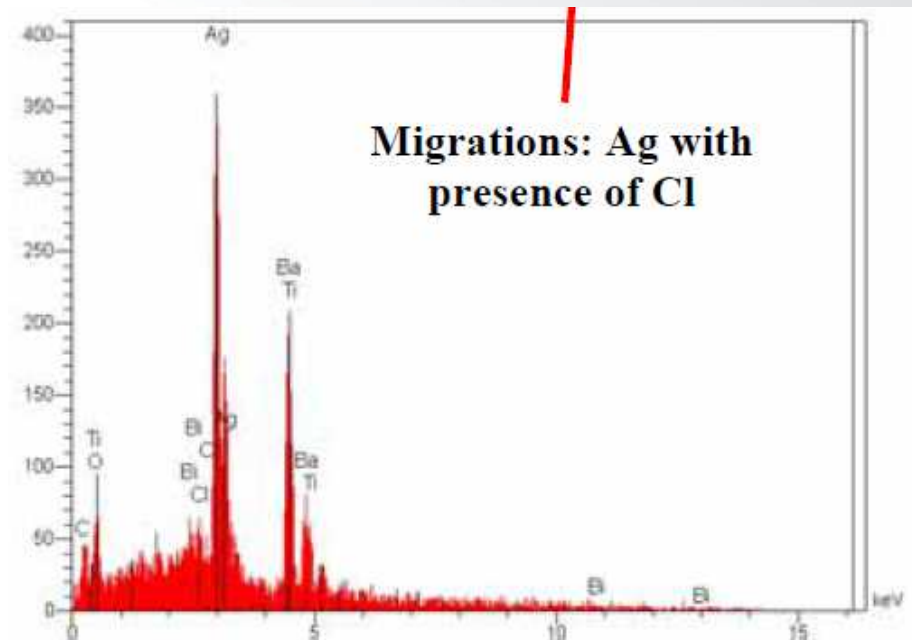
Environment: moisture and contaminant (Cl,..) leading to a dendritic growth of metallic material (Cu, Ag, ...)

→ **Short circuit**

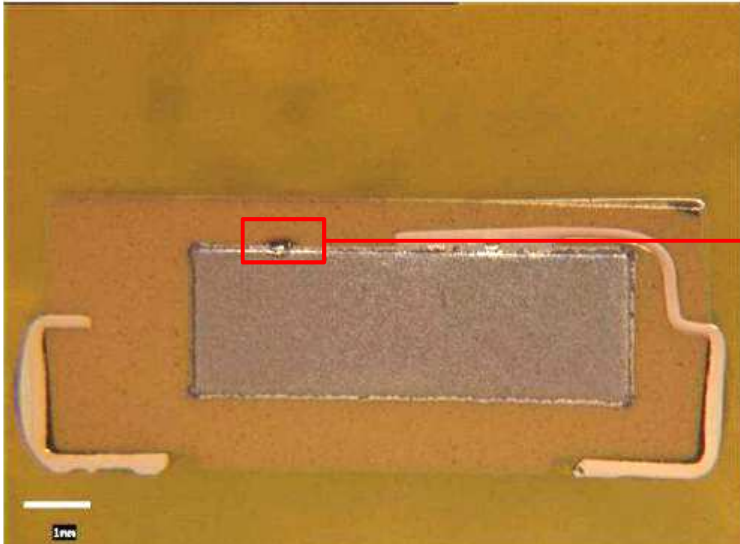
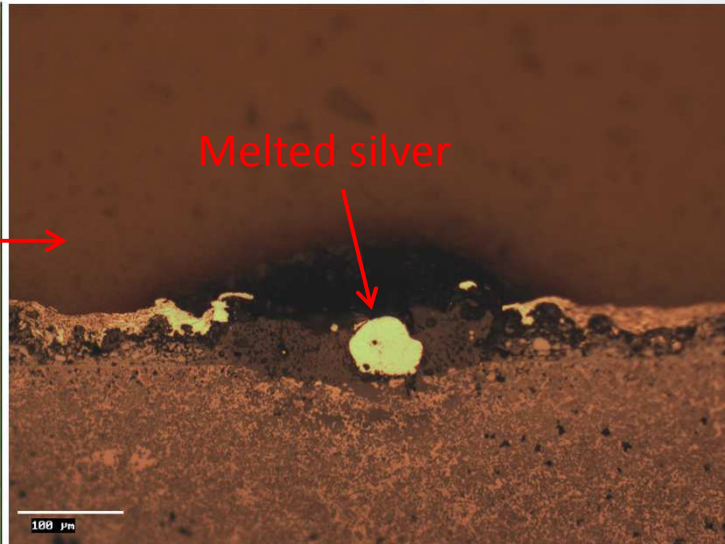
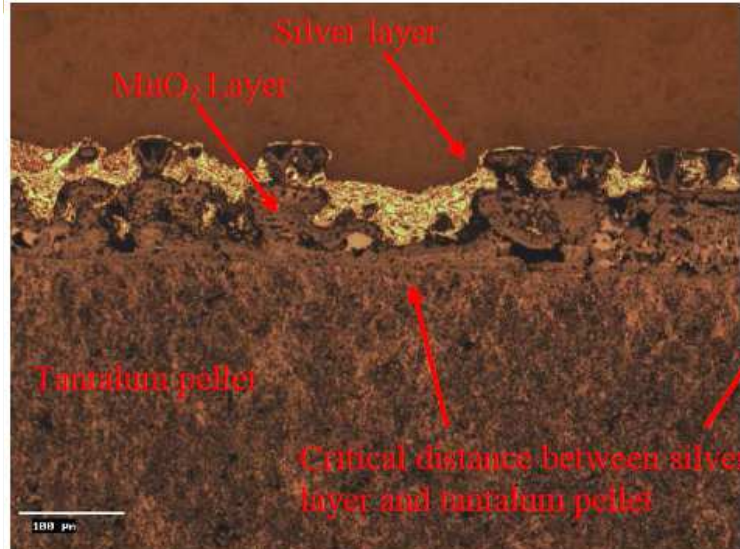
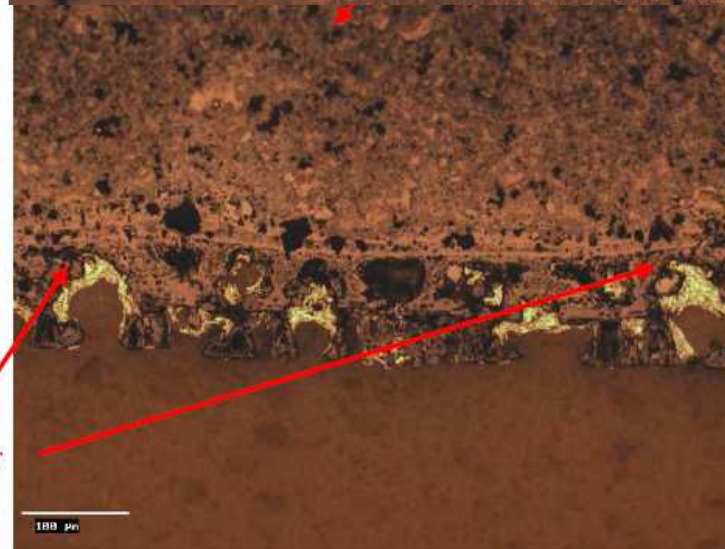
Tantalum Capacitor MnO₂ deposition

- Component quality
 - MnO₂ layer not homogeneous
 - Ag penetration
- Short circuit**

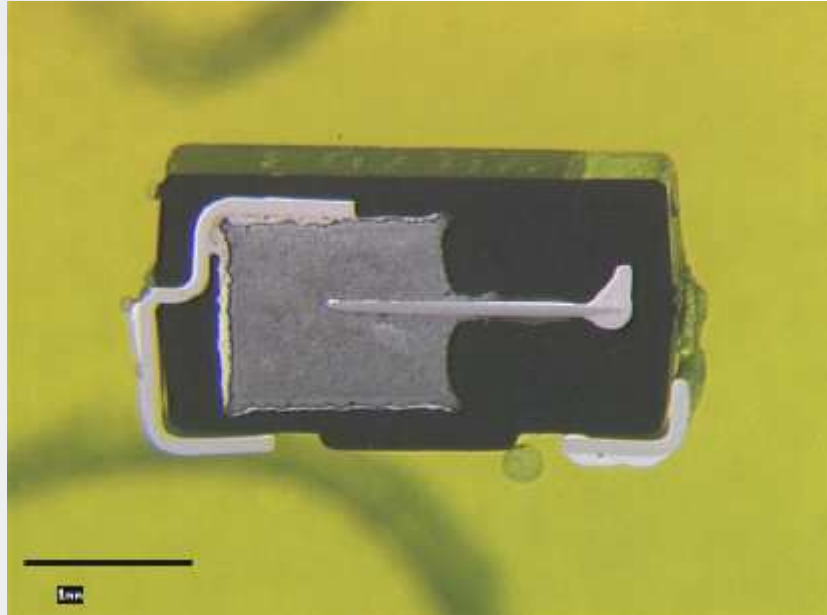
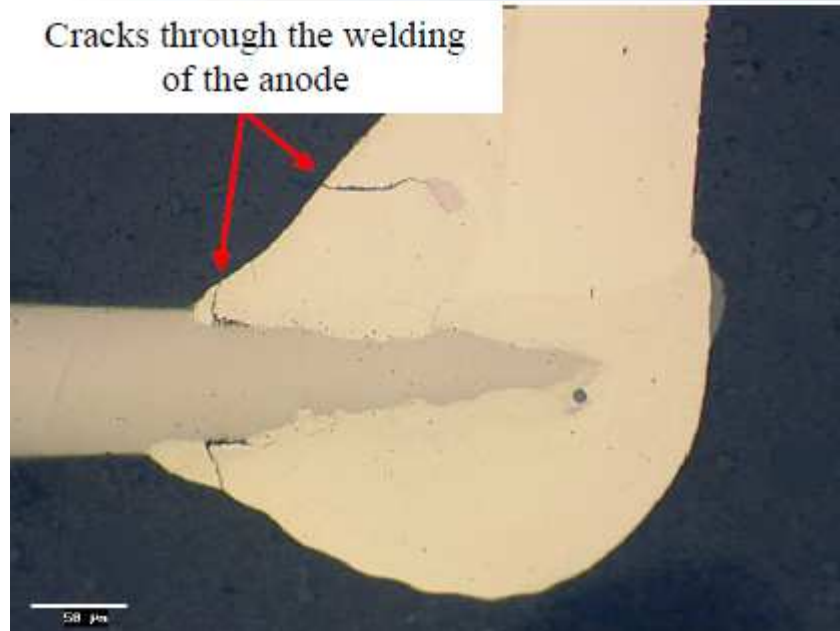
Tantalum Capacitors Anode Welding

- Component quality
 - Cracks on the anode solder
- **ESR increase**

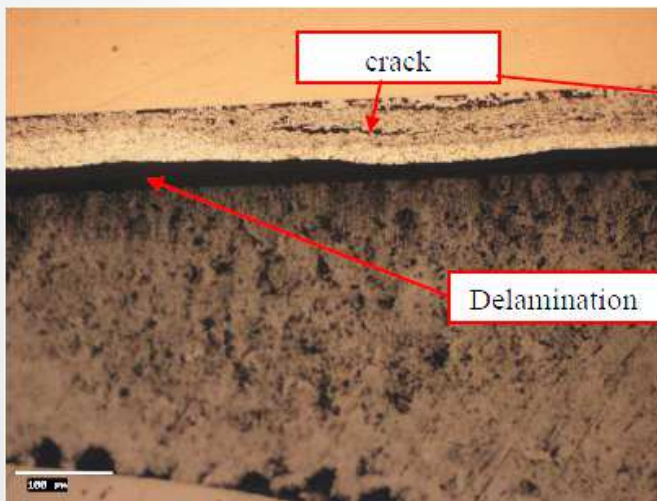
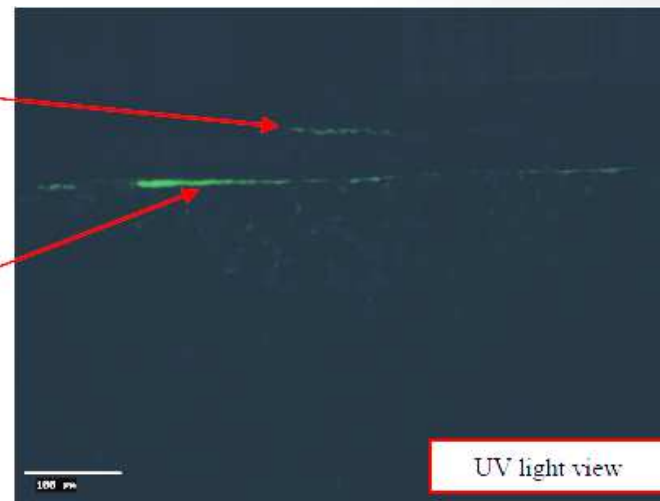
Delamination due to component quality or assembly process
→ ESR increase up to thermal runaway

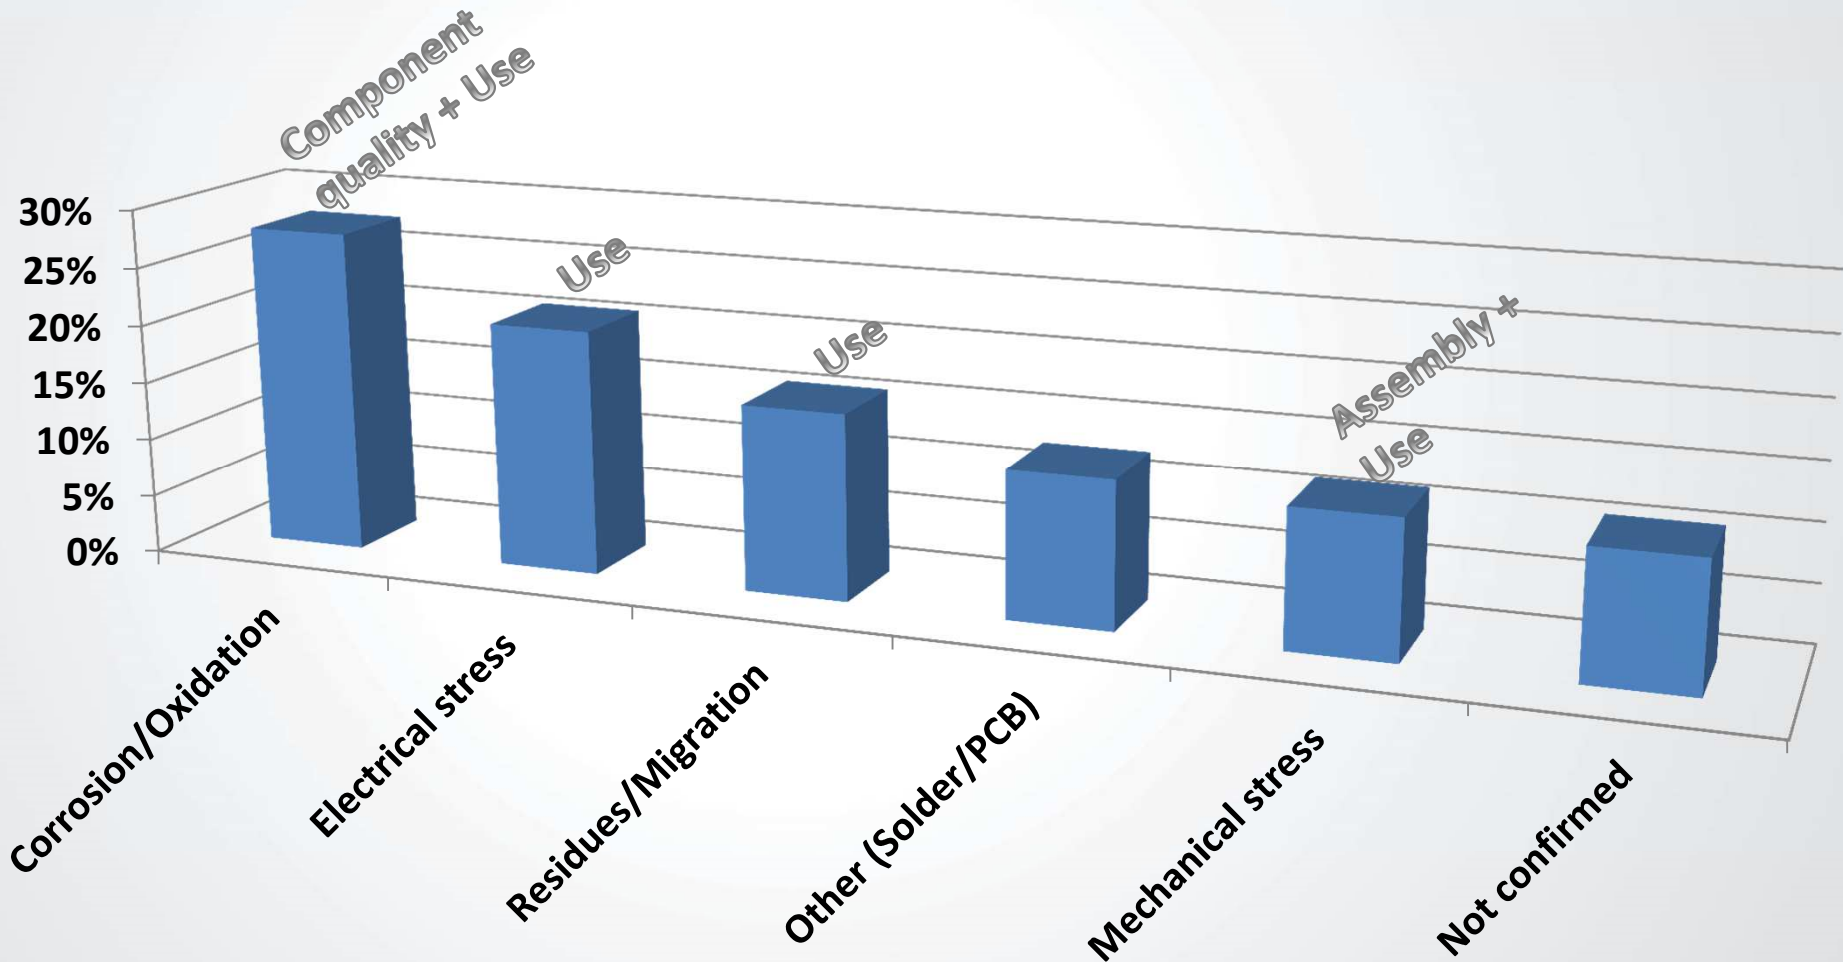
SMT Resistors (Thick+Thin film)

Main defects

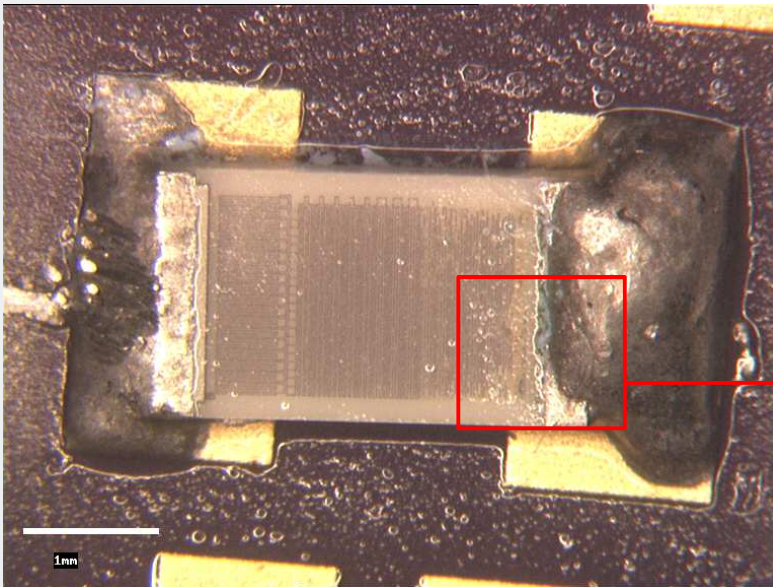
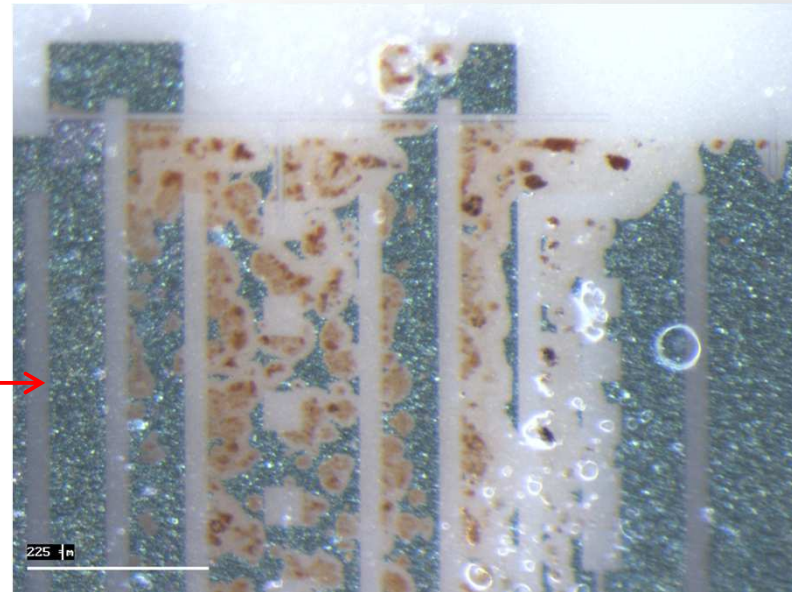
SMT Resistors (Thin film) Corrosion

Oxidation of the resistive layer in presence of humidity
→ **Resistance increase to Open circuit**

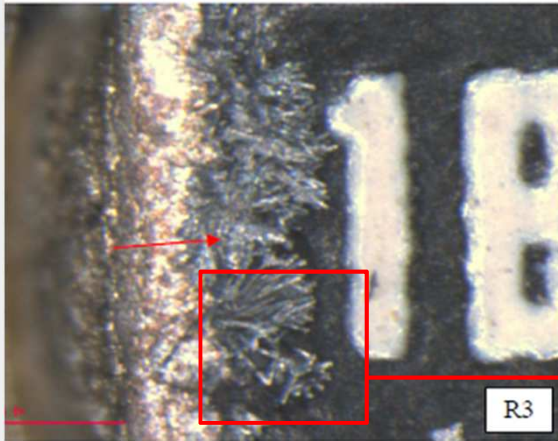
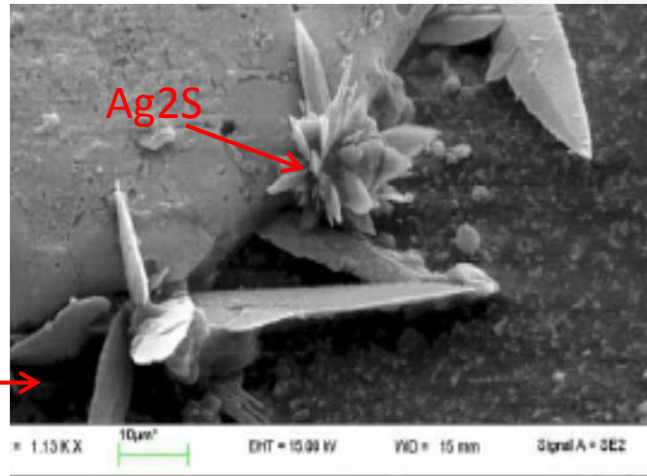
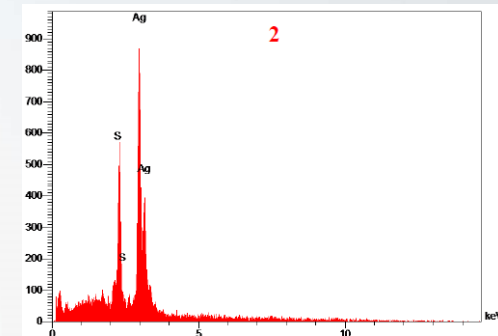
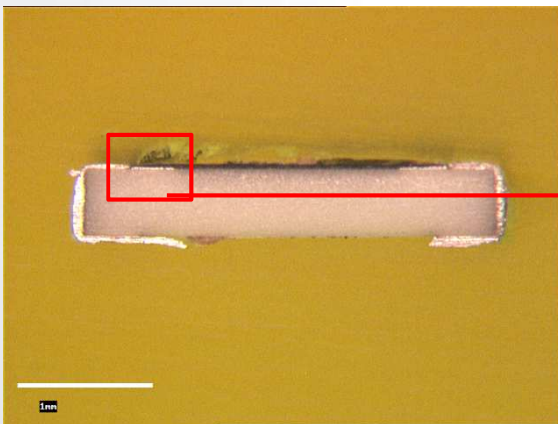
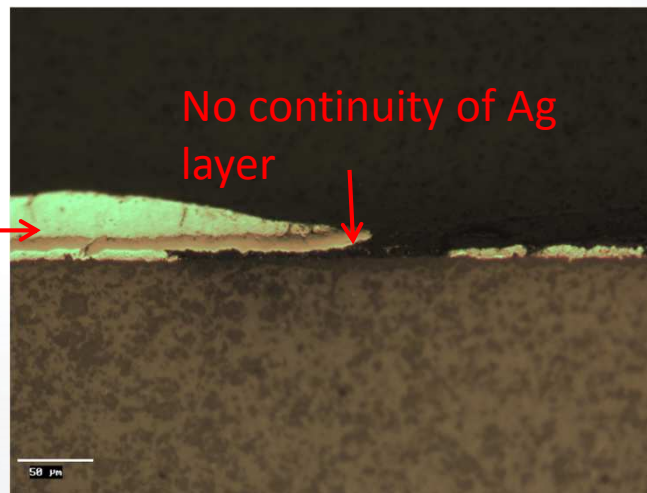
SMT Resistors (Thick film) Corrosion (sulfuration)

Environment:
Sulfur attack of silver occurs at the interface of the glass passivation layer and the resistor termination

→ **Open circuit**

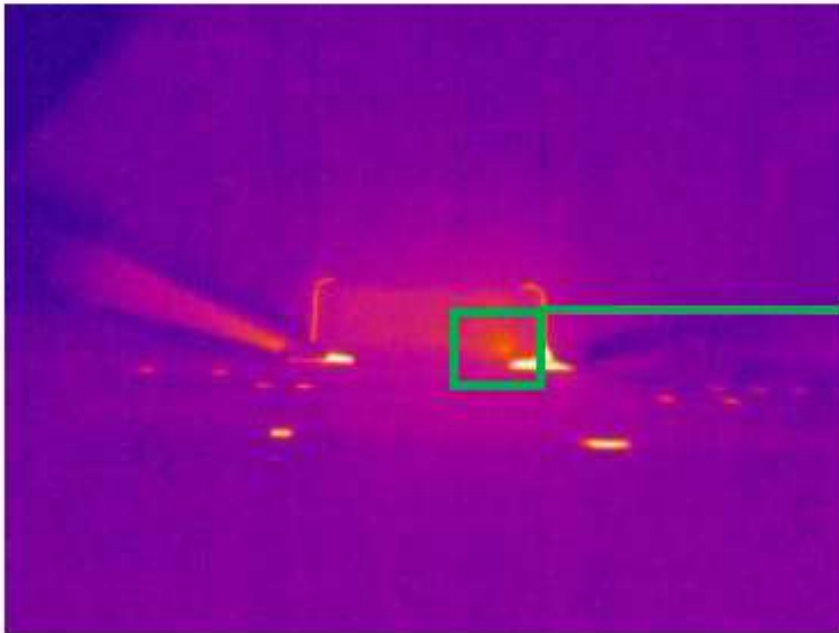
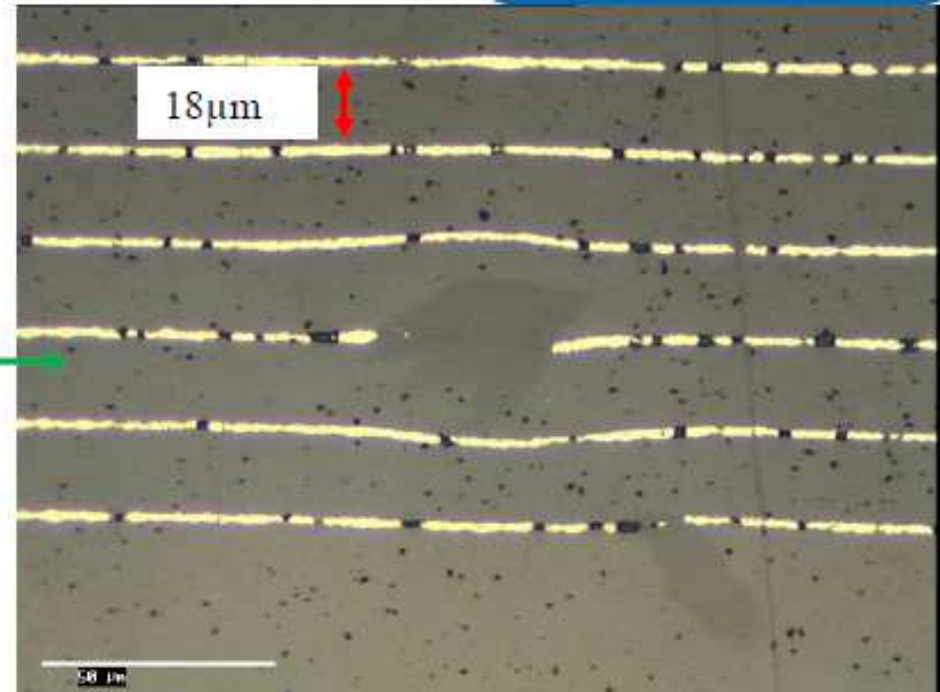
- Presence of a short circuit on a ceramic capacitor,
 - Infra red thermography confirm the presence of the SC
 - Cross section showed the presence of specific phases
- **Conductive or not?**

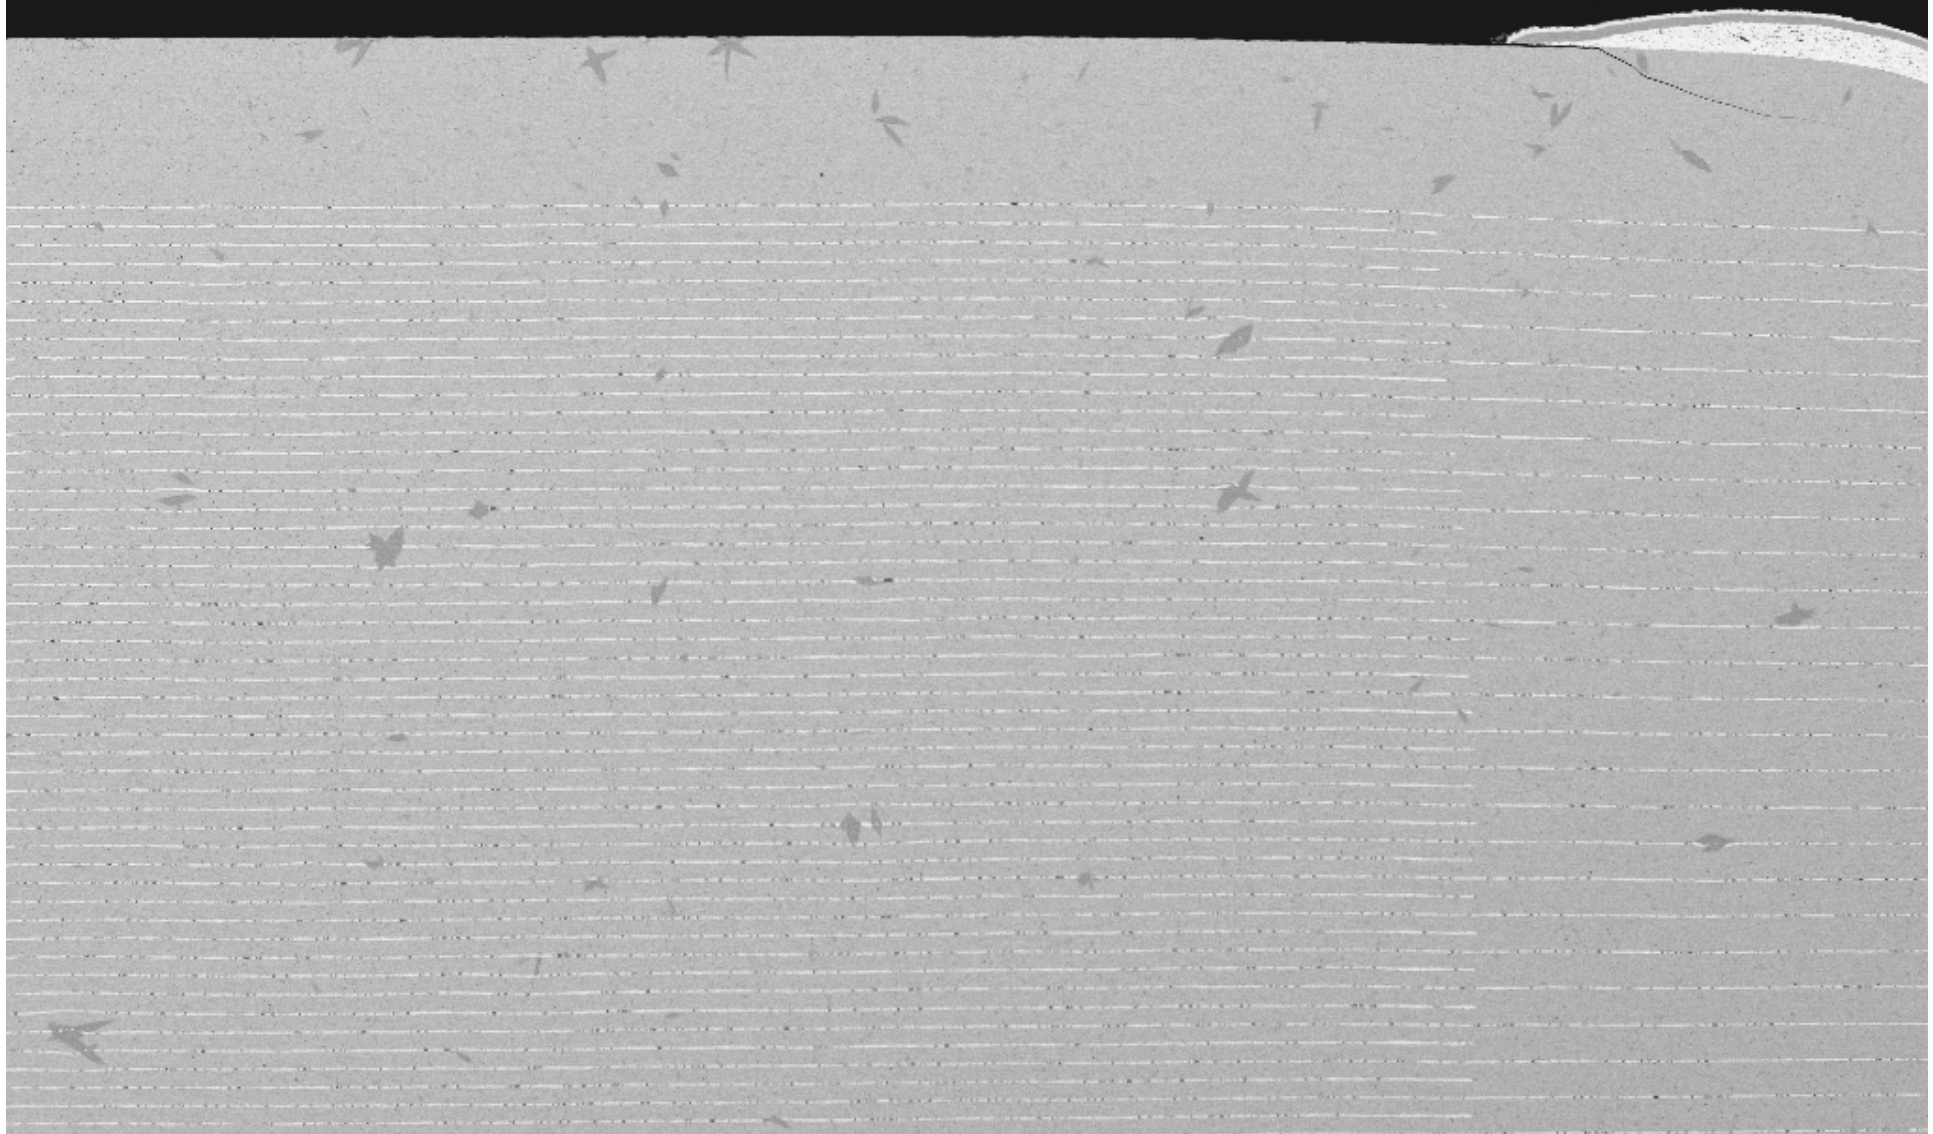
*Classical SEM view
(Chemical contrast)*

O: 13.5%W
Ti: 50.0%W
Ba : 36.5%W

O: 11.7%W
Ti: 29.4%W
Ba: 59.9%W

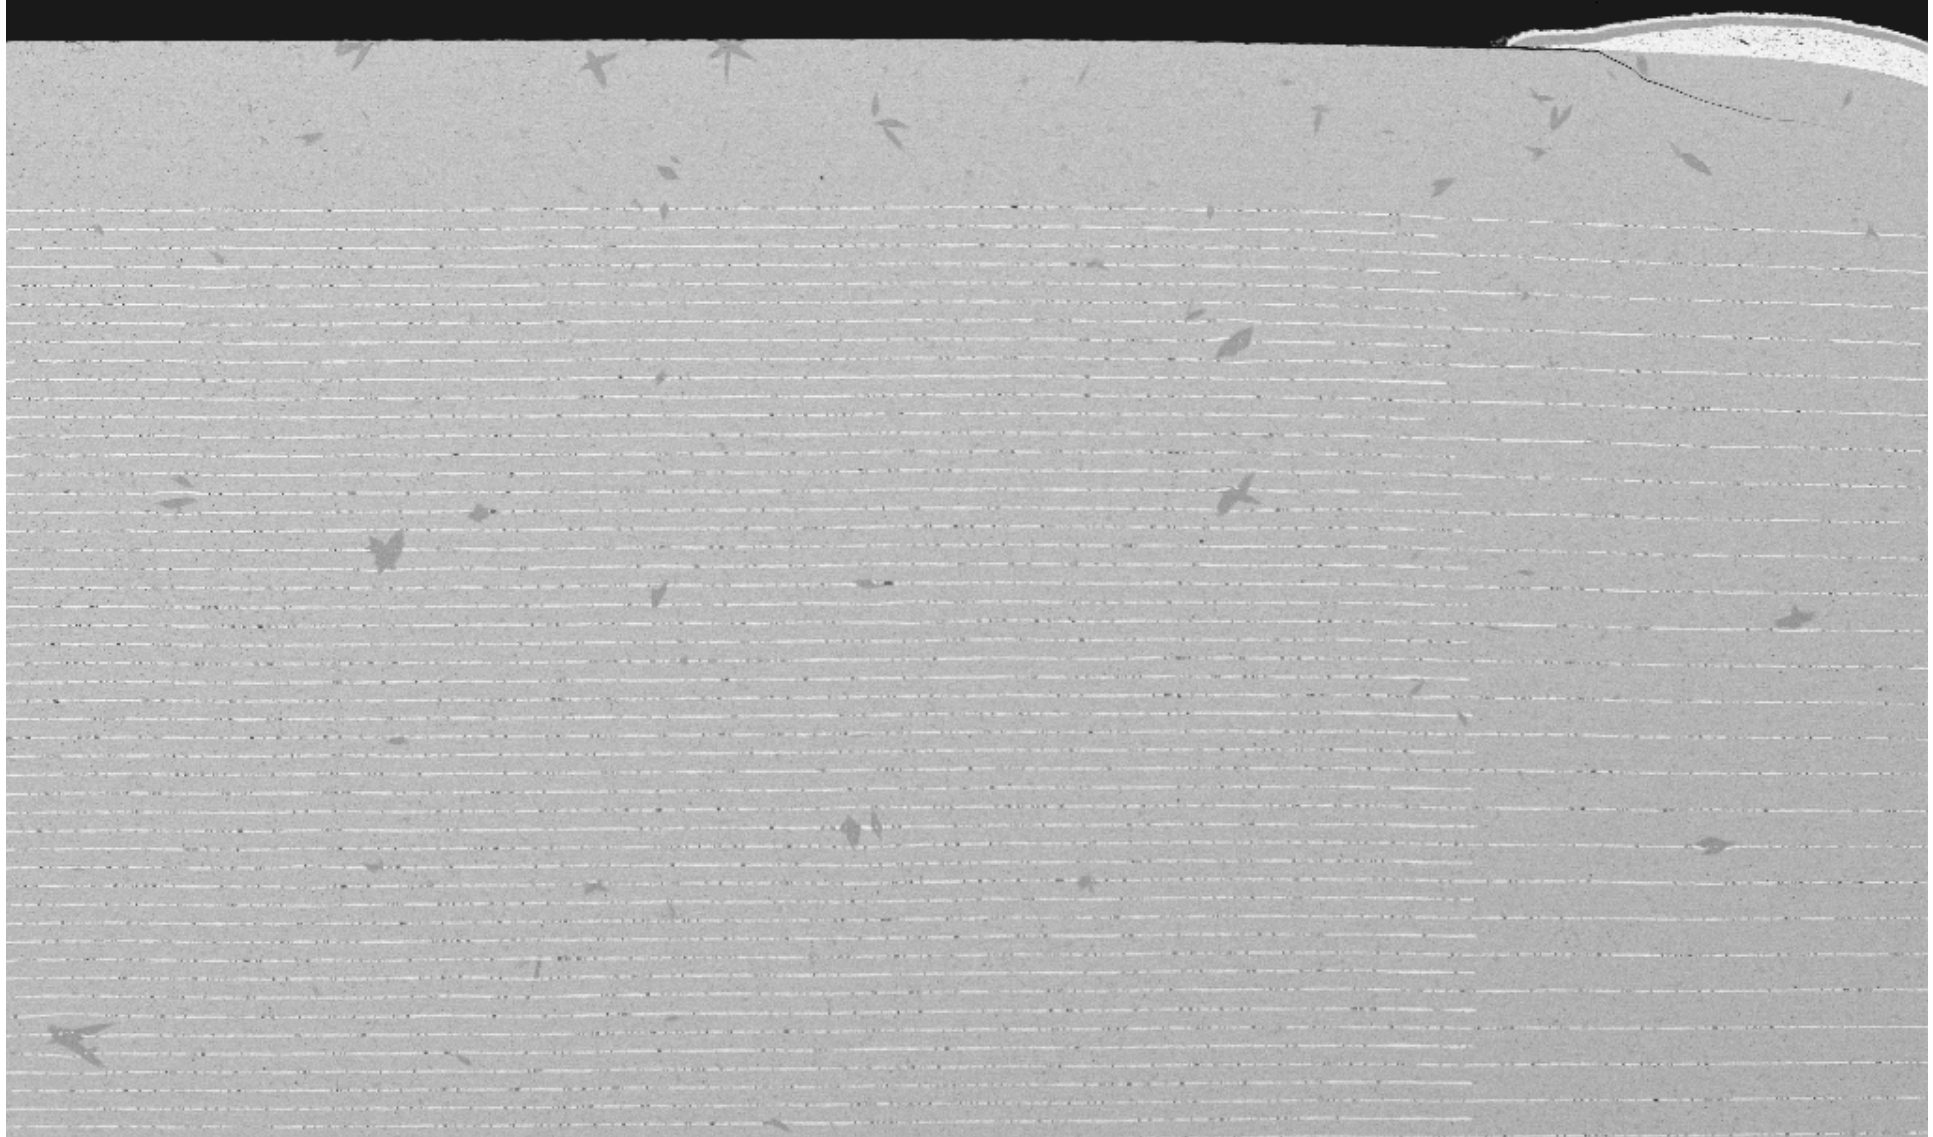
*Classical SEM view
(Chemical contrast)*
