2nd SPCD 12-14 October 2016

Passive components :
Feedback of 5 years of analysis
From all Electronic Sectors

Eric ZAIA (Material Engineer)

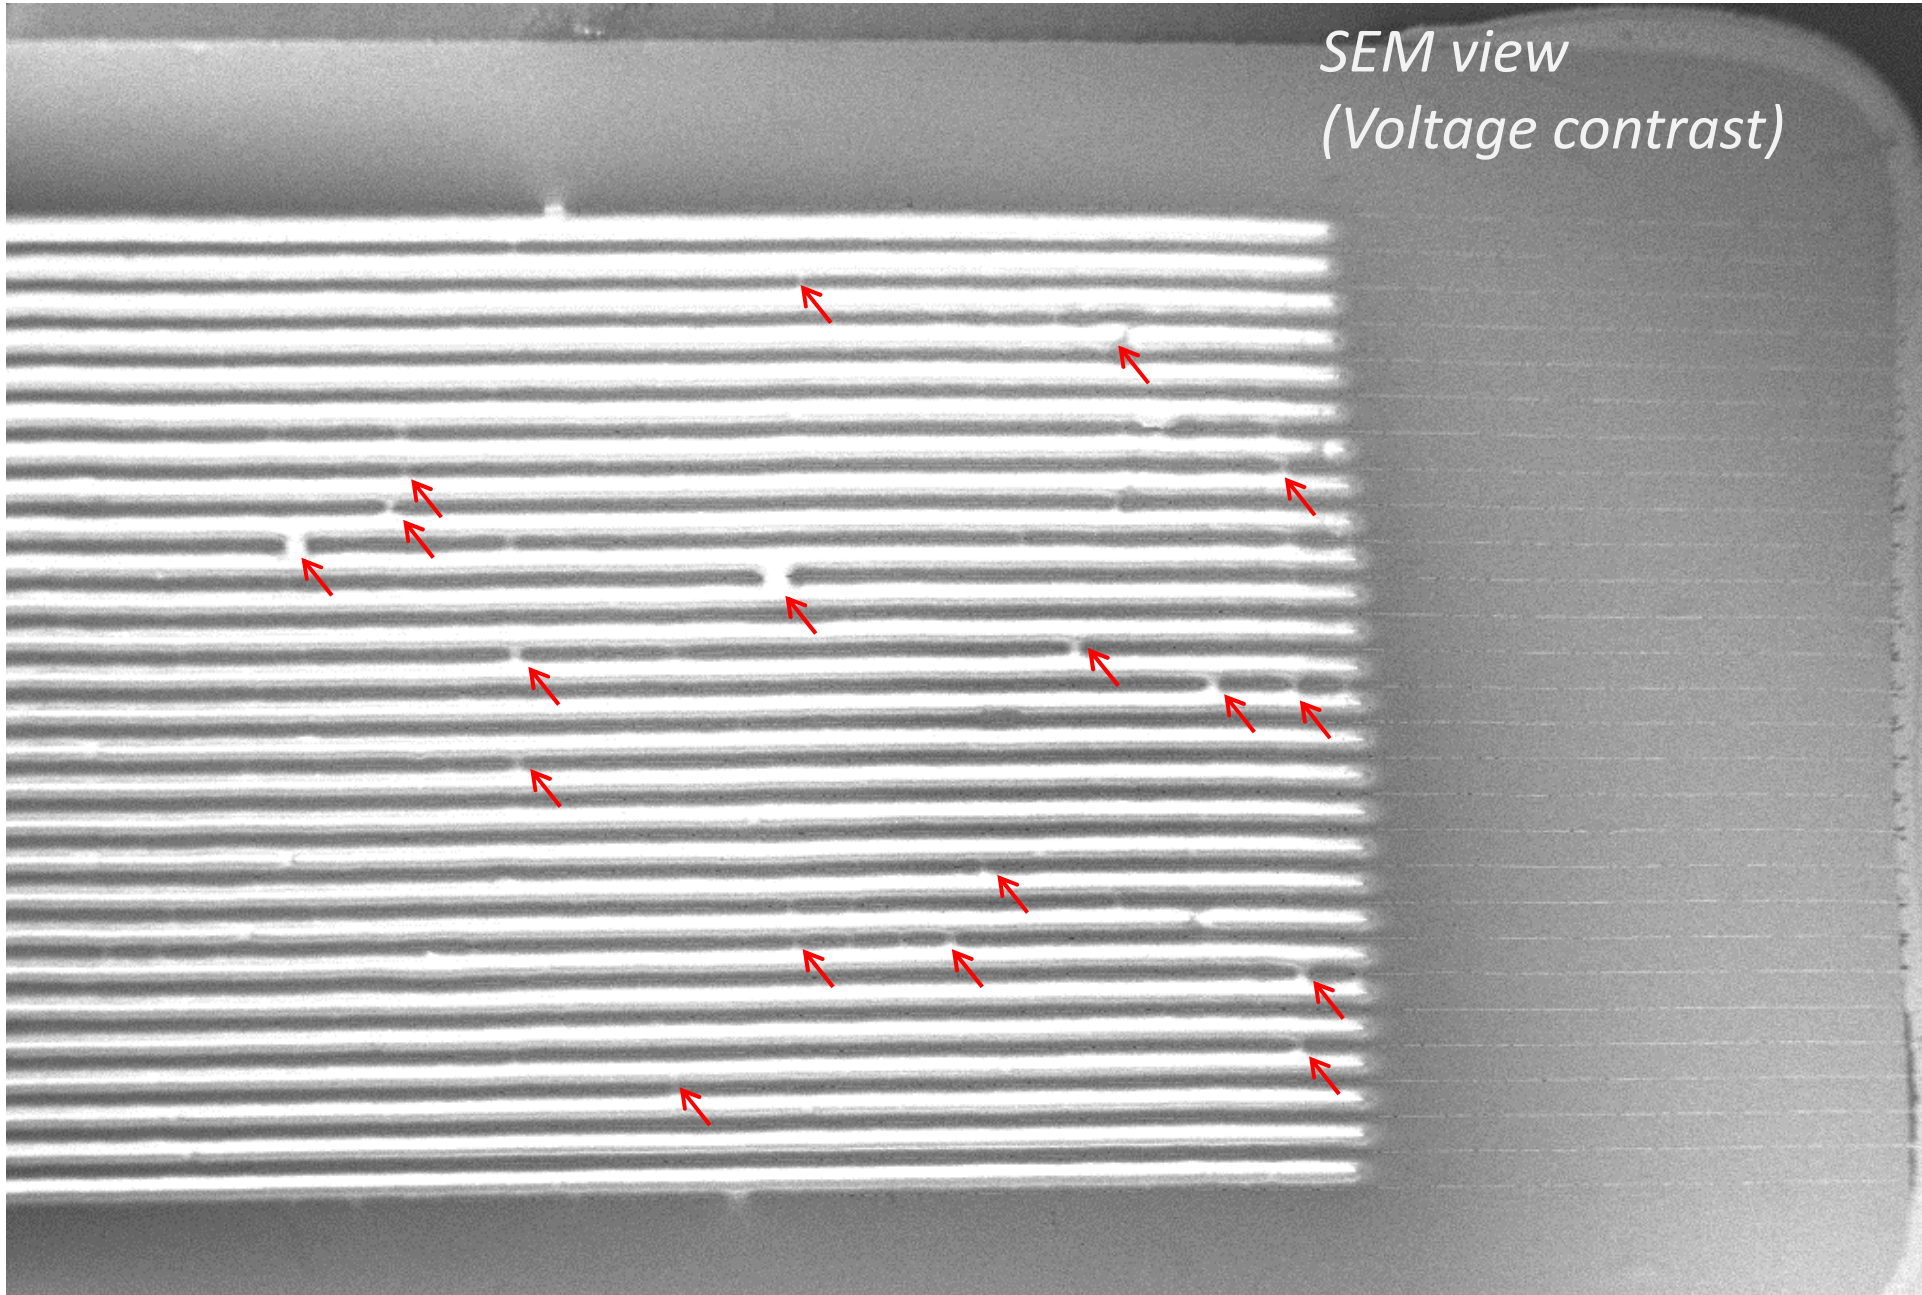
*SEM view
(Voltage contrast)*

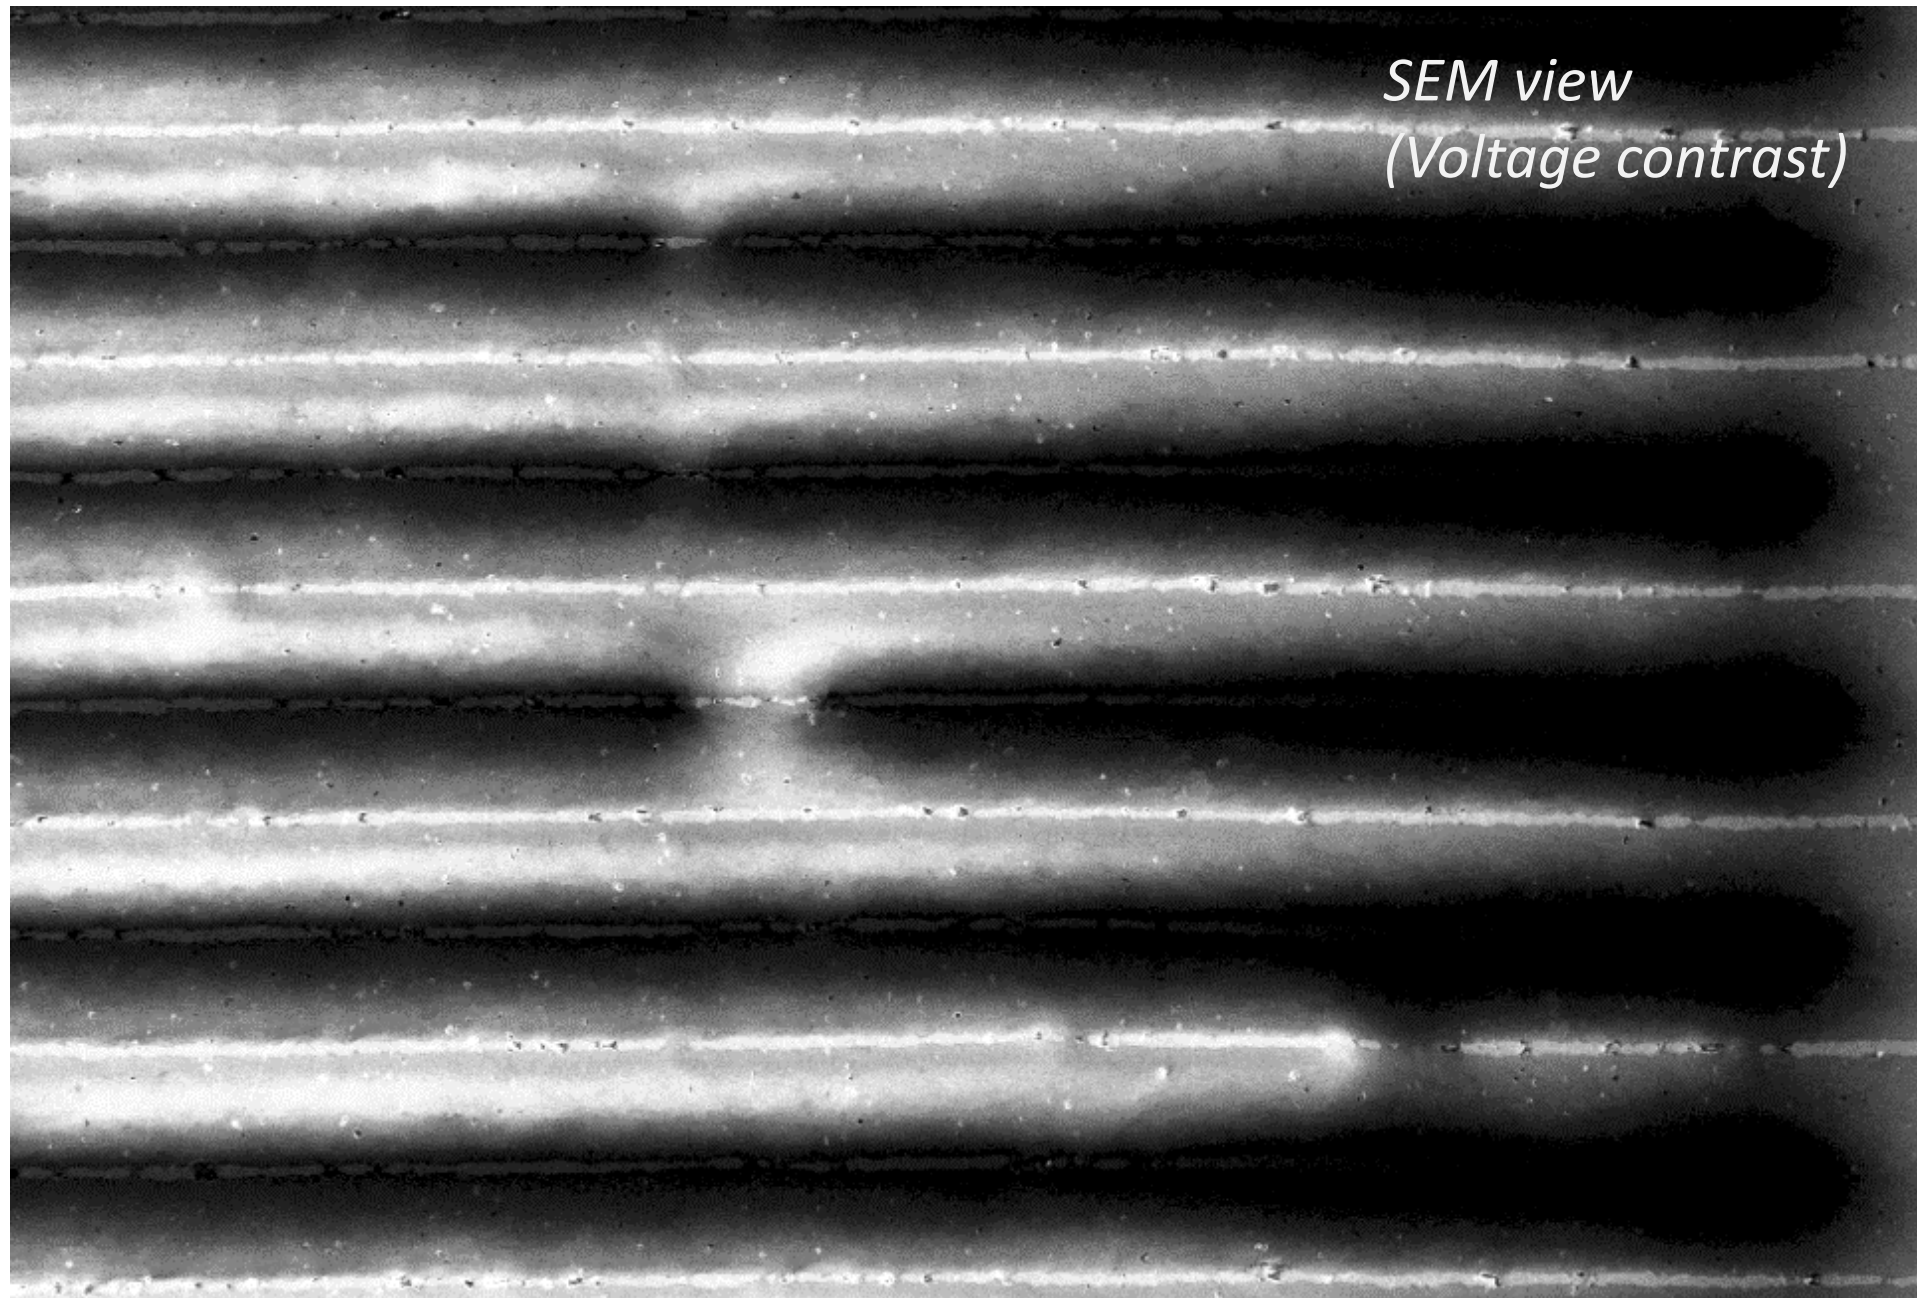
*SEM view
(Voltage contrast)*
