# SiC Plastic High Temperature Diodes

Juan Moreno | HRS Optoelectronics Laboratory | 27.03.2025

Seville - Spain  
25 to 27<sup>th</sup> March

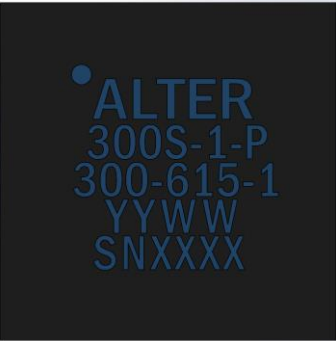
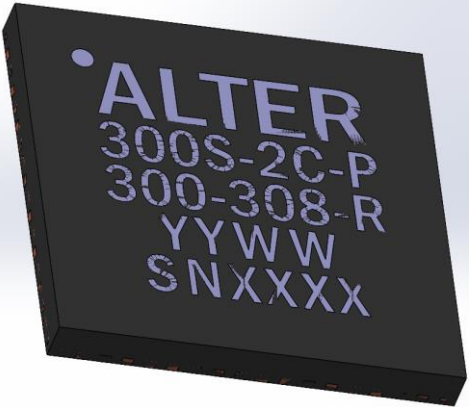
□ Based on BepiColombo  
SoLO Solar Array SiC  
Blocking diodes

- Single die

- Two dies module, common cathode

**Mold Type 1:  $T_g=120^{\circ}\text{C}$**

**Mold Type 2:  $T_g=242^{\circ}\text{C}$**

**Mold Type 3:  $T_g=195^{\circ}\text{C}$**

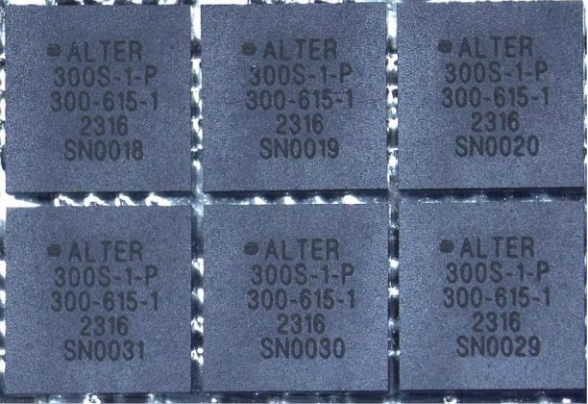
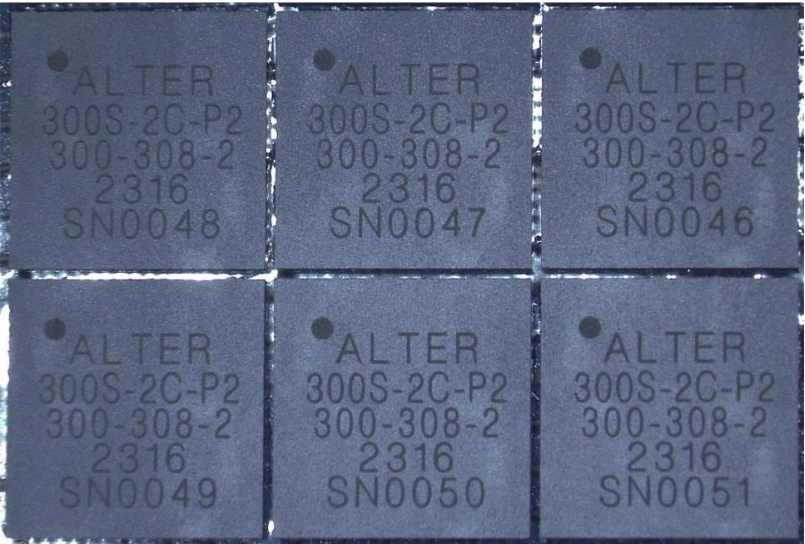
- Very good die attach strength
- Good, consistent bonding
- All mold compounds flowed with no issues
- Expected flowability of Type 1, similar for Type 3.  
Low flowability for Type 2 leading to excessive wire sweep

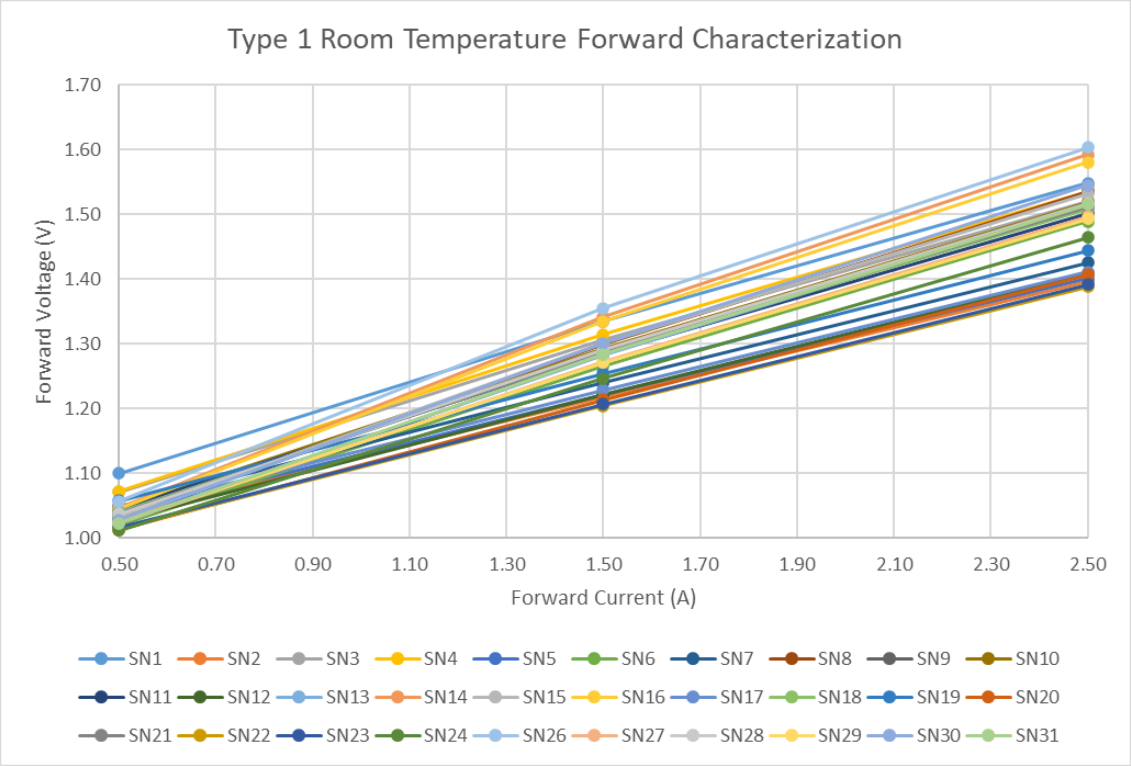
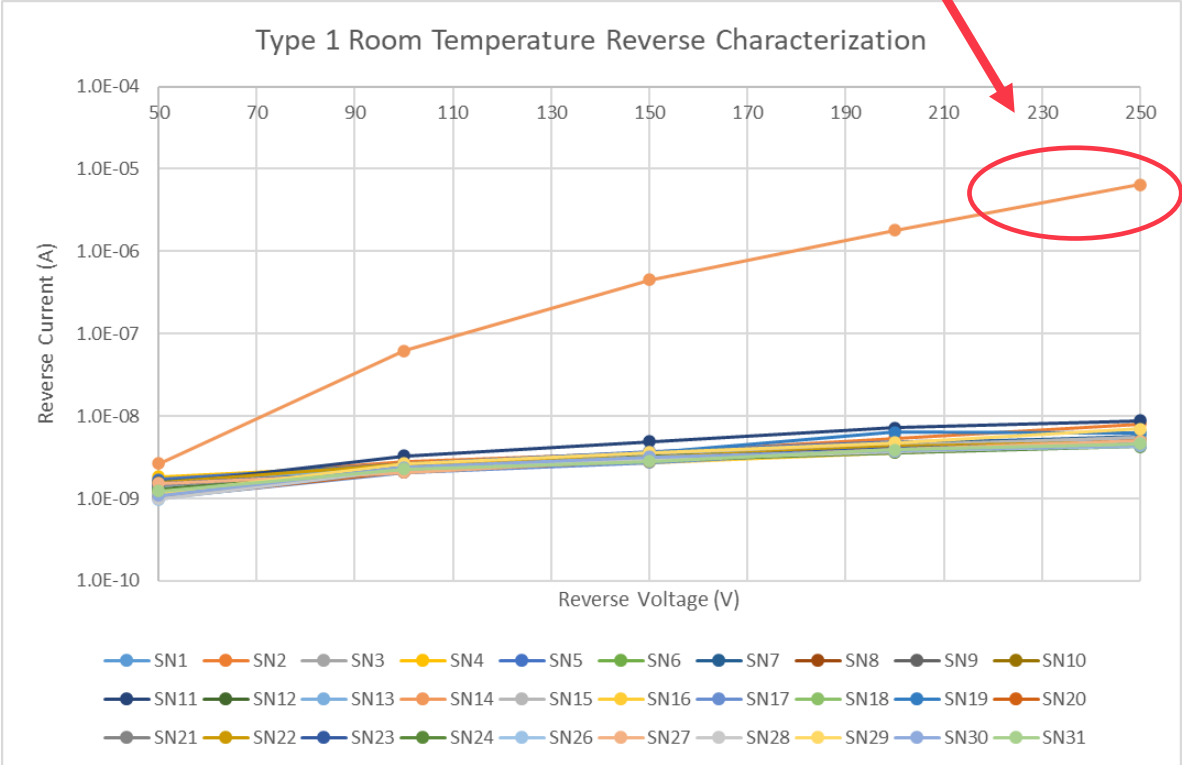
In-specs but out-of-family behavior (not submitted to evaluation)

-> Enough parts for all the 3 types for the study

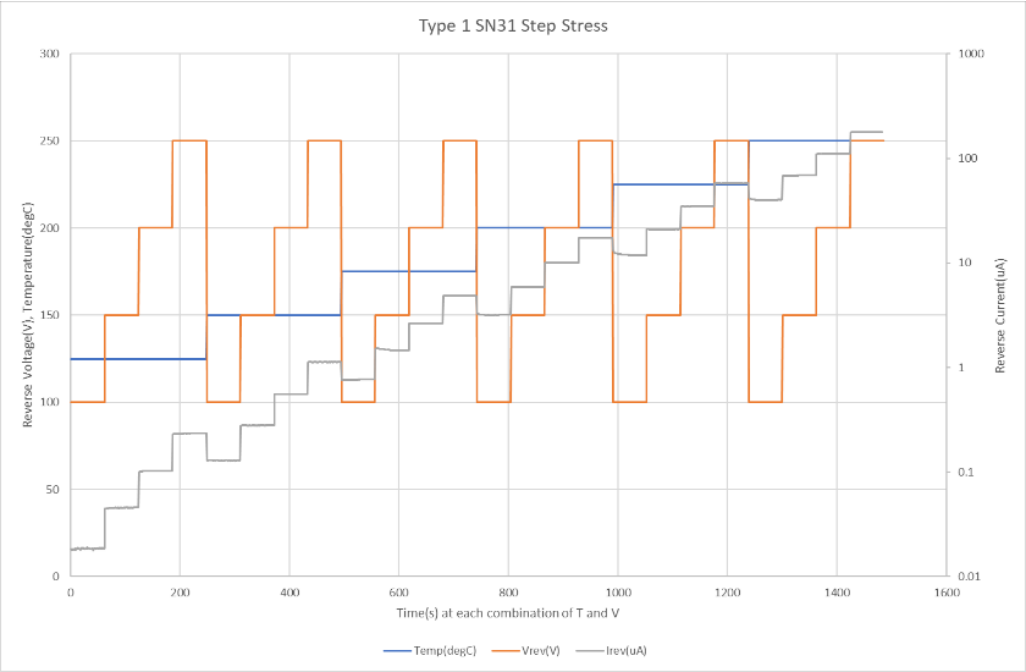
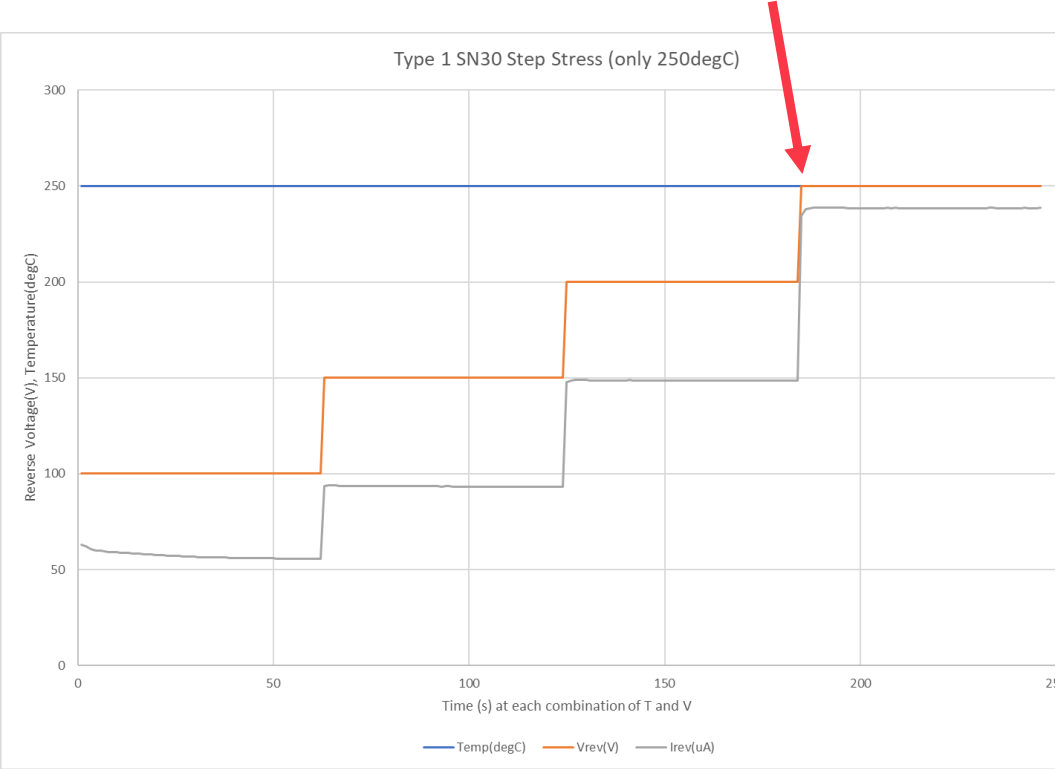
### Good Results: Type 1 as example

Good stability of the leakage at 250°C and 250V

Same Results for Type 2 and Type 3

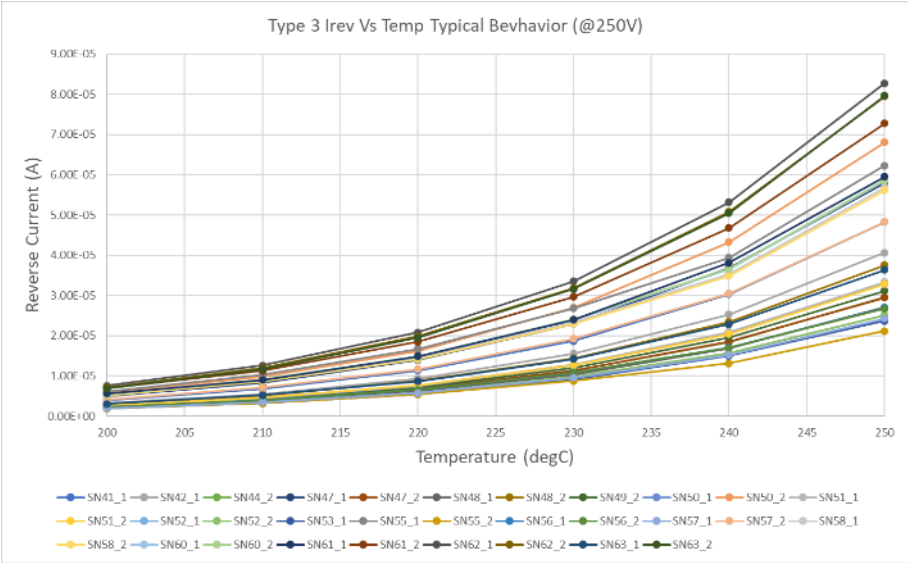
Big amount of data gathered:

- Electrical behavior as expected
- Same behavior for the 3 mold

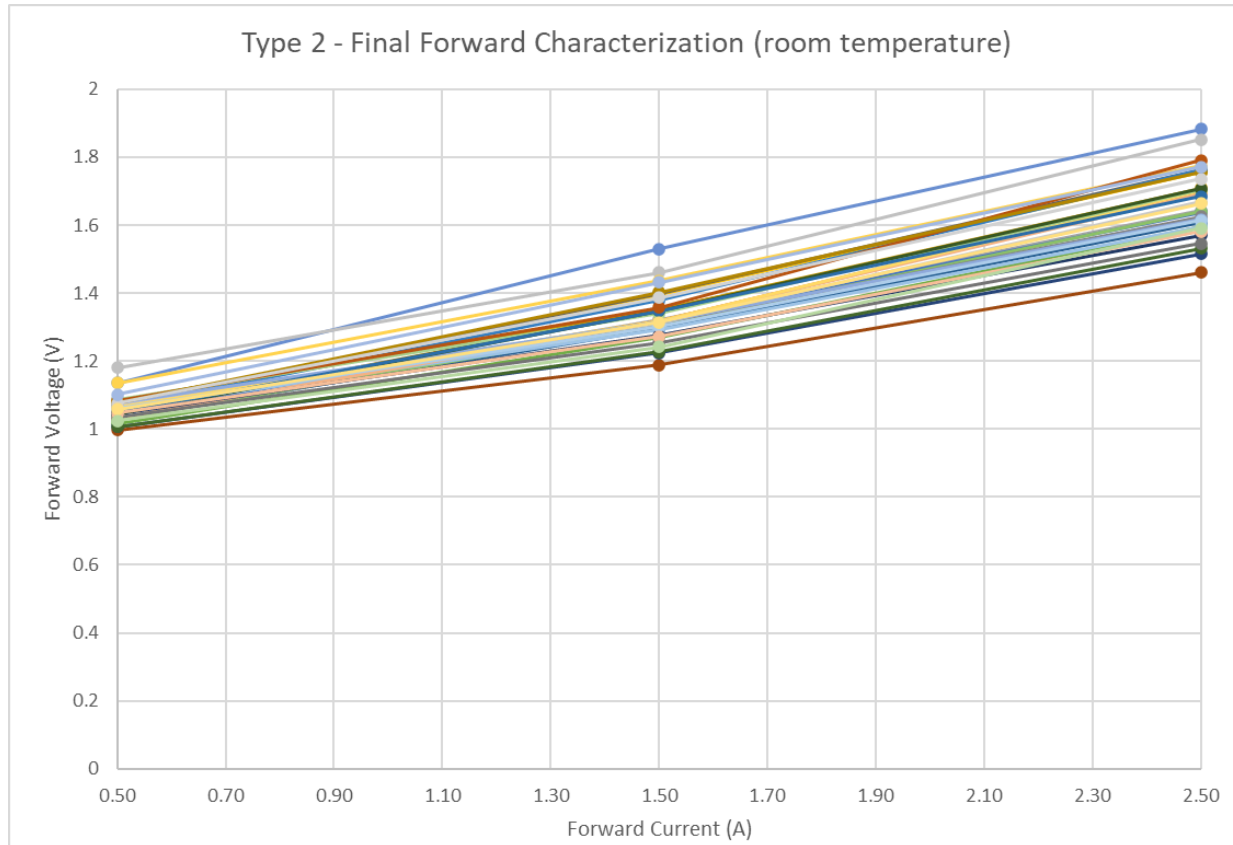
- ❑ Reverse currents OK, few abnormally higher (instable dies)
- ❑ Slight drift in forward voltages for types 2 & 3.

Vfwd(@2.5A) drift (die attach

- Type 1: No drift
- Type 2: 9% average increase
- Type 3: 8% average increase
