Corrosion of Silver-Plated Copper Conductors

The purpose of this paper is to detail the findings of the metallurgical examinations performed by ESA on cables discovered to have degraded by red plague corrosion. In addition, an extensive laboratory test programme was undertaken in an attempt to gain a more comprehensive understanding of the red plague phenomenon. The aims of this programme will be discussed, as will the results achieved to date. A test method based on the laboratory procedures of Anthony & Brown¹ has been developed into a draft ESA specification, which is thought suitable for the acceptance-testing of fabricated wires and cables.

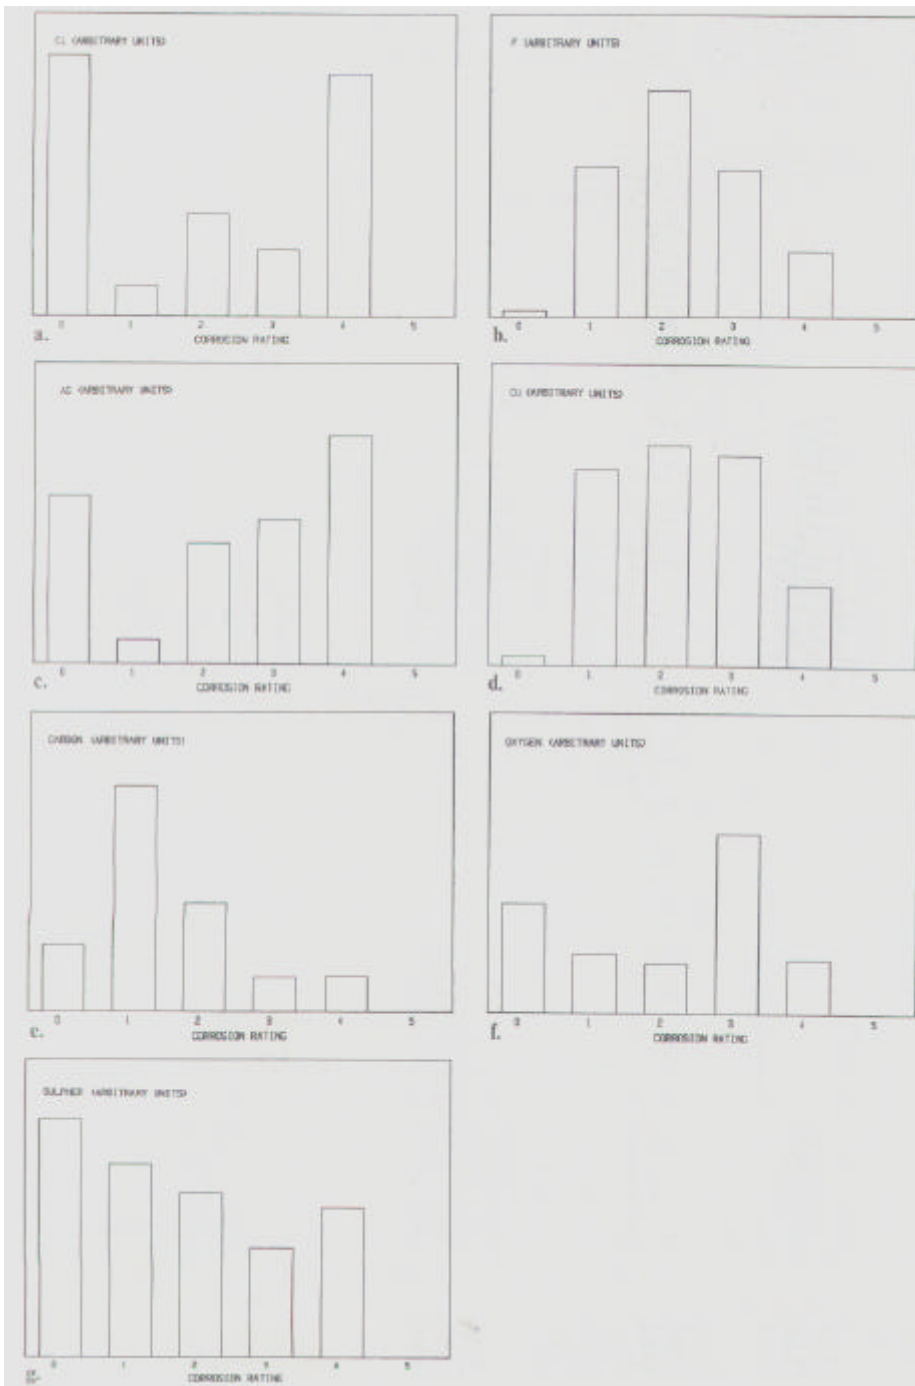
Figure 12a g. Influence of individual contaminants on the corrosion rating

The influences Of Surface elements on the corrosion ratings of wires and cables are shown in Figures 12a-g. This graphical presentation highlights two unexpected findings:

- High amounts of Cl⁻ are present with corrosion ratings of 0 and 4, whereas the intermediate ratings are connected to low amounts of Cl⁻
- F apparently does not contribute to strong corrosion.

A possible explanation is thought to be that chlorine and fluorine have different influences on the metals present.

programme (Fig. 12). When the graphs for chlorides and fluorides are considered, it is tempting to assume that the chlorides have protected the silver-plated copper strands against corrosion, but once a defect in the plating is present they increase the apparent amount of corrosion. The fluoride graph shows the reverse effect of corrosion behaviour.

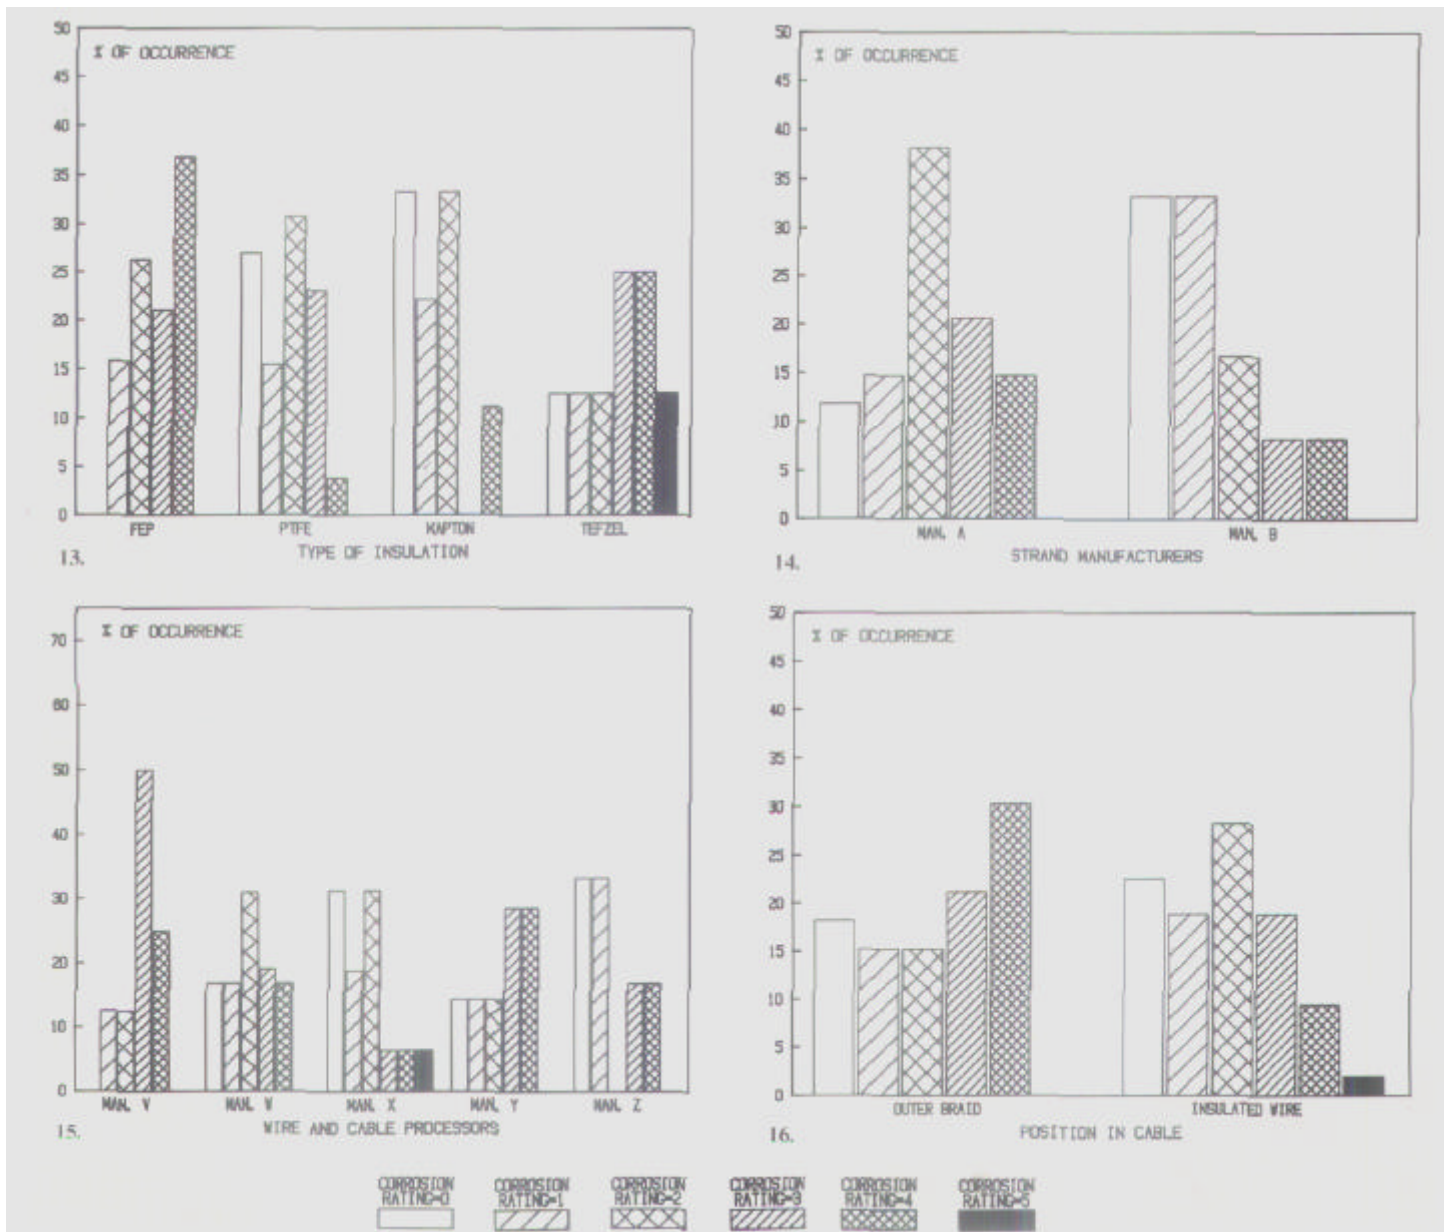
Figure 16. Positions of strand in cable and corrosion rating (for silver-plated strands). 'Insulated wire' includes inner conductor of cables and hook-up wires

The influence of strand position - whether braid or stranded wire - is illustrated in Figure 16. It seems that the accelerated test is likely to produce slightly more corrosion on the braided strands than on the inner conductor. The amount of air trapped within the insulations depends on both the construction of the cable and the method by which the insulation is applied. The braids are surrounded by a far greater volume of air than the inner conductors, thus permitting the ingress of greater quantities of oxygen and moisture during the test exposure.

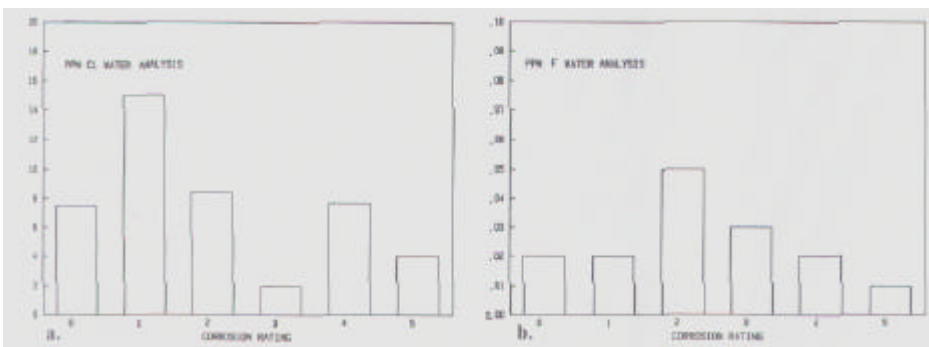
Figure 17a-b. Comparison of halide additions to water from test samples with their corrosion ratings

The halide contents of the water contained within the conical flasks during the 10d tests were noted to increase. The analytical results have been compared against the corrosion ratings for the wires or cables in Figures 17ab.

These figures show that contaminated water from the wire ends is returned to the flask in the form of drips. This confirms that the halides determined by AES existed in an ionic form rather than as monomers or polymers. There is a certain resemblance between Figures 17a,b and 12a,b.
