## Corrosion of Silver-Plated Copper Conductors

**Abstract** Silver-plated conductors, insulated, with fluorocarbon plastics or aromatic polyimide resin and used in aerospace applications, in both Europe and the United States, have been examined for evidence of red-plague corrosion. Extensive metallurgical investigations have shown that, in the worst cases, 3% of the strands making up the braid cross-section can have some degree of corrosion. Metallography revealed that it had initiated at isolated defects in the silver-plating.

In the latter half of 1983, ESA experienced the first case of red plague identified on a short length of  $125\Omega$  RF cable withdrawn from a contractor's store. On stripping the outer insulation, severe corrosion was noted to be present in small irregular patches along the newly exposed braid. To assess the origin and extent of this problem, and to define remedial actions, extensive efforts were made to locate and inspect all silver-plated copper wires and cables purchased and stored by ESA contractors from the same cable manufacturer. Finally, new wires and the remainders of wires and cables on reels from various silver-plated wire/cable suppliers we

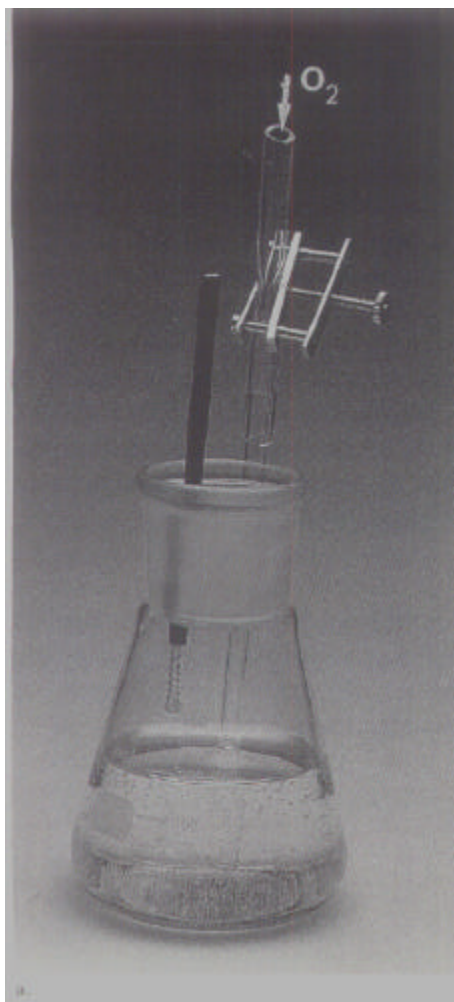
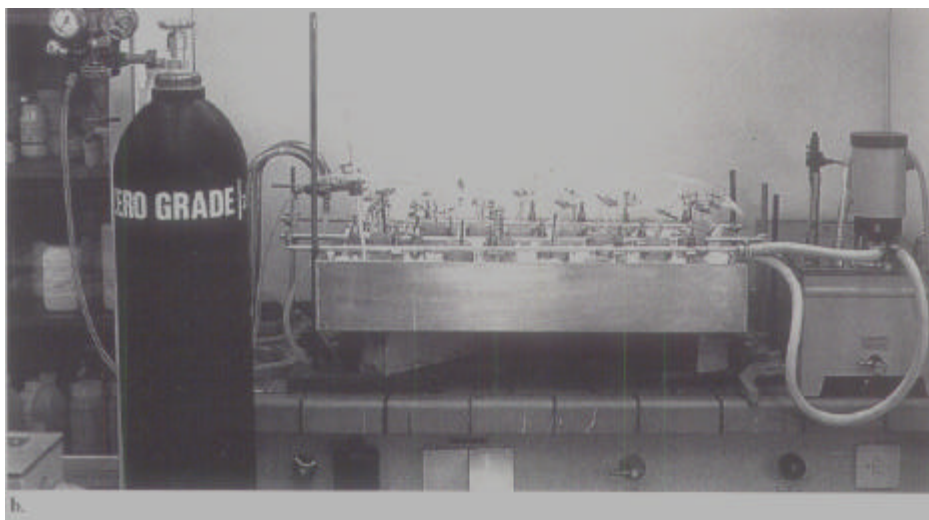
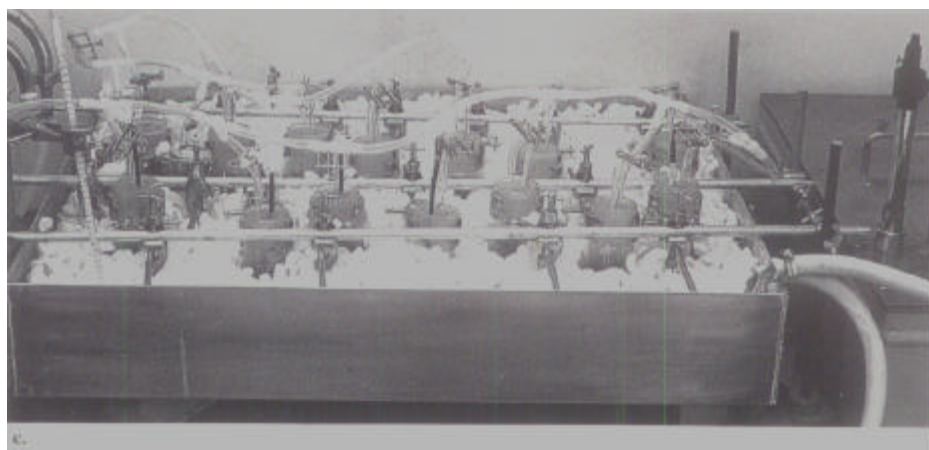
**Figure 10a. Conical-flask set-up for accelerated corrosion testing of RF-shielded cable to ESA PSS-01 -720 (draft)**

**Figures 10b & c. Fourteen samples under test, with flasks held at 58°C in a water trough (evaporation minimised by particles of floating polystyrene)**

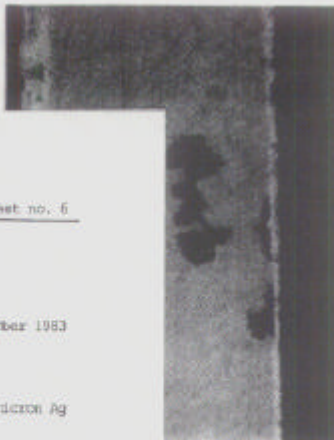
VISUAL INSPECTION OF CONDUCTORS AFTER 4 1/2 DAY CORROSION TEST (INSULATED AREA):  
OUTER BRAID (3) INNER WIRE STRAND (0)

VISUAL INSPECTION OF CONDUCTORS AFTER 10 DAY CORROSION TEST (INSULATION AREA):  
OUTER BRAID (3) INNER WIRE STRAND (2)

MICROSECTION RESULTS :  
Both braid and inner conductors have 2 microns silver coverage,  
braid corrosion extends into copper core, subsurface in worst strand.

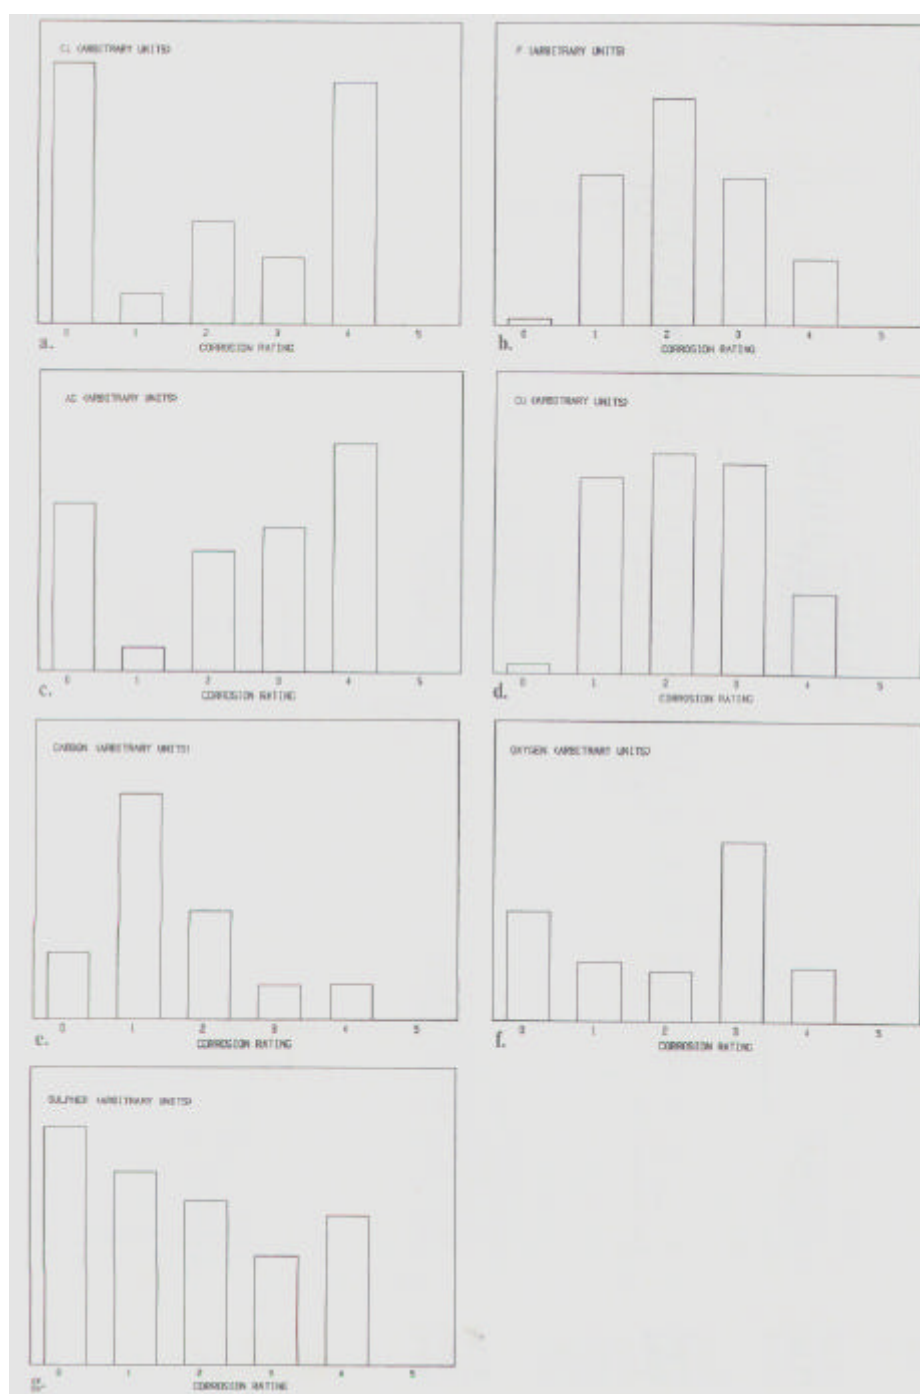
Figure 12a g. Influence of individual contaminants on the corrosion rating

The influences Of Surface elements on the corrosion ratings of wires and cables are shown in Figures 12a-g. This graphical presentation highlights two unexpected findings:

- High amounts of C1<sup>-</sup> are present with corrosion ratings of 0 and 4, whereas the intermediate ratings are connected to low amounts of C1<sup>-</sup>
- F<sup>-</sup> apparently does not contribute to strong corrosion.

programme (Fig. 12). When the graphs for chlorides and fluorides are considered, it is tempting to assume that the chlorides have protected the silver-plated copper strands against corrosion, but once a defect in the plating is present they increase the apparent amount of corrosion. The fluoride graph shows the reverse effect of corrosion behaviour.

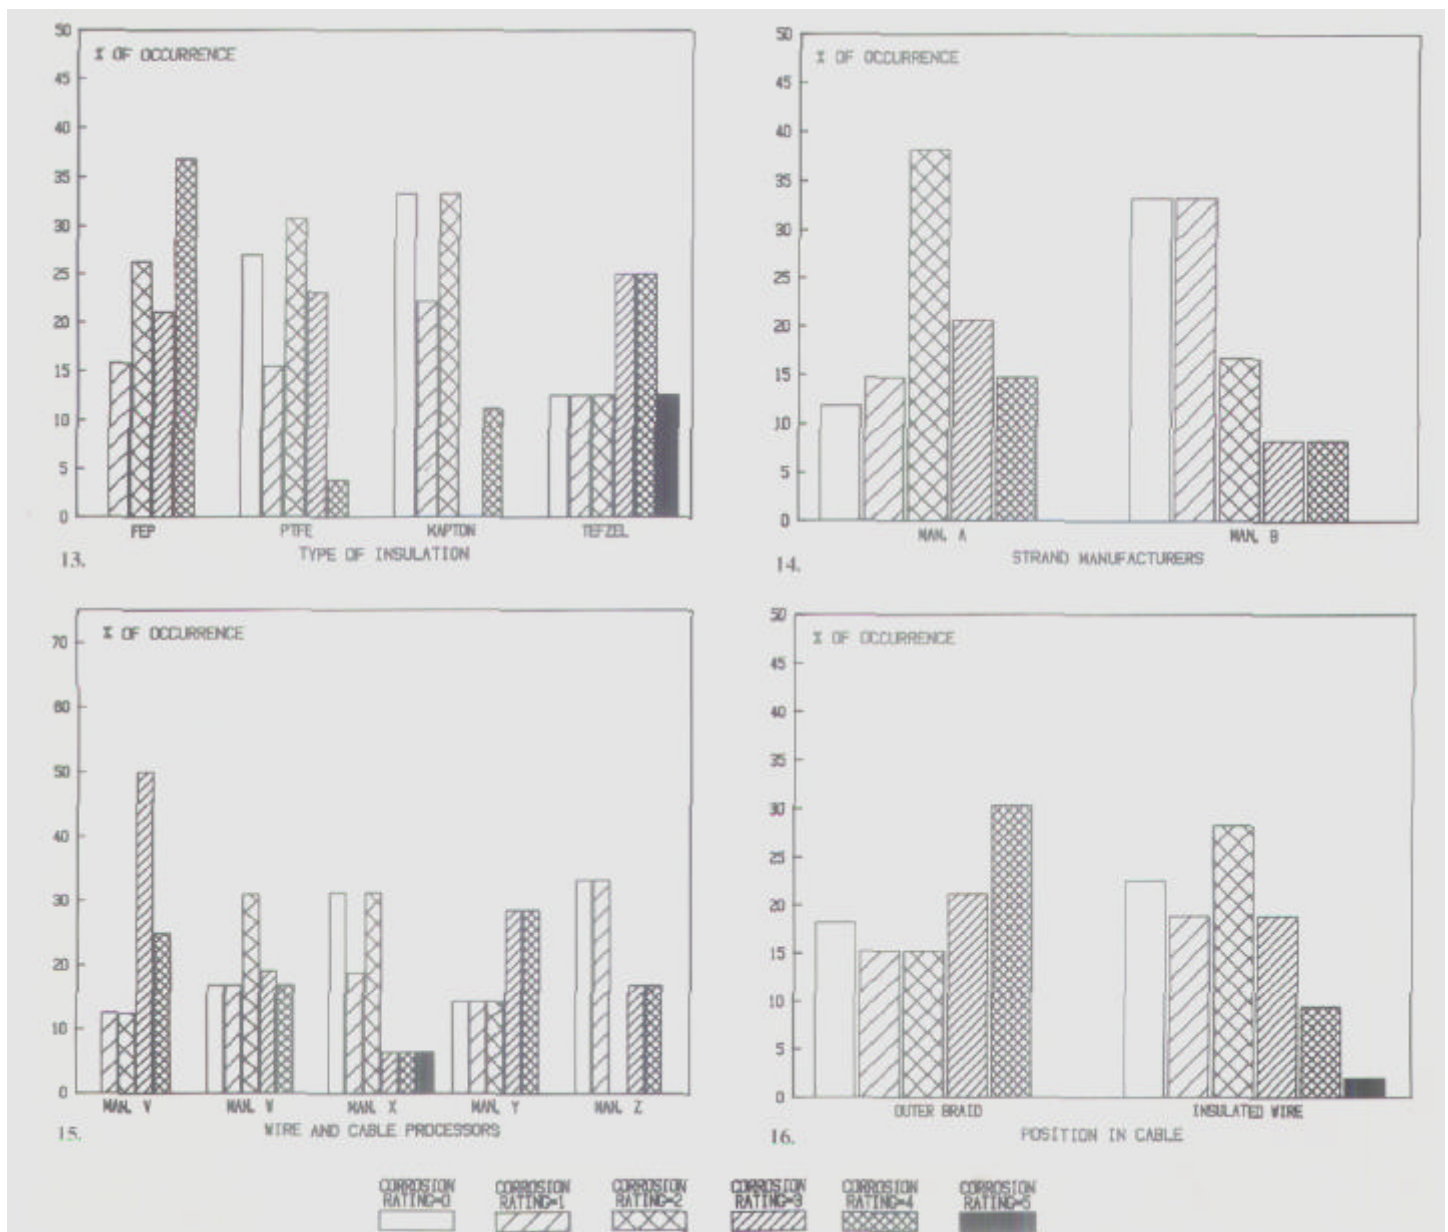
The influence of the strand manufacturer on corrosion rating is illustrated in Figure 14. These results show no marked difference (average of A = 2.1, of B = 1.3).

The influence of the wire and cable manufacturer on the corrosion ratings are illustrated in Figure 15. These results show that the accelerated test will produce corrosion on wires and cables from all manufacturers.

The influence of strand position - whether braid or stranded wire - is illustrated in Figure 16. It seems that the accelerated test is likely to produce slightly more corrosion on the braided strands than on the inner conductor. The amount of air trapped within the insulations depends on both the construction of the cable and the method by which the insulation is applied. The braids are surrounded by a far greater volume of air than the inner conductors, thus permitting the ingress of greater quantities of oxygen and moisture during the test exposure.

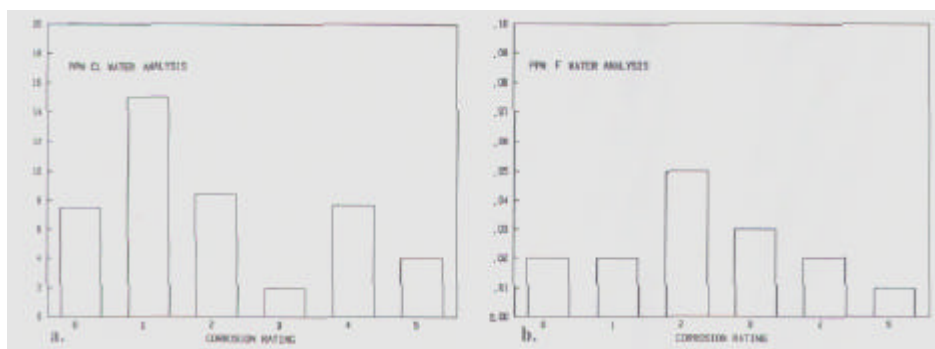
**Figure 17a-b. Comparison of halide additions to water from test samples with their corrosion ratings**

The halide contents of the water contained within the conical flasks during the 10d tests were noted to increase. The analytical results have been compared against the corrosion ratings for the wires or cables in Figures 17ab.

These figures show that contaminated water from the wire ends is returned to the flask in the form of drips. This confirms that the halides determined by AES existed in an ionic form rather than as monomers or polymers. There is a certain resemblance between Figures 17a,b and 12a,b.
