# ■ Dye Penetrant

**L. Sollecchia**

May 4<sup>th</sup>, 2007

The aim of this activity is the research of suitable dye penetrant to be used to detect the cracks in Area Array Connections at the end of verification test made in accordance with the ECSS-Q-70-38. Indeed due to the configuration of connections a microsection will not allow the detection of size of the cracks. For these reasons the ECSS-Q-70-38 requires the use of dye penetrant testing, to identify the extension of the cracks at the end of verification testing. Based on the area of the cracks the assembly will be considered approved or not as per ECSS-Q-70-38 .

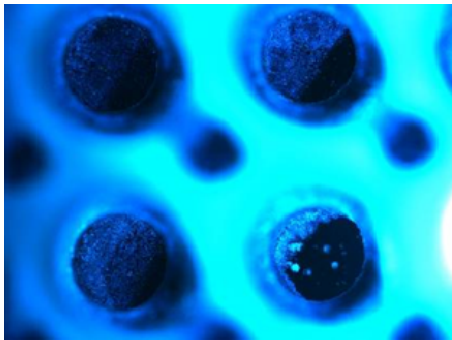
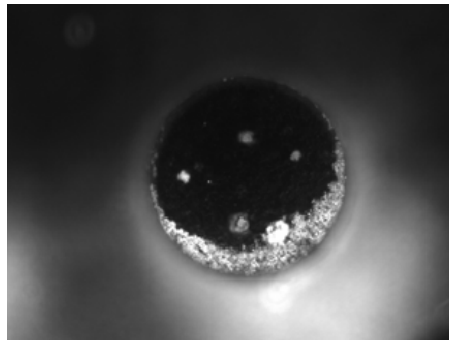
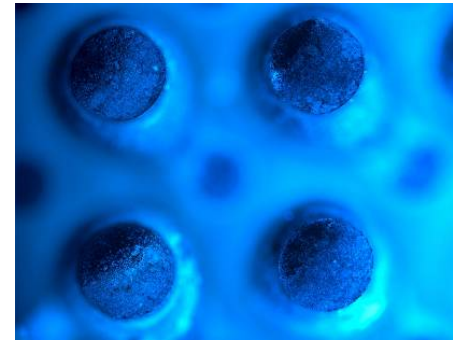
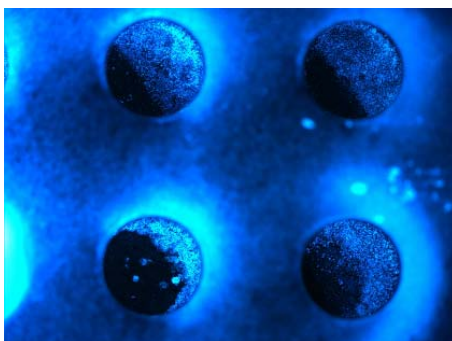
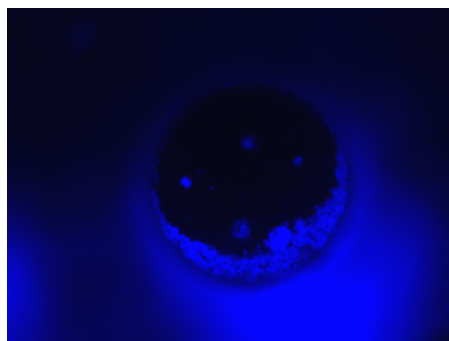
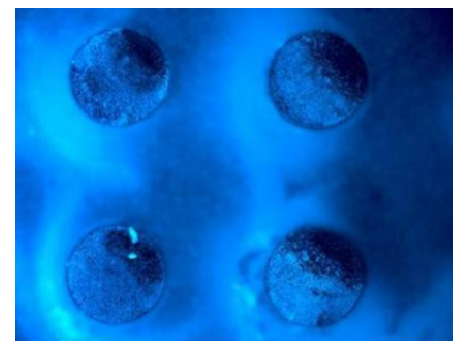
The results of the first run have been partially confirmed. The profile is nearly well defined, but during this second run a granular aspect has been detected, probably caused by a less concentration of dye bath, so in the next test it has been expected a review of dye bath concentration.

The comparison between the inspections of cracks on PCB side and Package side didn't show differences.

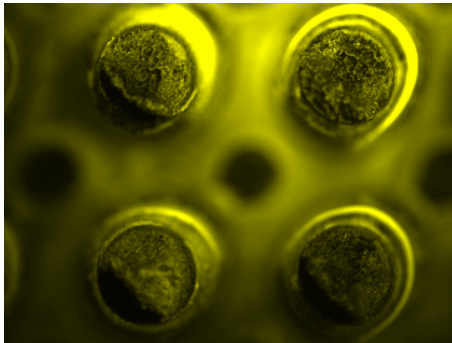
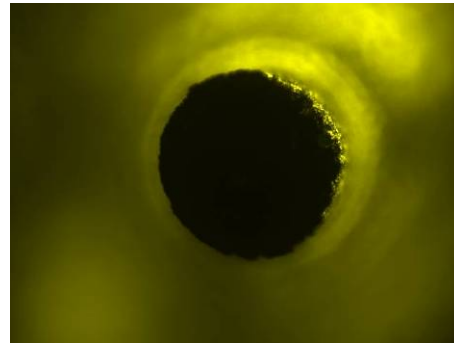
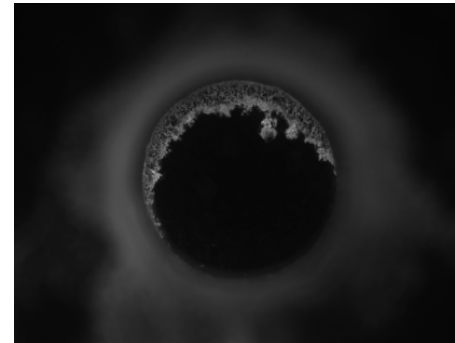
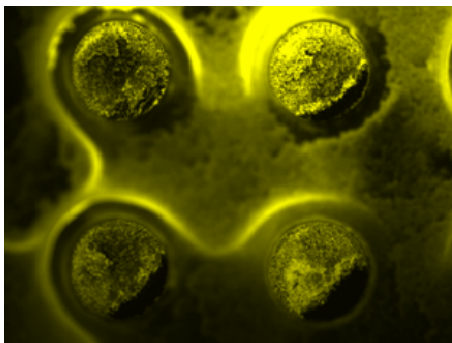
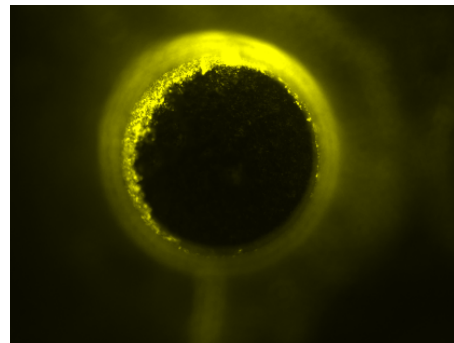
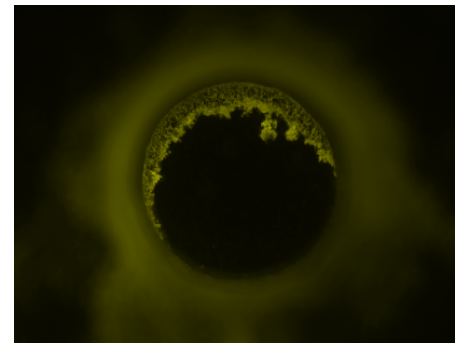
Each consideration done in the first test run in order to the profile definition or to other aspect has been verified. In addition the comparison between the inspections of cracks on PCB side and Package side didn't show differences .

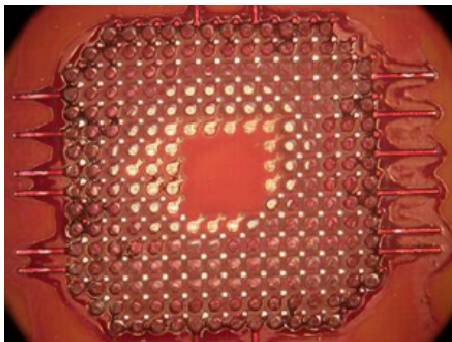
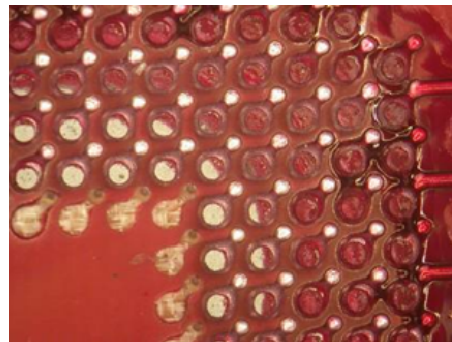
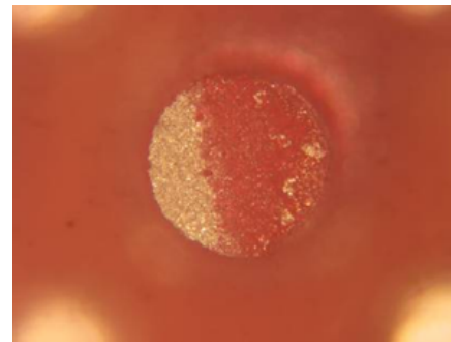
PCB Side

The results of this test run confirmed the good properties of Red Steel in this kind of analysis. The comparison between the inspections of cracks on PCB side and Package side didn't show differences.

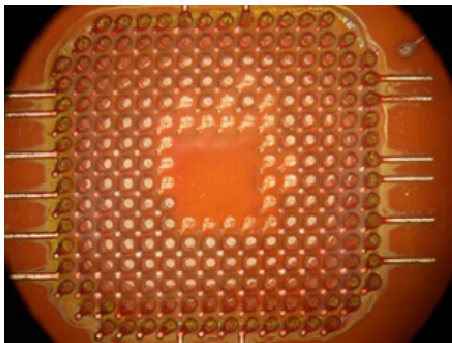
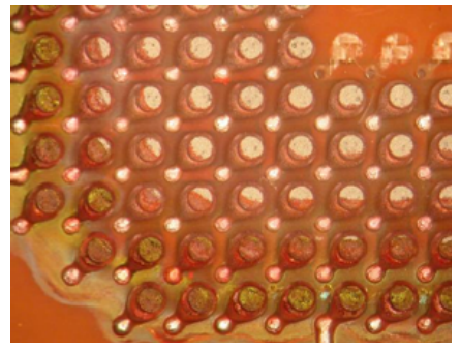
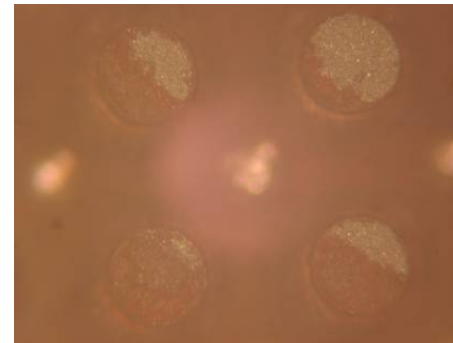
PCB Side

The Dye Penetrant Test has been performed on DBGA 228#1 from Test Vehicle S/N 2 (89% inspected)

The results of this test run confirmed the suitability of Eosina for dye penetrant test. The comparison between the inspections of cracks on PCB side and Package side didn't show differences.

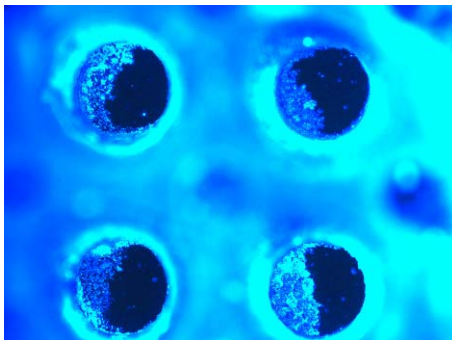
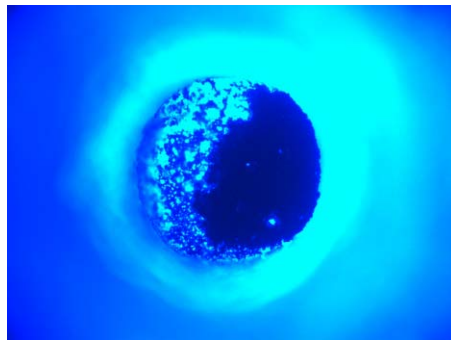
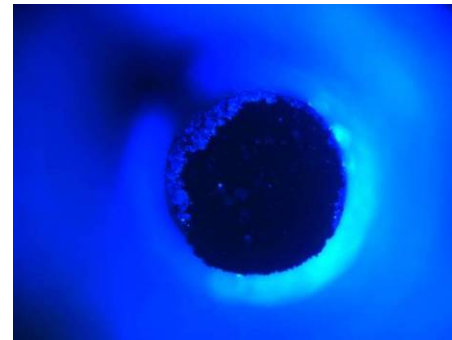
Inspection after  
1° Pull-Out

The Dye Penetrant Test has been performed on DBGA 444#1 from Test Vehicle S/N 4. After the first Pull-Out, 245 soldered joints (55.2%) have been inspected and after the second Pull-Out 179 soldered joints (up to 95.5%) have been inspected, with 20 residual joints (4.5%) still attached to package.

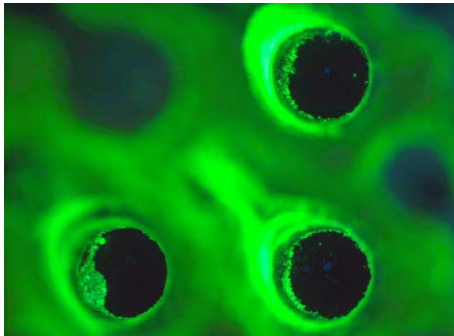
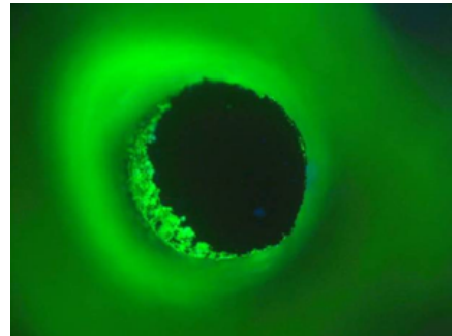
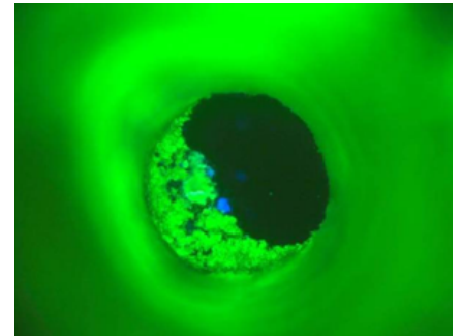
Inspection after  
1° Pull-Out

The Dye Penetrant Test has been performed on DBGA 444#2 from Test Vehicle S/N 4. After the first Pull-Out 260 soldered joints (58.5%) have been inspected and after the second Pull-Out 175 soldered joints (up to 98.0%) have been inspected, with 9 residual joints (2.0%) still attached to package.

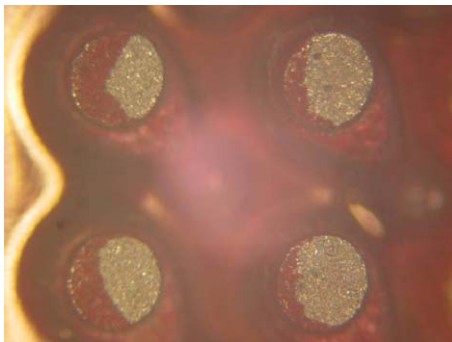
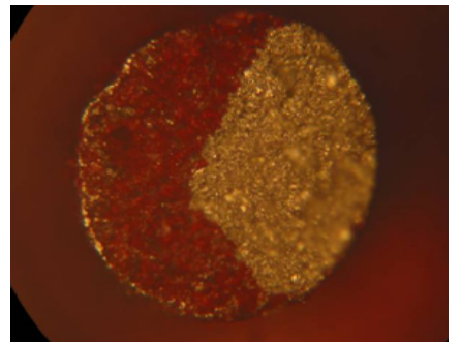
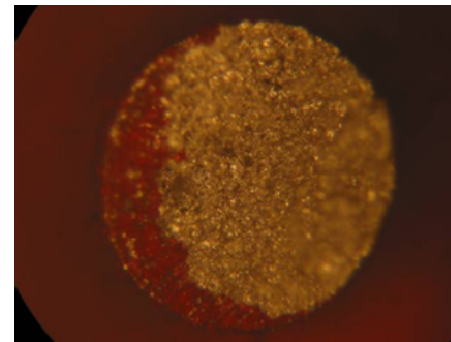
Inspection after  
1° Pull-Out

The Dye Penetrant Test has been performed on DBGA 444#1 from Test Vehicle S/N 3. After the first Pull-Out 254 soldered joints (57.2%) have been inspected and after the second Pull-Out 188 soldered joints (up to 99.5%) have been inspected, with 2 residual joints (0.5%) still attached to package.

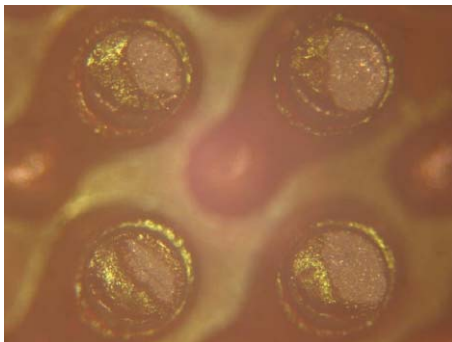
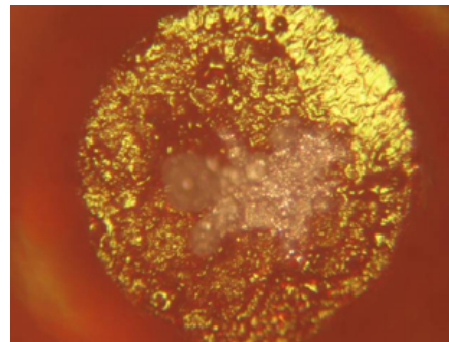
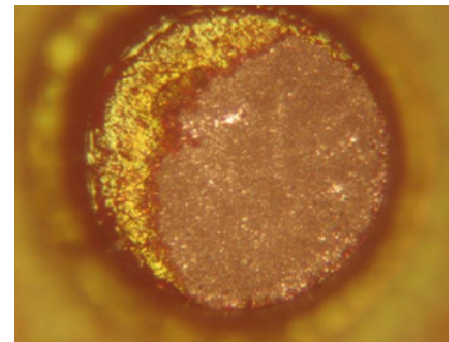
Inspection after  
1° Pull-Out

The Dye Penetrant Test has been performed on DBGA 444#2 from Test Vehicle S/N 3. After the first Pull-Out 271 soldered joints (61.0%) have been inspected and after the second Pull-Out 158 soldered joints (up to 96.6%) have been inspected, with 15 residual joints (3.4%) still attached to package .

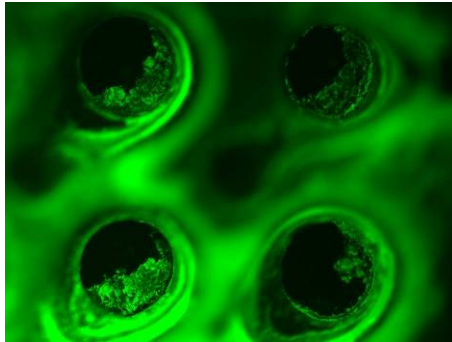
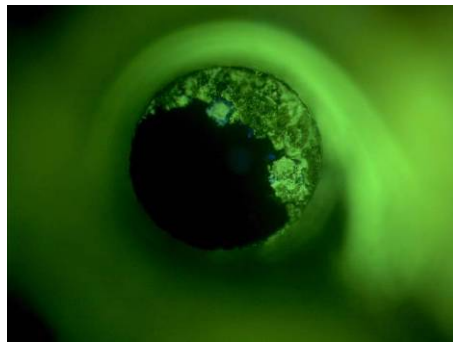
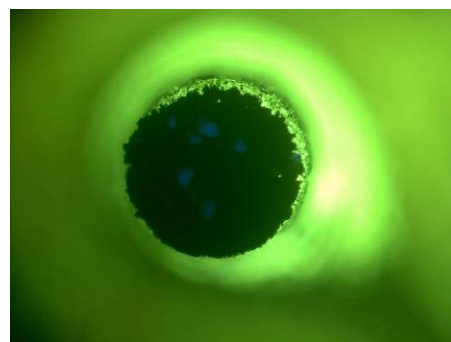
### IFWB-C2

Inspection after  
1° Pull-Out

- ✓ 😊 IFWB-C2: it is a good dye, suitable for detection of cracks on soldered joint. Moreover once dry, it doesn't produce any dust, and the inspection is quite easy.

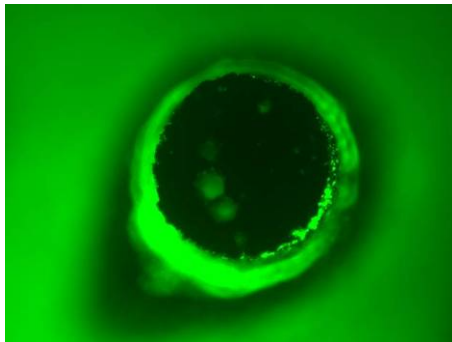
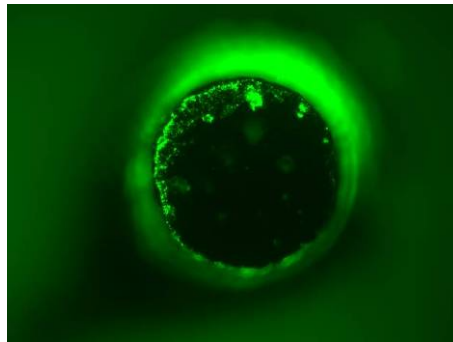
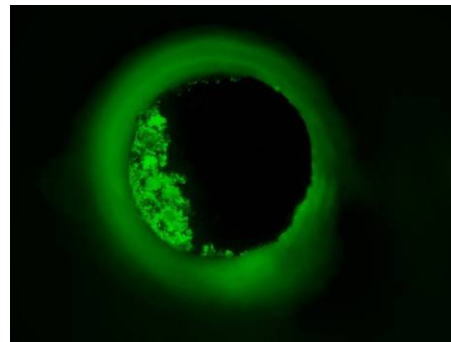
Inspection after  
2° Pull-Out

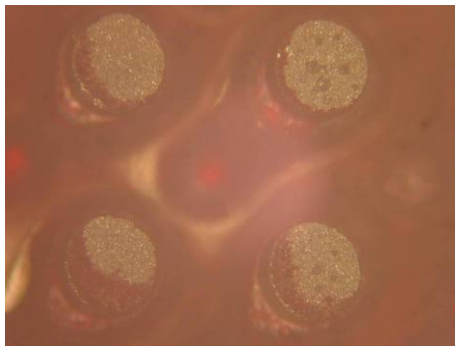
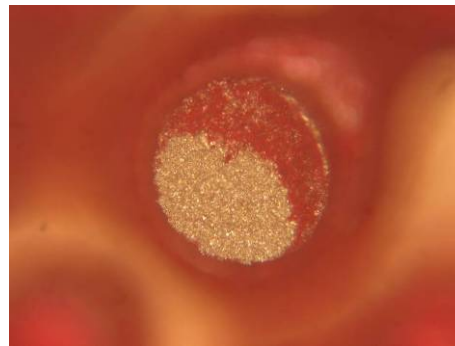
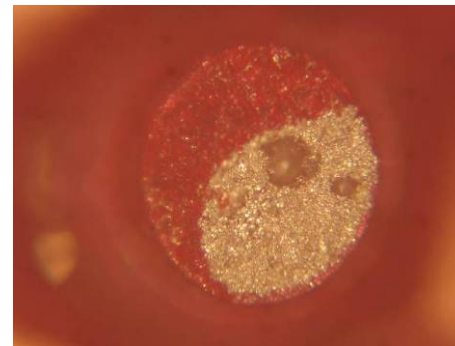
### RED STEEL

Inspection after  
1° Pull-Out

- ✓ 😊 RED STEEL: it is a very suitable product to detect the solder joint cracks, with an easiness of use and with the possibility to work on white light.

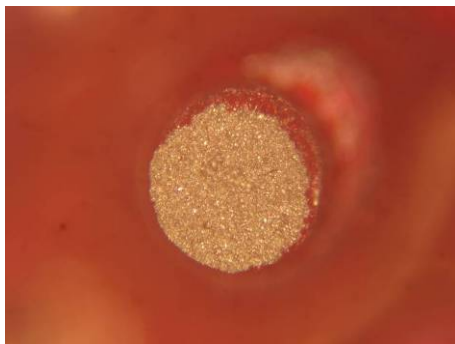
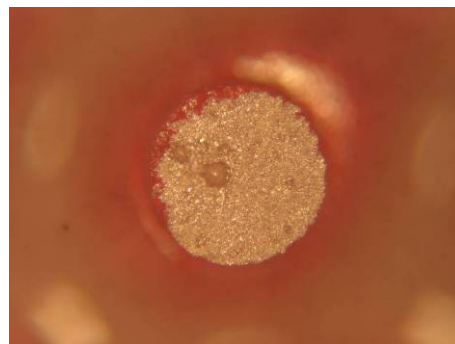
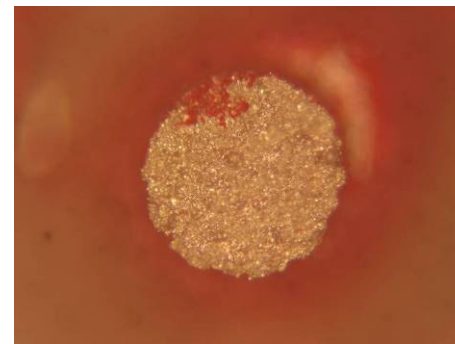
Inspection after  
2° Pull-Out

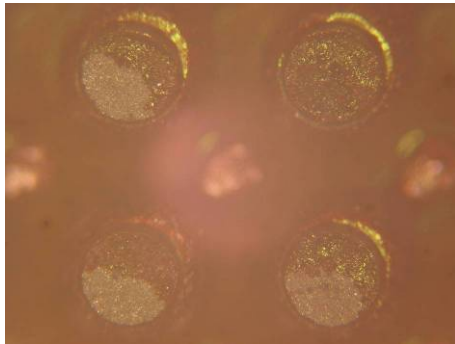
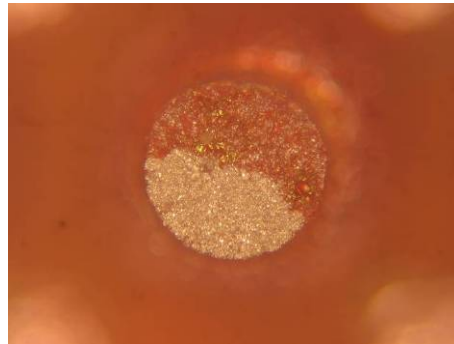
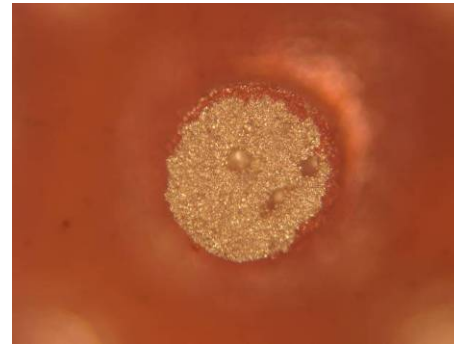
### EOSINA

Inspection after  
1° Pull-Out

- ✓ 😊 EOSINA: like the previous one, it is a very suitable product to detect the solder joint cracks, with an easiness of use and with the possibility to work on white light

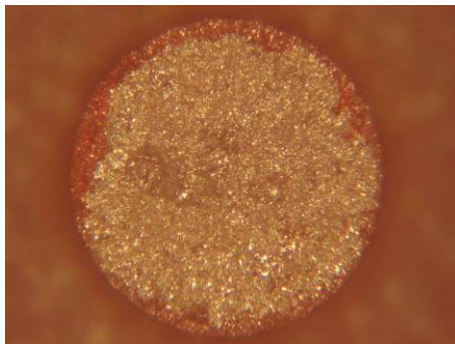
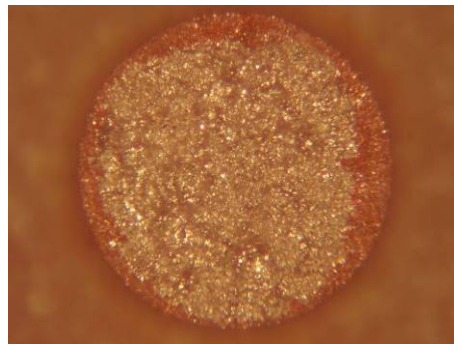
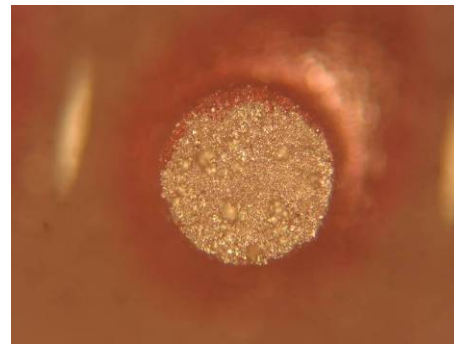
Inspection after  
2° Pull-Out
