PLATED THROUGH RELIABILITY AND MATERIAL INTEGRITY RESULTS FOR 24 MATERIALS PROCESSED THROUGH LEAD FREE ASSEMBLY

Bill Birch, Jason Furlong
PWB Interconnect Solutions Inc.
Ottawa, ON, Canada

ABSTRACT

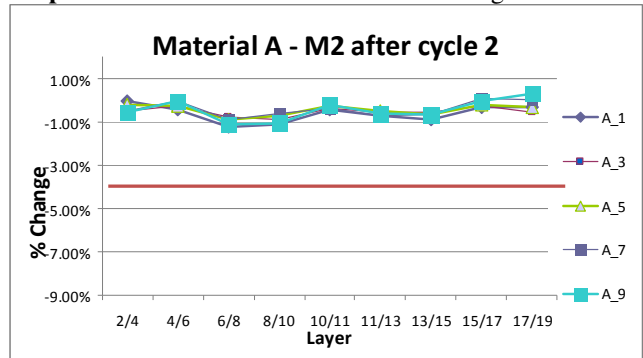
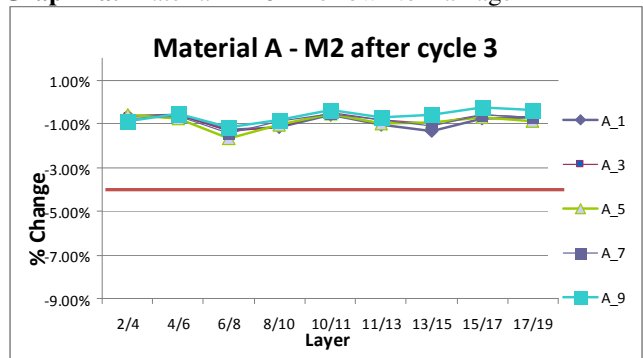
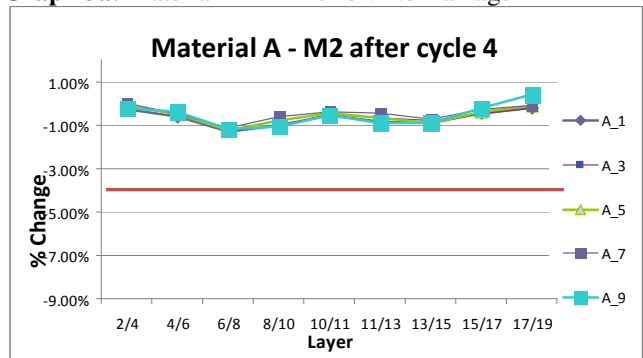
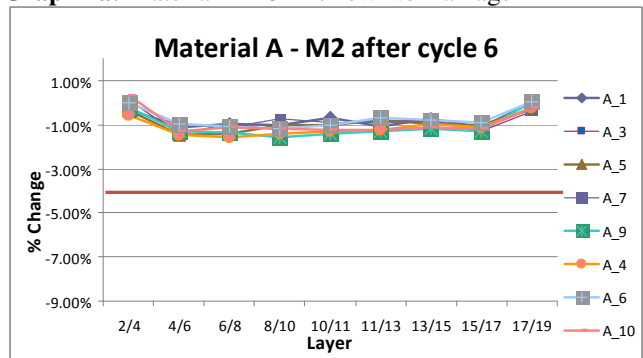
Graph 1a: Material A - 2nd Reflow No Damage

Graph 2a: Material A - 3rd Reflow No Damage

Graph 3a: Material A - 4th Reflow No Damage

Graph 4a: Material A - 6th Reflow No Damage

The four graphs associated to material “A” are virtually unchanged, confirming a robust material. The data does confirm a 1% reduction in bulk capacitance throughout the construction; this level of change is related to the inherent moisture removal and is considered normal for this type of construction.

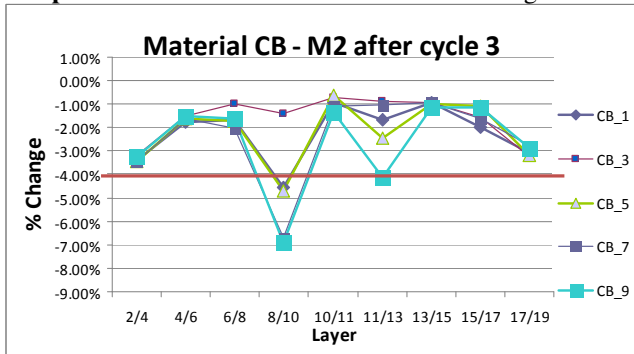
Graph 2b: Material CB - 3rd Reflow with Damage

Graph 1b illustrates the relative capacitance change measured in material “CB” after the 2nd pass through the reflow oven. The data shows a curvature conversion to the profile, with the outer layers exhibiting the highest change. Layers 8 to 10 measure a maximum of 2% reduction; layers 11 to 13 measured a 1% change. This small level of change is not classified as delamination, but it is an indicator that damage initiation has started. Graph 2b shows the measurements after the 3rd cycles, it confirms that the previous cycle damage initiation has now propagated into a delamination in 4 of the 5 coupons, between layers 8 and 10, compared to 1 coupon delaminating between layers 11 and 13.

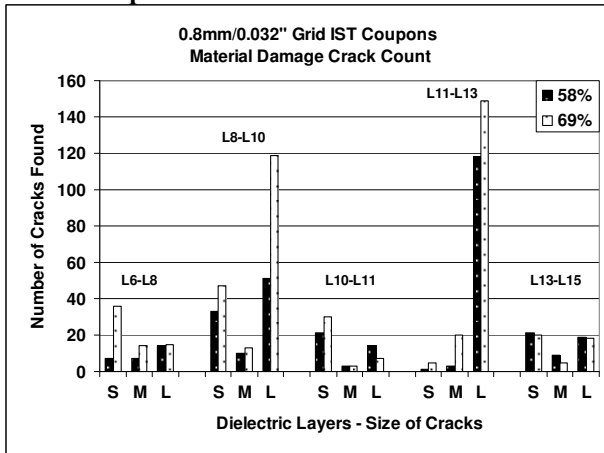
Graph 5: 0.8mm/0.032" Crack Distribution

Graphs 5 illustrates the distribution of small, medium and large sizes material cracks for the 0.8mm/0.032" grid coupons. The count is from the 15 materials that delaminated during the 6 cycles through the reflow oven. The data has been sub-divided by the two constructions (58% and 69%) used with each material. The data identifies that the majority of damage, signified by the medium and large cracks is occurring between layer 8 to 10 and layers 11 to 13. The B/C stage pairs are located equally on either side of the central C stage layers (L10/L11). The adjacent B/C stage pairs (L6 to L8 and L13 to L15) experienced relatively much less damage.

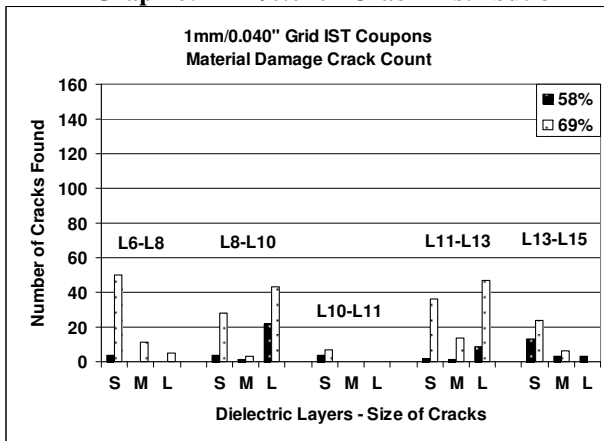
Graph 6: 1mm/0.040" Crack Distribution

Graph 6 relates to the same 24 materials, but the crack count is based on the 1mm/0.040" grid, for the 8 materials that exhibited delamination. The magnitude of damage is dramatically lower, and interestingly the dominance of the two dielectric pairs (L8 to L10 and L11 to L13) is still apparent, but less obvious.

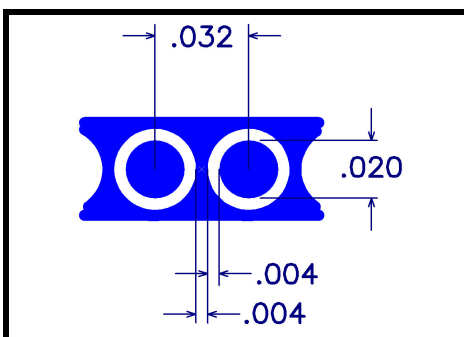
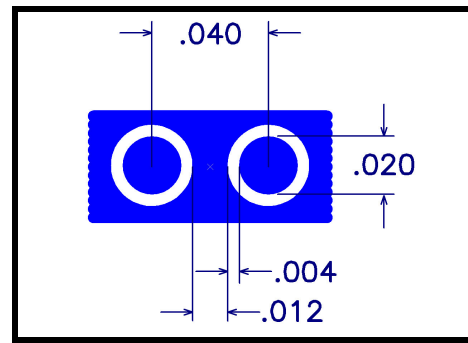
Based on failure analysis the weakest point of adhesion proved to be at the resin to glass interface, consequently the resin to copper and resin to resin bonds demonstrated to be strong enough to withstand the shear stress. The inclusion of non-functional pads decreases the surface area at the resin to resin interface of the B and C stage dielectrics, increasing the shear stress, by locking the resin at the non-functional pad locations. See figures 17 and 18 for geometries associated to the 2 grid sizes. This situation is consistent with decreasing the grid size while maintaining a common hole and pad diameter, as was evident in testing. Despite the grid size and non-functional pads the shear stress is equal, but the strain increases due to the smaller area in the x/y axis.

When the structure of the composite materials reaches a specific temperature during each assembly cycle an internal shear stress is generated by the mis-match of CTE. The CTE mismatch is caused by the combination of the strength of the glass restricting the x axis expansion, versus the non-restricted expansion of the resin in the y axis. The focal point of this CTE mismatch is located at the “knuckle” between the woven glass fabrics; this is premised on the examination of microsections that consistently exhibit material cracks at the cross-over point between the warp and the weft glass direction.

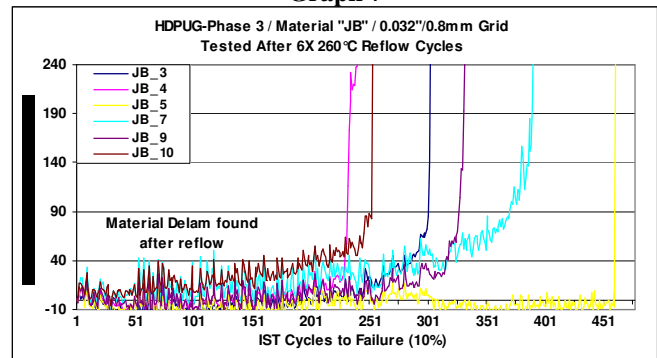
Graph 7

Most coupons in this study showed a slow progressive acceleration curve, indicating high quality copper plating. Example 1 shows coupons from material “JB” (Halogen Free 69%), shown in graph 7, confirm fatigue until approximately 225 to 300 cycles, then exhibit acceleration.

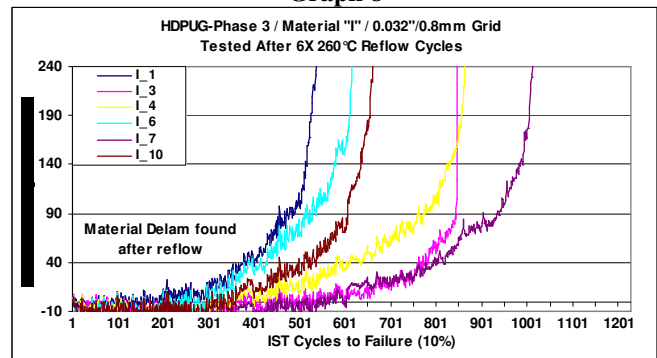
Graph 8

Example 2 are coupons from material “I” (High Speed FR4 58%) illustrated in graph 8, show failure initiated between 300 to 500 cycles, followed by a slow/progressive constant wear-out. This is a typical failure due to metal fatigue.

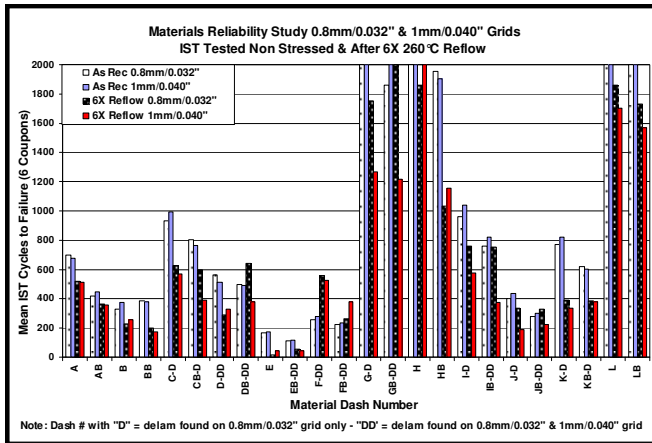
Graph 9 gives a graphical representation of the mean cycles to failure for the 0.8mm/0.032" and 1mm/0.040" grid coupons tested non-stressed and after 6X 260°C.

The initial impression confirms a wide variety of performances levels were achieved, from immediate failures to virtually unbreakable. The situation is further complemented by the fact that all material constructions were processed together through the same electrolytic copper plating chemistry, removing the ambiguity and overriding confounding effects. Under ideal conditions it would permit an ability to rank each material, under the pretence that inherent material properties were dominating performance. Unfortunately in this study we must incorporate the reality that 15 of the 24 materials on the 0.8mm/0.032" grid and 8 of the materials on the 1mm/0.040" grid delaminated during assembly.
