ESTEC's Materials and Electrical Components Laboratory capabilities on testing passive components

12-14 October 2016
ESA/ESTEC, Noordwijk, The Netherlands

Joaquín José Jiménez Carreira ⁽¹⁾,
⁽¹⁾EEE component engineer, ATG EUROPE B.V. on behalf of ESA/ESTEC
Keplerlaan 1, PO Box 299, 2200AG Noordwijk (The Netherlands)
Email: Joaquin.jimenez@esa.int

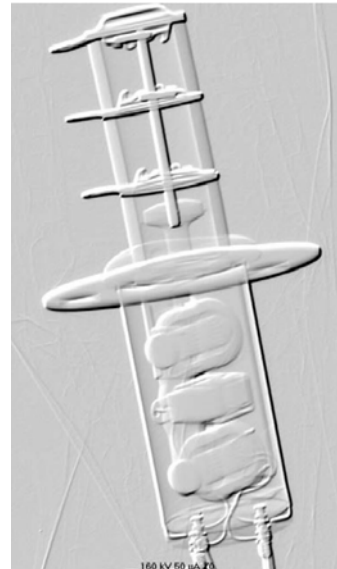
Fig. 2 Relief enhanced version

The number of applications of X-ray investigation for failure and constructional analysis is enormous. For instance, it is a powerful tool in order to get information about the internal structure of relays (Fig. 1 to Fig. 3 refer).

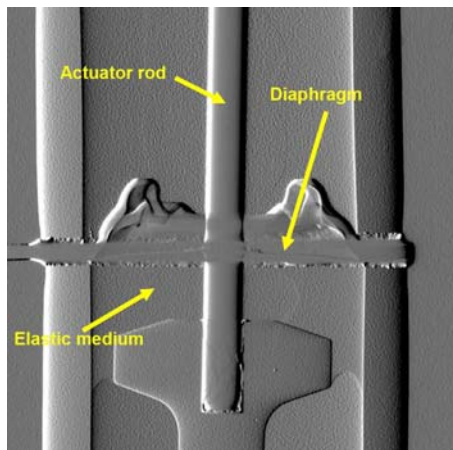
Fig. 3 Detailed view identifying different parts of the relay

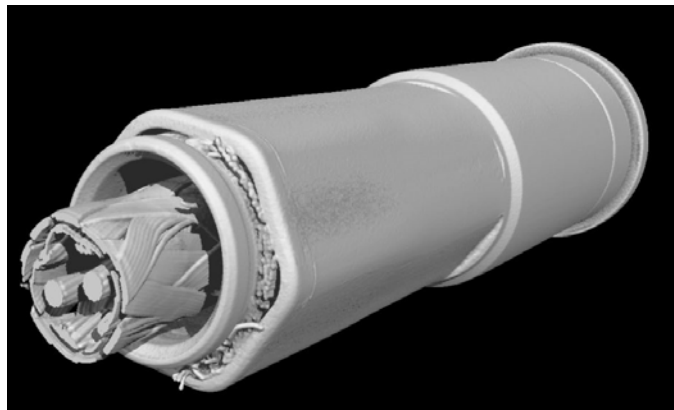
Several CT scans were performed on this part, focussing on its front-end and rear-end (or cable end, Fig. 10 refer). One of the big advantages of this technique is the possibility of doing virtual sections of the parts. Fig. 11 illustrates the body cracking associated with the over-long crimp in the reference sample, labelled as “Indicator 1”. Note that a 6mm long correct crimp would have been confined to an end region of the body with a deliberately reduced wall thickness to facilitate the deformation (see the red arrows in Fig. 11). By extending the crimp length, a much thicker wall was deformed and immediately next to the outer surface section change, the forces used resulted in through cracks.

Fig. 9 Cracks on the outer shell of the connector

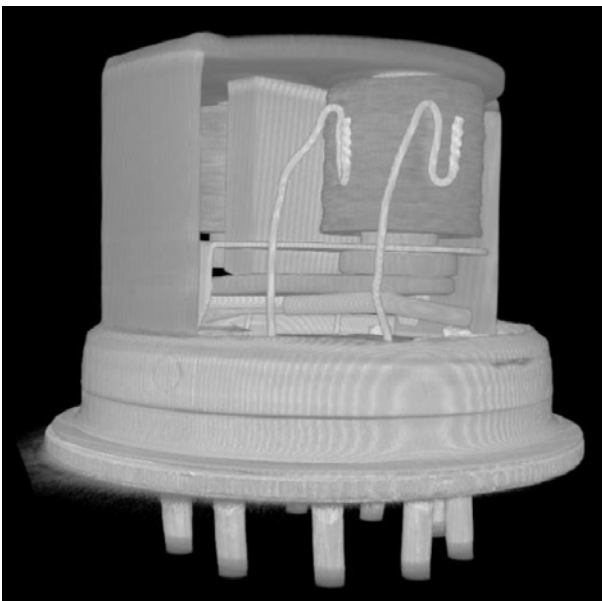
Fig. 20 Tomographic model of the relay

To illustrate the power of the CT scan tool, Fig 20 illustrates a CT scan of a relay. This model allowed for a quick detection of the pivot bar being bent (Fig 21 refer). All this information can be gathered without performing any destructive testing.

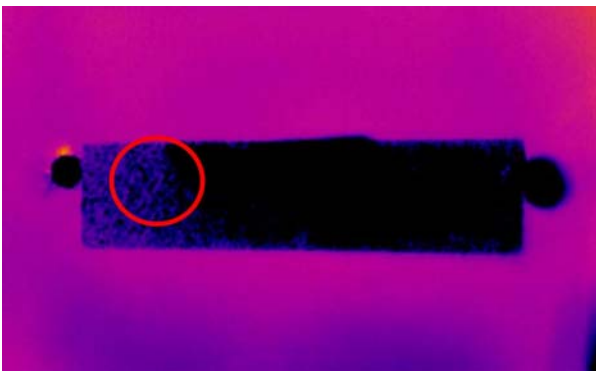
temperature of the part could be seen to rise, but a barely perceptible early warming point could be detected in the top surface. The top surface was therefore thinned to remove the concealing plastic. Fig. 26 and Fig. 27 show the results of repeating the IR images with the top plastic thinned. The bottom edge was then thinned to the point indicated by the yellow line in Fig. 27. The edge view is shown in Fig. 28 and Fig. 29, unbiased, and then biased, after the thinning of the edge. The circled area shows the target area for the next sectional plane. Fig. 32 shows an optical view corresponding with the IR image of Fig. 30 and Fig. 31. The failure was then located and exposed in the area pointed by the IR images. With the help of SEM and EDX analysis, a point of contact between the silver cathode metal and the bulk Tantalum was found (see Fig. 33).

Fig. 28 Further thinning - unbiased

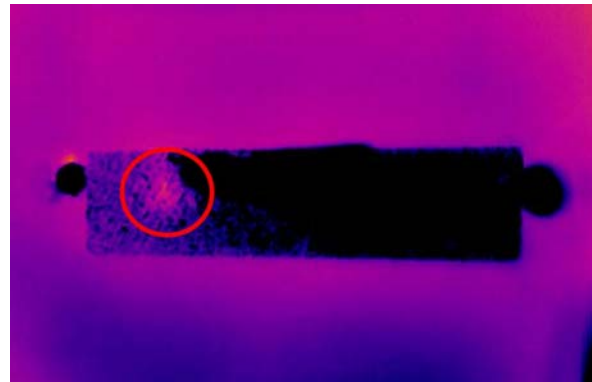
Fig. 29 Further thinning - biased

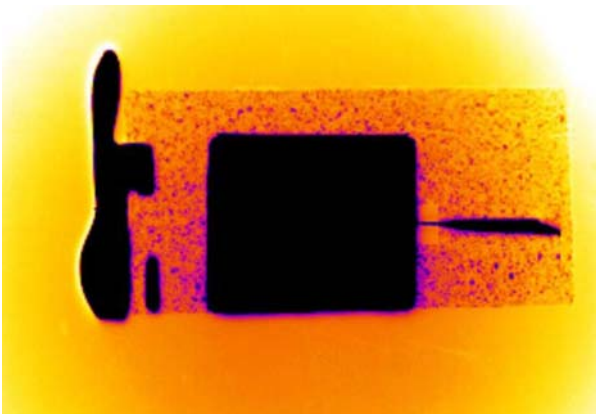
Fig. 30 Third section plane - unbiased

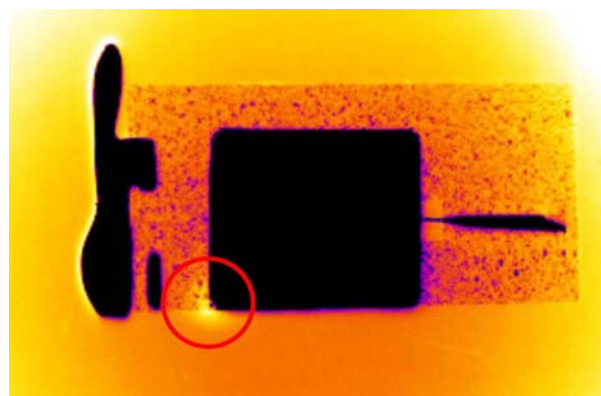
Fig. 31 Third section plane - biased

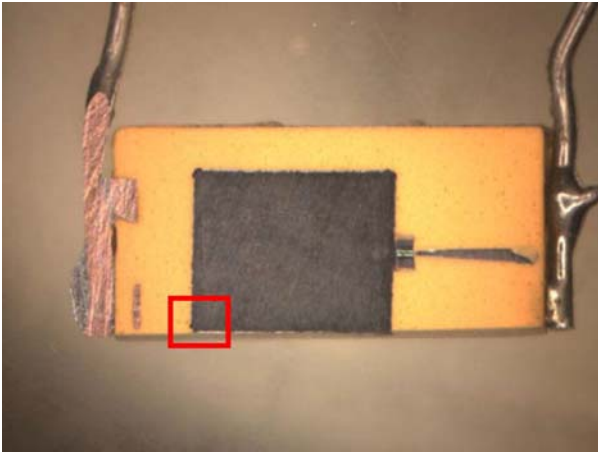
Fig. 32 Optical view of Fig. 30 and 31

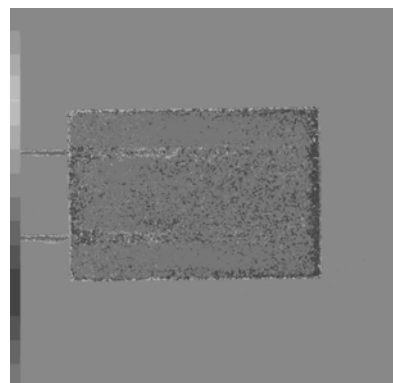
A series of polyester capacitors was submitted to the lab for a thorough investigation of specific design elements. Among others, possible delaminations between the case and the potting epoxy. The C-SAM did not detect any delaminations in these capacitors.

Fig. 35 CSAM image of polyester capacitor

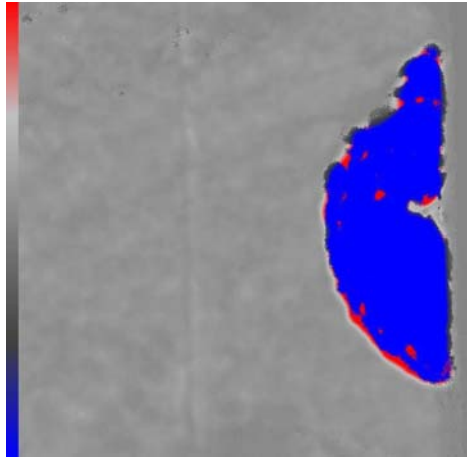
In order to check the validity of this investigation, deliberate delamination was created to verify the technique, Fig. 36 refer.

Fig. 36 Intentioned delaminations

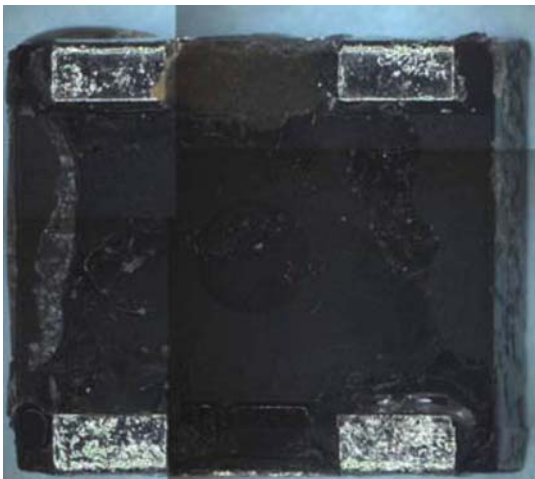
Fig. 37 Optical bottom view of the capacitor

This technique has helped to detect some defects in a tantalum, solid electrolyte surface mount chip capacitor that was investigated in the lab. Fig. 37 shows the bottom view of the capacitor and Fig. 38 shows the CSAM image of the bottom layer of the capacitor.

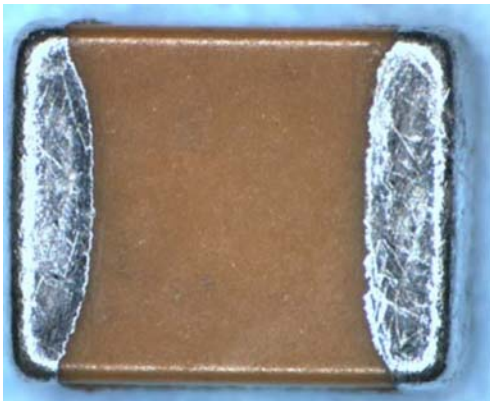
Fig. 40 Top view of failed capacitor

One multilayer chip capacitor was delivered to the lab for failure analysis investigation. Electrical measurements demonstrated an anomaly in the capacitor at lower frequencies. The part (Fig. 40) was potted in epoxy resin and microsectioned (Fig. 41). Two different cracks can be seen in this section (see red arrows in Fig. 41):

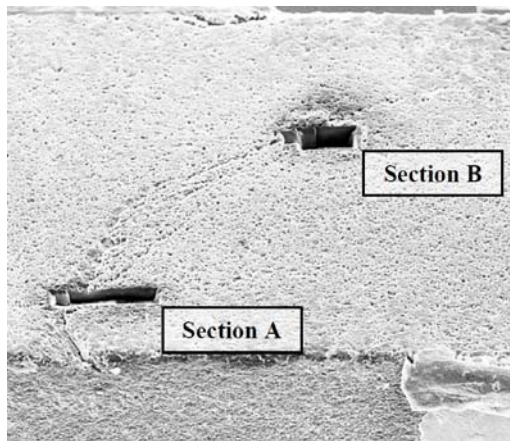
Two FIB cuts (Fig. 49) were performed along the crack shown in Fig. 48:

Fig. 49 SEM view of the FIB sections along the crack in Fig. 48

The red arrows in Fig. 50 and 51 indicate the crack propagating within the bulk material. This demonstrates that the crack is propagating inside the bulk material and allowed for a precise measurement of its length, which is out of the specification limits.

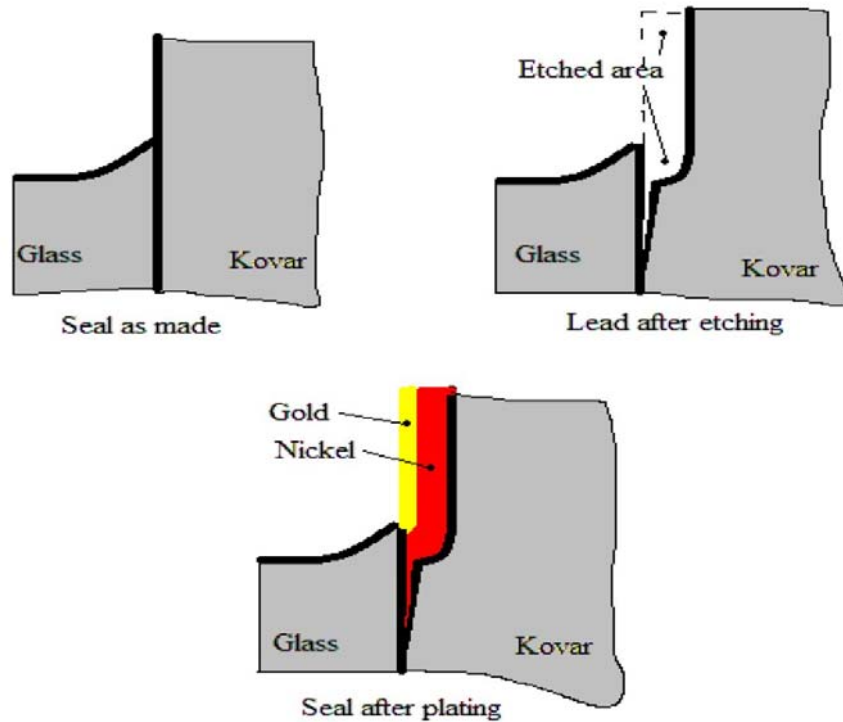
A very interesting failure investigation carried out in the lab was performed on an electronic component, in which two of its three leads were unintentionally internally short circuited. The package material was kovar, with three leads attached to the package body through a glass seal. On each of the parts examined, there was a notable reduction in the diameter of the lead, where it is not enclosed in the glass of the seal. The reduction is of the order of 20 microns overall. Additionally, the etching solution used for electroplating crept down the interface between the glass and the lead to a depth approaching 150 microns, well below the glass meniscus surface down the sides of the lead. The nickel plating was therefore deposited into this gap to an equivalent depth. In the area where the dendrites were formed there was therefore a nickel seed layer which could support a pure nickel dendrite formation. The concept is illustrated below (Fig. 52 refer):

Fig. 52 Process of formation of a nickel seed layer

Nickel is the external layer of the leads inside the glass seal. Some of these packages presented a crack in the glass seal. Time and a proper chemical activator caused a linear growth of the nickel through the crack in the glass seal: a dendrite. Eventually, this led to a short circuit in the package and a subsequent component failure. The mechanism causing the cracks in the glass seal could not be discovered.

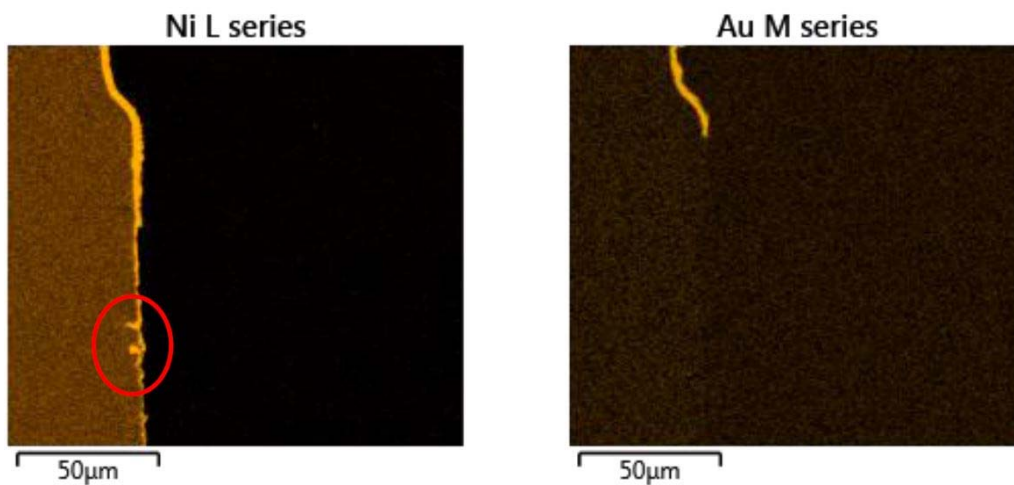
This was demonstrated by the EDX analysis produced the following results (Fig. 53):

Fig. 53 EDX analysis right at the meniscus area
