## Experience and lessons learned from HALT

Aarón Nercellas Ventas, Electronics Area Manager

- Software defined radio developed by Alén Space (TRL9 - 2018)
- Core architecture based on SoC - TRX
  - Zynq-7000 SoC (28 nm) Xilinx, Linux OS
  - AD9364 Transceiver from Analog devices, 70MHz - 6 GHz
  - DDR3L 1GB, NAND Flash 1GB, 4Mb MRAM
  - PC104 form factor
  - 1TX and 1RX RF ports
  - Power consumption: 2.5W in TX mode

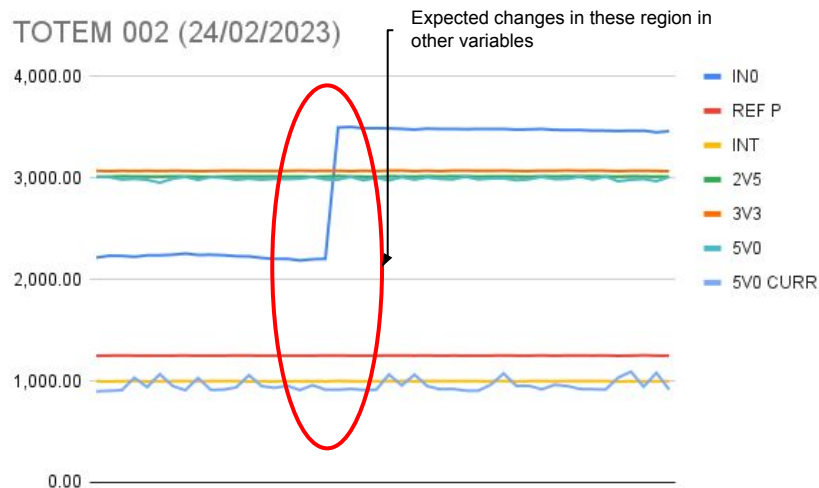
Failure description: FE\_AN\_IN0 outside of range while the rest of parameters are in range. Several boards affected.

1. Confirmation of the anomaly in the laboratory
  - a. Non destructive anomaly that cannot be replicated in the laboratory
2. Investigation analysis
  - a. Replication of set up
  - b. Extend test operational time to make TOTEM heat up
  - c. Exchange all data from the test with ALTER and try to correlate the out of range condition with other parameters
3. Conclusions
  - a. The anomaly could not be replicated in the lab. Data analysis did not yield valuable insight.
  - b. Possible causes
    - i. Set up: this specific analog value was read with a loopback
