ALTER |   **ACCEDE | ESCCON**  
**2025** Seville - Spain  
25 to 27<sup>th</sup> March

**ATCOS GSTP Study: Alternative Test Methods for COTS – Test Results**

# Study goal

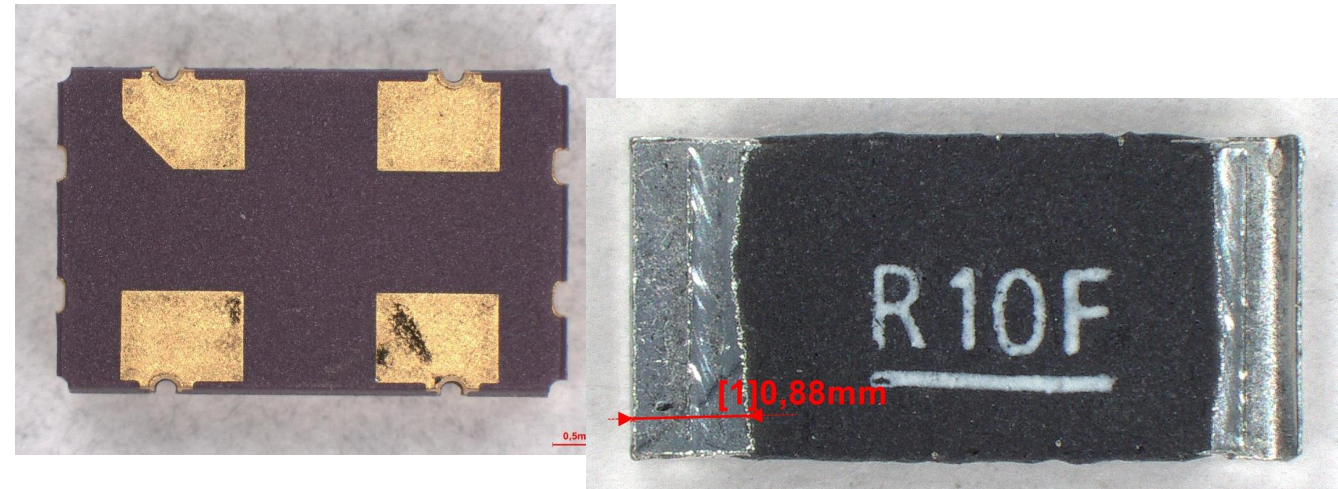
- **30 component types tested, 1116 components total**  
7 ICs, 1 hybrid, 3 oscillators, 7 discretes, 1 inductor, 6 capacitors, 4 resistors, 1 connector
- **Results of visual inspection:**
  - 1 shipment completely rejected → inadequate packaging (by distributor -> ESD+damage)
  - 17 component types 100% pass, 13 component types with some fails
  - 63 of 1116 components failed → but still being used for board manufacturing
    - Foreign particles and contamination
    - Scratches
    - Corrosion on test points or pins
    - Exposed base material of pins
    - Package discolorations
    - Deviation from specifications
    - Bent pins

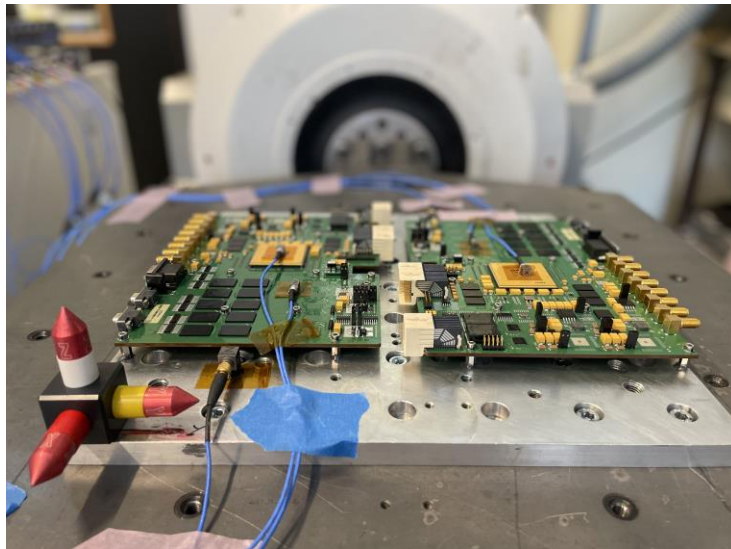
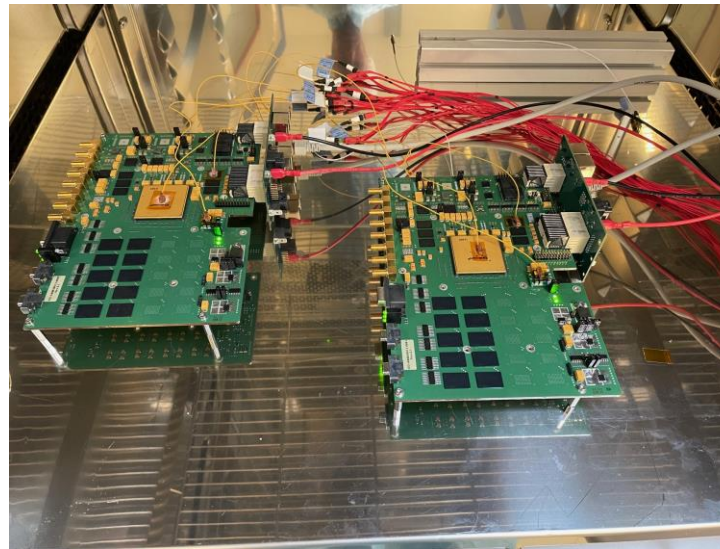
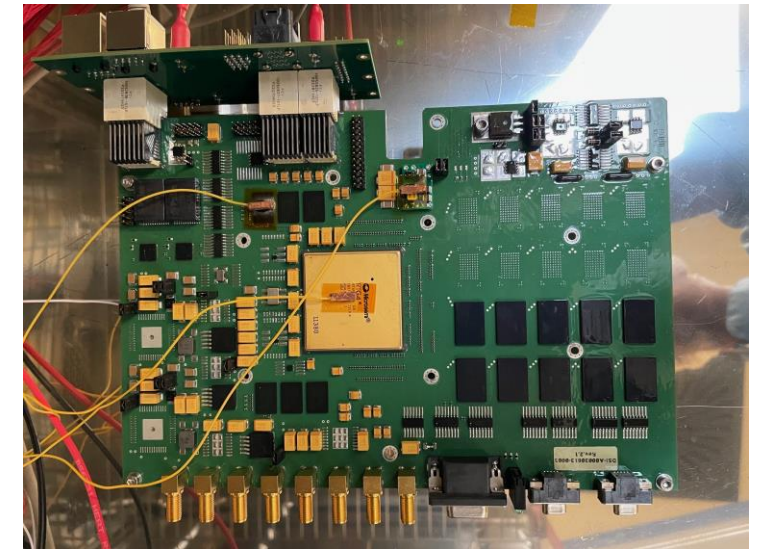
- Screening tests performed on 5 Boards
- Results Visual Inspection: **passed**
- Results Functional Testing: **passed**
- Results Electrical Testing: **passed**

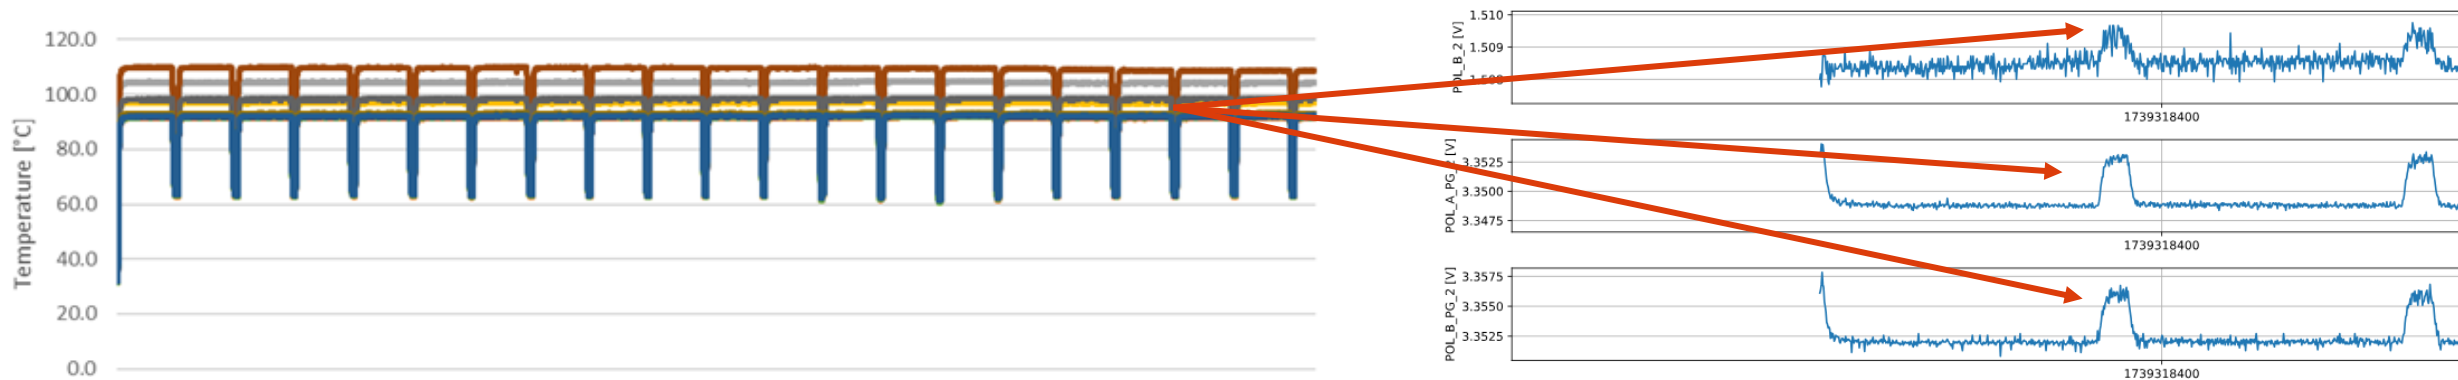
In-Situ parameter measurements

- Mechanical tests performed on Board 1 and Board 2 (**passed**)
- Life test almost completed on Board 3 and Board 4 (~800h)
  - All functions still regular
  - No significant drift in monitored electrical parameters

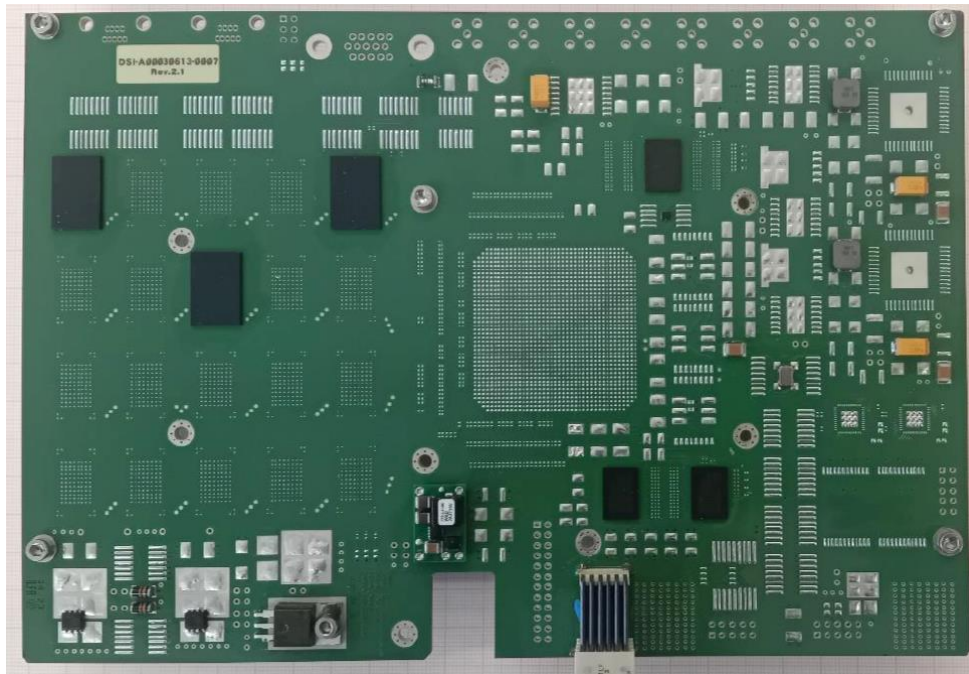
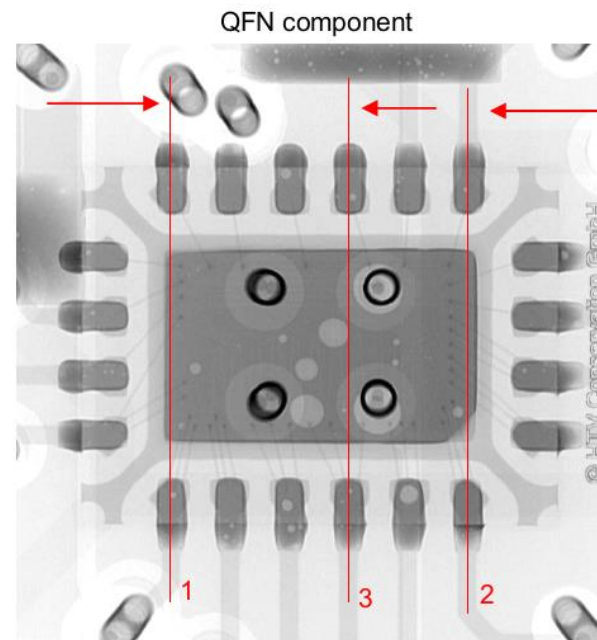
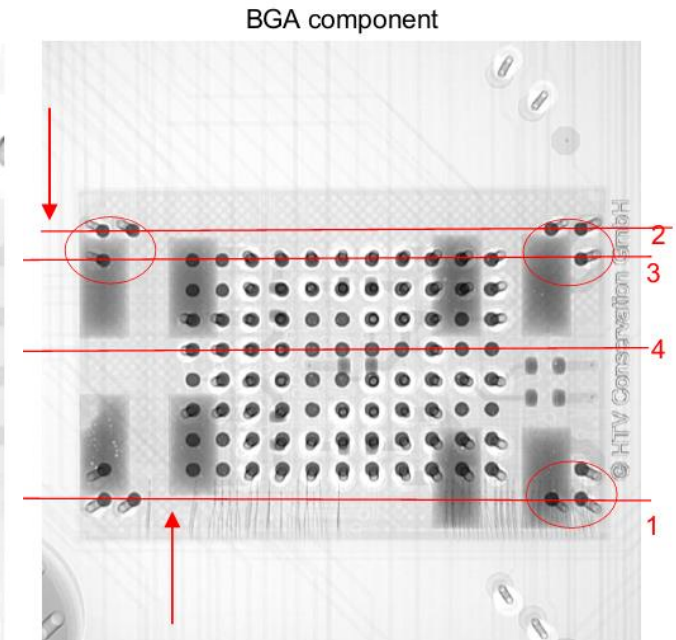
- **Mounting Verification on passive board (16 component types)**
  - Environmental Testing completed → no obvious damages
  - Microsectioning ongoing
