DOCUMENT CHANGE REQUEST

Title:	CMOS 8-Stage Shift and Store Bus Register with Synchronous Serial Outputs and 3-State Parallel		
Number:	9306/026	Issue:	2

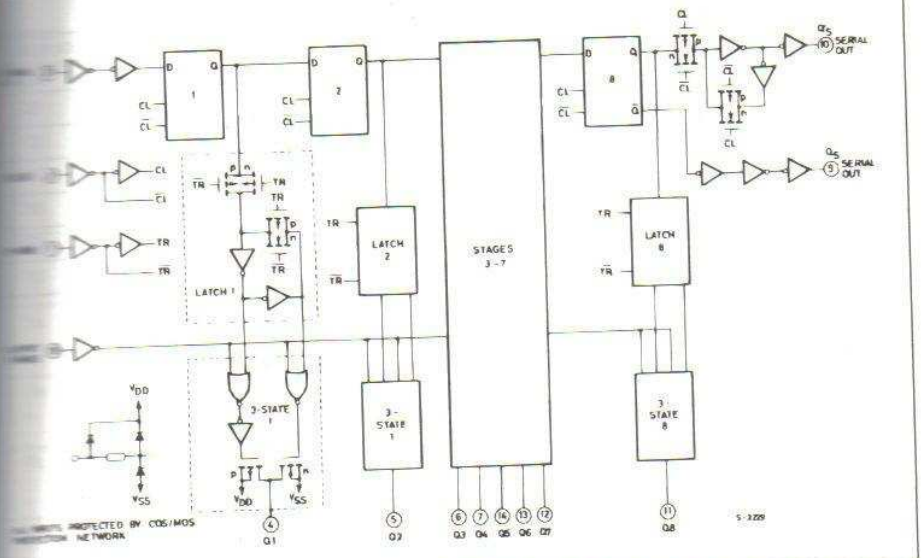
DIAGRAMS

timing diagram is wrong.

during migration from old ESA/SCC form to ESCC form, the diagram was copied and an error was introduiced: the second negative pulse of STR shall start at the next falling front of CLK (in the same time as OE).
Good diagram is proposed in attached file
