Seville - Spain
25 to 27th March

Revolutionizing PCB Soldering Verification with Computer Vision

MC. López, M. Dominguez

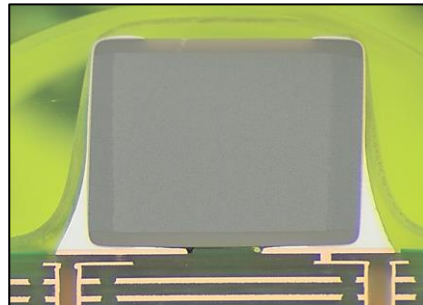
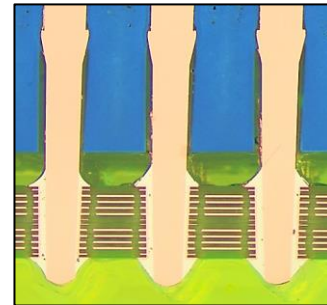
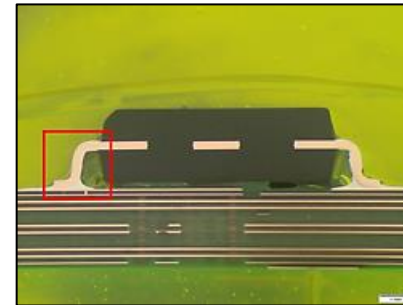
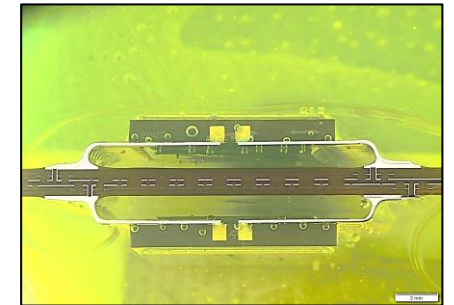
Grinding/Polish

ALTER Technology has developed different **grinding protocols depending on the device** and based on the component materials of the device.

These methods define each **parameter** during the process, like:

- Abrasive Surface
 - Diamond coated bases
 - SiC sandpapers
 - Polishing clothes
- Lubricant
- Rotation Speed
- Pressure
- Time
- Grit size

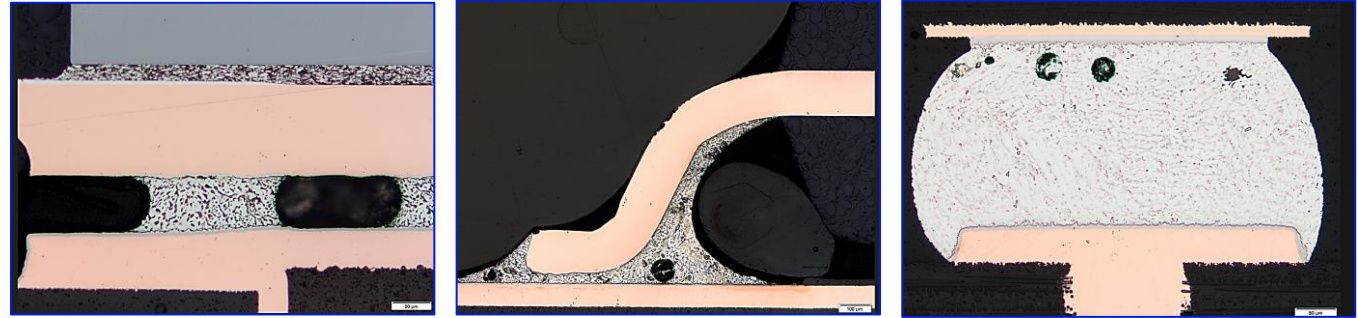
First round: Chat GPT

- Due to the complexity of the anomalies we can find in a solder joint, a simple defect was chosen to begin with: **Voids in solder joint.**

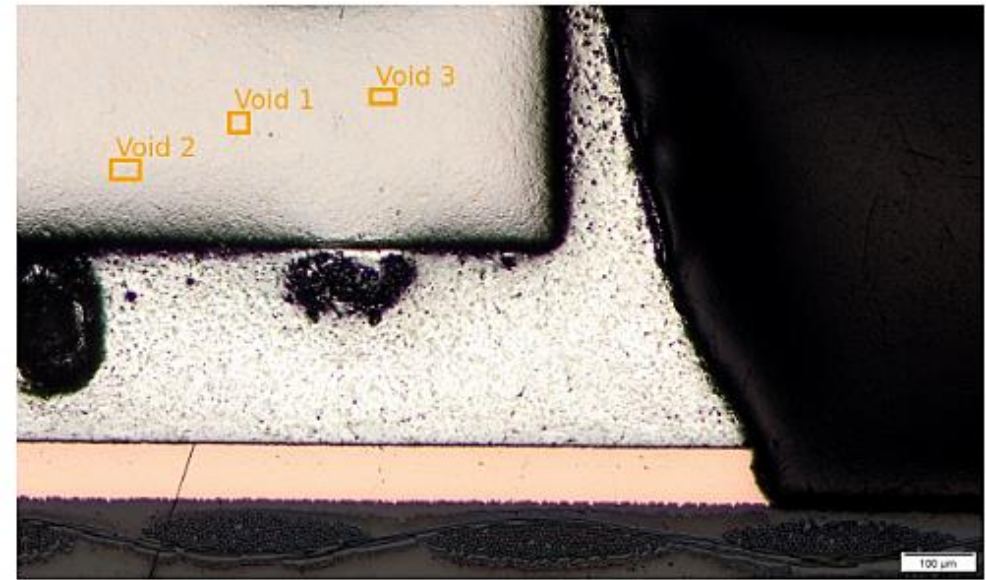
- The standard ChatGPT fails to identify the most evident anomalies in the picture.

- Although ChatGPT understands the acceptance criteria and the quality of the picture seems good enough, the results are totally unacceptable.

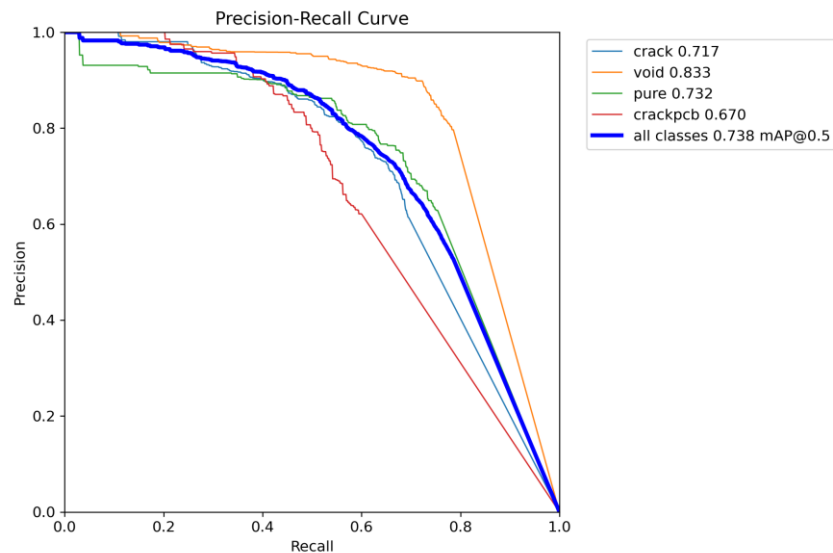
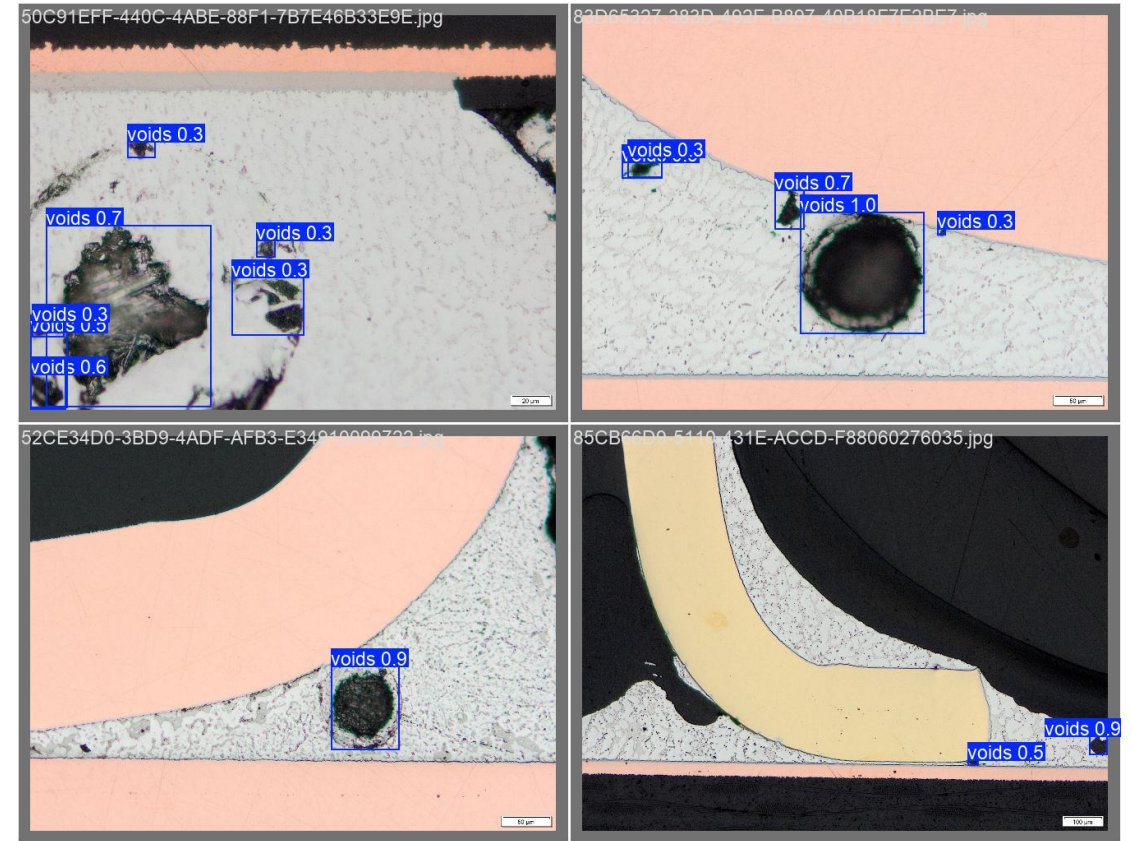
Second Round: Single anomaly detection

- We have hundreds of images classified with the label **VOID**. These images are used to train the system to recognize a black hole in the SnPb solder like a void.
- Once we have classified hundred of pictures with one single anomaly, voids, it seems that **the model is able to identify** most of them and evaluate the degree of confidence that could be provided.

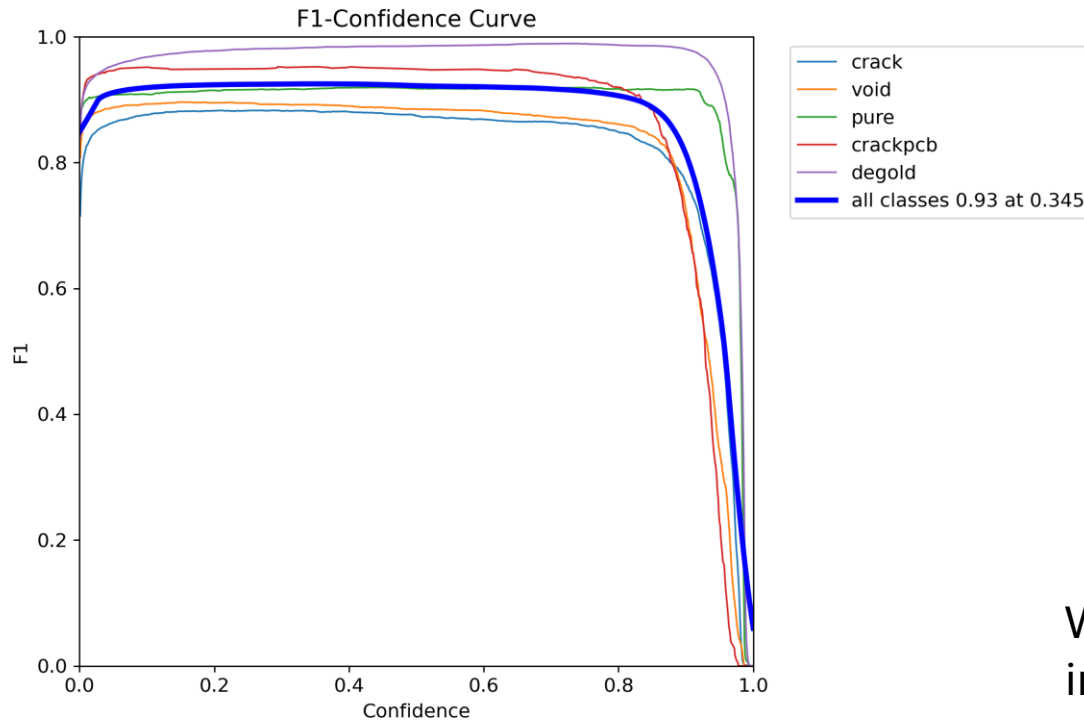
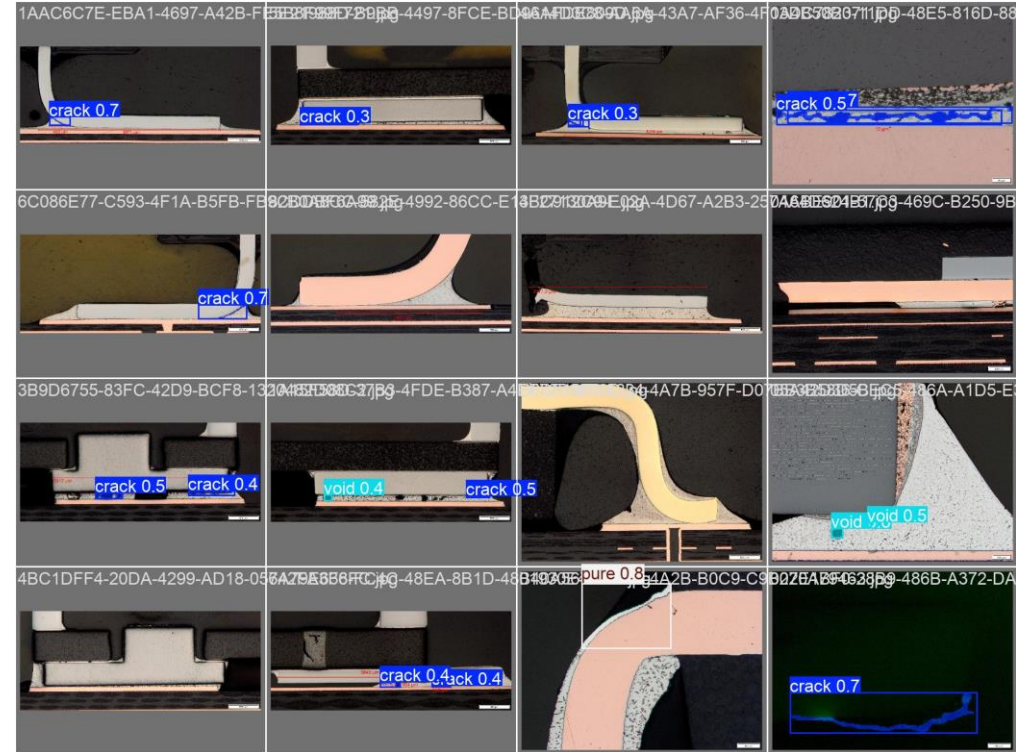
Third Round: Everything at once

- This new training allows:
 - Improve the degree of **fulfillment** of the system.
 - Provide the **ability to predict** rare events.

With the **current results**, the **model** has not only met the initially defined standards but has **exceeded them!!**
