# Invotec Group

### The Drive Towards Zero Contamination Within the Delivered PCB

#### BACKGROUND TO INCIDENTS OF INCLUSIONS

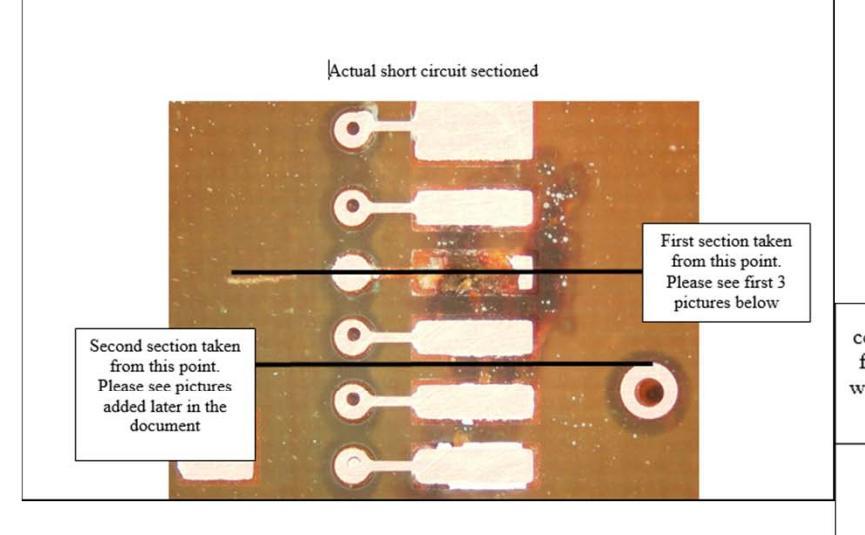
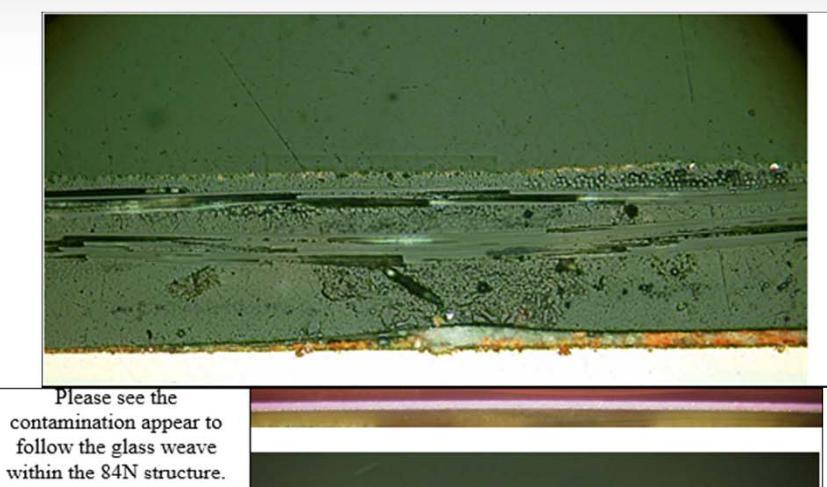
#### Example of Actual Short Circuit

#### Surface Appearance

#### . Internal pathway created

#### Characteristics of the Inclusions

In Total 7 Reported Incidents within the Time Frame

All Polyimide with Copper Invar Copper CTE control layers

All incidents occurred after around 100 hours usage time

Every failure was located between PWR/GND layer within a laminate core

No evidence of a Metallic Inclusion, only a void created by the short circuit

Common trace elements found were Carbon (caused by the short circuit event) and Chlorine

### **Corrective Actions in Partnership with Customer**

Initial Corrective Action was to improve cleaning of inner layers at the lay up by means of brushing Good intention but subsequently PCB found containing an embedded bristle

Cleaning Technique changed to Vacuum Cleaning of inner layer

Analysis of cleaning head shown to have PVC content (heavy chlorine)

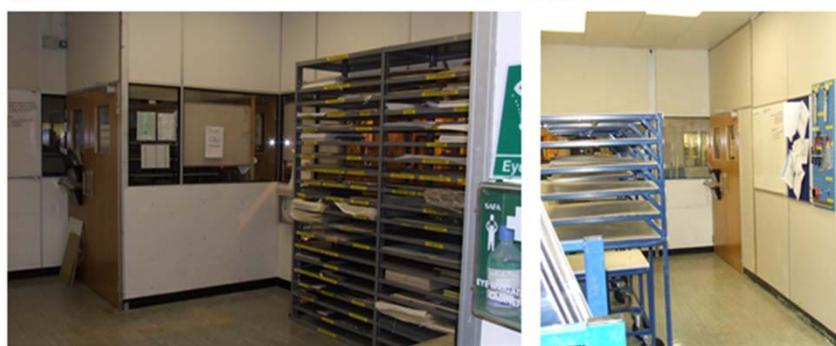
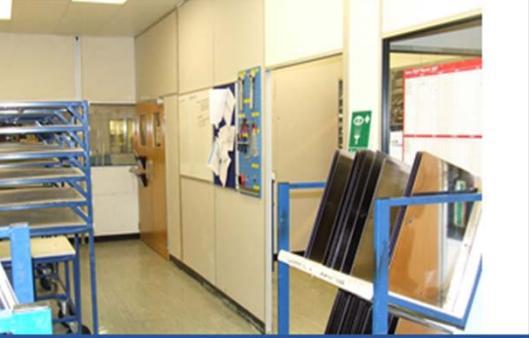
#### Before and After 5S Activity

Central Lam Bonding Room Improvements After befores After

Before

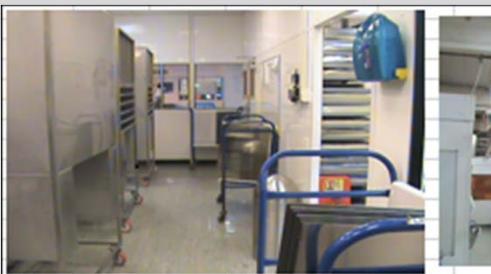
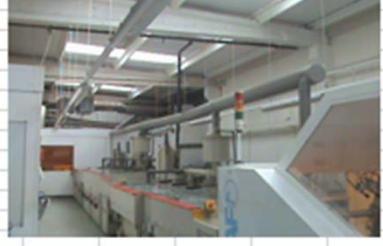
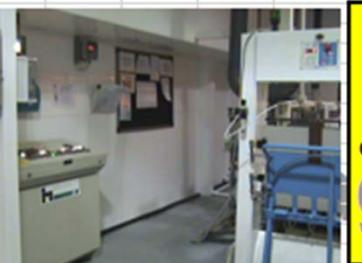
## Lay Up Room Improvements

'Easy Clean' Cladding of Room throughout

**Total Roof Refurbishment**

Stainless Steel Food Hygiene Standard Furniture

All Lay Up Stations Grounded to minimise Static

Laminar Flow & De ioniser Lay Up Stations

Interlock Doors for Access

Clearly Visible Charts showing what Tools , Kit and accessories are allowed within the area

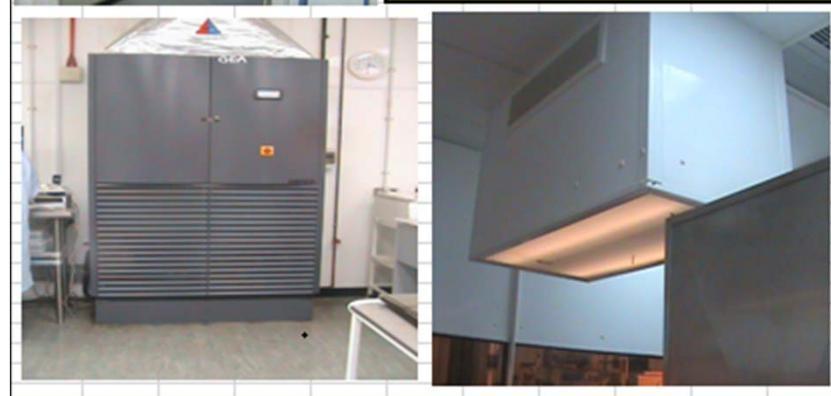
#### ENVIRONMENTAL IMPROVEMENTS

CLADDING, NEW ROOF, STEEL FURNITURE, AIR CON, ANTI-STATIC, INTERLOCKED DOORS, LAMINAR FLOW

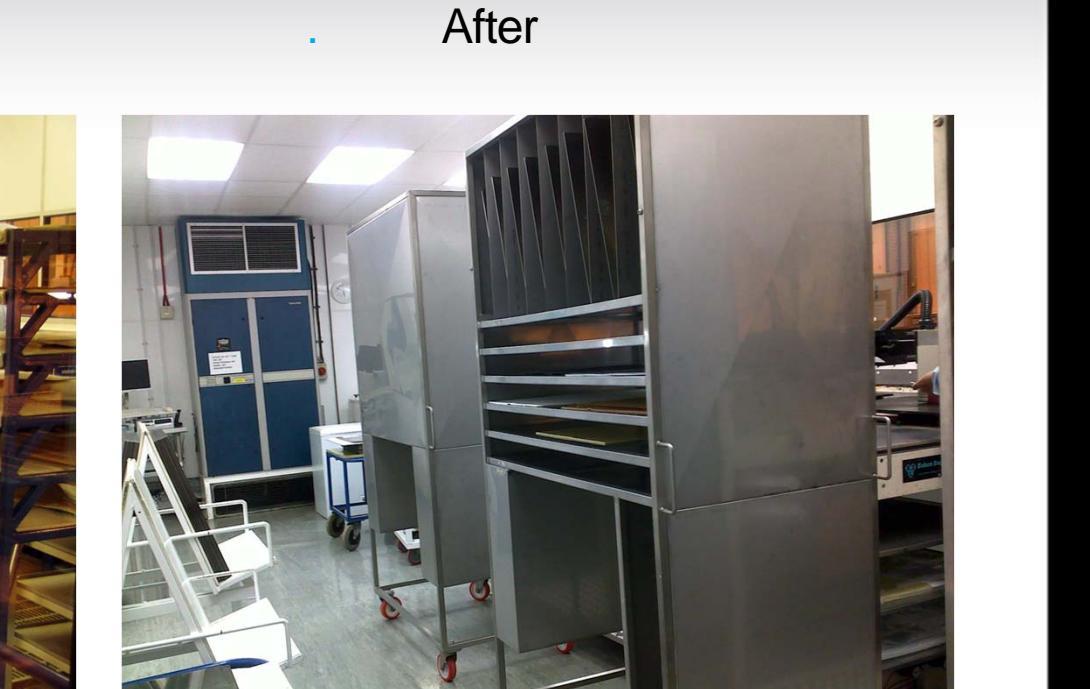
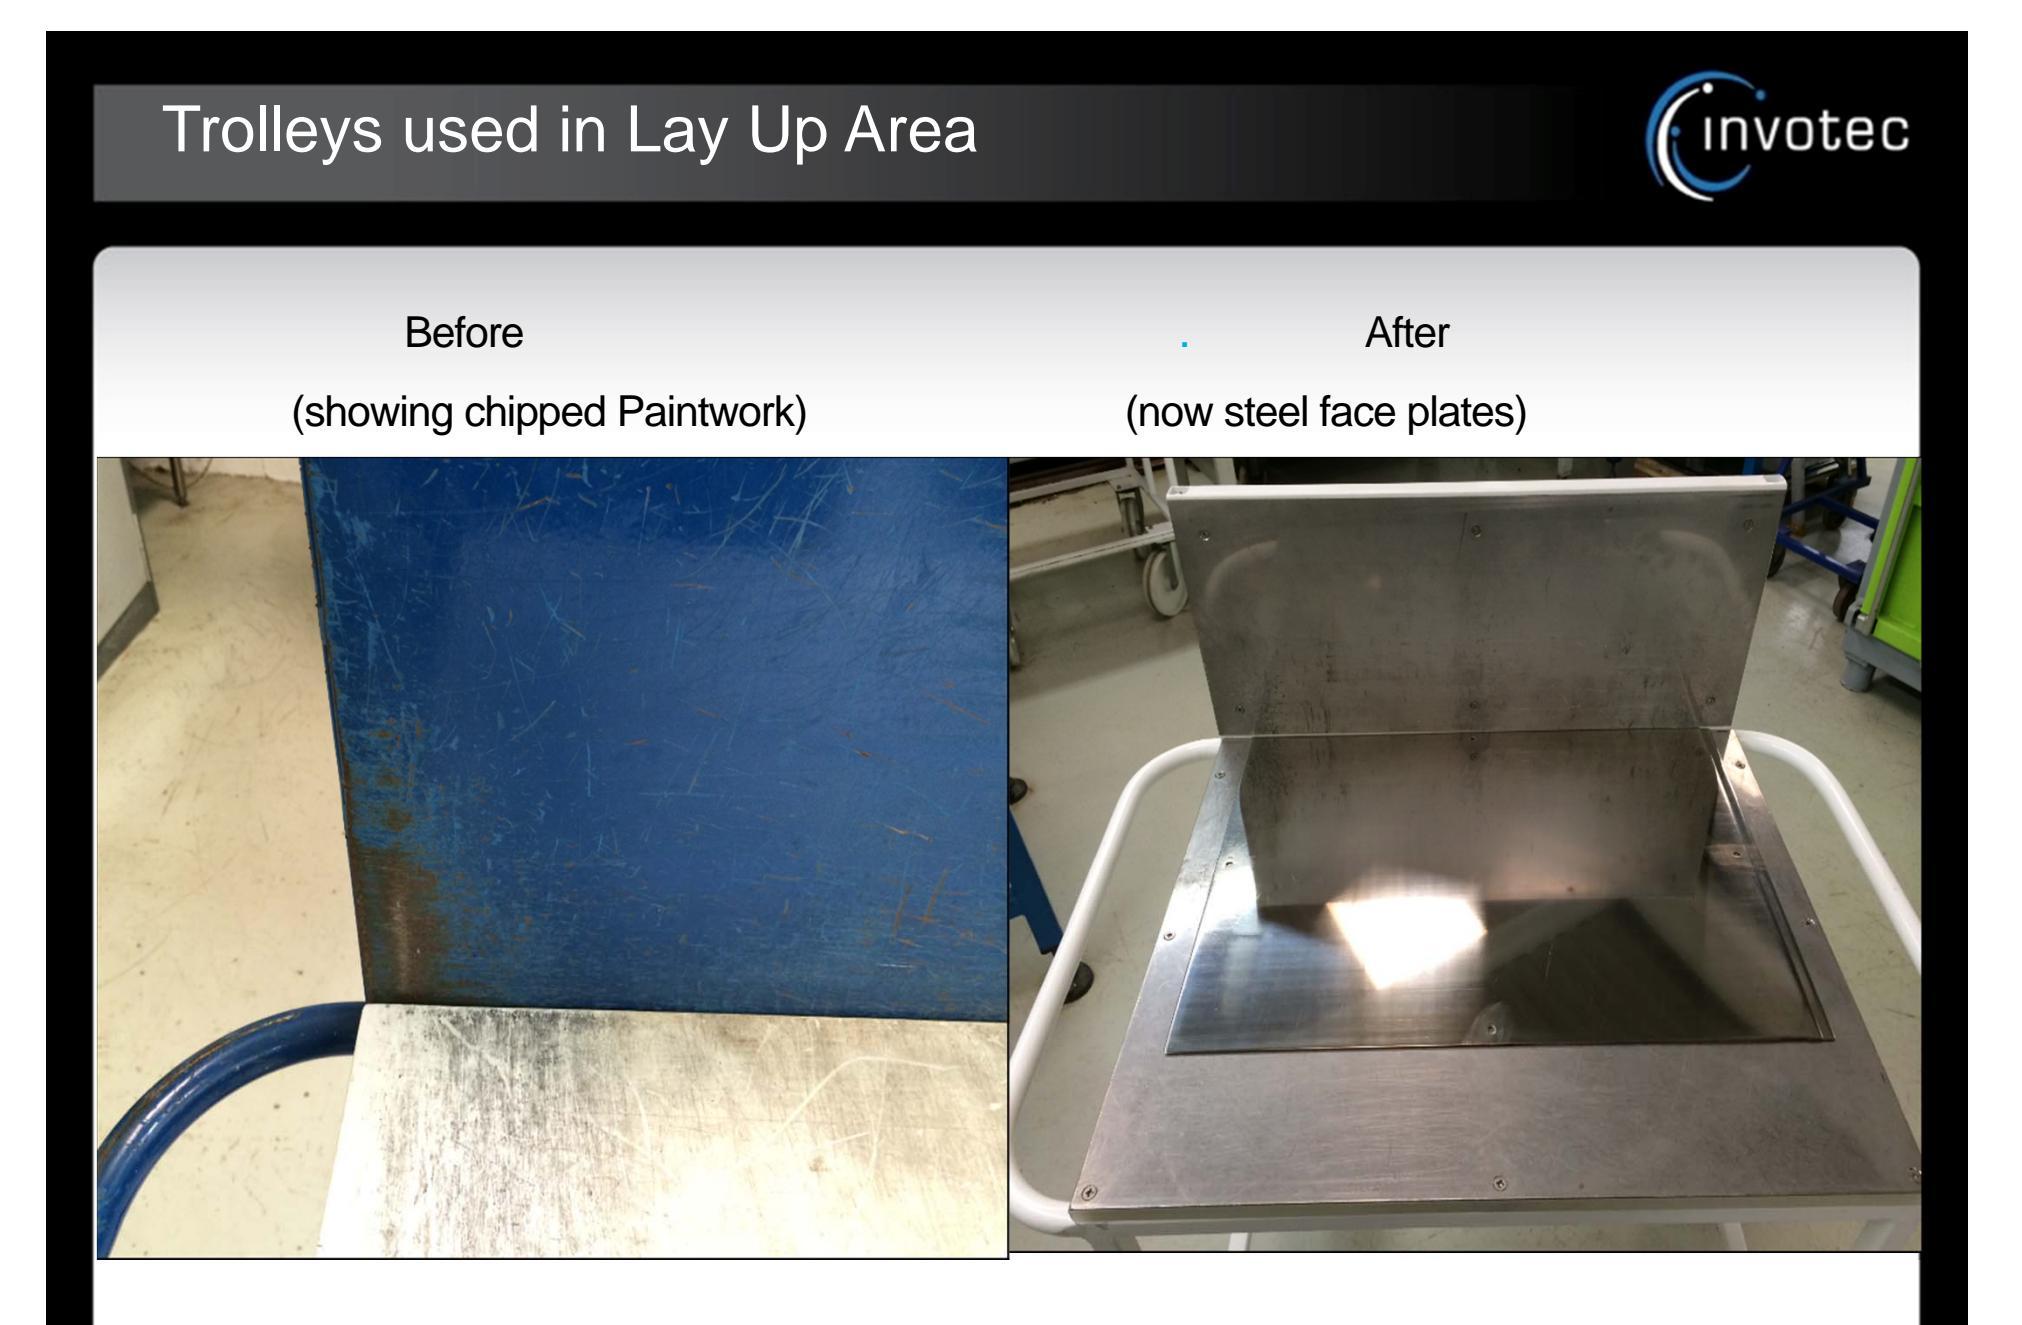
### Lay Up Area Improvements

Before

Old composite Furniture removed Plastic Trays replaced

Prepreg stacked Horizontal Inner Layers stacked Vertical

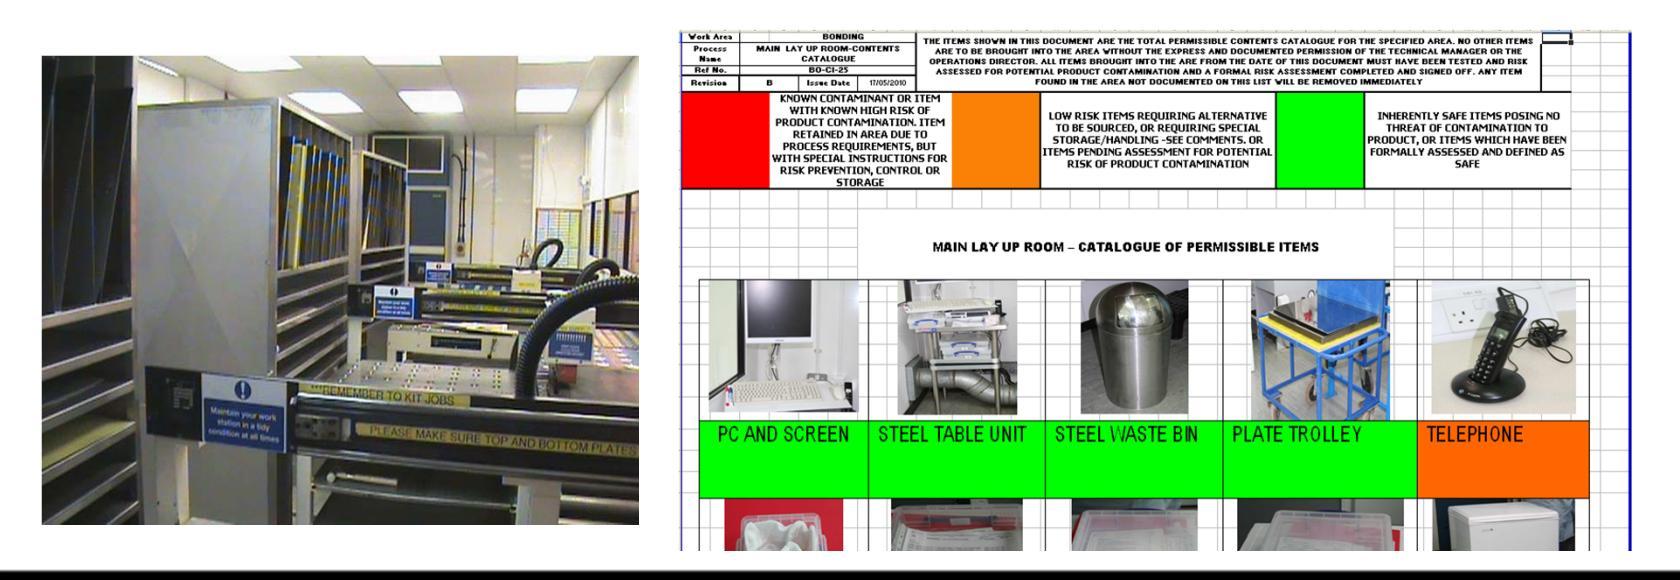
#### **Product Contamination Reduction**

We have developed improved 5S checks in areas such as Bonding Lay up to strictly control materials allowed into the area and prevent potential contaminants entering our products. Further 5S cleaning checks and instructions ensure that potential contamination in critical areas is held to an absolute minimum.

GREEN = OK

AMBER = LOW RISK

RED = RISK / CAREFUL USAGE AND REINSPECTION OF ITEM
